PHASE 2 INITIAL BOREHOLE DRILLING AND TESTING, IGNACE AREA

*WP01 Commissioning Report – Site Infrastructure
Setup for IG_BH03*

APM-REP-01332-0261

February 2020

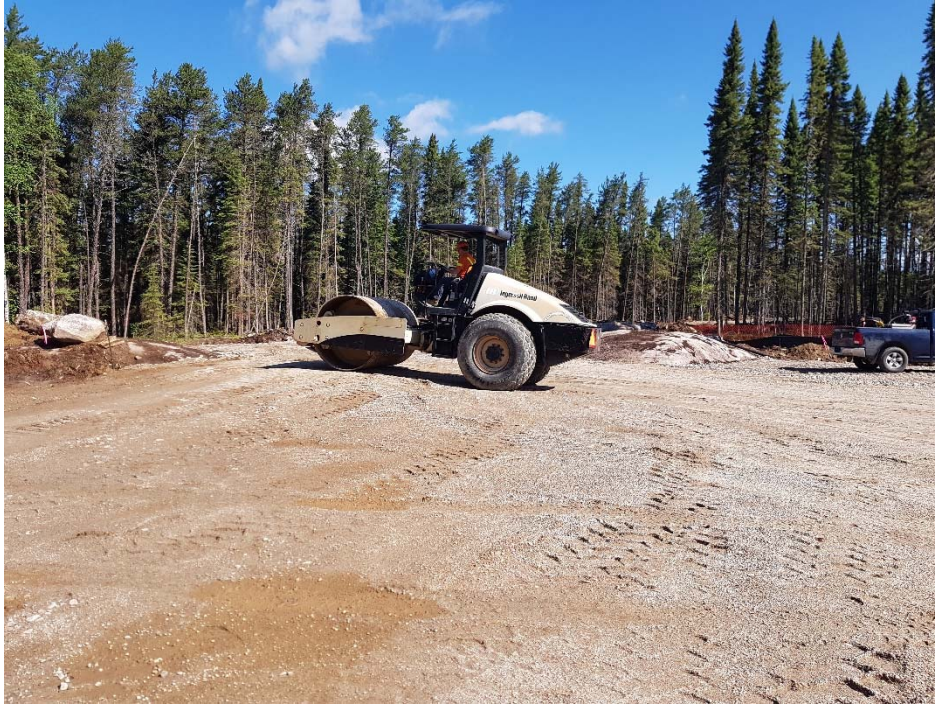
Subgrade material for the drill sites and pad of IG_BH03 was obtained from two sources. Approximately 6,040 m³ of subgrade material was sourced from the Butler Pit (MNRF Licence #668). An additional 2,140 m³ of subgrade material was sourced from the Dyment Road Borrow Pit (MNRF Licence #917). The subgrade material was compacted by excavator tracks, and final compaction was performed at the site using a smooth drum roller (Appendix D, Photo 1).

Photo 1: Facing north from the west side of the drill site. A vibratory roller was used to pack the final layer of subgrade material.

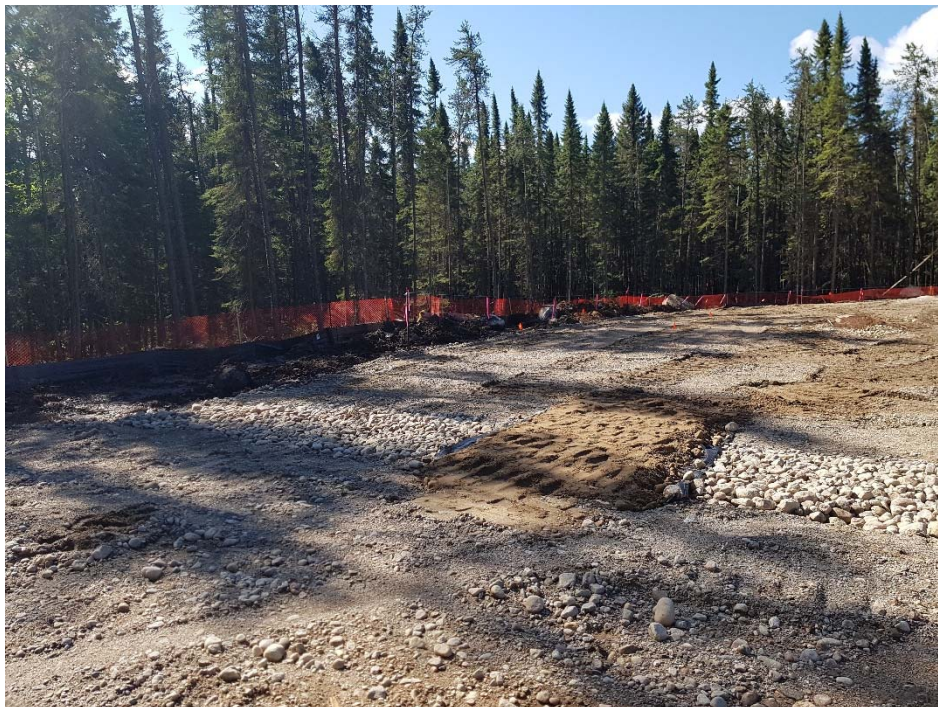
Photo 2: Facing south from the northeast corner of the drill site. To assist in self-drainage at the north end of the site, a drainage swale was dug into the subgrade, and was backfilled with cobbles to allow easterly movement of rainwater off of site. Walking paths were created next to the anticipated office trailer locations to mitigate tripping hazards associated with walking on cobbles.

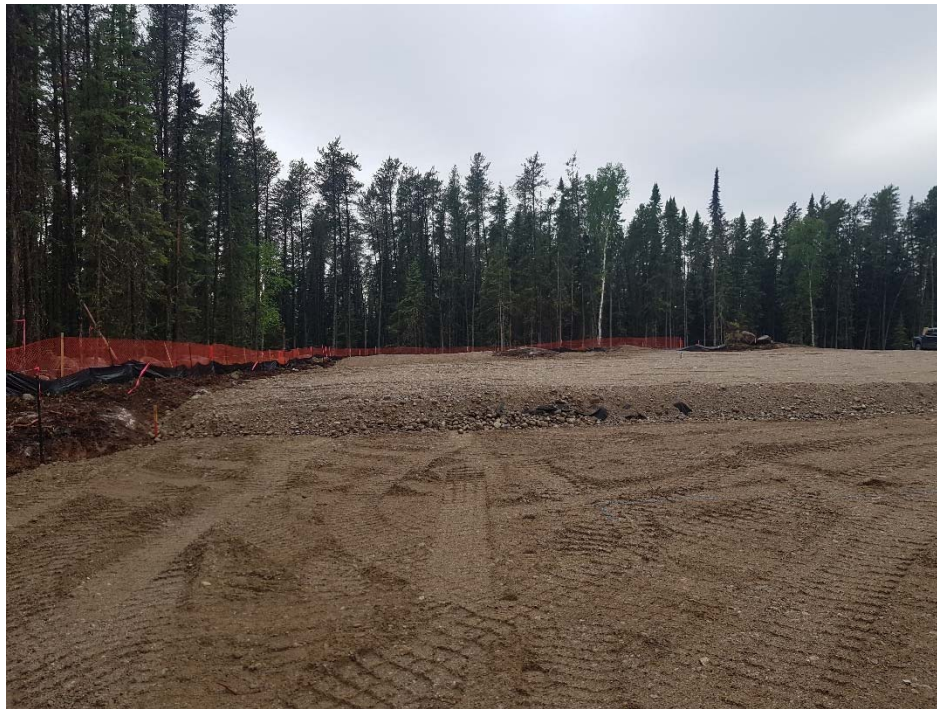
The drill pad was initially planned to be located on the northern side of the drill site but was moved to the southern side of site to take advantage of more level and firm ground conditions. The drill pad area was covered with a 0.15 to 0.2 m lift of cobble to provide stability and drainage. Layers of geotextile and cobble were continued in 0.15 to 0.2 m lifts until the drill pad was raised to the desired final grade. Each lift was compacted by track machine followed by a smooth drum roller. Placement, grading and compaction of the final layer of granular material at surface to create the finished grade and surface. The drill pad is elevated 40 cm higher than the rest of the drill site, and measures approximately 15 x 15 m in size (Appendix D, Photo 3). The drill pad is sloped towards a 1 m deep sump in the center.

Photo 3: Facing west towards the elevated drill pad at IG_BH03. Perimeter silt and snow fencing can be observed to the left, and access road approach can be observed on the right side.

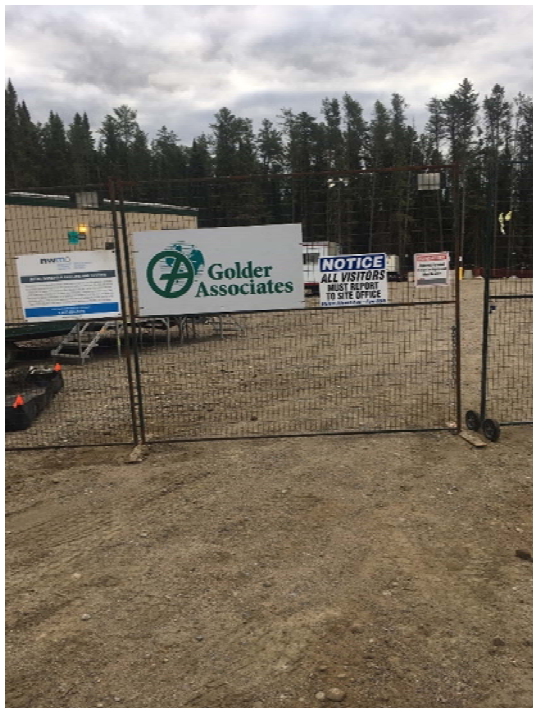
Following drill site construction, steel security fencing was erected around the site perimeter, to prevent site creep, demark work areas on the site, and to keep wildlife from entering the work area. Approximately 180 linear metres of 2.5 m tall fencing was installed around the perimeter of the drill site. Two lockable gates were installed on the western side of the site, to allow worker access to the drill site from the parking lot. In addition to the perimeter fencing, approximately 40 linear metres of 1.8 m tall fencing was installed inside the site, to define a work zone around the drill rig. Workers inside this drilling work zone were required to wear additional personal protective equipment. Two gates were installed along the interior fence to allow workers access to the exclusion zone area (Appendix D, Photos 4 and 5).

Photo 4: Facing east from the parking lot towards the site perimeter fencing of IG_BH03

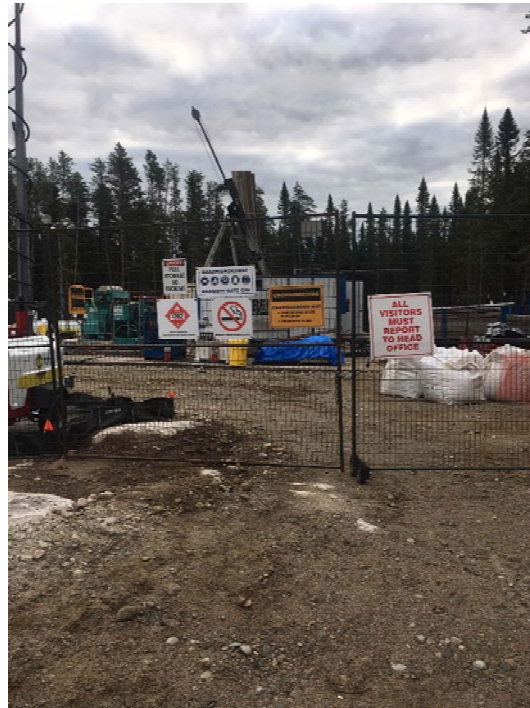
Photo 5: Facing east from the parking lot towards the fencing around the drill laydown area of IG_BH03

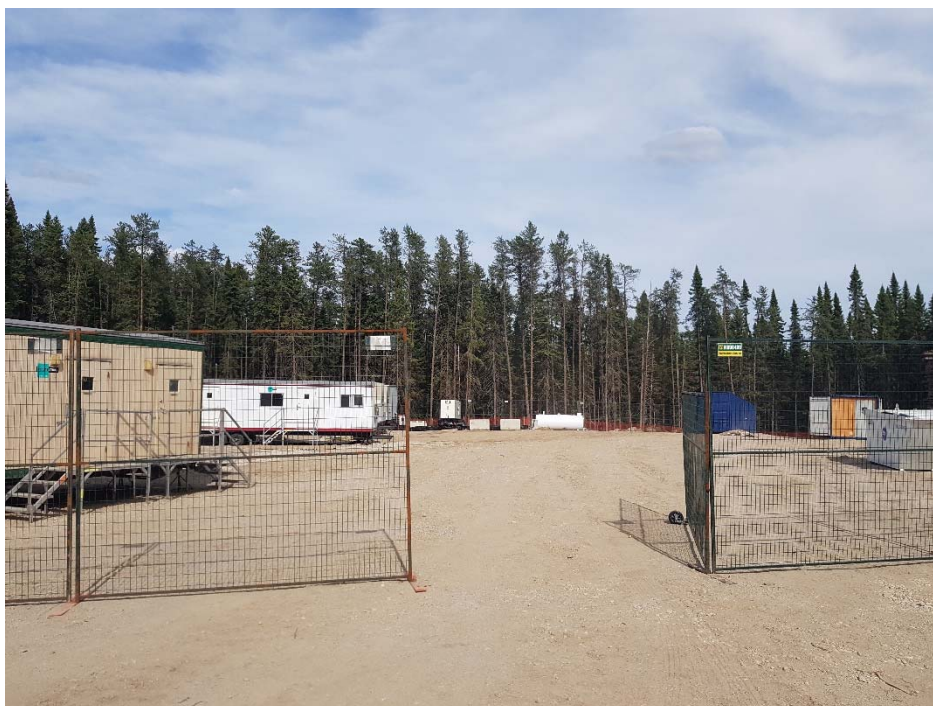
Three mobile office trailers were set up and levelled on the north side of site and function as field offices for Golder, the NWMO, and Rodren. The offices are all heated and air conditioned, have electrical power, cellular communication, and internet service via the local cellular network (Appendix D, Photo 6).

Photo 6: Facing East from the parking lot on June 27, 2019. Visible from the left are the wash cart, three office trailers, generator and fuel storage tank (not yet in place), core storage seacan, core logging seacan, garbage and recycling bins.

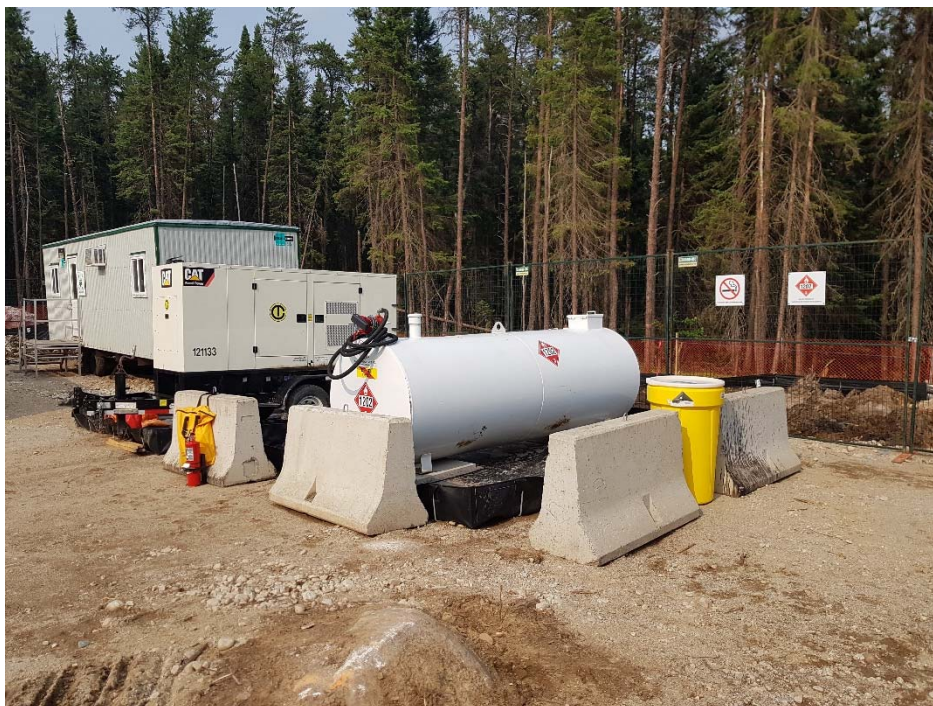
A 4,500 L double-walled fuel storage tank was located adjacent to the generator, so that refueling of the generator could be performed directly from the fuel storage tank. The fuel tank was also placed inside secondary containment with an overflow storage capacity of 5,350 L, which exceeds the capacity of fluids within the tank. The tank was placed on concrete pads to provide a stable foundation beneath the tank. Fibre matting was placed beneath the concrete pads to prevent punctures to the containment from the concrete pads. The fuel tank was surrounded by four concrete bollards to protect it from vehicular traffic and heavy machinery. Photographs of the generator and fuel storage tank are available in Appendix D, Photo 7).

Photo 7: Facing north towards the site generator and fuel storage tank. Concrete barriers were placed around the fuel storage tank to protect it from inadvertent contact by heavy equipment.

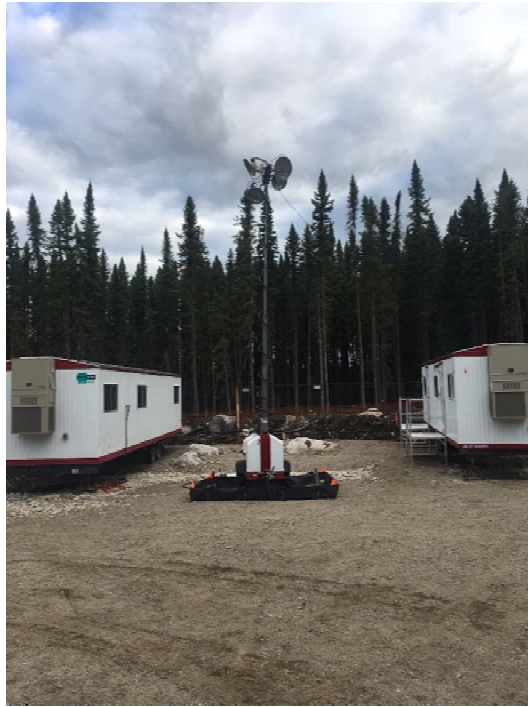
Four 8-kW diesel powered light towers are installed at the site to provide lighting during the 24-hour drilling and testing operations. The light towers were placed at the approximate four corners of the site to allow for even distribution of light. The light tower placement also considered: ground stability, level of activity in the area, and the ability for accessing the light towers by truck for refueling or repairs. The light towers were all placed within secondary spill containment prior to use. The secondary containments were sized so that the entire light tower footprint would be within containment, and therefore, the capacity of the containments (2,800 L) exceeds the volume of fuel and oil within the light towers (133 L). The typical installation can be viewed in Appendix D, Photo 8).

Photo 8: Facing north towards one of four 8-kilowatt light towers. Each light tower was placed in a secondary containment berm to capture any potential spills. The site cell phone signal booster is visible at the top of the light tower.

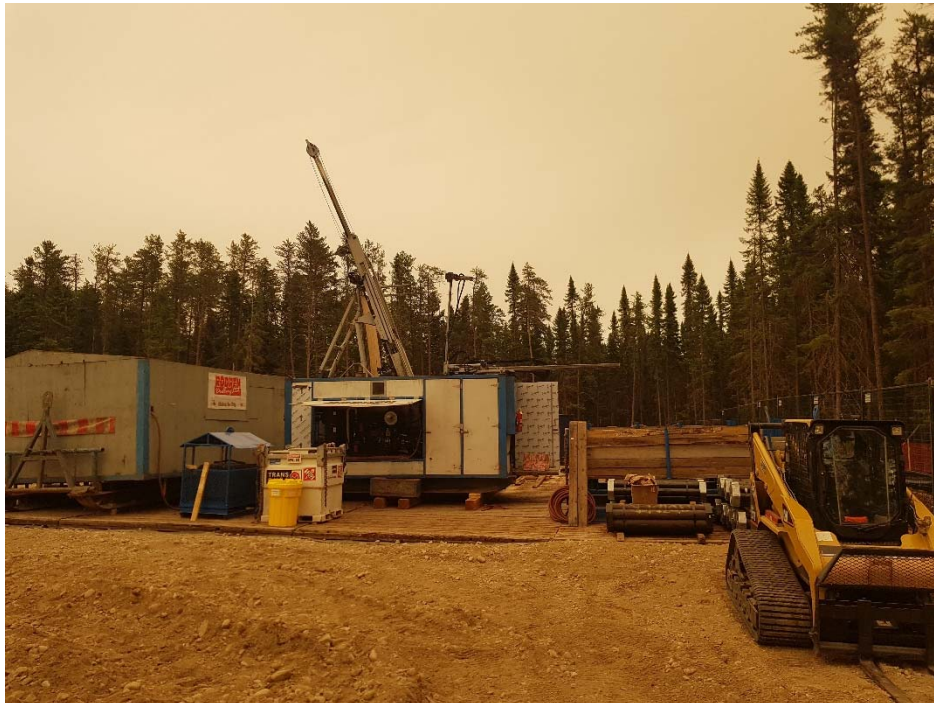
An auxiliary Kubota GL 7000 diesel generator was utilized by Rodren Drilling to supply any additional power requirements that they might need. The generator was equipped with GFCI outlets, and power is distributed through temporary electrical extension cords that are set up as required. The generator was housed within a containment structure and placed next to Rodren's 1,500 L fuel storage tank for ease of refueling. The 1,500 L "fuel cube" is double-walled fuel storage tank with a built-in spill containment system. Rodren's auxiliary generator and fuel storage tank are shown in Appendix D, Photo 9.

Photo 9: Facing east towards the drill pad. From the left are the drill water settlement tanks, auxiliary generator, fuel storage tank, drill rig, drill rod holders, and temporary skid steer.

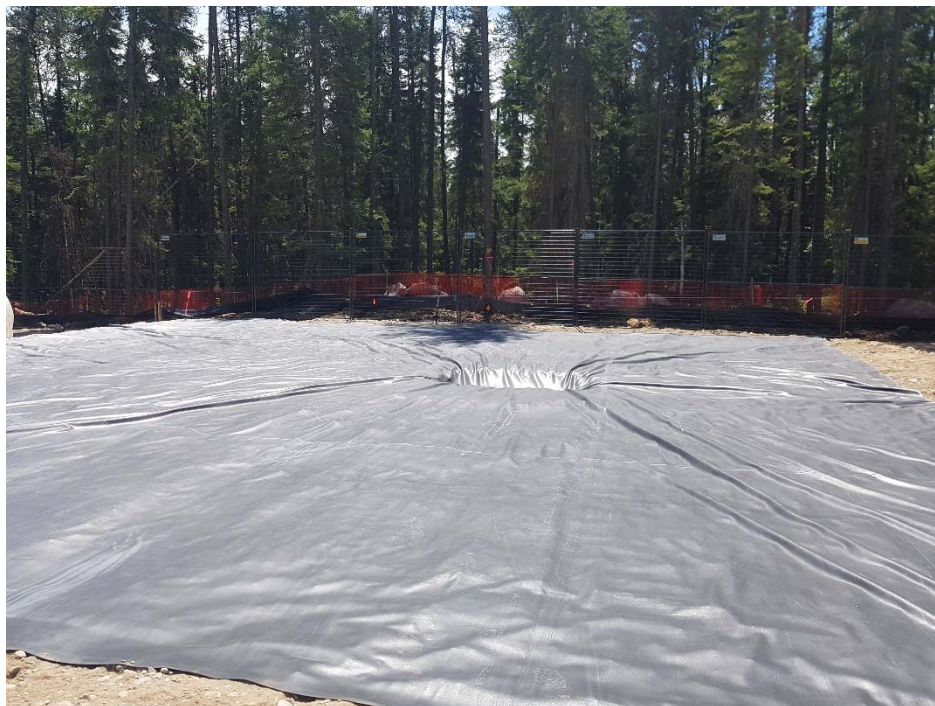
Photo 10: Facing south towards the secondary containment liner and sump used to collect spilled drill water on the drill pad. The drill pad is graded towards the central sump.

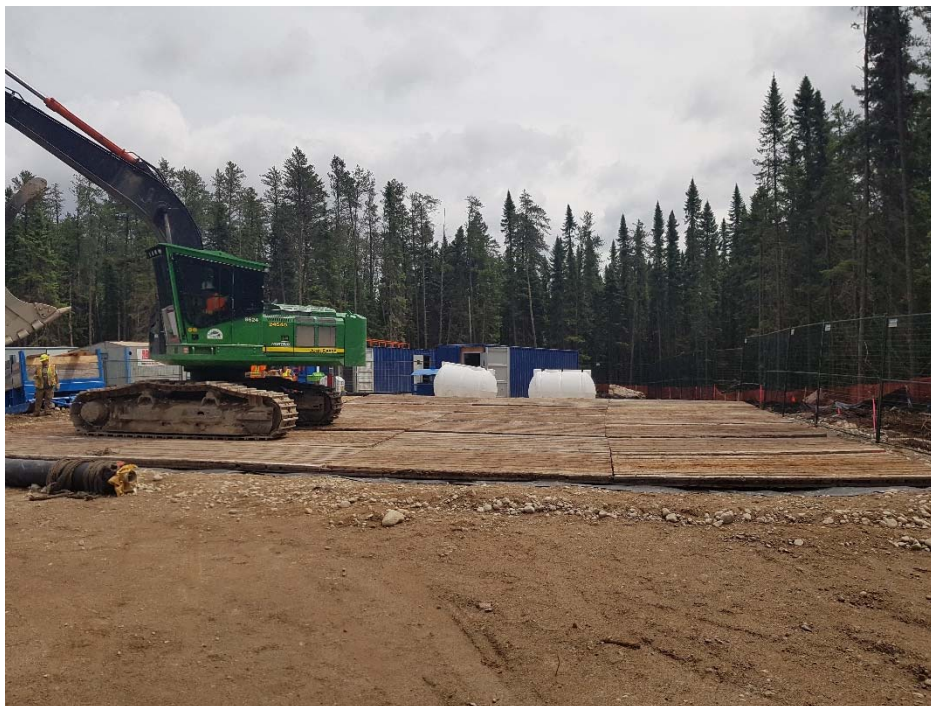
the main secondary containment system beneath the drill area. Rig matting was placed over top of the central sump system, to provide a level and solid foundation for the drill rig infrastructure (Appendix D, Photo 11)

Photo 11: Facing east towards the rig matting which was placed over top of the drill pad secondary containment liner

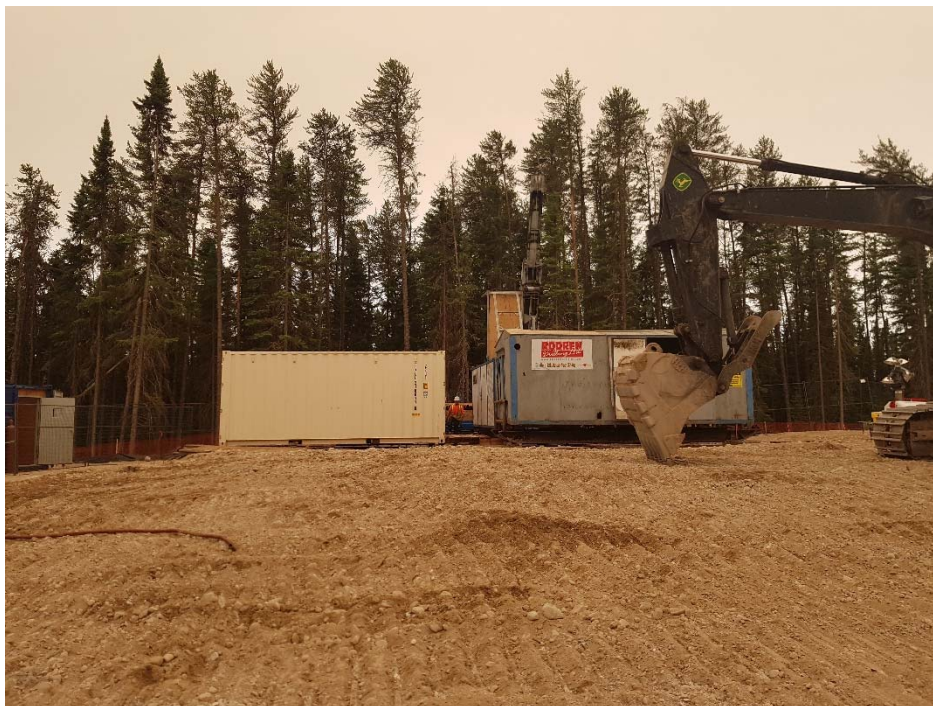
Drill cuttings were initially removed from the drill water through the use of three-stage gravity settlement tanks. The gravitational settlement was enhanced by the use of Magnasol AN1, and AMC Flock Blocks, both of which are anionic flocculants which slowly dissolve into the settlement water to assist in settlement. The gravitational settlement tanks were used from the start of drilling until August 17, 2019, at which point the settlement tanks were replaced with a diesel-powered centrifuge to simplify the drill water circulation system and to allow for easier disposal of the drill cuttings. Once the drill water passes through centrifuge, it is reused as drill fluid down-hole. The removed drill cuttings are shovelled into waste storage containers for disposal off site. The settlement tank building is pictured in Appendix D, Photo 12, and the centrifuge is pictured in Photo 13.

Photo 12: Facing south towards the fluorescein storage tanks on the left, and the drill water settlement tanks on the right.

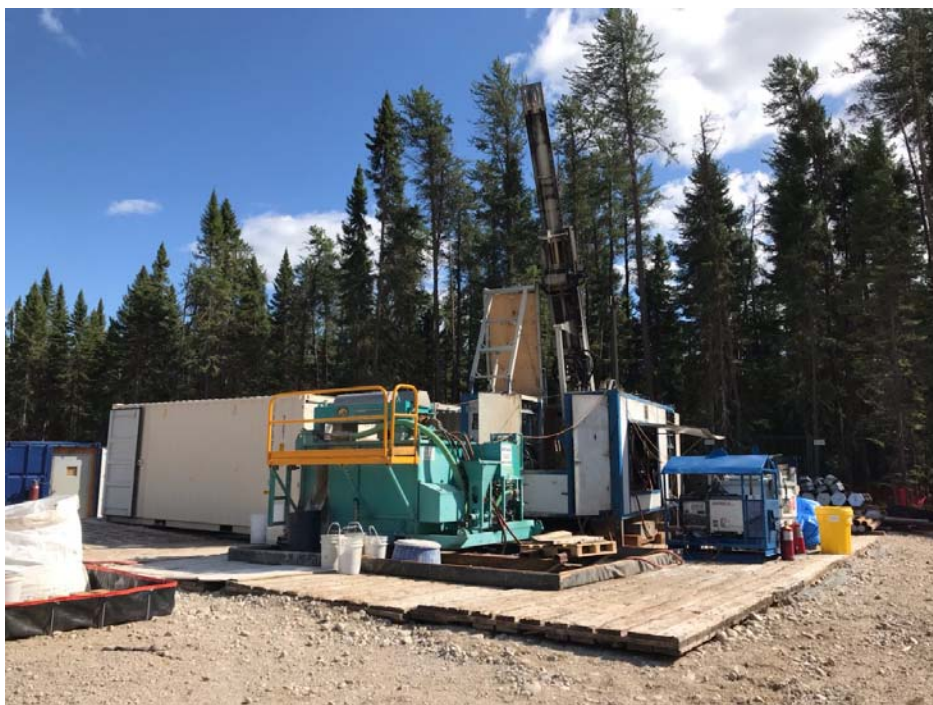
Photo 13: Facing southeast towards the centrifuge which replaced the drill water settlement tanks. Drill cutting storage can be observed in containment berm on the left side of the photo.

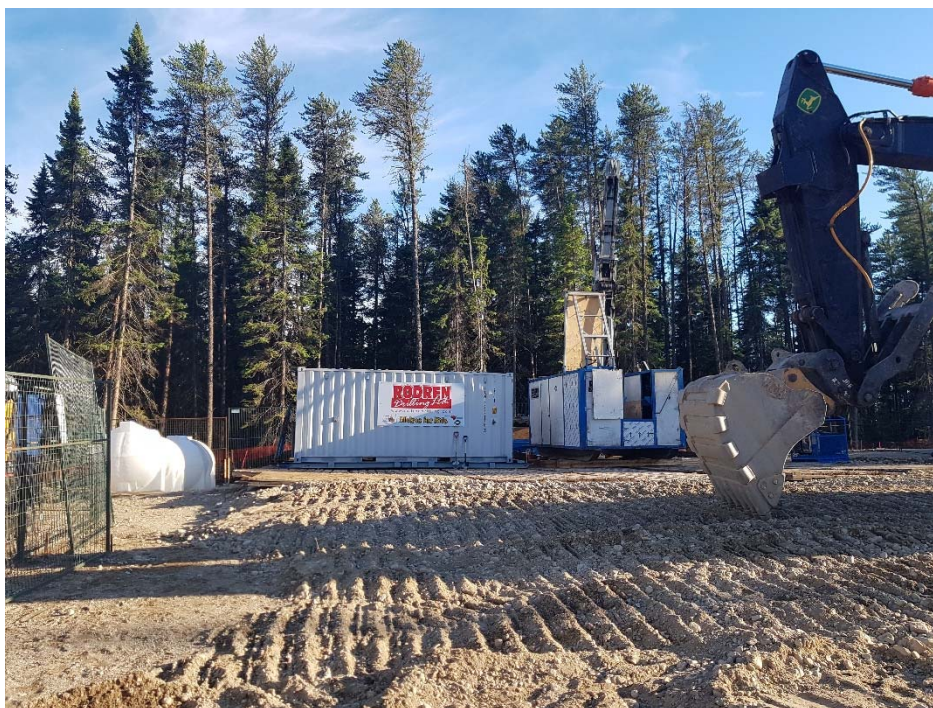
Photo 14: Facing south towards the drill rig, and core extraction shack, sitting on the drill pad secondary containment and rig matting.

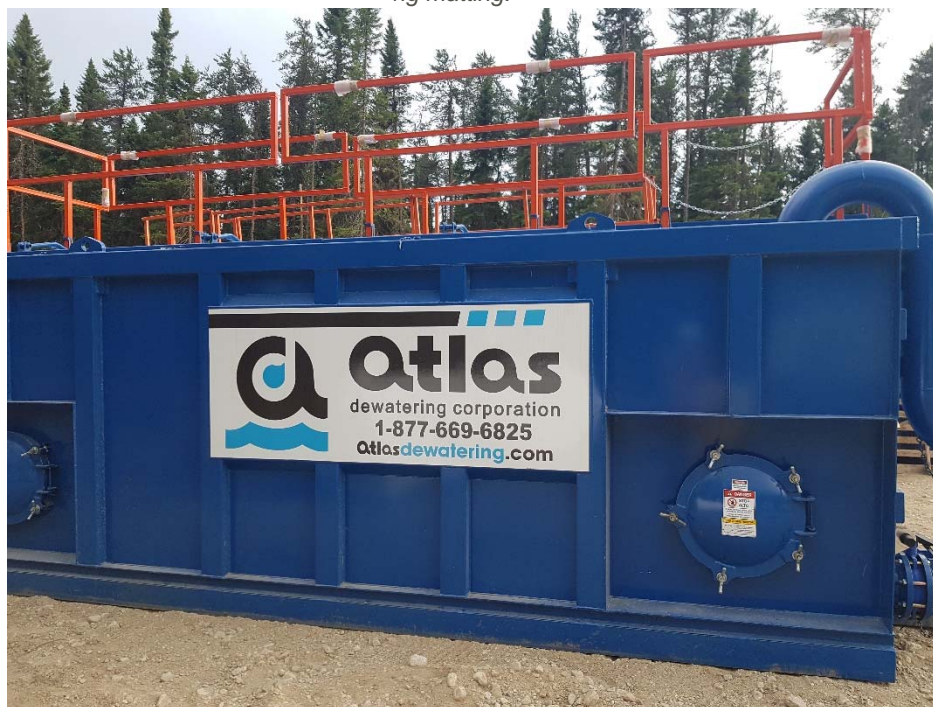
Photo 15: Facing south towards one of the two 28,350 L baker tanks located on the east side of site. The baker tanks are used to store source water supplied from the Township of Ignace.

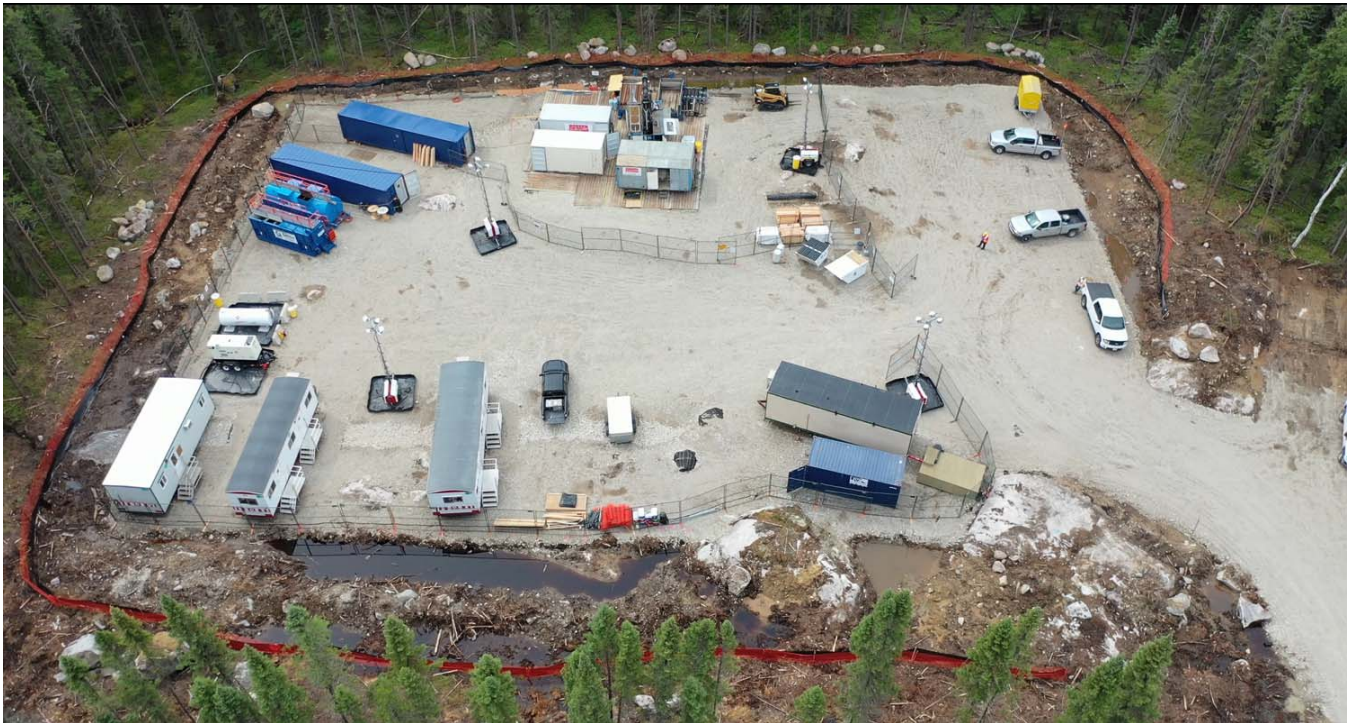
Photo 16: Facing south towards the commissioned IG_BH03
