# PHASE 2 INITIAL BOREHOLE DRILLING AND TESTING AT IG\_BH04/05/06 - IGNACE AREA

*WP01 Site Demobilization Report – Site  
Infrastructure for IG\_BH05*

**APM-REP-01332-0312**

**October 2022**

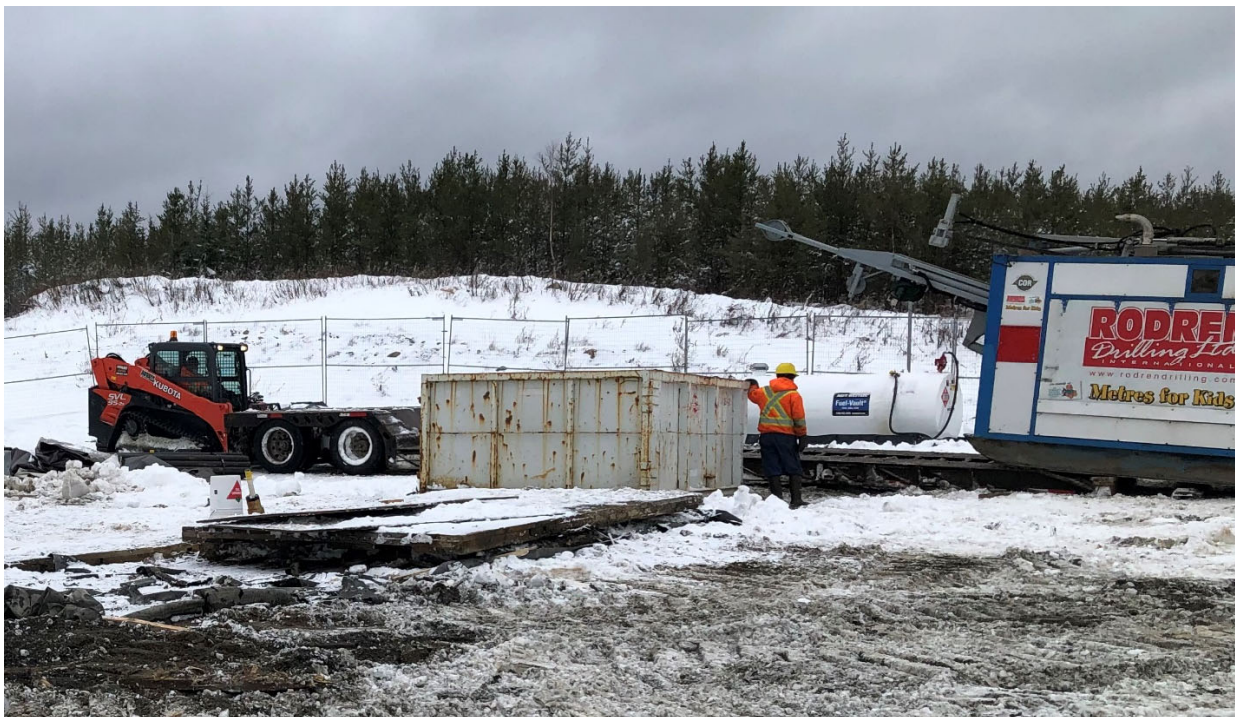
Photo 2 – Loading the Rodren drill rig onto a flat bed trailer for demobilization – November 16, 2021

The EF-75 was demobilized by Rodren from IG\_BH05 on November 16, 2021 using a flat deck transport truck to Rodren's facility in Winnipeg, Manitoba (Appendix A, Photo 2).

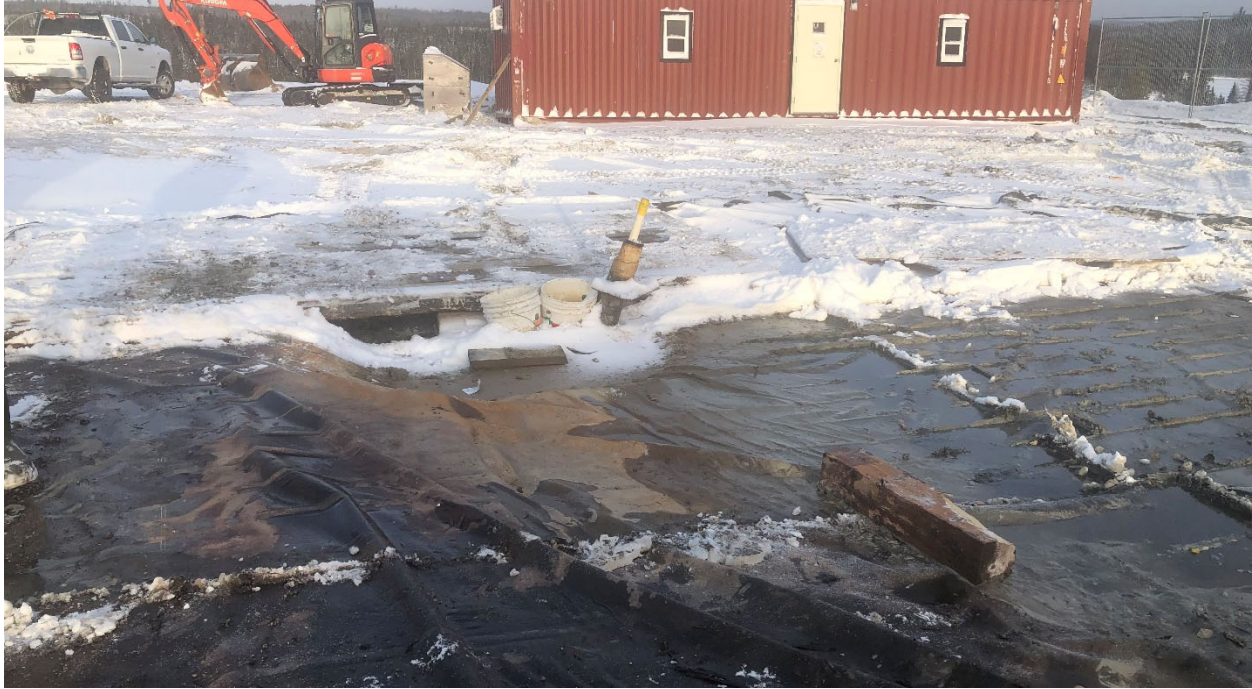
*Photo 3 – Rig mats removed from IG\_BH05 drill pad, secondary containment in process of being removed - November 18, 2021*

The rig mats were removed from the drill pad on November 18, 2021 and stacked on-site in preparation for off-site demobilization. On November 23, 2021 the rig mats were loaded onto a transport truck and transported off-site to Rodren's facility in Winnipeg, Manitoba.

The secondary containment system was disassembled and placed into the waste bin on November 18, 2021 and disposed off-site by Obish's subcontractor, B&M Delivery, on November 24, 2021 (Appendix A, Photo 3).

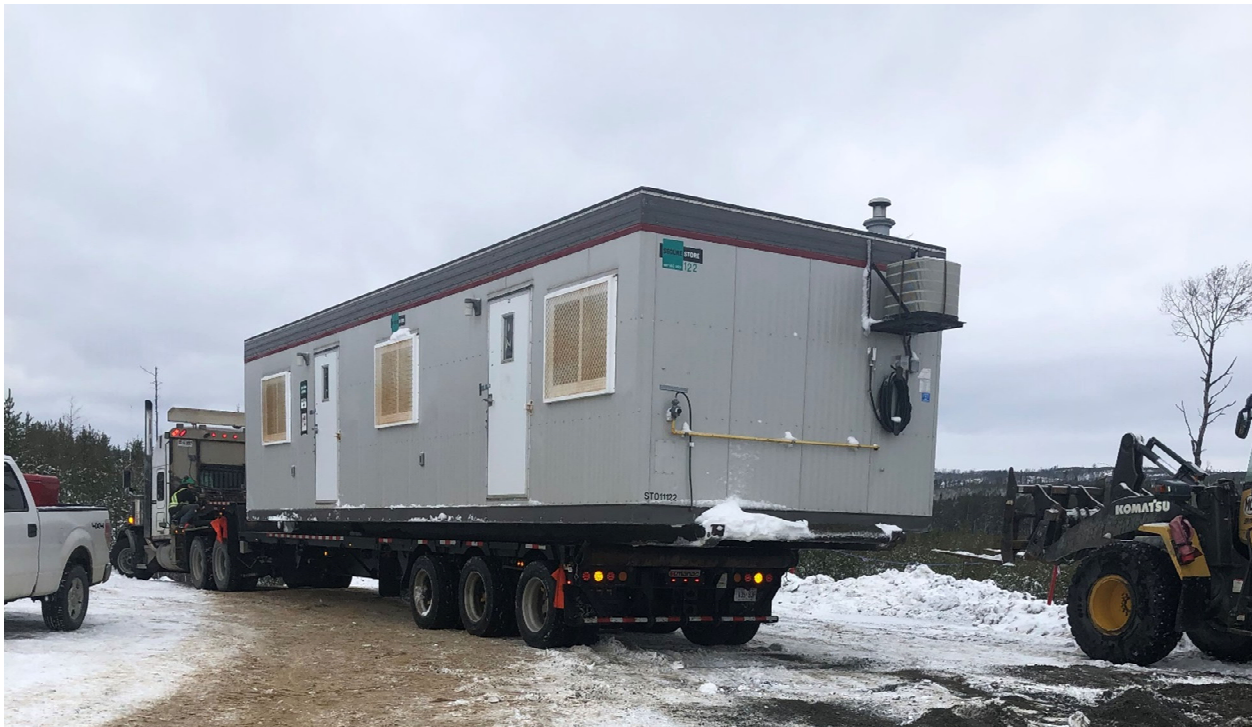
*Photo 4 – Demobilization of office trailer from IG\_BH05 – November 17, 2021*

The Golder and Rodren office trailers were demobilized from IG\_BH05 on November 17, 2021 and the NWMO/WLON office trailer was demobilized on November 17, 2021 by Secure Store (Appendix A, Photo 4).

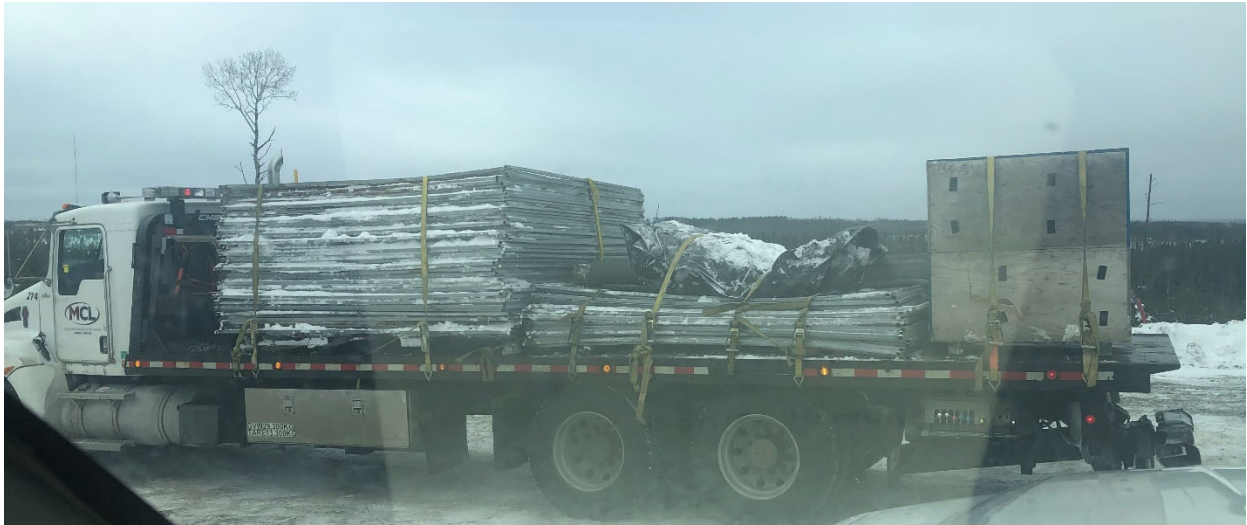
*Photo 5 – Demobilization of perimeter fencing from IG\_BH05 – November 18, 2021*

Obish took down all perimeter and interior fencing at IG\_BH05 on November 16 to 18, 2021 and transported the fencing off-site on November 18, 2021 (Appendix A, Photo 5).

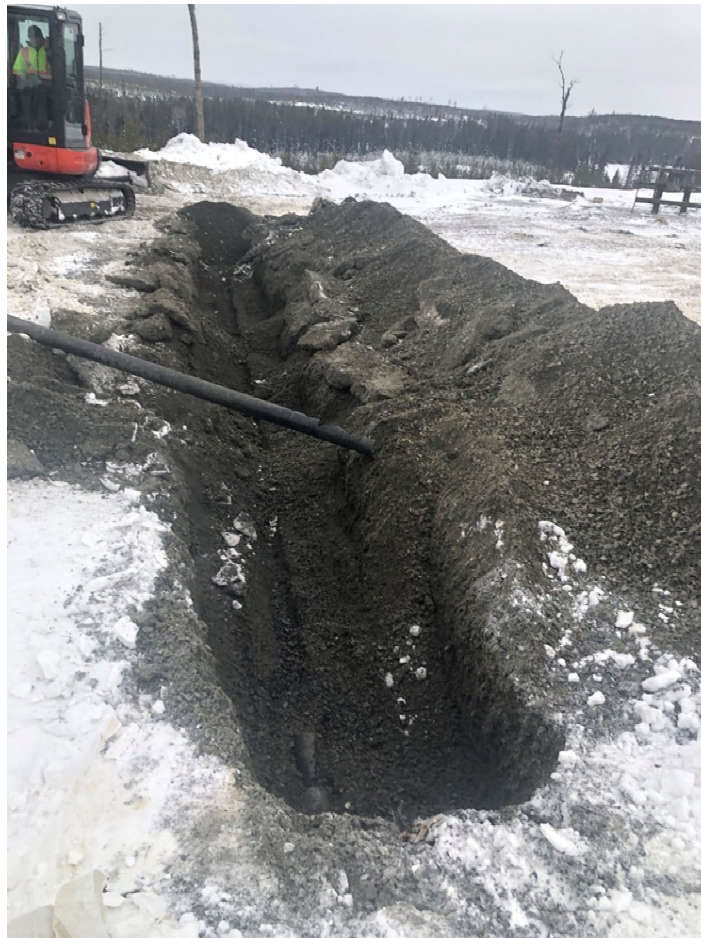
*Photo 6 – Underground electrical conduit excavation and removal – November 18, 2021*

On November 18, 2021 all underground electrical conduit infrastructure including PVC piping, grounding wires, and grounding plates were excavated and removed by Obish from IG\_BH05 (Appendix A, Photo 6).

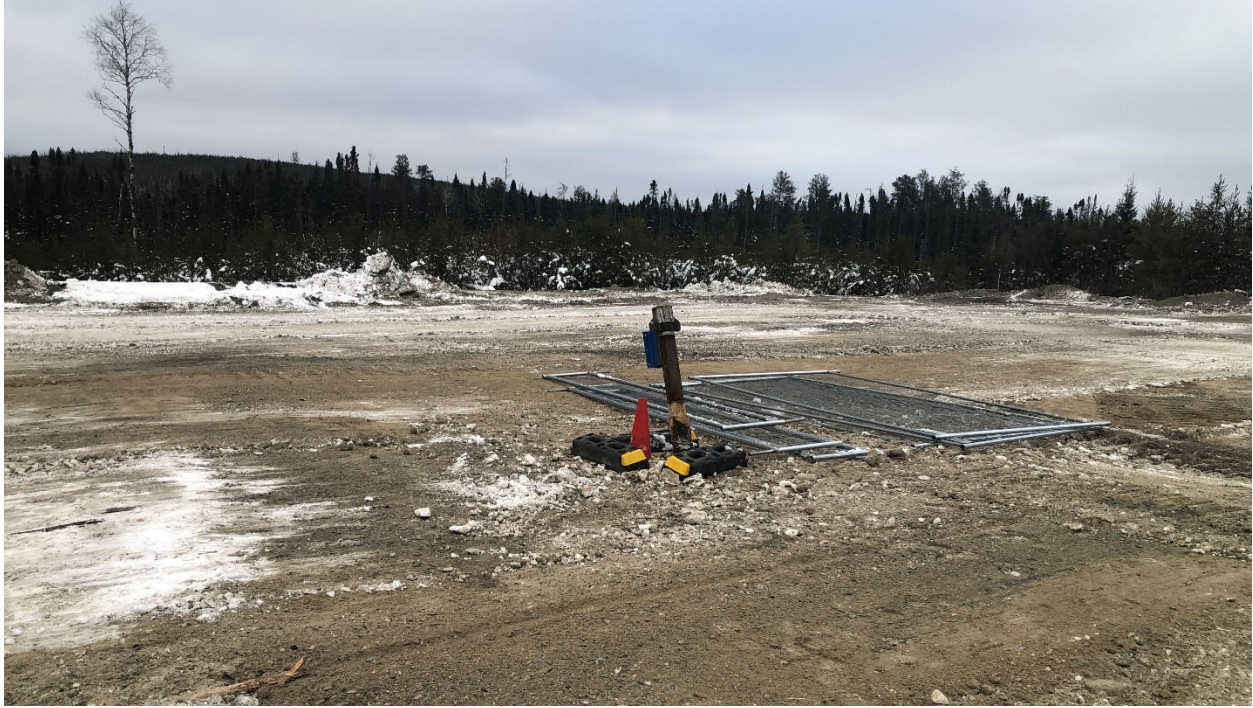
*Photo 7 – Final site condition with final wellhead casing installed, NWMO supplied locks in place, grading complete - November 20, 2021*

A threaded HWT extension casing with a lockable lid was installed at IG\_BH05 by a Rodren welder on November 19, 2021. On November 20, 2021 Rodren completed final surface grading of IG\_BH05 with a bulldozer (Appendix A, Photo 7).

After grading was completed, security fencing provided by the NWMO was installed around the borehole and the casing lid was secured with locks provided by the NWMO.

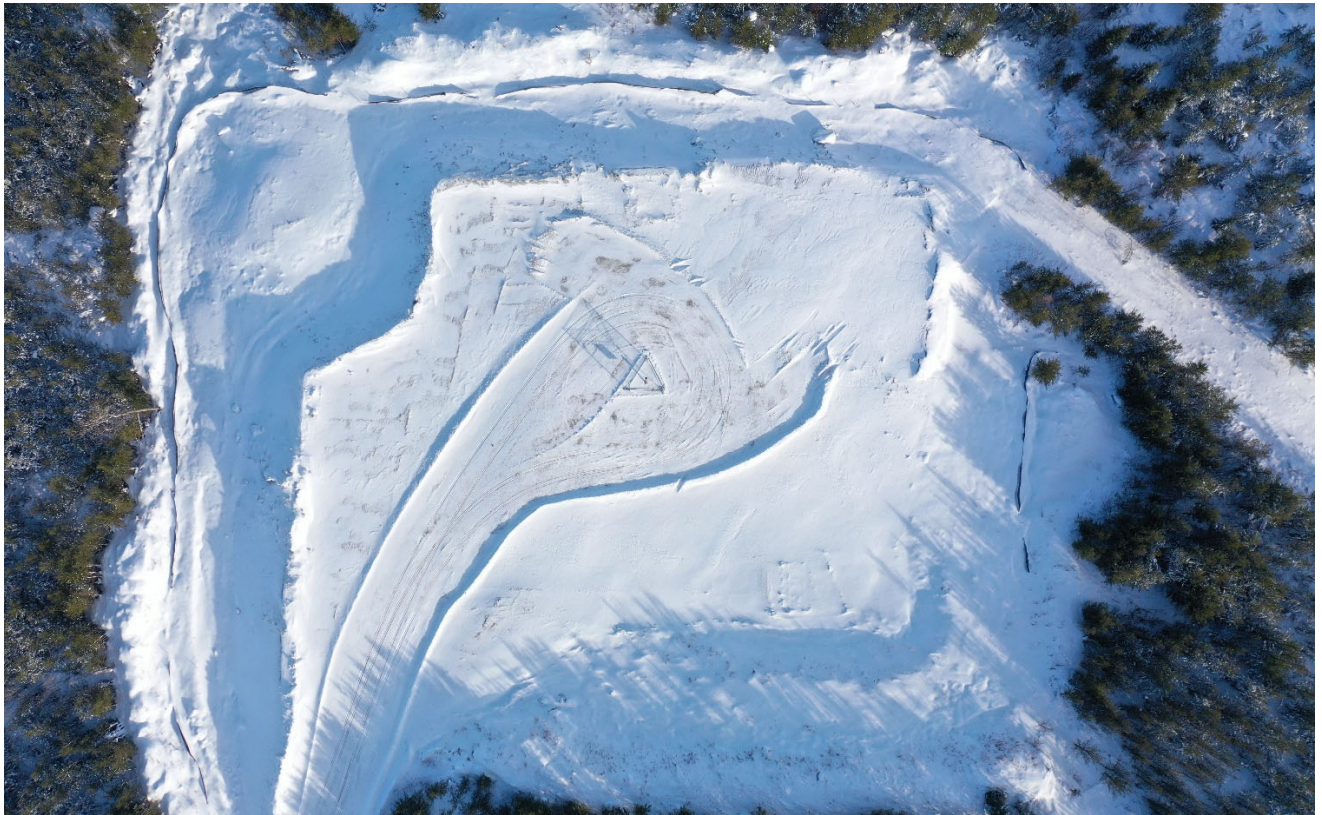
An aerial photo of the IG\_BH05 drill site was taken following demobilization on December 10, 2021 by Geoff Crann of the NWMO (Appendix A, Photo 8).

*Photo 8 – Aerial drone photo of IG\_BH05 following demobilization – December 10, 2021.*

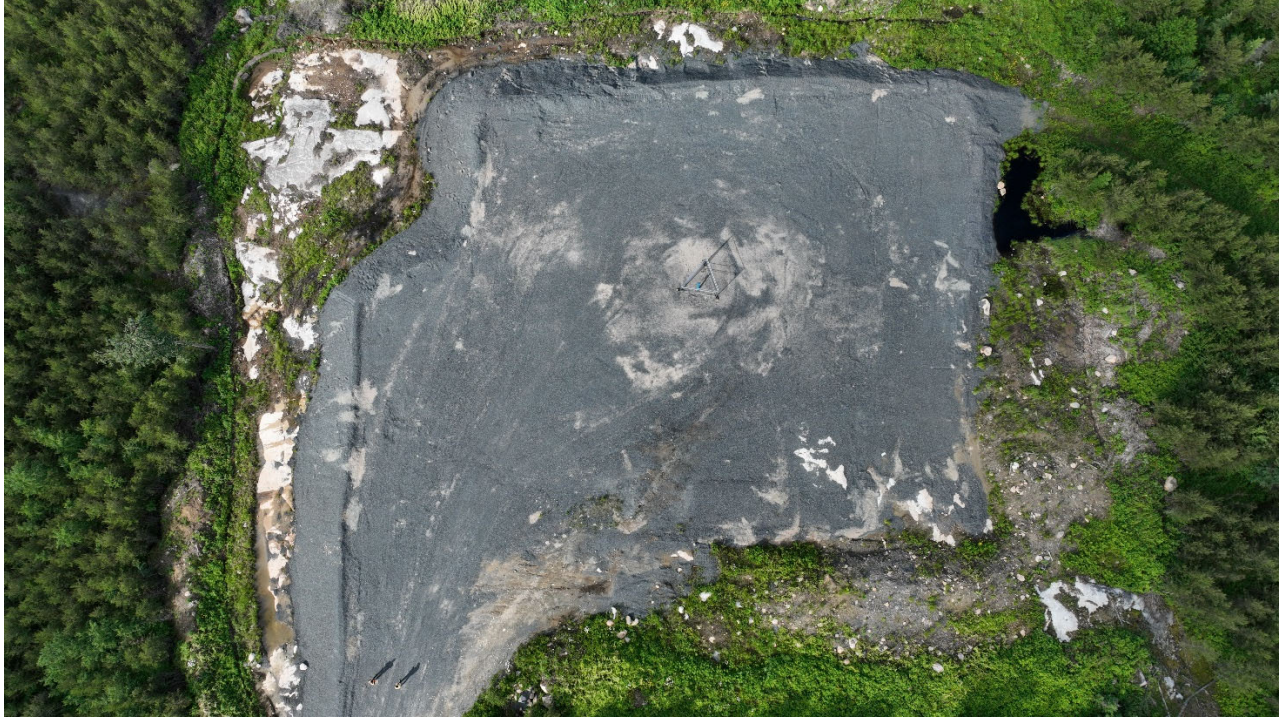
At the end of the day, a final walkover was completed by Geoff Crann and Warren Willis, and it was confirmed there was no litter or staining observed, the site conditions were acceptable, and no additional work was required.

An additional aerial photo of the IG\_BH05 drill site was be taken in post-thaw conditions on June 28, 2022 by Geoff Crann of the NWMO (Appendix A, Photo 9).

*Photo 9 – Aerial drone photo of IG\_BH05 following post-thaw clean-up and inspection – June 28, 2022.*

Golder returned to IG\_BH05 on June 28, 2022 to complete final site clean-up and decommissioning activities in post-thaw conditions. The NWMO's Geoff Crann met on-site with Warren Willis, Golder's site supervisor, and a labourer from Obish. Sandbags, general debris, garbage, gravel with minor staining, and the perimeter silt fence were collected and removed from the site.

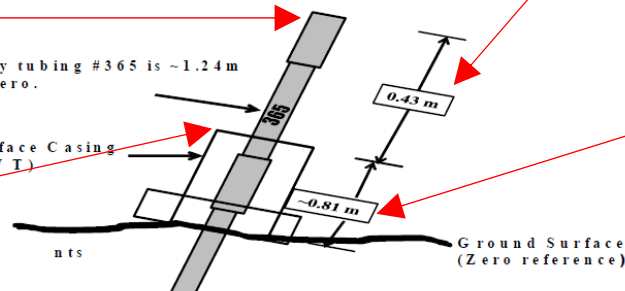
Distance along hole between  
original HWT casing and top of  
Westbay riser pipe (0.43 m)

Distance along hole between  
original HWT casing and ground  
surface reference point (0.81m)

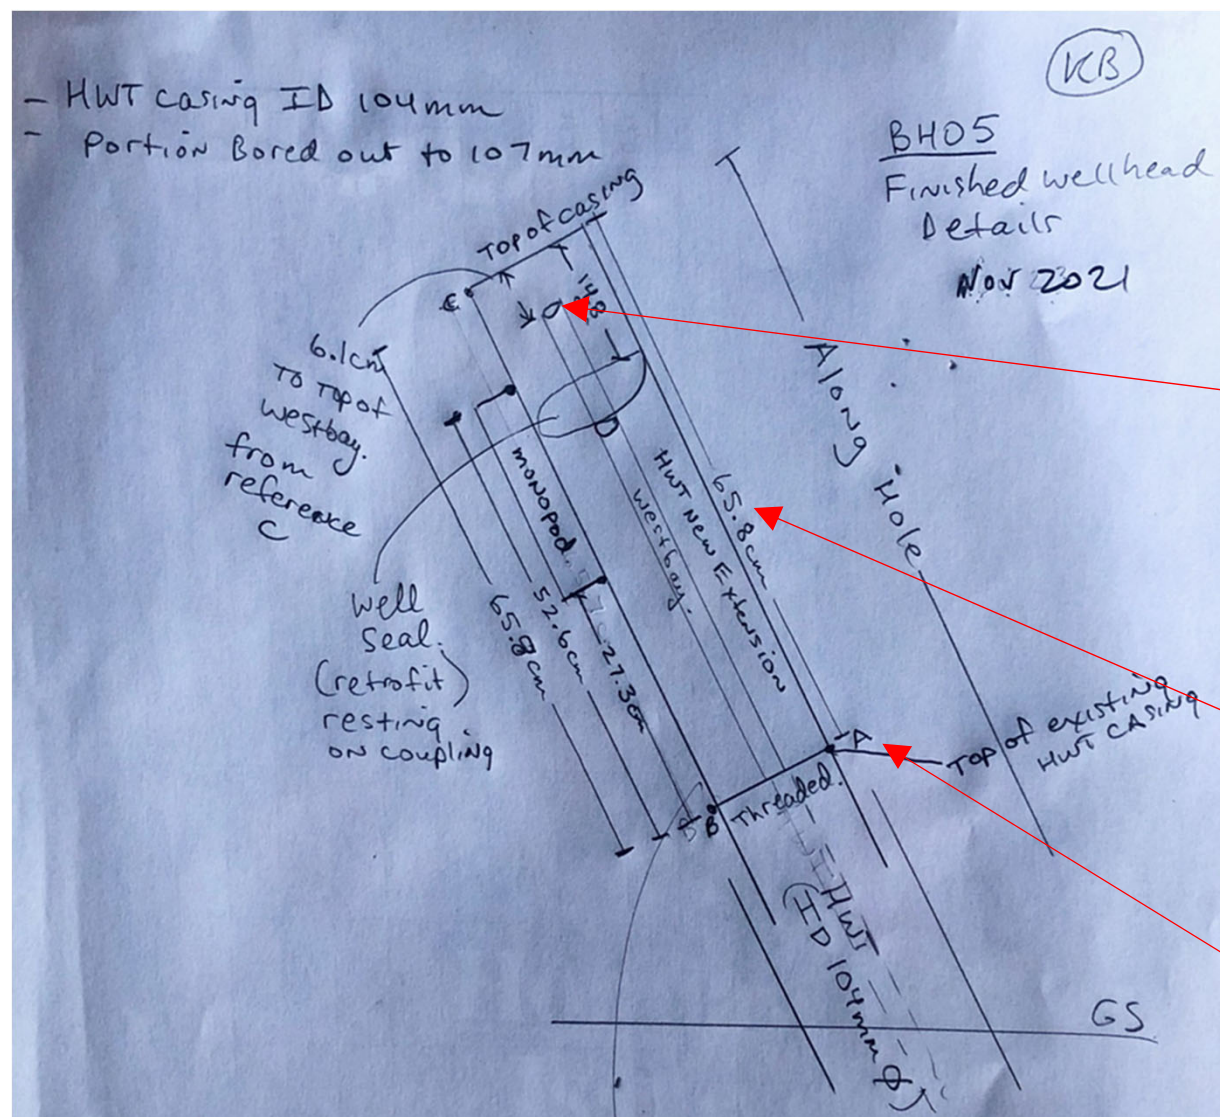
# Attachment 4 – Sketch of Extension to IG\_BH05 surface casing and Westbay riser pipe (by Site Supervisor)

Top of Westbay riser pipe (after extension was added)  
Net length of extension = 0.167 m

Length of HWT extension added = 0.658 m
