PHASE 2 INITIAL BOREHOLE DRILLING AND TESTING AT IG_BH04/05/06 - IGNACE AREA

*WP01 Site Demobilization Report – Site
Infrastructure for IG_BH06*

APM-REP-01332-0353

Golder Associates Ltd.

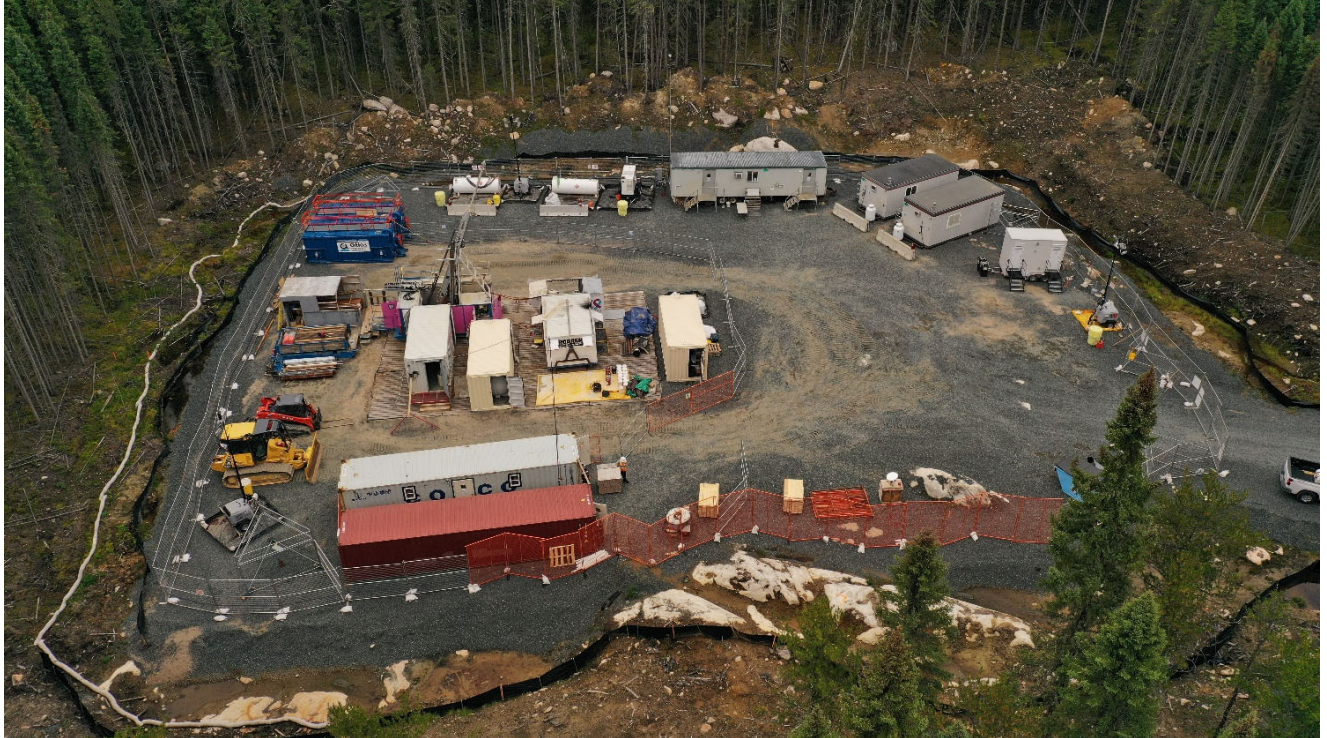
Photo 1 - Drone photo of the commissioned IG_BH06 site, taken September 2021.

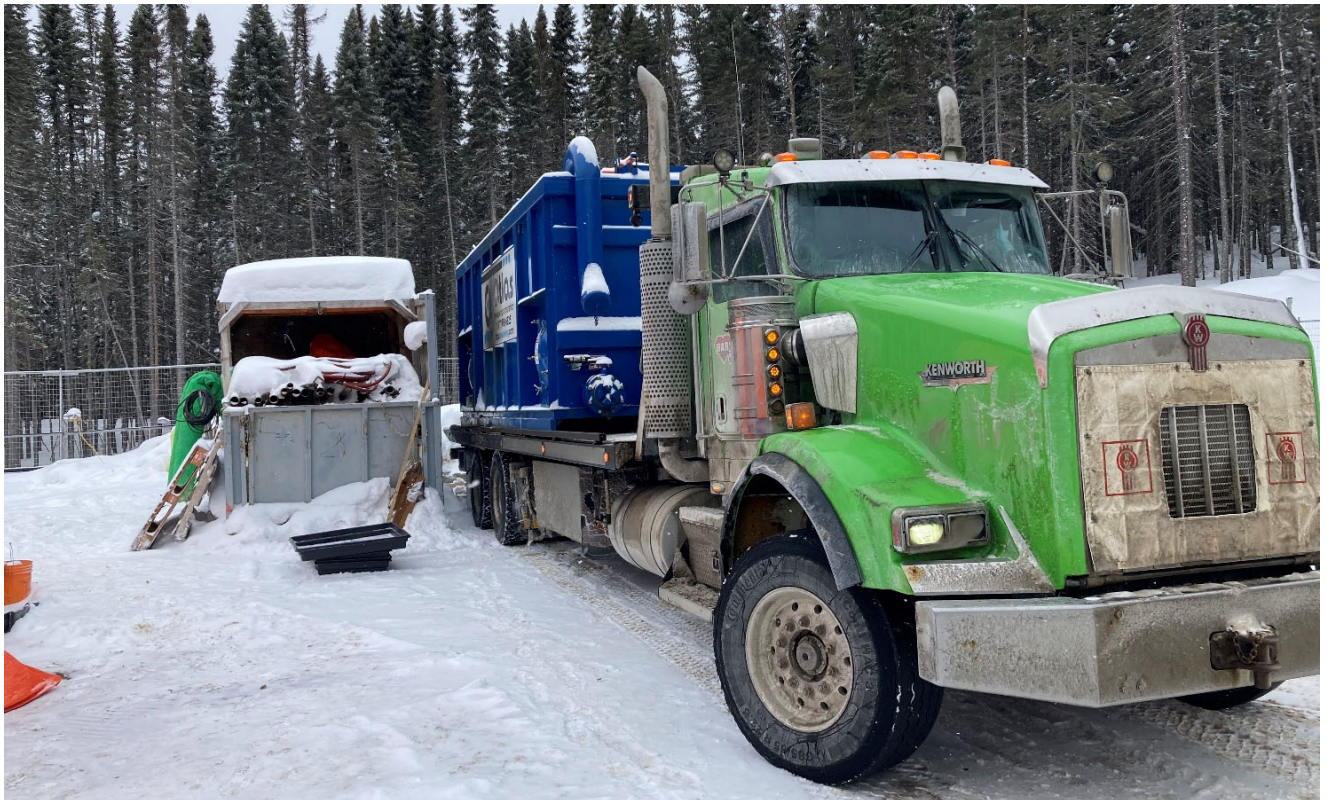
On December 20, 2021, Atlas Dewatering removed one of the Baker Tanks from IG_BH06 after WP02 and WP05 activities were completed. On February 9, 2022, Atlas Dewatering removed the remaining Baker Tank after WP06 activities were completed (Appendix A, Photo 2).

Photo 2 – Baker Tank demobilization, taken February 9, 2022

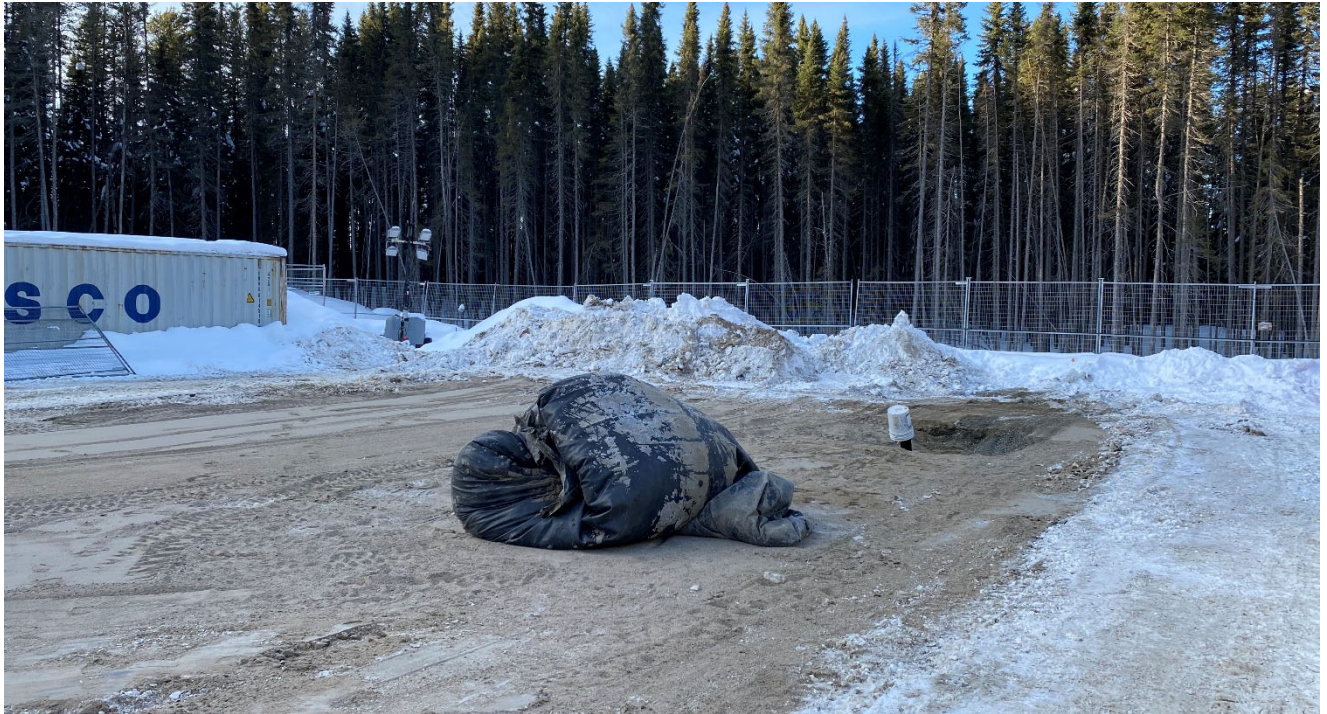
The secondary containment system was disassembled and placed into a waste bin on February 27, 2022 and disposed off-site by Obish's subcontractor, B&M Delivery, on February 28, 2022 (Appendix A, Photo 3).

Photo 3 – IG_BH06 after removal of rig mats and secondary containment system, taken February 27, 2022

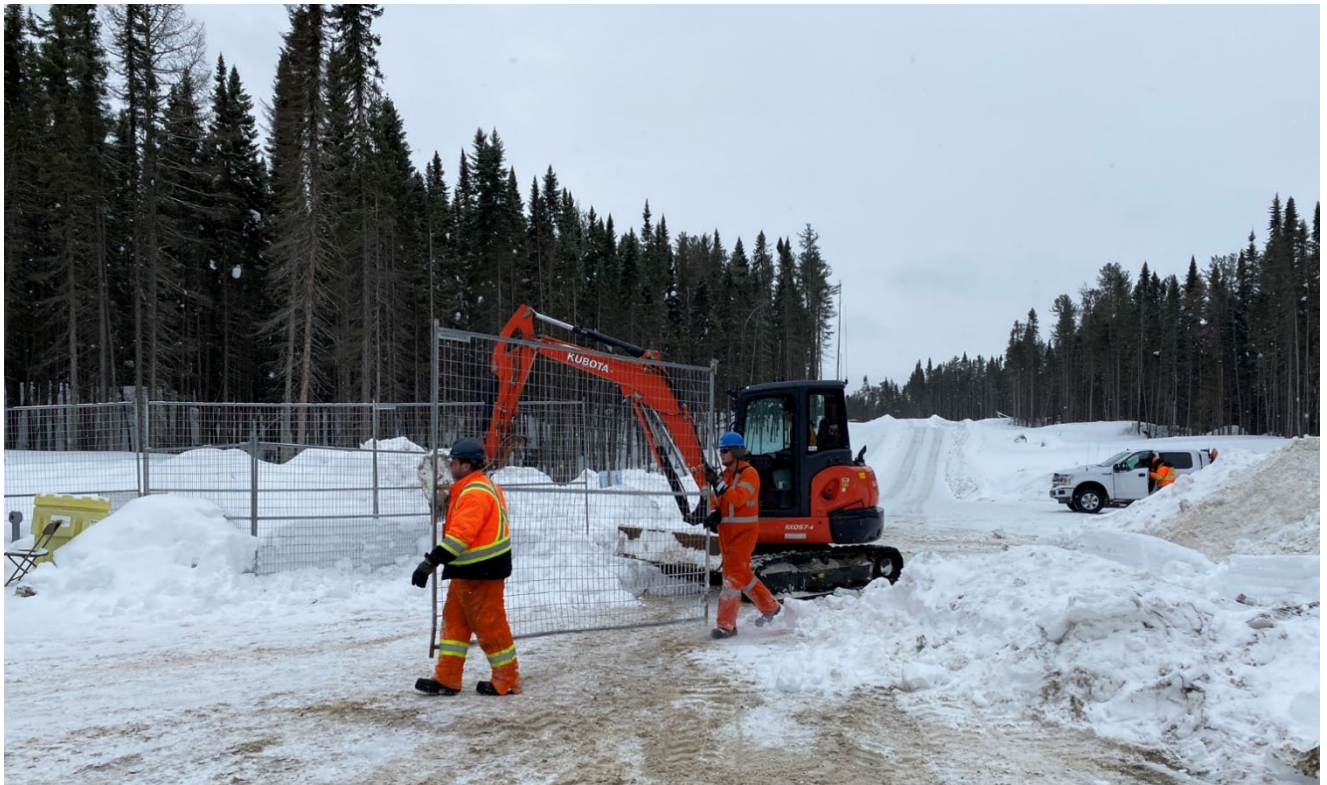
Obish took down all perimeter and interior fencing at IG_BH06 from February 28 to March 2, 2022 (Appendix A, Photo 4) and transported the 190 m (620 feet) of 2.5 m (8 feet) tall fencing to the NWMO's warehouse in Ignace on March 2, 2022. The remaining (rented) fencing was transported off-site by Obish to be returned to their supplier.

Photo 4 – Perimeter fence removal, taken February 28, 2022

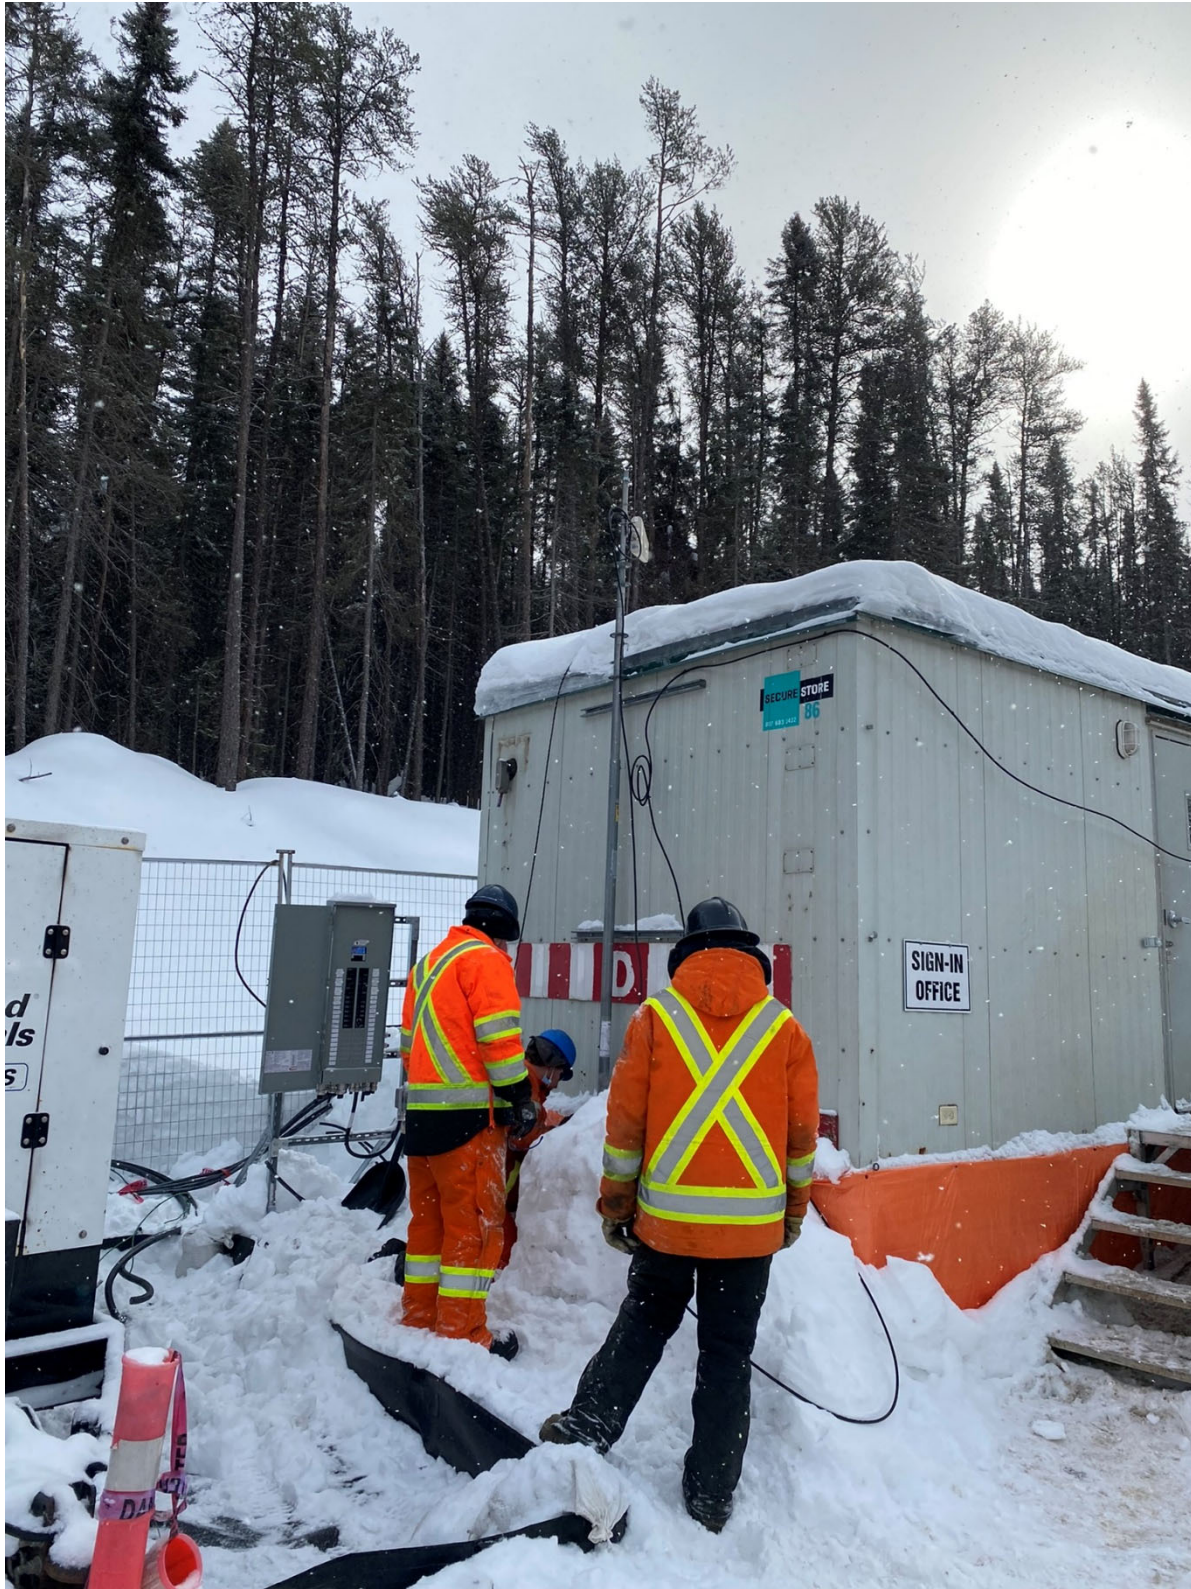
The two 15 m (50 feet) communication masts were removed from the Golder's office trailer and the Core Logging Seacan on February 28, 2022. All elements of the site communication systems were disconnected and packed for demobilization on February 28. (Appendix A, Photo 5).

Photo 5 – Communication system disconnect & removal, taken February 28, 2022

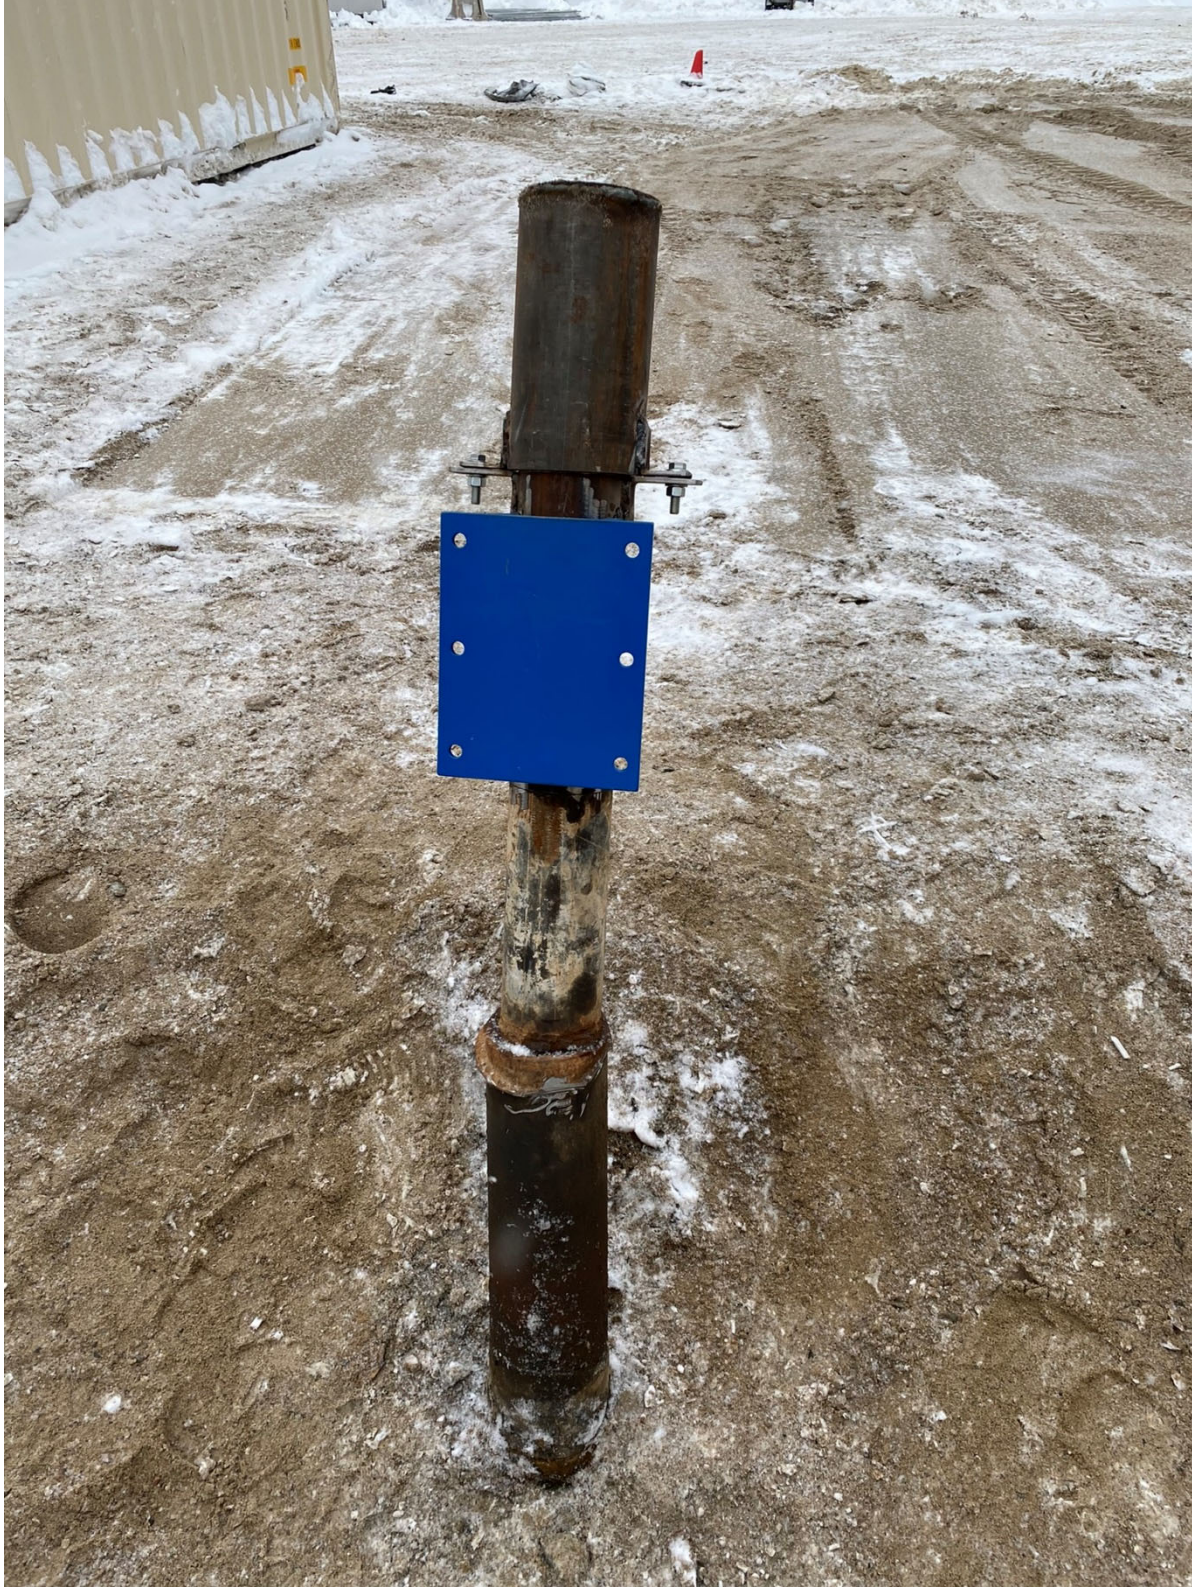
A threaded HWT extension casing with a lockable lid was installed at IG_BH06 by a Rodren welder on February 28, 2022 (Appendix A, Photo 6).

Photo 6 – IG_BH06 borehole welded cap, taken February 28, 2022.

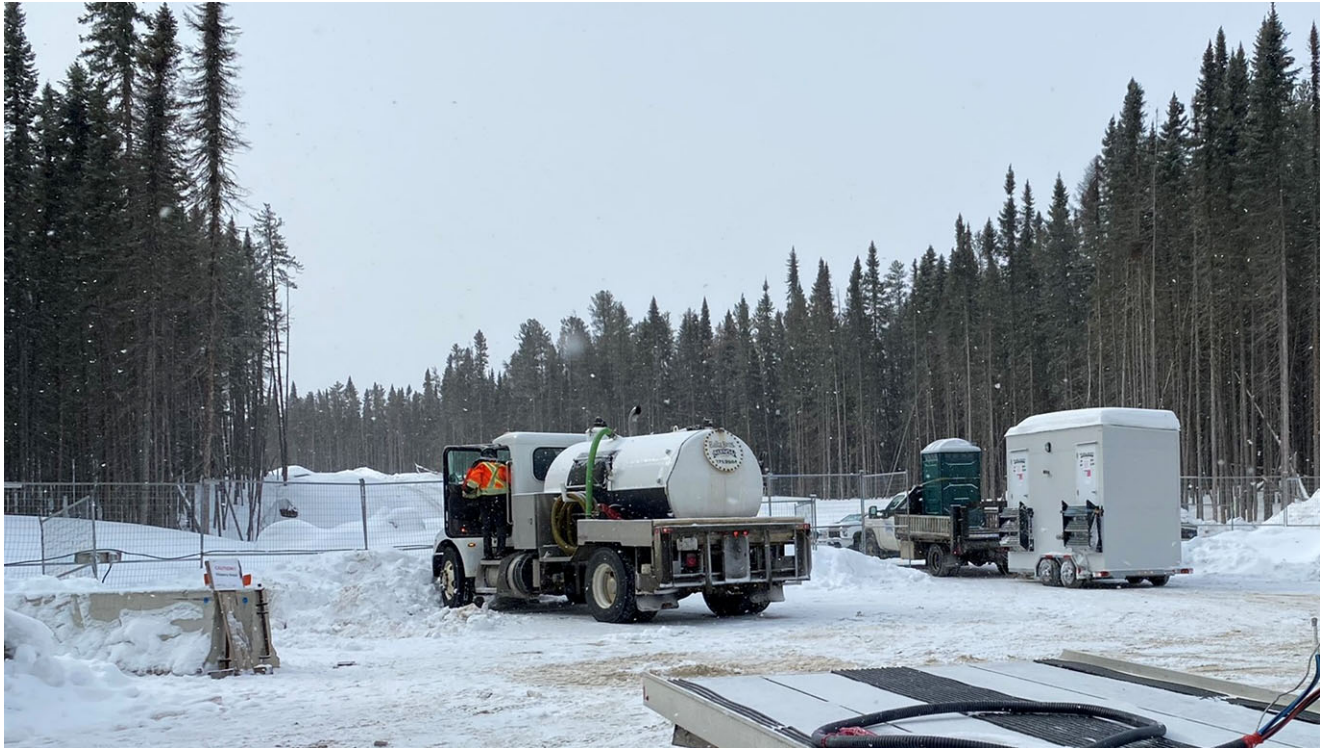
and one sink. The self-contained washroom trailer was demobilized off-site from IG_BH06 by Obish subcontractor, Balla Bros, on February 28, 2022 (Appendix A, Photo 7).

Photo 7 – Removal of washroom trailer, taken February 28, 2022.

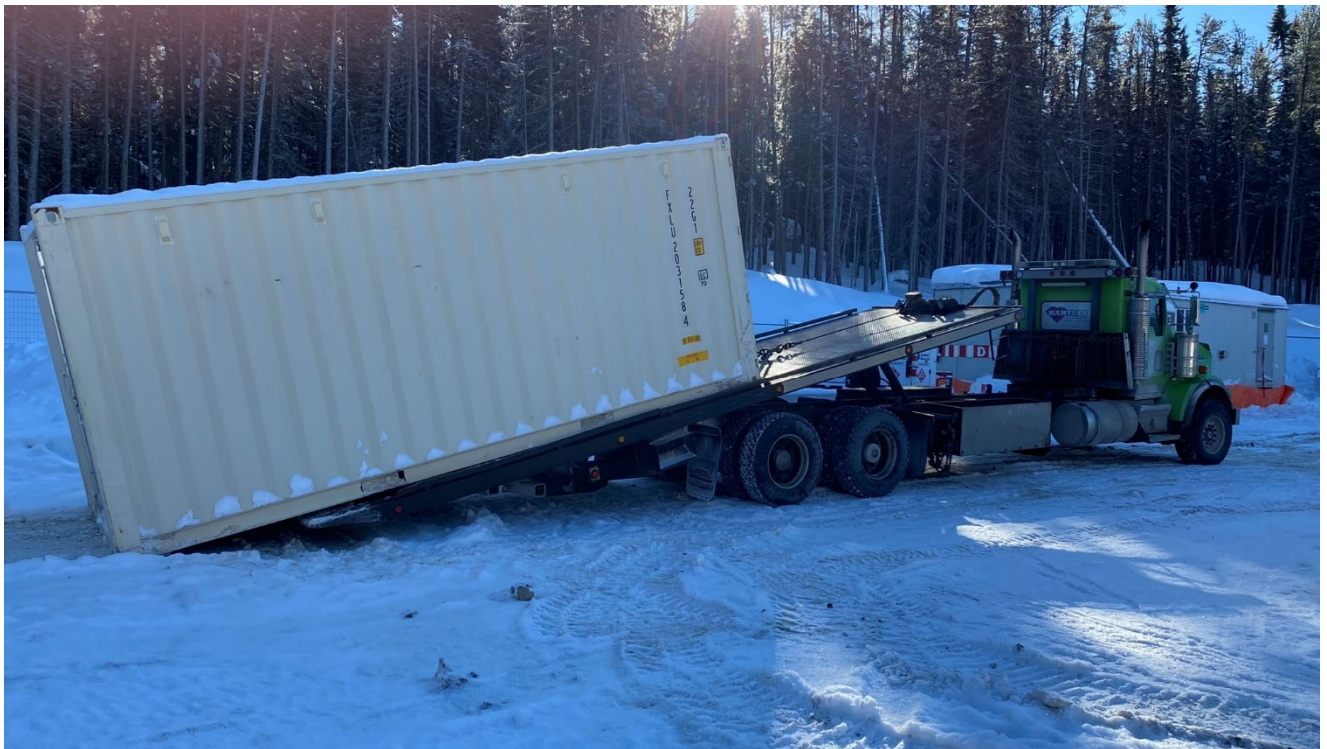
On March 1, 2022 the two 6 x 2.5 m (20 x 8 feet) storage seacans were demobilized from IG_BH06 by Secure Store (Appendix A, Photo 8).

Photo 8 – Demobilization of storage seacan by Secure Store, taken March 1, 2022.

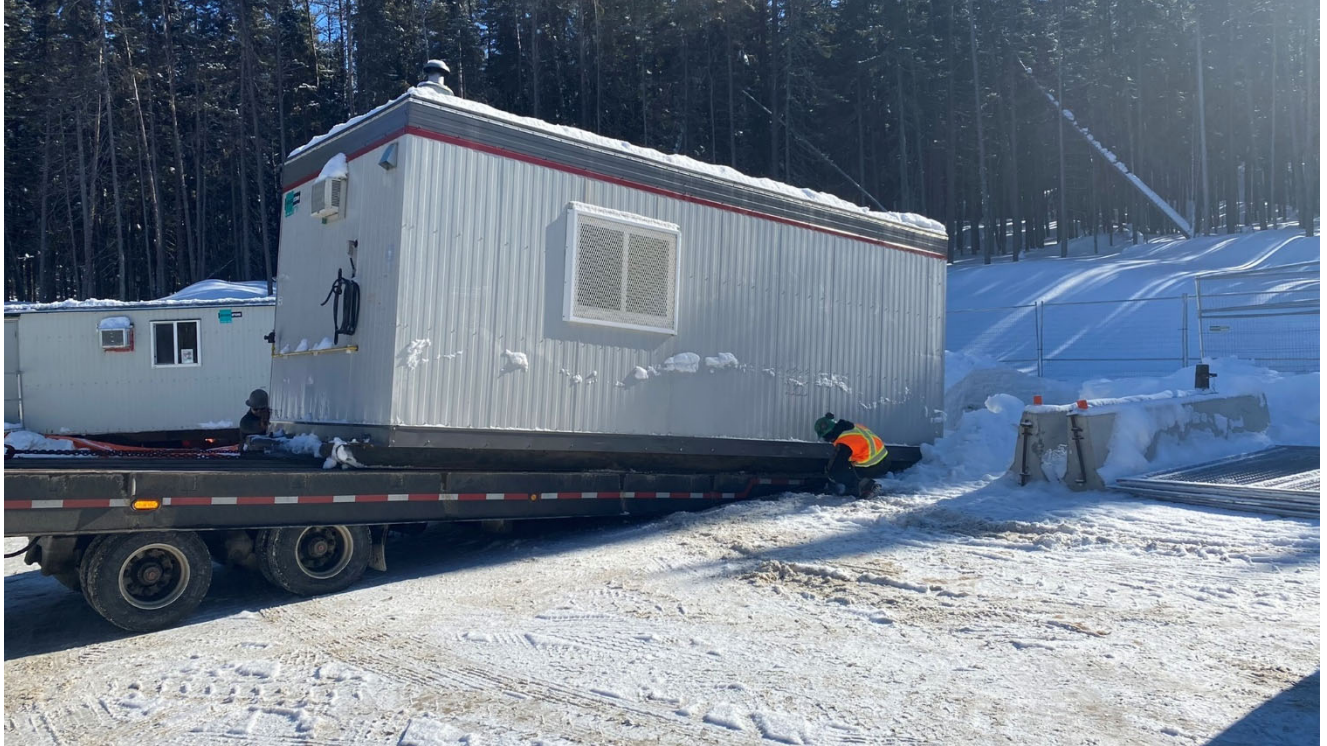
All three site trailers were loaded onto trailers on March 1, 2022 (Appendix A, Photo 9) and moved to Tower Road. On March 3, 2022 the snow and ice were removed from the roofs of all three of the trailers and two of the site trailers were demobilized from IG_BH06 by Secure Store. The final site trailer was demobilized from IG_BH06 by Secure Store on March 7, 2022.

Photo 9 – Loading of office trailer by Secure Store, taken March 1, 2022.

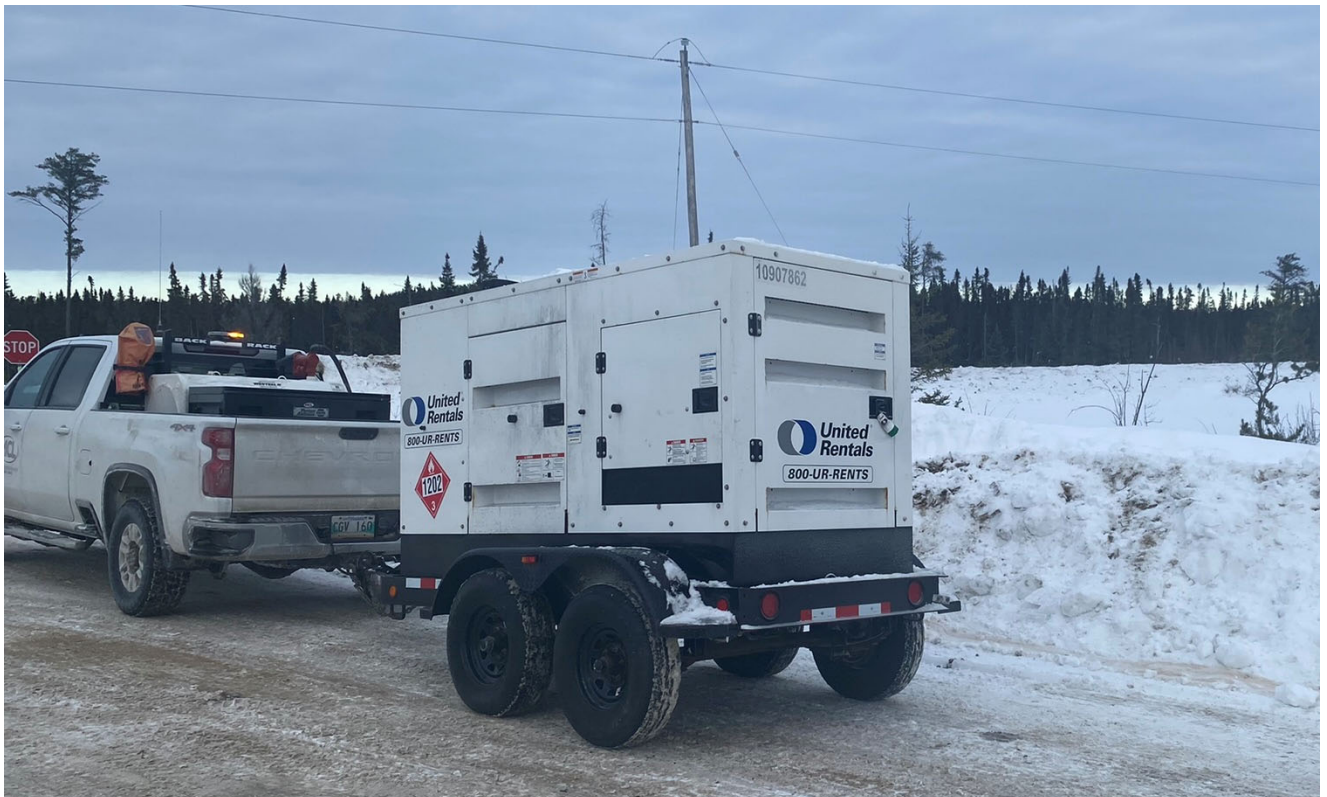
On March 1, 2022, the Cummins mobile diesel generator was demobilized from site and returned to United Rentals by Obish (Appendix A, Photo 10).

Photo 10 – Demobilization of electrical generator by Obish, taken March 1, 2022.

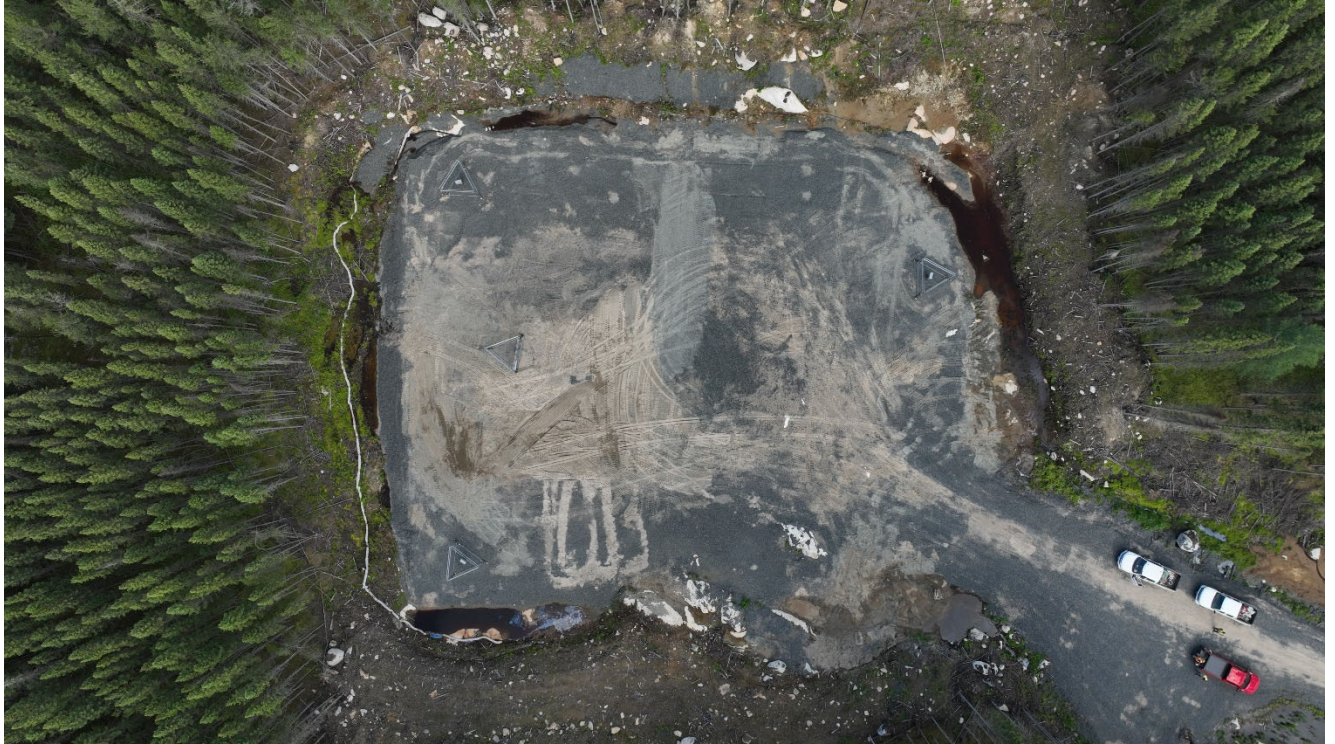
An aerial photo of the IG_BH06 drill site was taken following completion of all site activities on June 28, 2022 by Geoff Crann of the NWMO (Appendix A, Photo 11).

Photo 11 – Aerial drone photo of IG_BH06 following post-thaw inspection, taken June 28, 2022

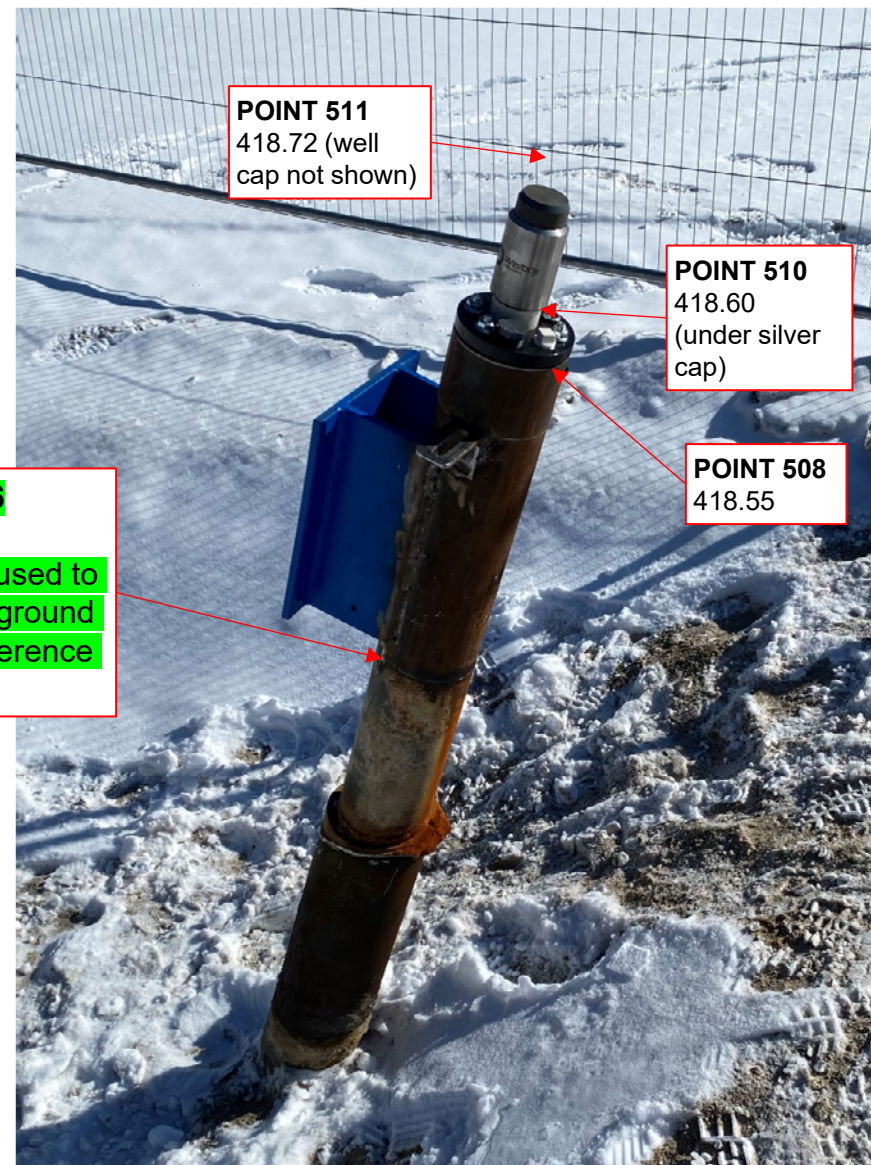
Attachment 2 – Original Casing Stickup and Ground Level Reference Point from WP02 Data Report for IG_BH06

Based on the data review, Golder concluded that in the same manner to what happened at IG_BH05, the surveyed position of the HWT (PQ) surface casing at IG_BH06 reported in the letter from Rugged Geomatics was inadvertently mistaken to be the position of the HWT (PQ) surface casing as it was during drilling, testing and Westbay installation. However, prior to being surveyed by Rugged Geomatics in March 2022, this original casing at IG_BH06 was extended after the installation of the Westbay system in order to complete the well head with a monopod bracket and protective casing.

The original position of the HWT (PQ) surface casing prior to it being extended was also surveyed and was identified by Rugged Geomatics as survey point 506 “welded joint on pqt”.

Using that information, the correct ground surface elevation reference datum for IG_BH06 was calculated relative to the original position of the HWT (PQ) casing. Golder prepared a memo detailing the IG_BH06 datum correction which is provided in Appendix C.

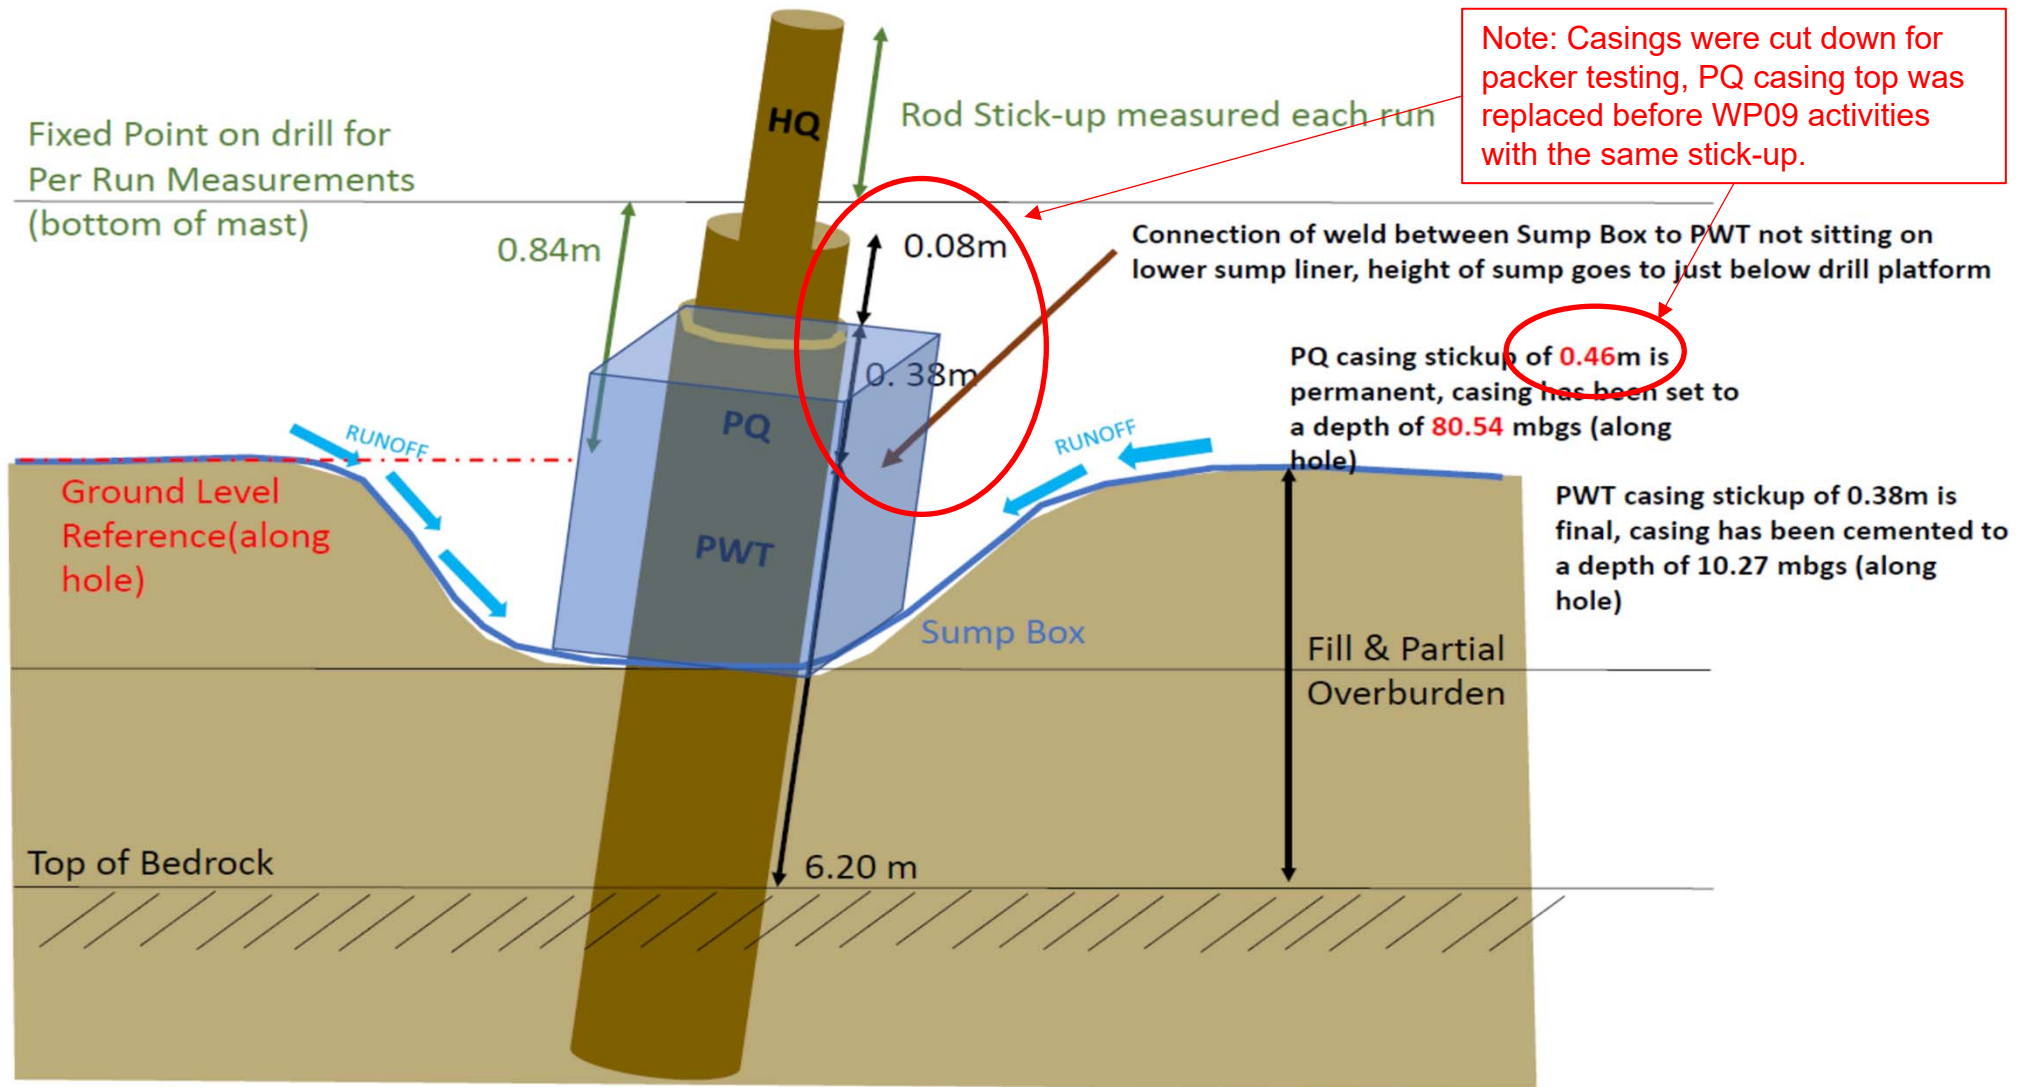
Attachment 3 - Schematic Showing IG_BH06 Well Head

A - Initial Well Head during Drilling / Testing and B - Final Well Head with Locking Extension Added
