Determination of the Threshold Stress Intensity Factor and Velocity of Delayed Hydride Cracking of Endplate Welds in CANDU Fuel Bundles with Different Design and Manufacturers

NWMO TR-2010-25

G. K. Shek

Kinectrics Inc.

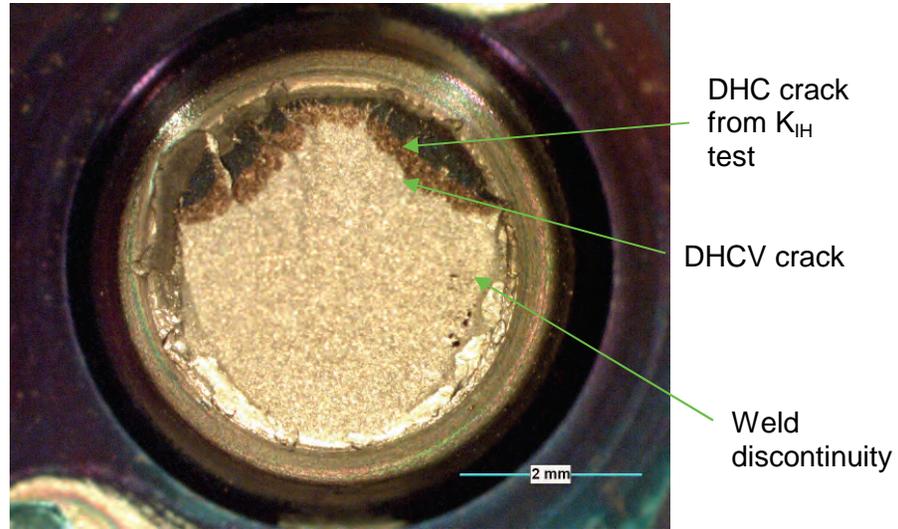
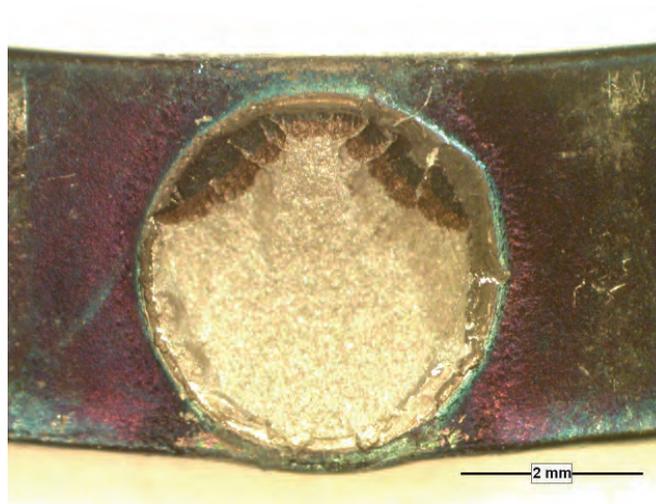
Figure 10: Fracture surfaces of sample in Test 09-106 on GE 37-element bundle

The sample was broken open to reveal the DHC fracture surface. Figure 10a shows the fracture surfaces on the endplate and endcap sides. The two segments of DHC cracks corresponding to the K_{IH} and DHCV tests can be observed clearly, as well as the weld continuity. The first crack segment with the darker oxide occurred during the K_{IH} test. This crack segment did not have uniform depth around the perimeter of the weld and was longer at the two locations about 45° deviated from the top of the weld. This non-uniform crack shape indicates that the stress field at the endplate weld can be quite complex and cracking may not have initiated at the top of the weld.

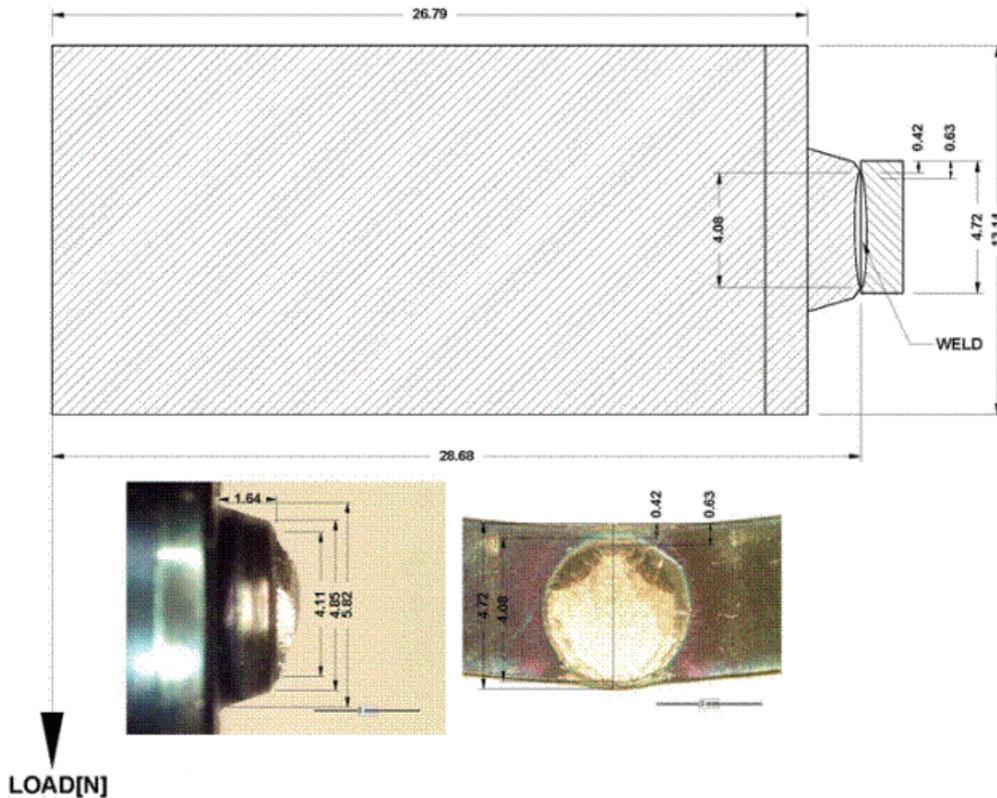
Figure 11: Dimensions of welds measured from fracture surfaces of sample in Test 09-106 on GE 37-element bundle

Figure 11 shows the various dimensions measured from the fracture surfaces of the welds on the endplate and endcap side, as well as a schematic diagram of the endplate and endcap notch constructed from the measured dimensions. In this weld, the notch depth on the ID side was determined to be 0.42 mm and the weld discontinuity was about 0.21 mm deep at the top of the weld.

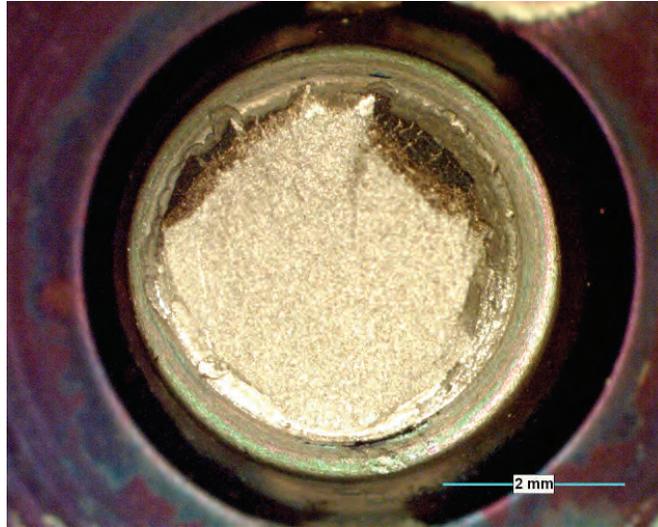
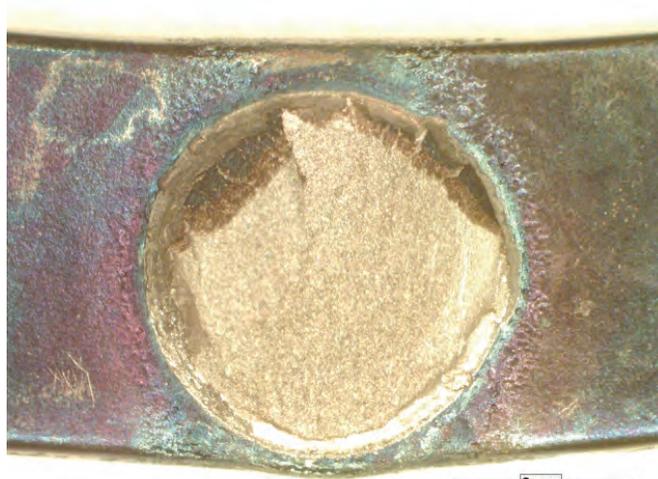
Figure 13: Fracture surfaces of sample in Test 09-120 on GE 37-element bundle

Figure 13 shows the fracture surfaces of the DHC cracks on the endcap and endplate side. The two crack segments corresponding to the K_{IH} and DHCV are similar in appearance as that of Test 09-106. Cracking appeared to be initiated at the two locations about 45° from the top of the weld. Figure 14 shows the dimensions of the weld measured from the fracture surfaces and a schematic diagram of the endplate and endcap notch constructed from the measured dimensions.

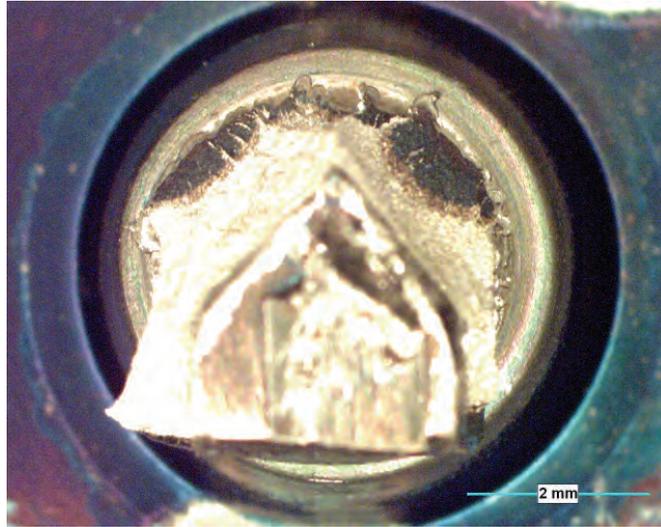
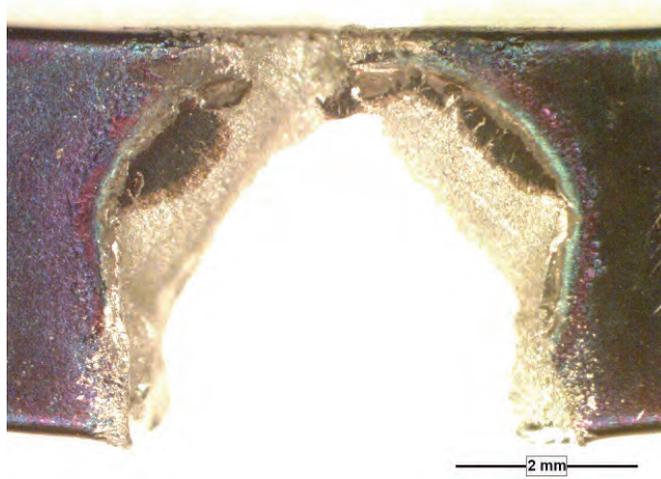
Figure 15: Fracture surfaces of sample in Test 09-136 on GE 37-element bundle

Figure 15 shows the fracture surfaces of the DHC cracks on the endcap and endplate side. The endplate strip was torn off in the attempt to break open the cracked sample. The two crack segments corresponding to the K_{IH} and DHCV are clearly visible and cracking appeared to be initiated at the two locations about 45° from the top of the weld. Figure 16 shows the dimensions of the weld measured from the fracture surfaces and a schematic diagram of the endplate and endcap notch constructed from the measured dimensions.

(b) Fracture surface on endplate side (endplate strip was torn)

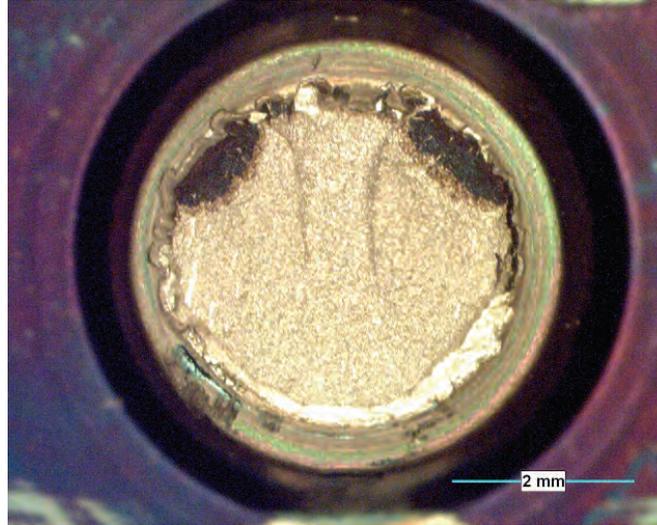
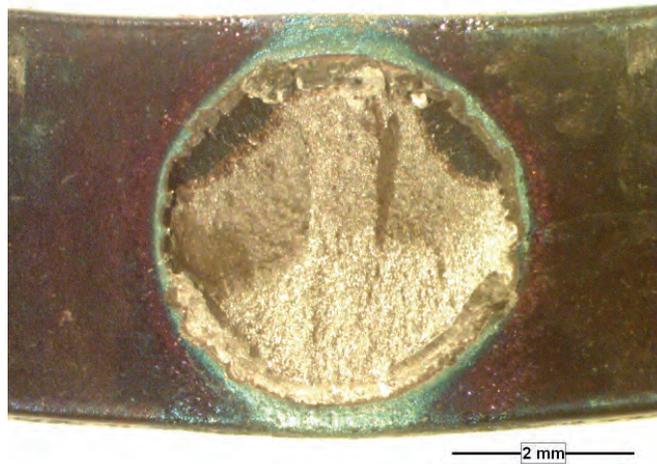
Figure 17: Fracture surfaces of sample in Test 09-148 on GE 37-element bundle

Figure 17 shows the fracture surfaces of the DHC cracks on the endcap and endplate side. The two crack segments corresponding to the K_{IH} and DHCV are clearly visible in which cracking appeared to be initiated at the two locations about 45° from the top of the weld. Figure 18

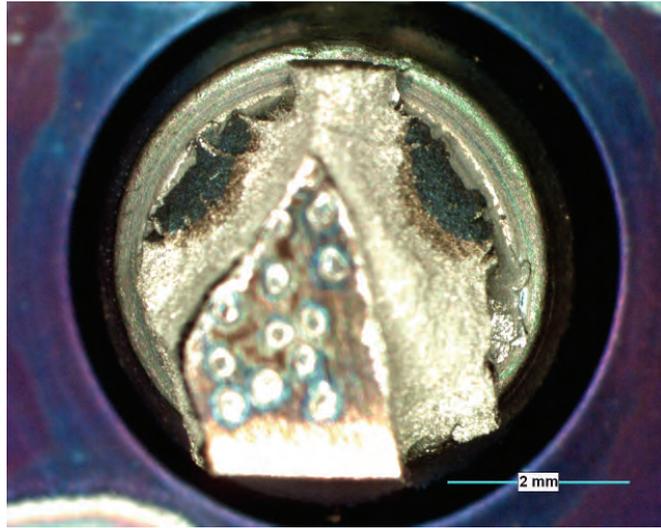
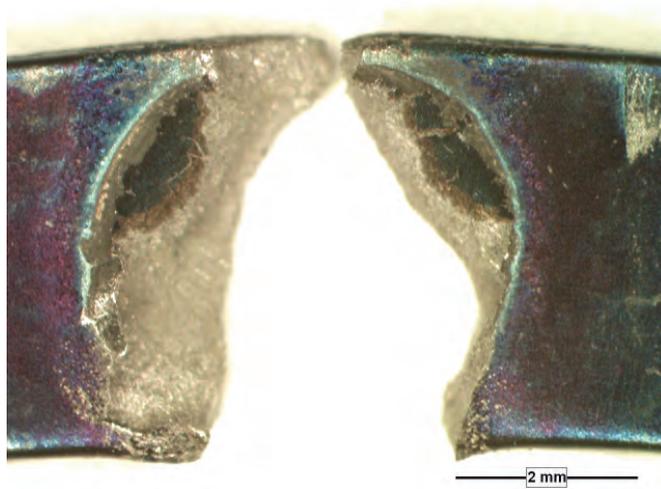
Figure 20: Fracture surfaces of sample in Test 09-124 on GE 37-element bundle in which the OD side was loaded under tension

Figure 20 shows the fracture surfaces of the DHC cracks on the endcap and endplate side. The endplate strip was torn off in the attempt to break open the cracked sample. The two crack segments corresponding to the K_{IH} and DHCV are clearly visible in which cracking appeared to

be initiated at the two locations about 45° from the top of the weld. Figure 21 shows the dimensions of the weld measured from the fracture surfaces and a schematic diagram of the endplate and endcap notch constructed from the measured dimensions.

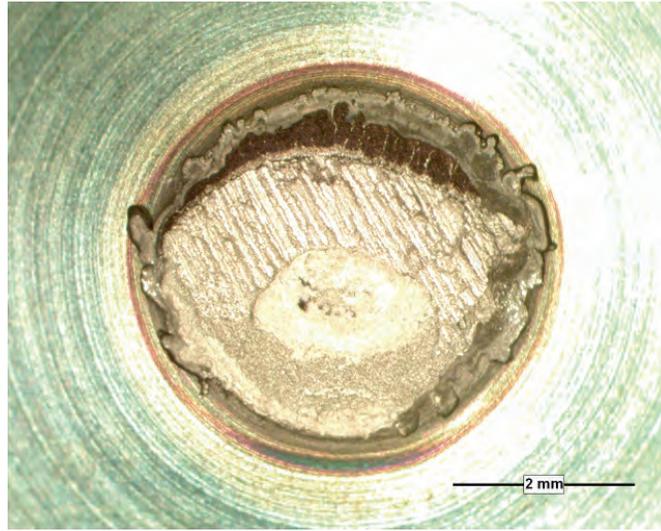
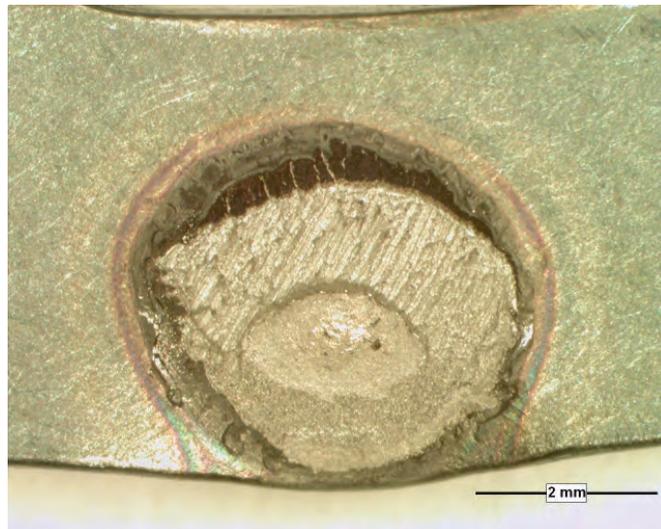
Figure 24: Fracture surfaces of sample in Test 09-125 on GE 28-element bundle

Figure 24 shows the fracture surface of the DHC crack after heat-tinting. The location of crack initiation appeared to be at the top of the weld, as the crack was longest at that location. The weld was skewed towards the OD side of the endplate. This is consistent with the result of metallographic examination shown in Figure 4. In addition, the weld area appeared to be closer to an elliptical shape instead of the “circular” shape observed in the welds of the GE 37-element bundle. Figure 25 shows the dimensions of the weld measured from the fracture surfaces and a schematic diagram of the endplate and endcap notch constructed from the measured dimensions. The notch depth on the ID side was deeper than that of the welds from the GE 37-element bundle, as a result of the weld skewing towards the OD side of the endplate. Therefore, it is expected that higher load will be required to initiate DHC from the OD side of the endplate.

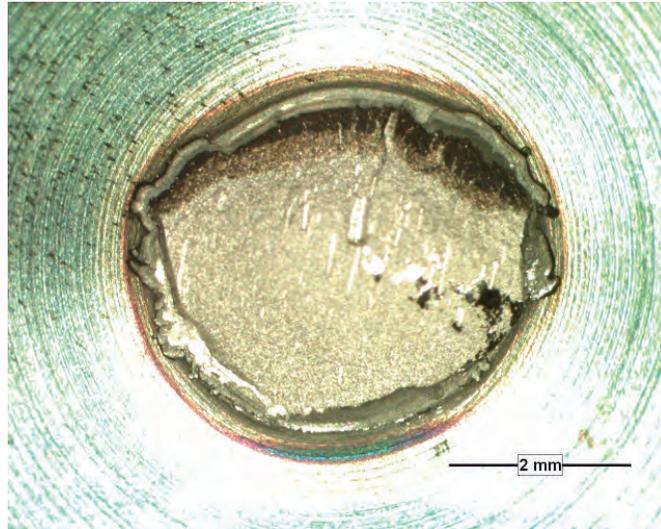
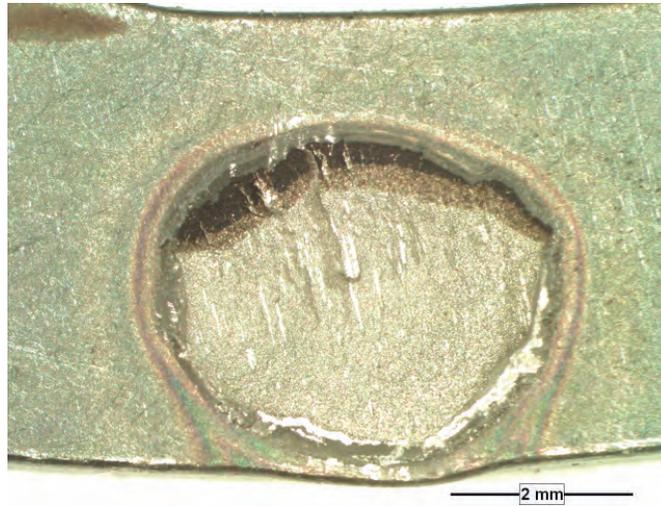
Figure 26: Fracture surfaces of sample in Test 09-130 on GE 28-element bundle

Figure 26 shows the fracture surfaces on the endcap and endplate side. The two crack segments corresponding to the K_{IH} and DHCV test are clearly visible. The fracture surface is similar to that of Test 09-125 in which cracking appeared to have initiated near the top of weld. The weld had an elliptical shape and was skewed towards the OD side of the endplate. Figure 27 shows the dimensions of the weld measured from the fracture surfaces and a schematic diagram of the endplate and endcap notch constructed from the measured dimensions. The

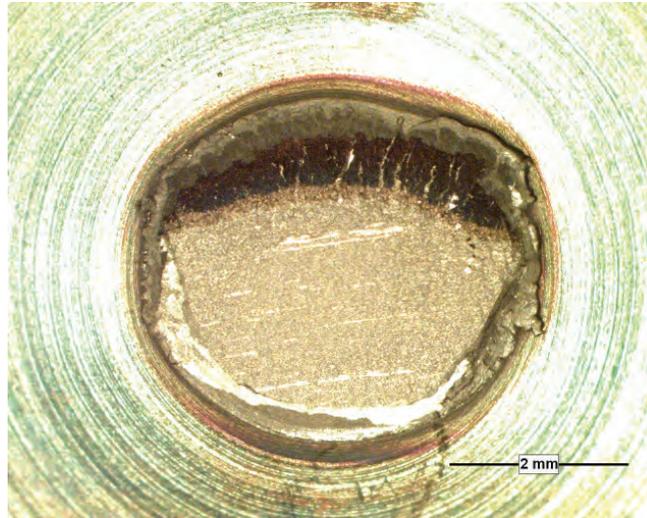
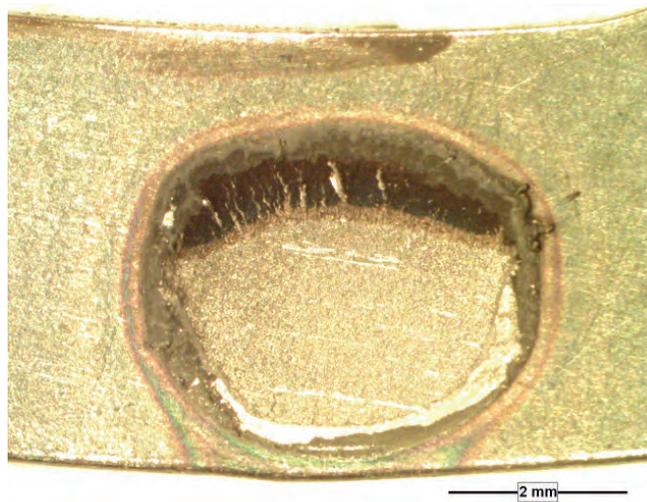
Figure 28: Fracture surfaces of sample in Test 09-144 on GE 28-element bundle

Figure 28 shows the fracture surface on the endcap and endplate side which are similar to that of Tests 09-125 and 09-130. Cracking appeared to have initiated from the top of the weld. The

weld had an elliptical shape and skewed towards the OD side of the endplate. Figure 29 shows the dimensions of the weld measured from the fracture surfaces and a schematic diagram of the endplate and endcap notch constructed from the measured dimensions.

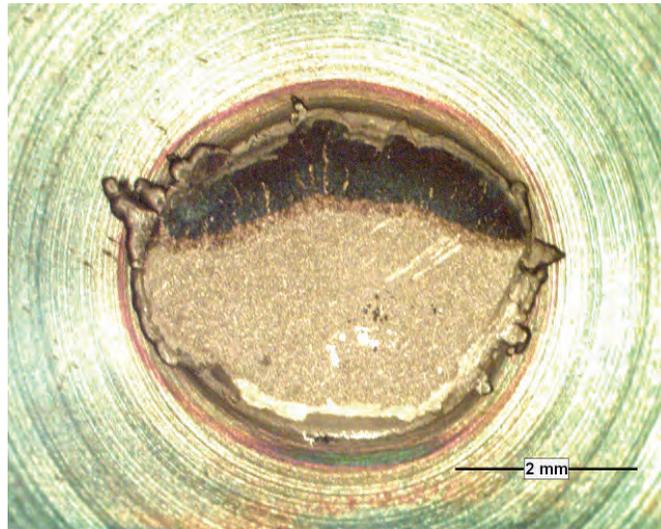
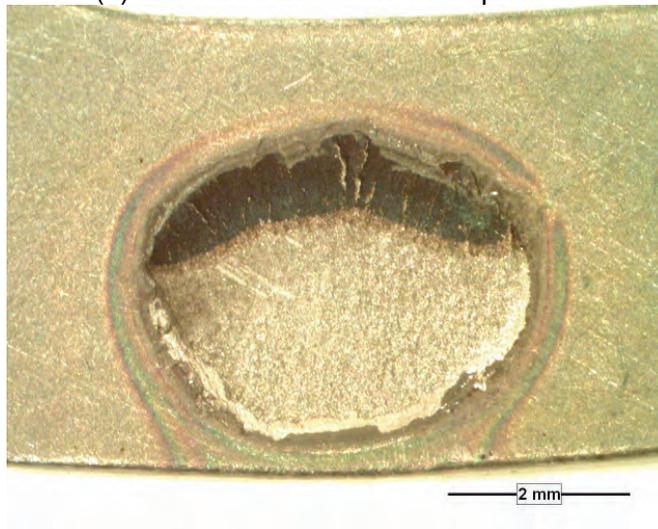
Figure 30: Fracture surfaces of sample in Test 09-172 on GE 28-element bundle

Figure 30 shows the fracture surfaces on the endcap and endplate side. The two crack segments corresponding to the K_{IH} and DHCV test are visible. Cracking was initiated at the top of weld. The weld had an elliptical shape and was skewed towards the OD side of the endplate. Figure 31 shows the dimensions of the weld measured from the fracture surfaces and a schematic diagram of the endplate and endcap notch constructed from the measured dimensions.

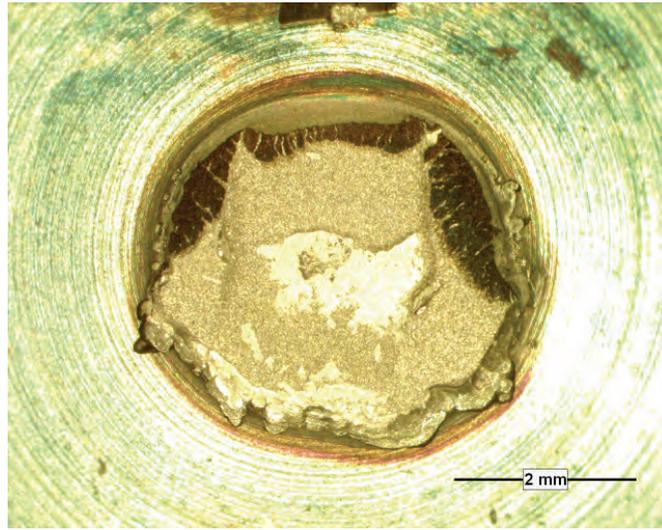
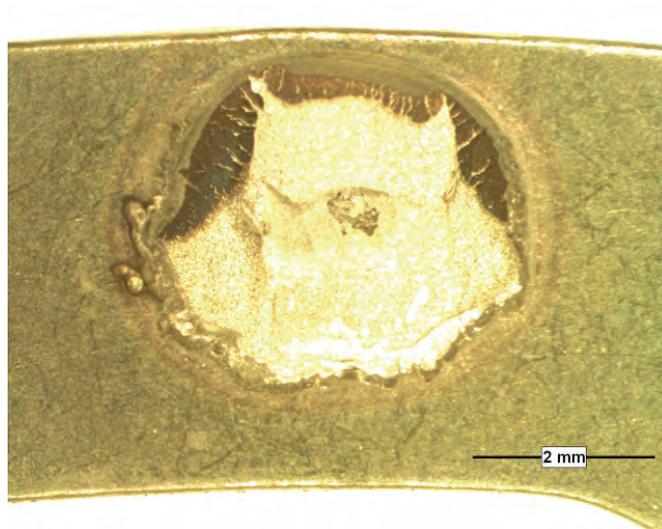
Figure 33: Fracture surfaces of sample in Test 09-182 on GE 28-element bundle in which the OD side was loaded under tension

Figure 33 shows the fracture surfaces on the endcap and endplate side. Unlike the tests with the samples loaded on the ID side, cracking appeared to have initiated near the 45° away from the top of the weld. The weld was skewed towards the OD side of the endplate. Figure 34 shows the dimensions of the weld measured from the fracture surfaces and a schematic diagram of the endplate and endcap notch constructed from the measured dimensions.

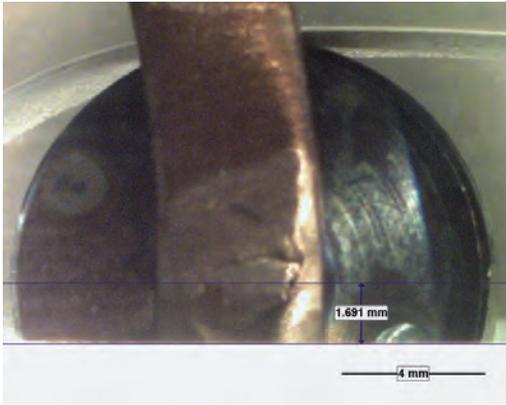
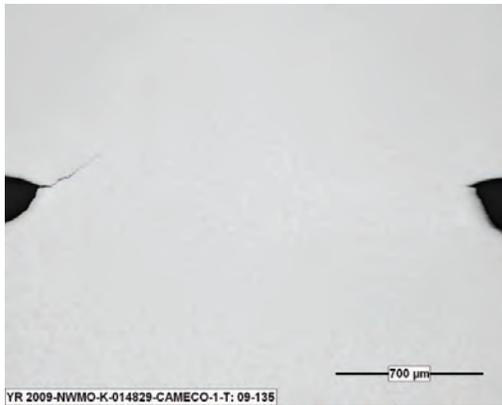
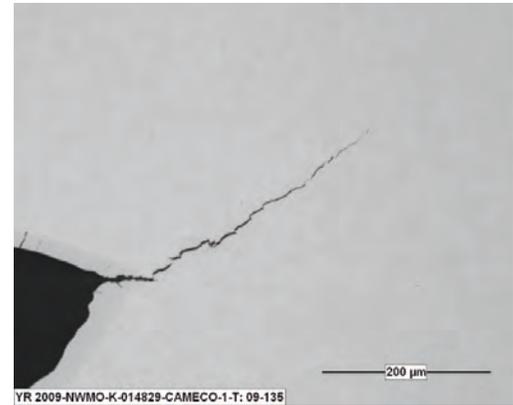
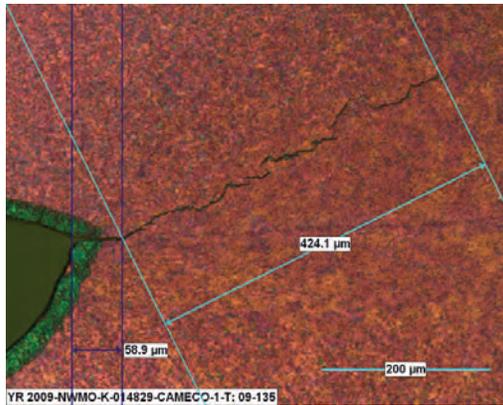
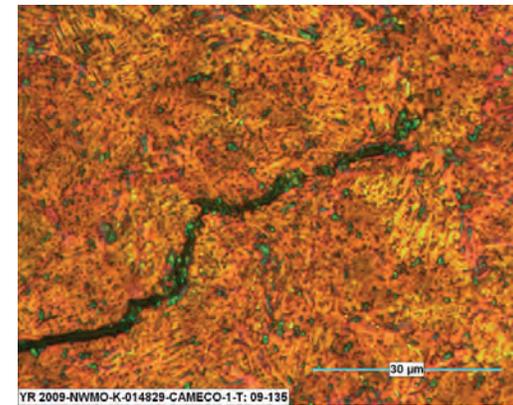
Figure 37: DHC crack shown in metallographic section about 1.7 mm from mid-section of weld of sample from Test 09-135

will appear deeper, as it is not at the mid-section of the weld. At higher magnification, a crack was observed at the ID side of the weld which grew at about 30° into the endplate side of the weld (Figure 37c). The sample was anodized which revealed the hydride layer on the sample surface (Figure 37d). At the higher magnification, the crack path appeared to be decorated with hydride particles. At this plane, the DHC crack was about 424 μm long. Upon further grinding to the mid-section of the weld, the crack disappeared as shown in Figure 38. The notch at the mid-section of the weld was relatively blunt and no weld discontinuity was observed.

(c) As-polished; higher magnification showing the crack on the ID side of endplate

(d) Anodized; showing hydride layer on surface and hydride particles along the crack

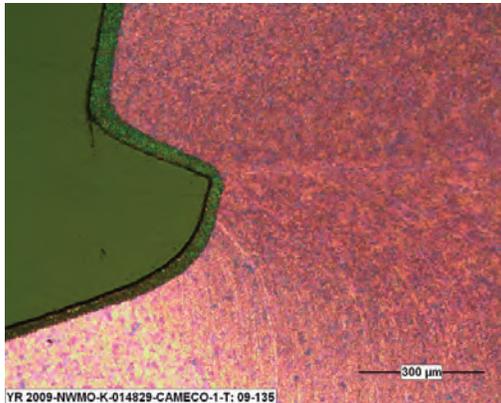
(d) Anodized, ID side, no DHC crack

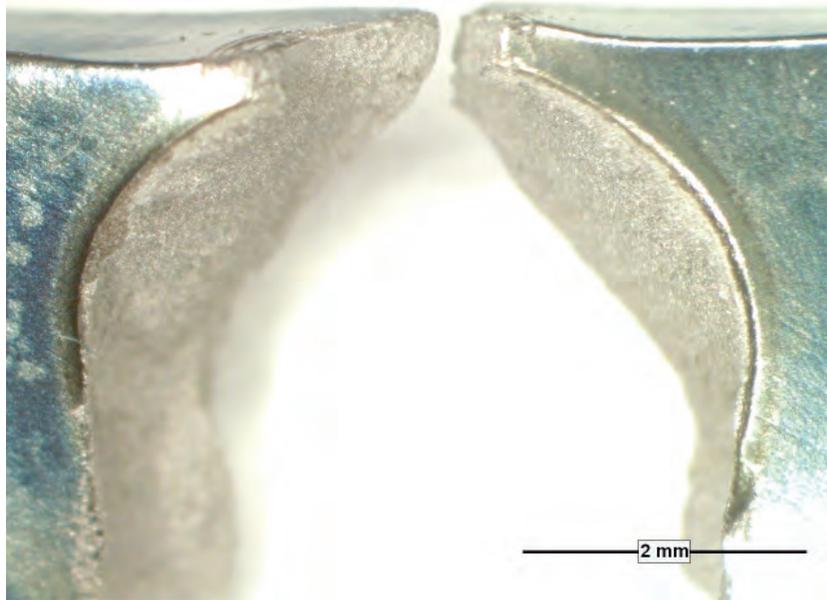
Figure 40: A small crack with thin oxide was observed on the sample of Test 09-186
