# PHASE 2 INITIAL BOREHOLE DRILLING AND TESTING AT IG\_BH04/05/06, IGNACE AREA

WP01 Commissioning Report - Site Infrastructure Setup for IG\_BH04

APM-REP-01332-0293

June 2021

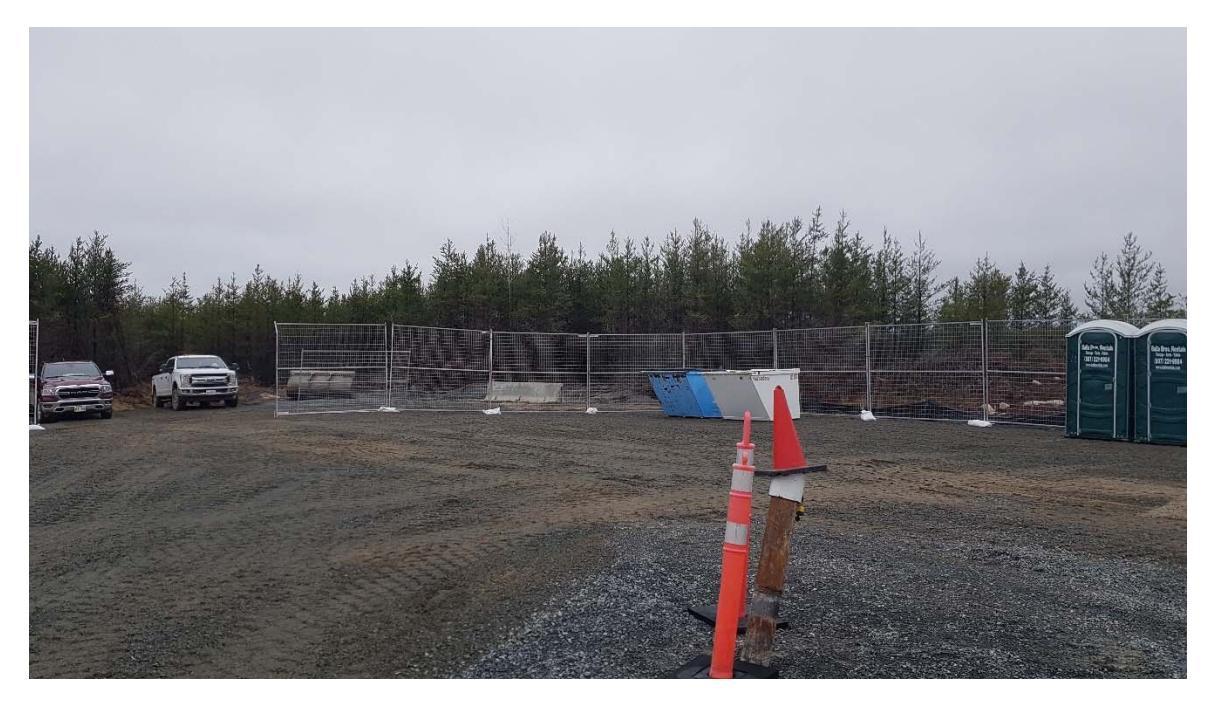
Approximately 190 m (620') of 2.5 m (8') tall fencing was installed around the perimeter of the site to define the work area, provide security and to discourage wildlife from entering the site. A lockable gate was installed on the southwest side of the site, to allow worker access to the site from the parking lot (Appendix A, Photo 1).

Photo 1 - Security Fence with the Lockable Gate

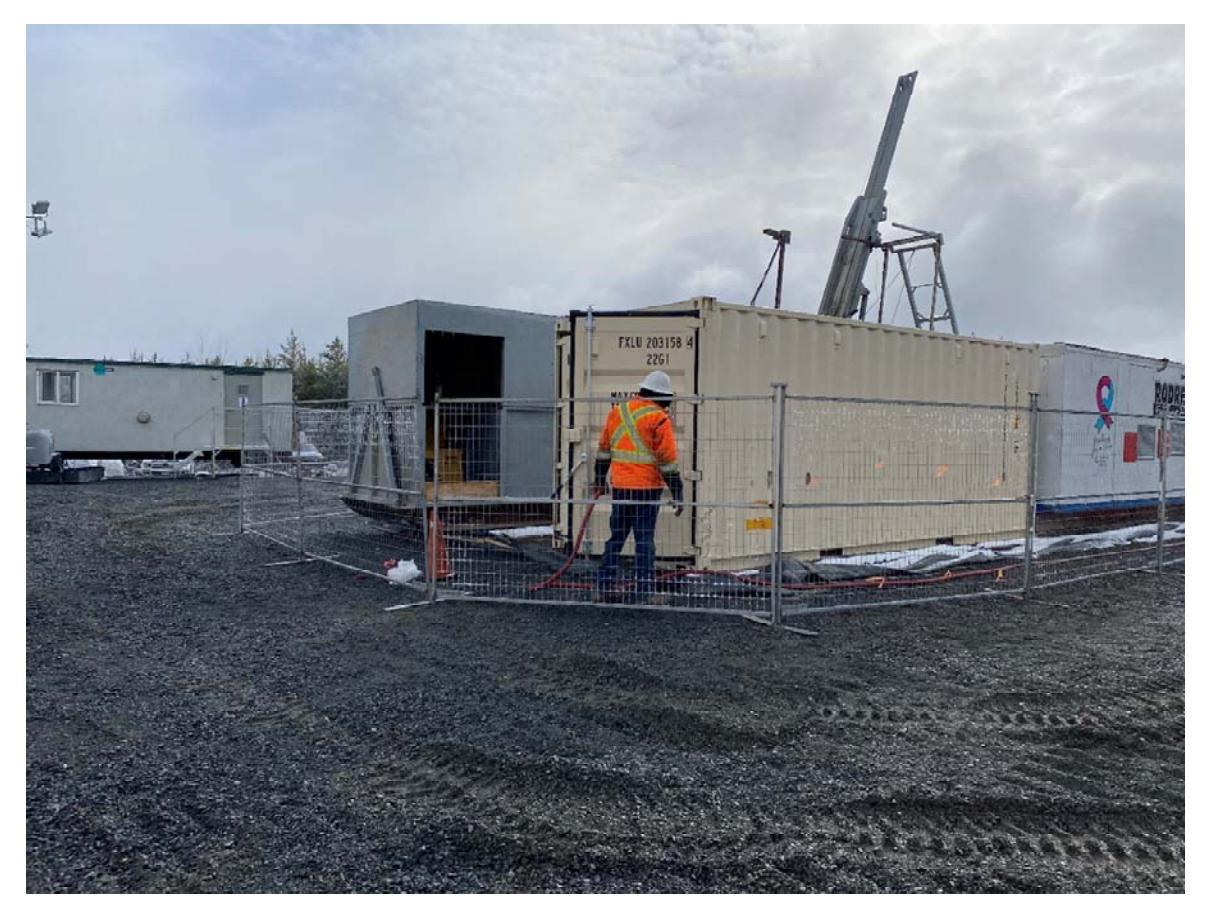
In addition to the perimeter fencing, approximately 70 m (230') of 1.8 m (6') tall fencing was installed around the drill rig area to define an exclusion zone (Appendix A, Photo 2).

Photo 2 - Drilling Rig Area Security Gate

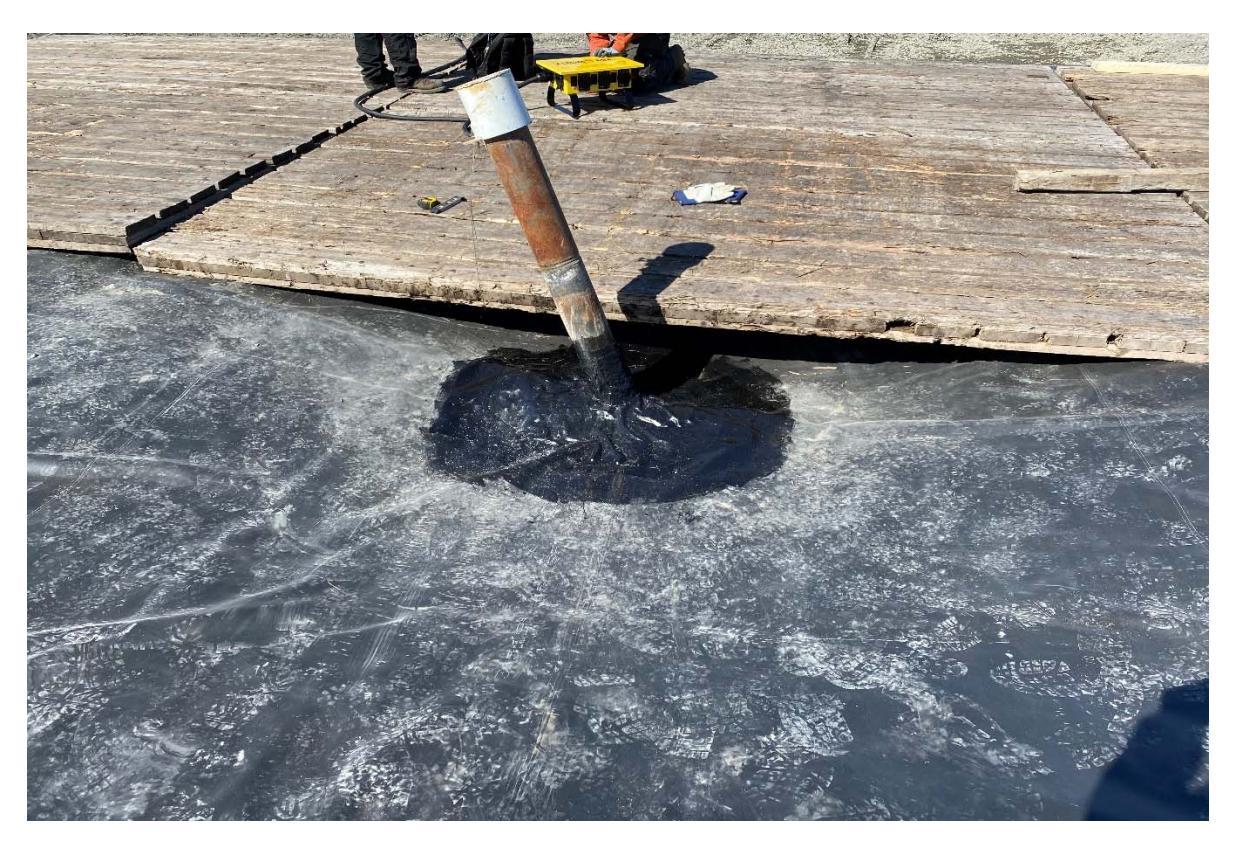
Prior to arrival of the drill rig on site, the drill pad was set up with a secondary containment system which was constructed on site to capture any drill fluid spills that could potentially occur at the drill or drill fluid circulation system. The system was designed with a central sump and the drill pad was graded to slope into the central sump. The containment liner consisted of two rubber layers, each layer was sealed to the outer casing of the borehole to prevent leaks through the liner (Appendix A, Photo 7).

Photo 7 - Double Sealed Liner

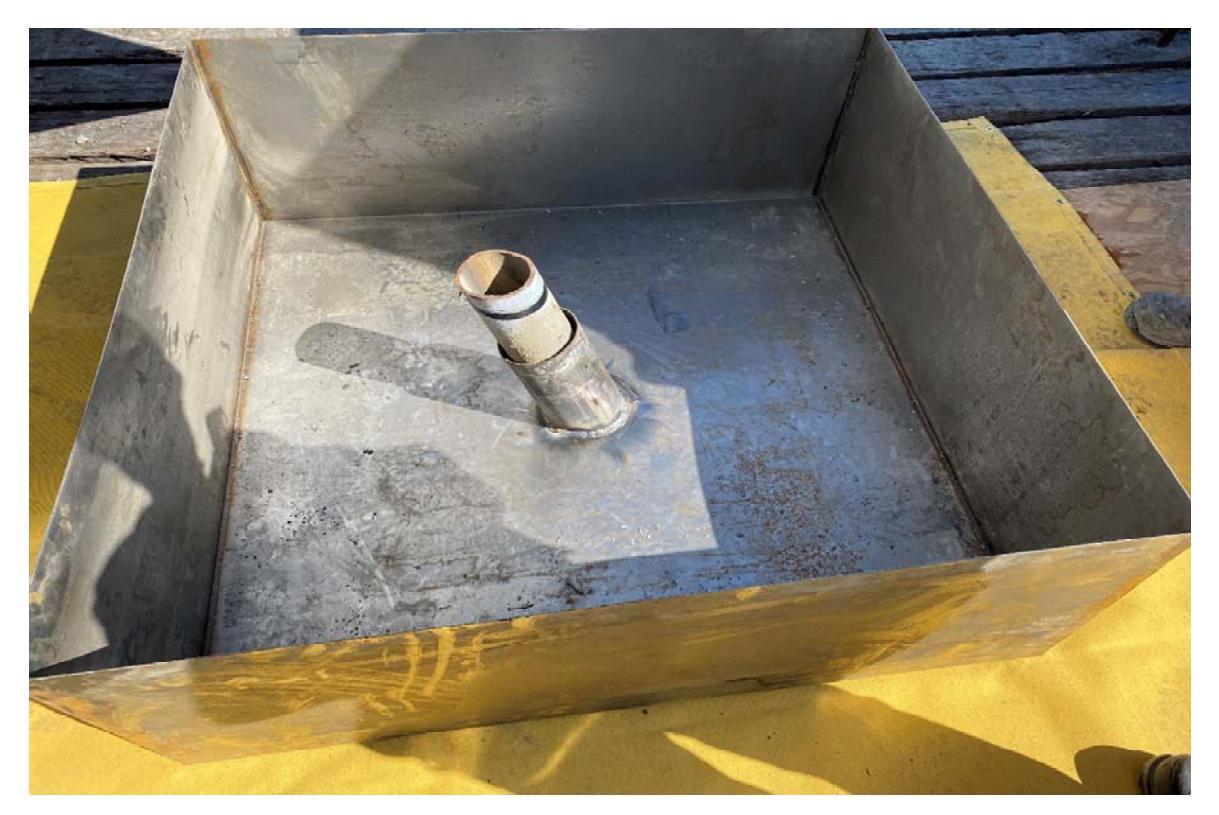
Upon the completion of the secondary containment, a steel drill water sump was constructed at the borehole collar (welded to the outer casing (appendix A, Photo 8) to capture drill fluid as it exited the borehole during drilling and testing. Drill fluid was pumped from the drill water return sump into the centrifuge unit where drill cuttings are removed. Once the cuttings were removed from the drill water, the water was recycled back into the drill water tank and into the borehole.

Photo 8 - Steel Sump - Welded

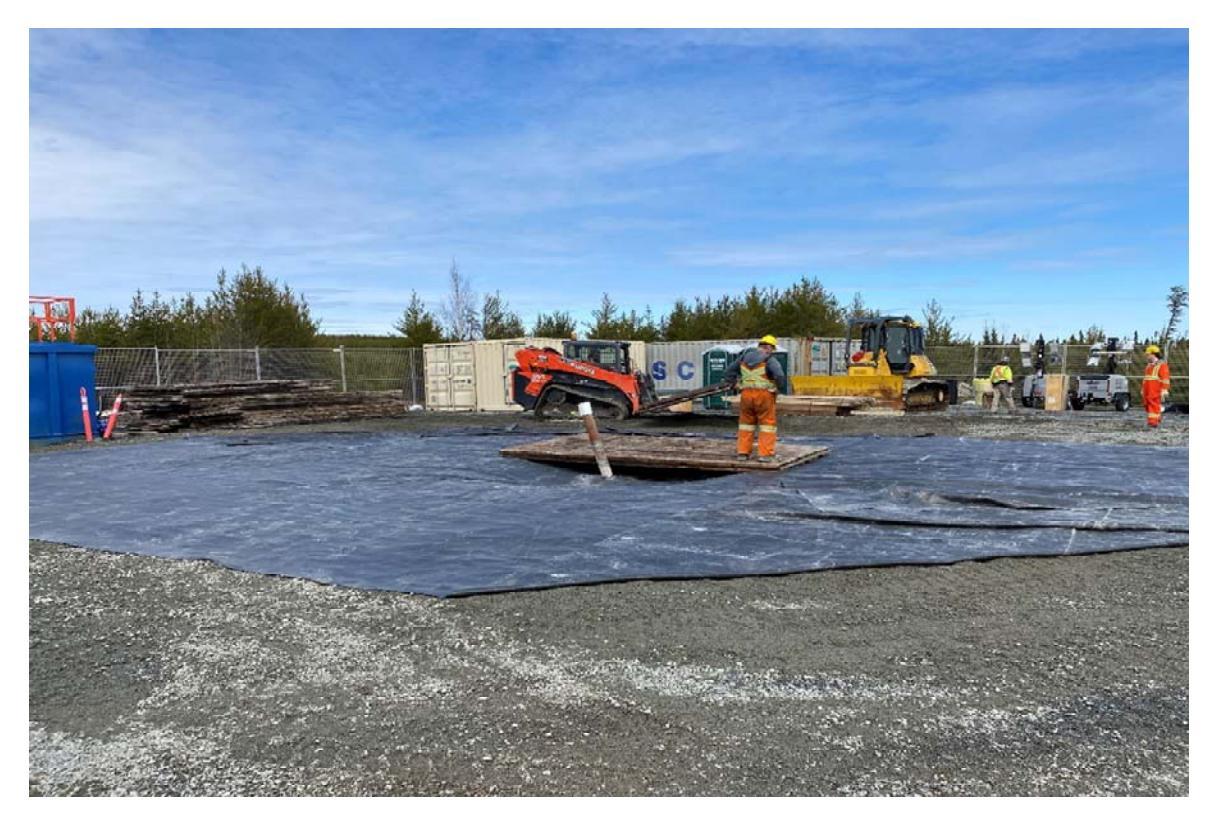
$ft^2$ ) of lateral coverage, large enough to encompass the footprint of the drill rig, AMC SRU Centrifuge Recycling Unit, wastewater tank, and fluorescein tank. The wastewater and fluorescein tanks were stored in a 6 x 2.5 m (20 x 8') seacan located on the drilling rig secondary containment (Appendix A, Photo 9).

Photo 9 - Drilling Rig Area Secondary Containment Setup

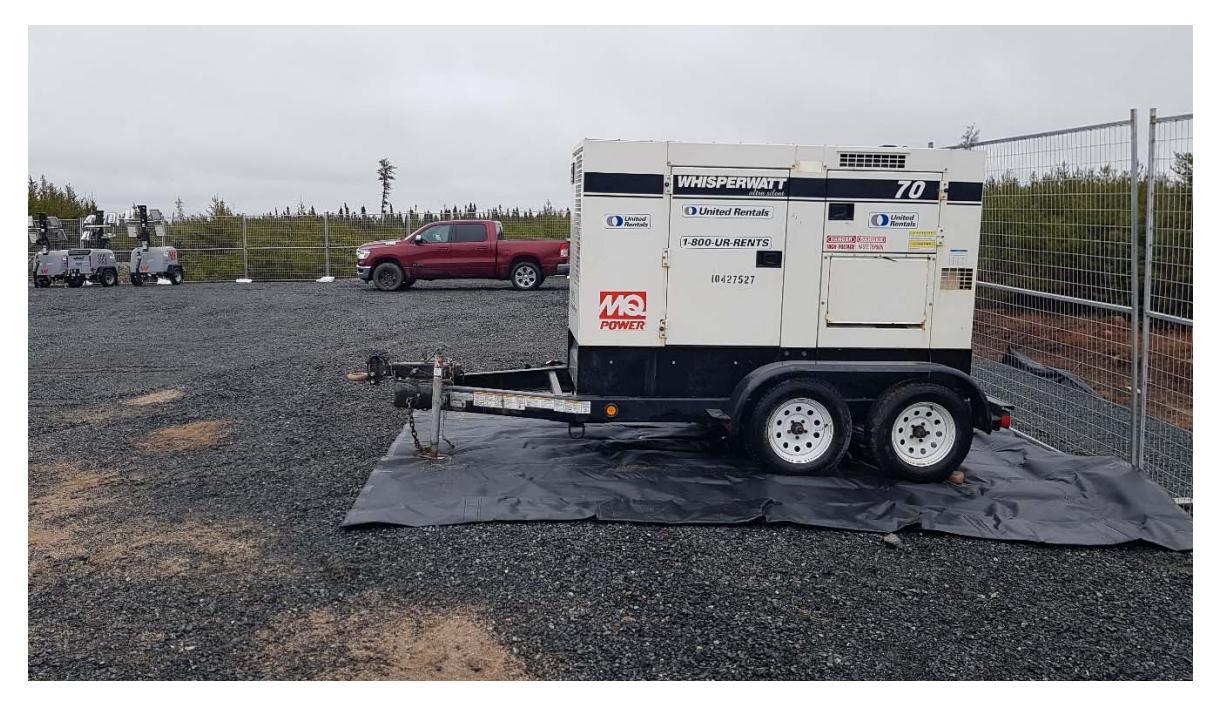
The site was powered by MQ WhisperWatt 70 diesel-electric generator, which supplied 56 kW (70 kVA) of 120 V single-phase output. It was used to power the site office trailers, core storage seacans, washroom trailer, and a portable power system on the drill pad. The location of the generator was chosen to minimize the length of electrical distribution cables, to protect the generator from vehicular traffic, and to allow for access by truck in the event that the generator required repairs or replacement (Appendix A, Photo 14).

Photo 14 - Power Generator Setup

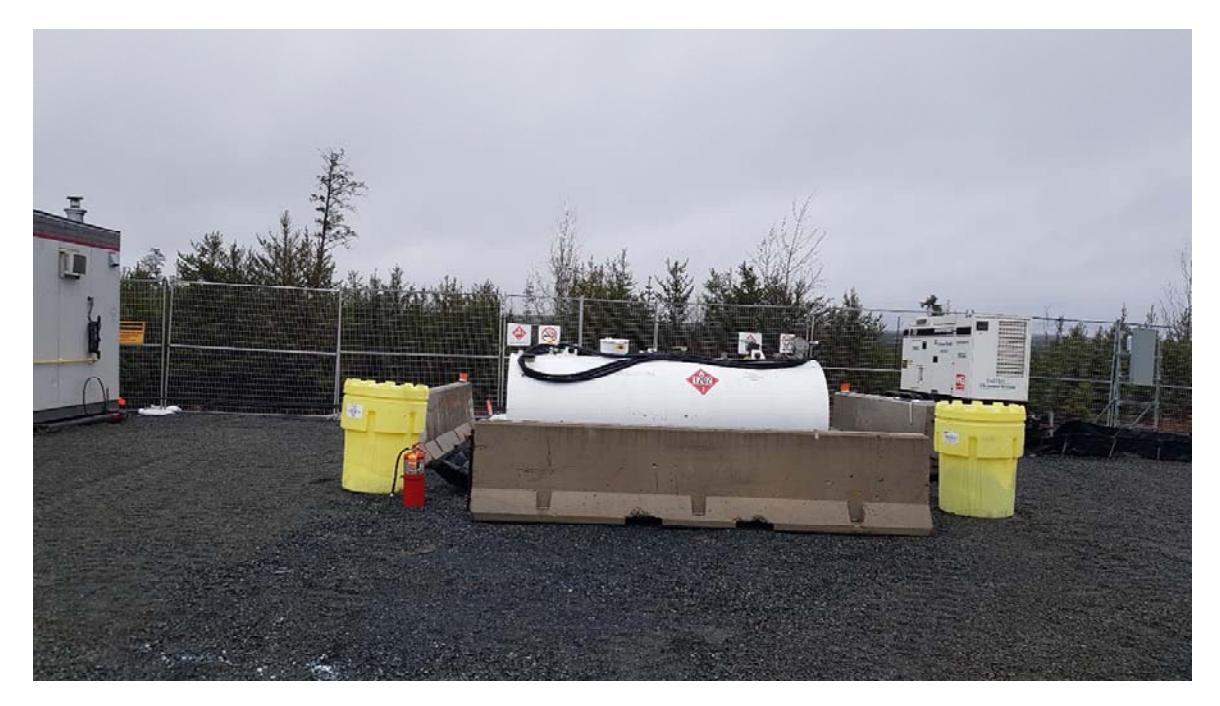
A 4,500 L double-walled fuel storage tank was located adjacent to the generator, so that refueling of the generator could be performed directly from the fuel storage tank. The fuel tank and generator were placed inside a secondary containment berm with containment capacity of 5,460 L, sufficient to contain the maximum amount of fuel and oil in the system. The fuel tank was surrounded by concrete barricades to protect it from vehicular traffic and heavy machinery. The generator and fuel storage tank is shown in Appendix A, Photo 15.

Two petroleum hydrocarbons spill kits (359 L each) were placed beside the site fuel supply and generator, and a universal spill kit was set up near the drill rig area. Two bins full of sawdust were also placed by the washroom trailer to manage potential spills in that location. Four additional portable spill kits were placed in Golder's site trailer and storage seacans for fast spill response, if required (Appendix A, Photo 15).

Photo 15 - Fuel Tank, Concrete Barricades, Spill Kits and Fire Extinguisher

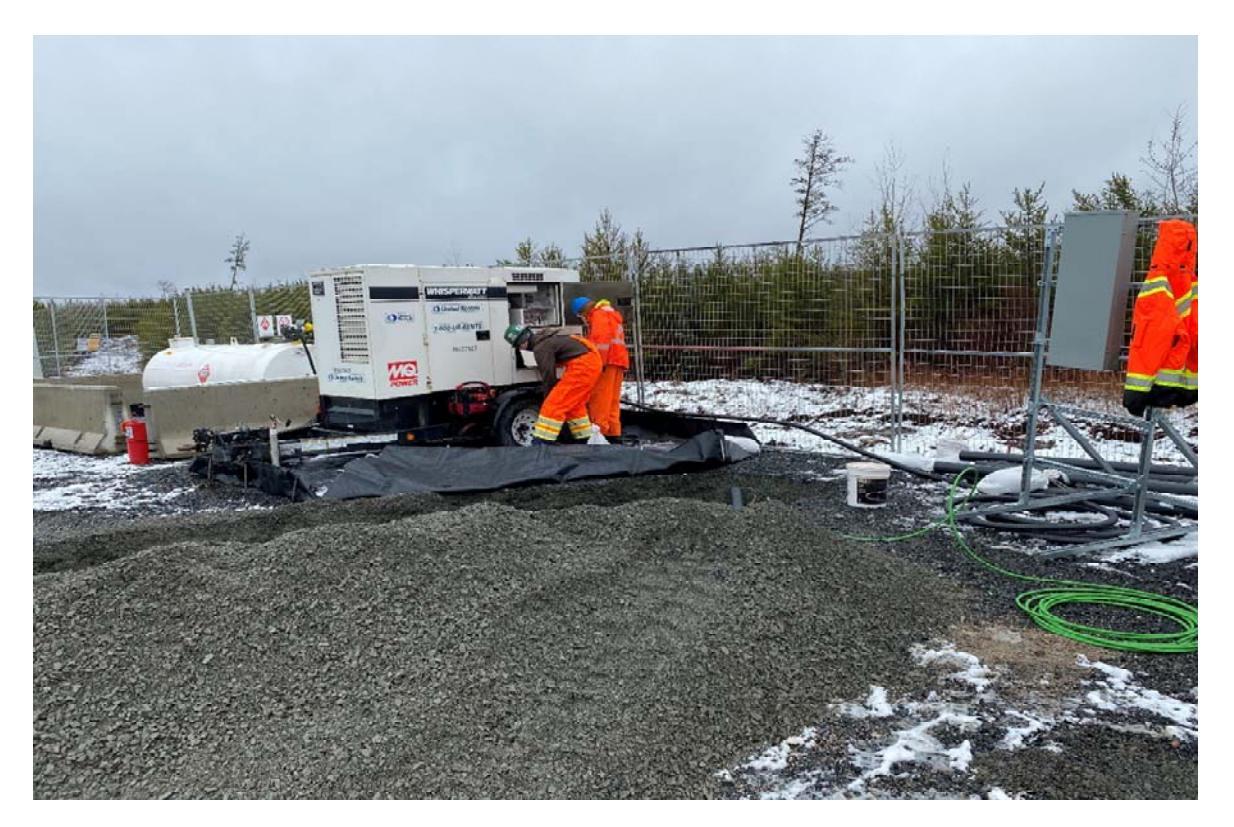
Set up of the electrical distribution system from the generator to the site facilities was performed by Fediuk Electric under the direction of Justin Fediuk, Master Electrician License #6002843. Power was distributed to the site facilities via double jacketed electrical cables. The majority of the power lines were mounted to the site perimeter fence. In areas where the electrical lines passed through a trafficable area, they were buried underground inside ABS conduit (Appendix A, Photo 17)

Photo 17 - Electrical Power Setup

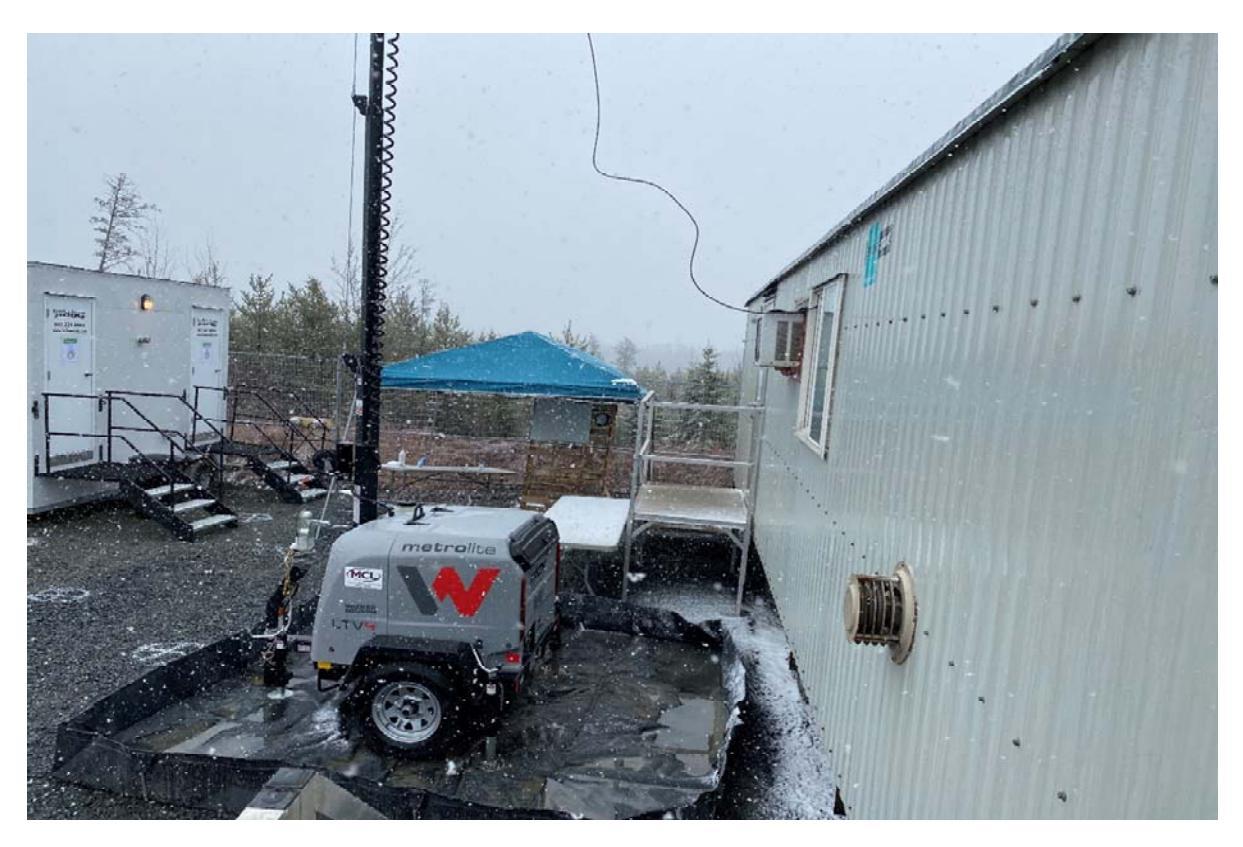
Three 4-kW - Wacker Neuson Metrolite LTV4 diesel powered light towers with LED lights were installed at the site to provide outside illumination during work at night. The light towers were positioned to provide an even distribution of light (Appendix A, Photo 18). The light tower placement also considered: ground stability, level of activity in the area, and the ability to access the light towers by truck for refueling or repairs. The light towers were all placed within their own secondary spill containment. The containments were sized so that the entire light tower footprint would be within containment, and the containment capacity (2,800 L) exceeded the maximum volume of fuel and oil within the light towers (180 L) (Appendix A, Photo 19).

Photo 19 - Light Tower in a Secondary Containment
