# Development of Delayed Hydride Cracking Test Apparatus and Commissioning Tests for CANDU Fuel Bundle Assembly Welds

**NWMO TR-2009-08**

**October 2009**

Kinectrics Inc.

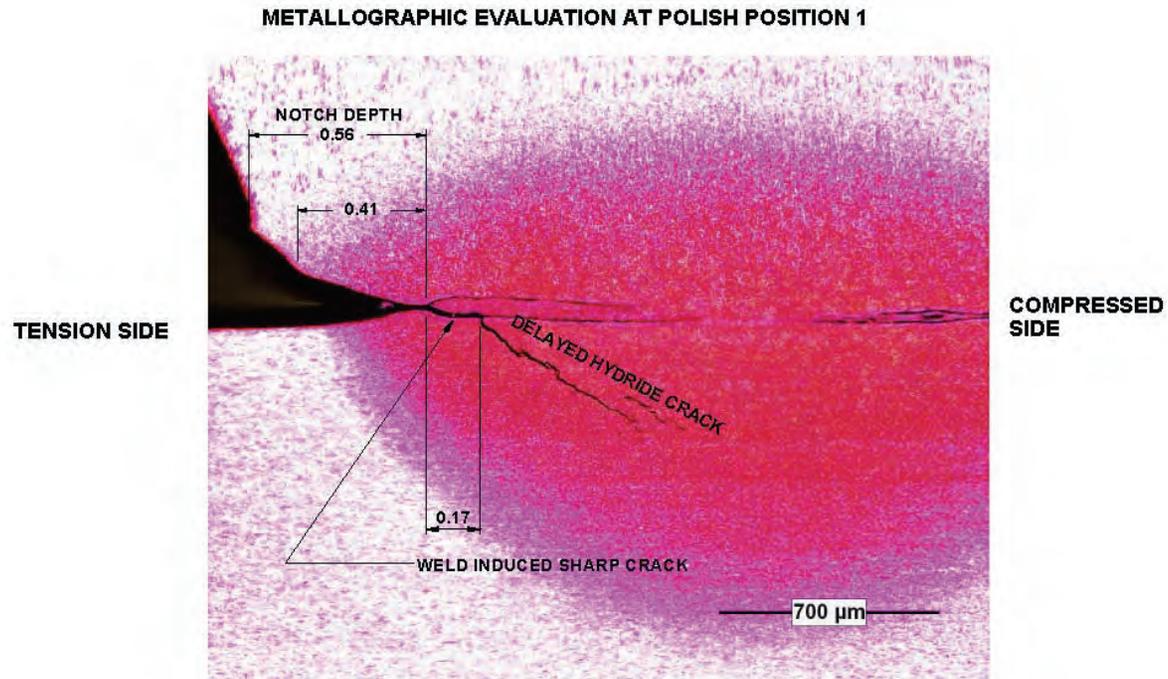
Figure 1: Metallographic Section of a Weld Sample after the DHC Test Showing the Notch and Weld Discontinuity (The DHC Crack Deviates about 33° from the Plane of the Weld Discontinuity) (Test 07-09)

In order to calculate the  $K_I$  at the weld discontinuity, which is treated as an initiating crack, the depth and profile of the weld discontinuity need to be determined. This can be done by metallographic examination (and/or fractography) to determine the dimensions of the notch and weld discontinuity. Figure 1 is a metallographic section of the weld prepared after a  $K_{IH}$  test (details of the  $K_{IH}$  test will be provided in Section 3.4). The depth of the notch formed between the endplate and endcap and the depth of the weld discontinuity can be measured from the micrograph and used as input to calculate the applied  $K_I$  in the DHC test. It should be noted that in order to obtain the proper depths of the notch and weld discontinuity for  $K_I$  calculation, the metallographic section should be taken at a location near the middle of the weld.

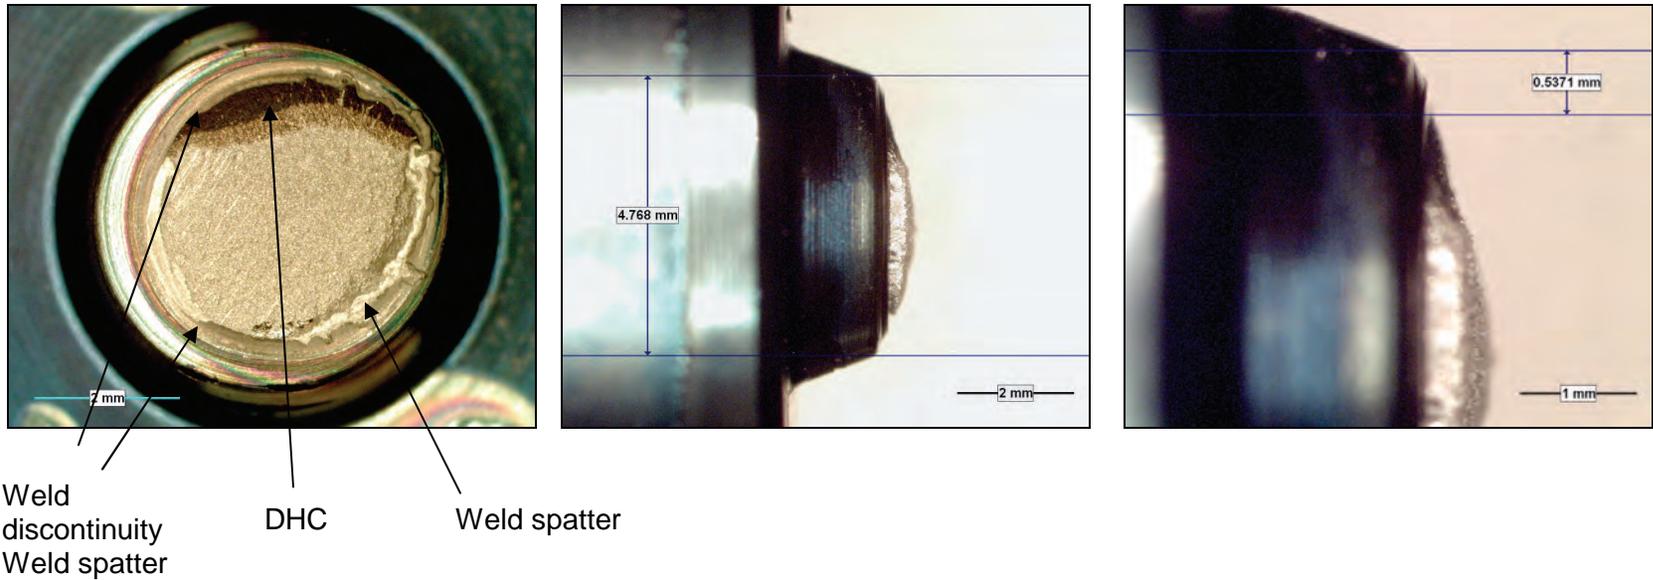
Top view of DHC crack on endcap

Side-view showing the weld diameter

Side-view showing the combined notch and crack depth

**Figure 2: Fracture Surface on the Endcap after the DHC Test to Illustrate the Appearance of the Weld Discontinuity and Weld Spatter (Commissioning Test 07-104)**

Figure 2 shows an example of a DHC crack of a commissioning test to be described in Section 3.4. The diameter of the weld and the combined depth of the notch and weld discontinuity can be determined from the side-view of the fracture surface. Figure 2 also shows the presence of weld spatter on the endcap surface. However, the spatter does not appear to affect the depth of the notch and weld discontinuity or the load-bearing area.

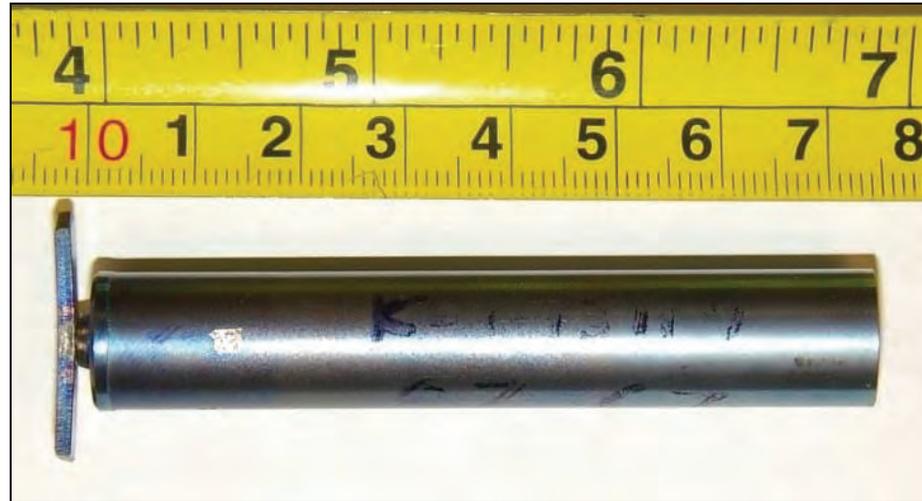
Side view

End view

Figure 3: Sample for DHC Test

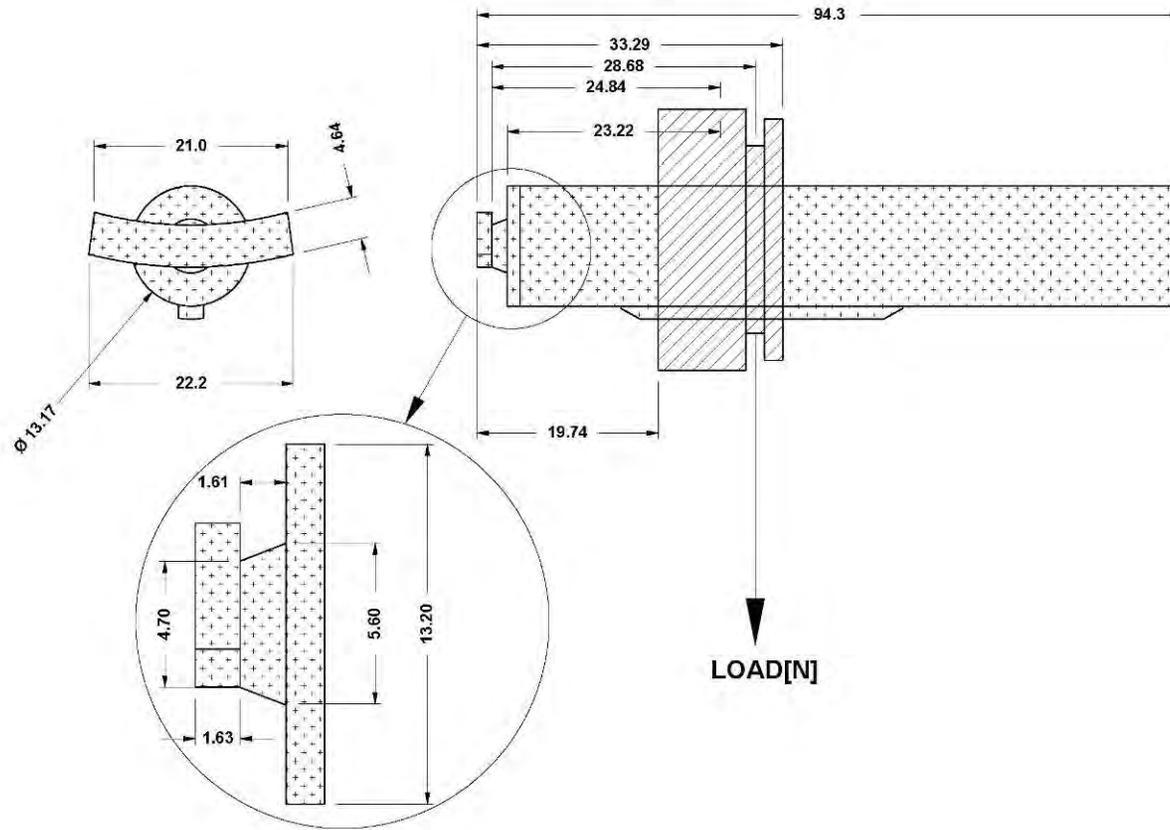
Note: In this illustration, the lever arm distance from the centre of the collar to the weld discontinuity is 24.94 mm. The endplate thickness is about 1.6 mm. The loading is applied by pulling down on the collar.

**Figure 4: Drawing of DHC Test Sample which Includes the Collar for the Loading Cable and Showing the Nominal Dimensions**

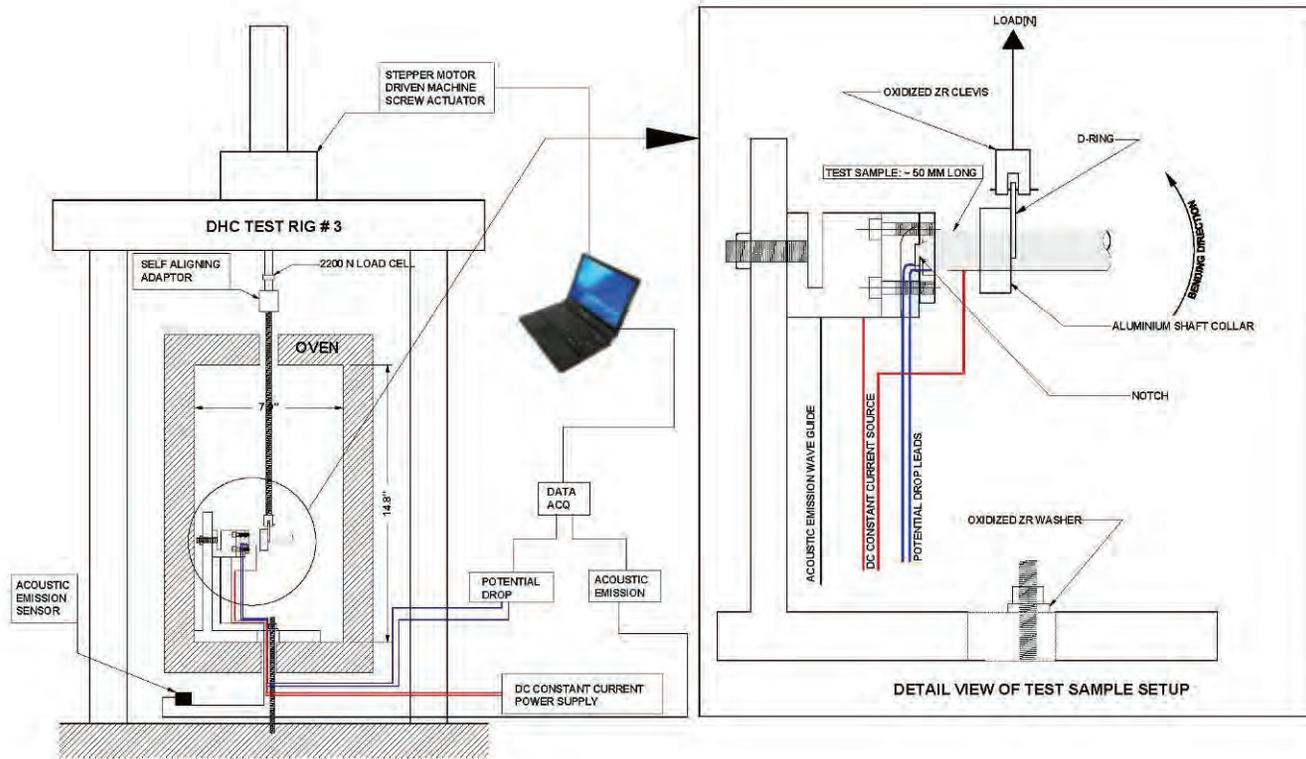
Figure 5: DHC Test Apparatus

Figure 5 shows a schematic diagram of the test apparatus which consists of the loading rig, furnace for heating, crack monitoring system using both acoustic emission and direct current potential drop, and data acquisition and control system.

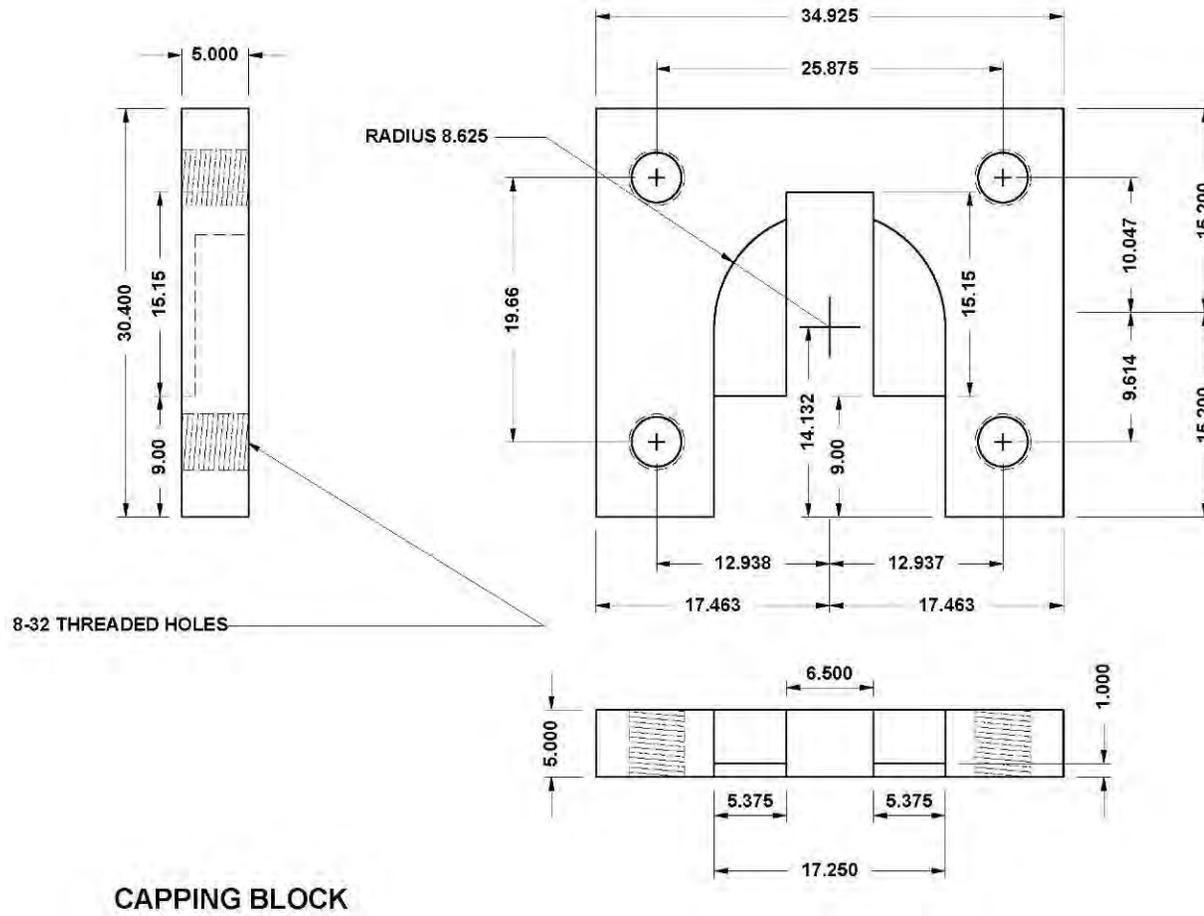
Figure 7: Design of Capping Block

For the loading rig design, the sample is anchored by gripping the endplate strip between two machined blocks connected by threaded bolts (Figure 6). The capping block (Figure 7) has a 1 mm thick portion which goes into the gap between the endplate and spigot of the element so that the sample can be anchored close to the weld. The capping block was made with 17-4PH Stainless Steel. The backing block (Figure 8), which was made with 300 series stainless steel, has a machined groove for placing the endplate strip. Backing blocks with different machined grooves can be made to accommodate elements with different endplate strips (strip with different curvatures, widths or straight strip). The backing block is in turn supported in a platform through a threaded bolt and nut. The connection at the platform can be designed to

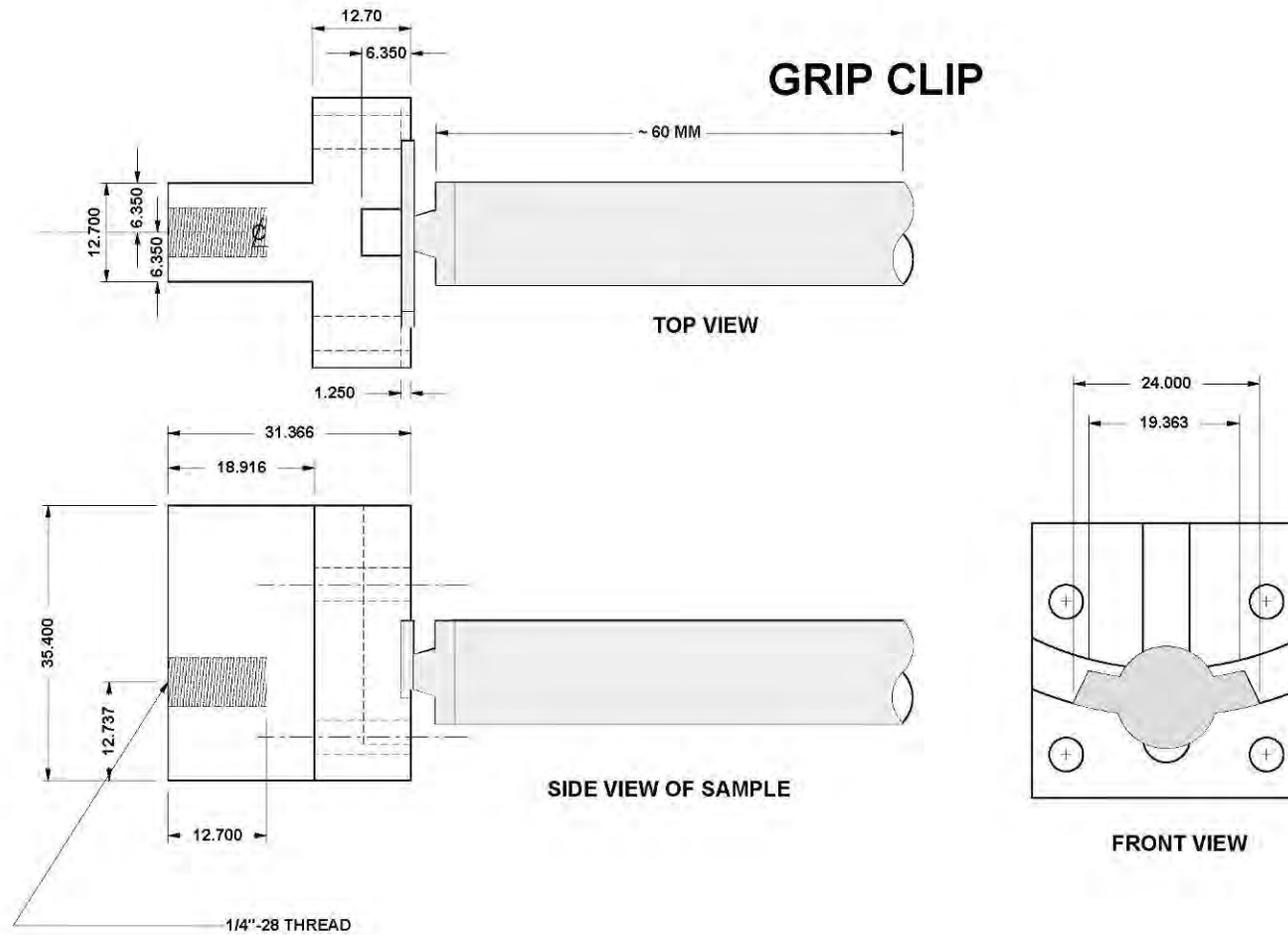
Figure 8: Design of Backing Block. The Endplate Thickness about 1.63 mm

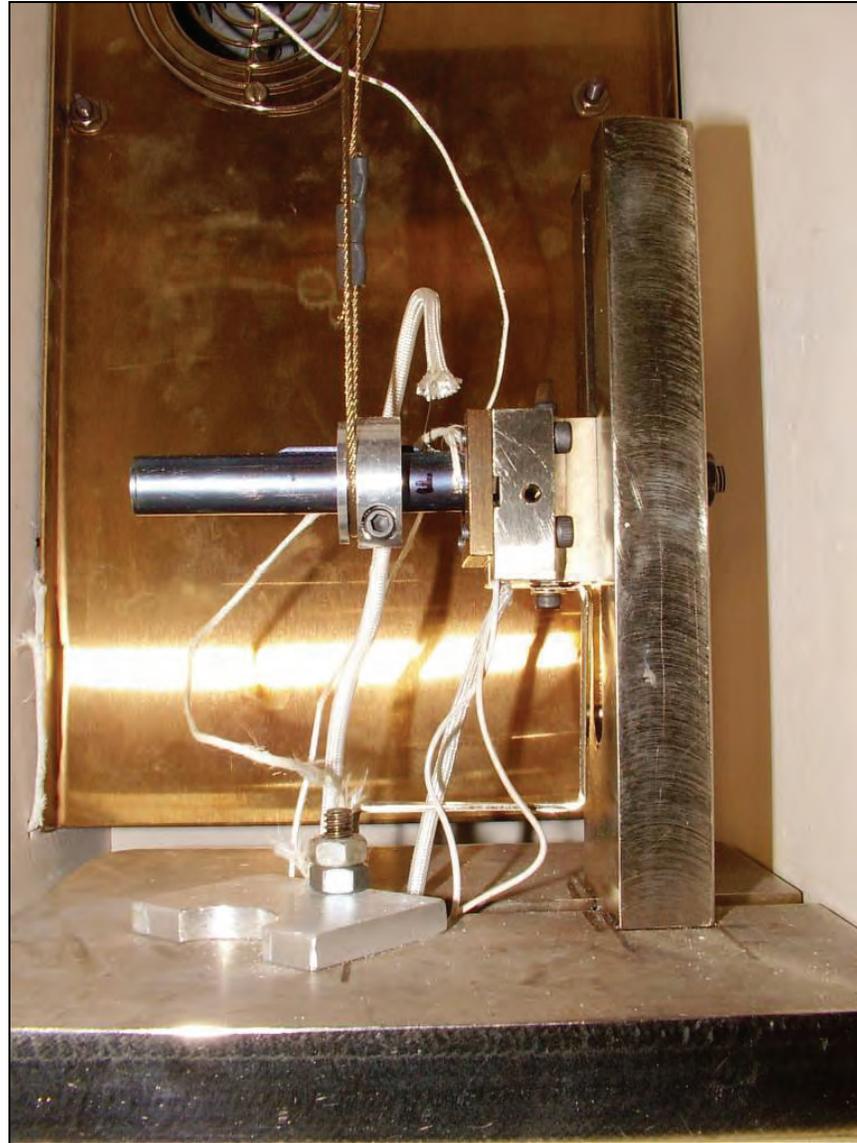
**Figure 9: Photograph Showing the Sample in the Loading Rig under Load**

Figure 9 shows that the sample is loaded by pulling up on the fuel element through a steel cable placed around a groove in an aluminum collar attached to the fuel element. This produces a tensile bending stress in the lower part of the weld. The pull rod is connected to a load cell and an actuator, controlled by a stepper-motor. The loading system is designed with a relatively short lever arm (e.g. 28.68 mm in the illustration shown in Figure 4) to avoid having a large bending moment at the weld. It should be noted that the loading system can be designed to pull down on the fuel element, in which case the top part of the weld will be under tensile bending stress.

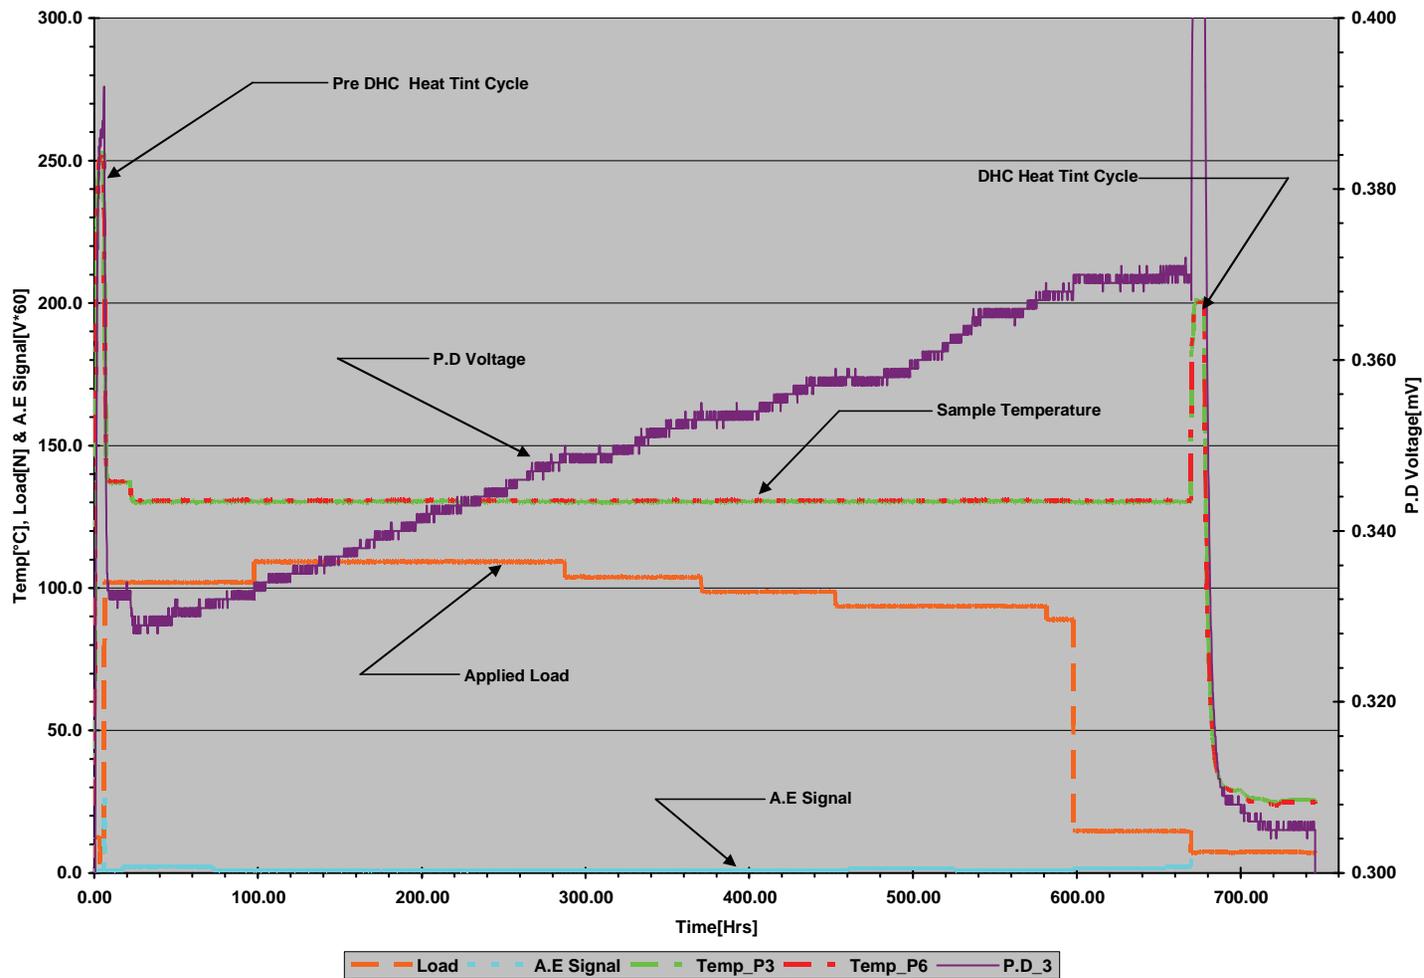
Year 2006.. K-013119.. Test: 06\_134.. Fuel Pencil: GE-L22222C Button # 8. ~10 PPM.. Dec 14.2006.

Figure 10: Test Record of Demonstration Test Showing the Temperature, Load, Potential Drop (PD), and, Acoustic Emission Signals (AE) (Test 06-134)

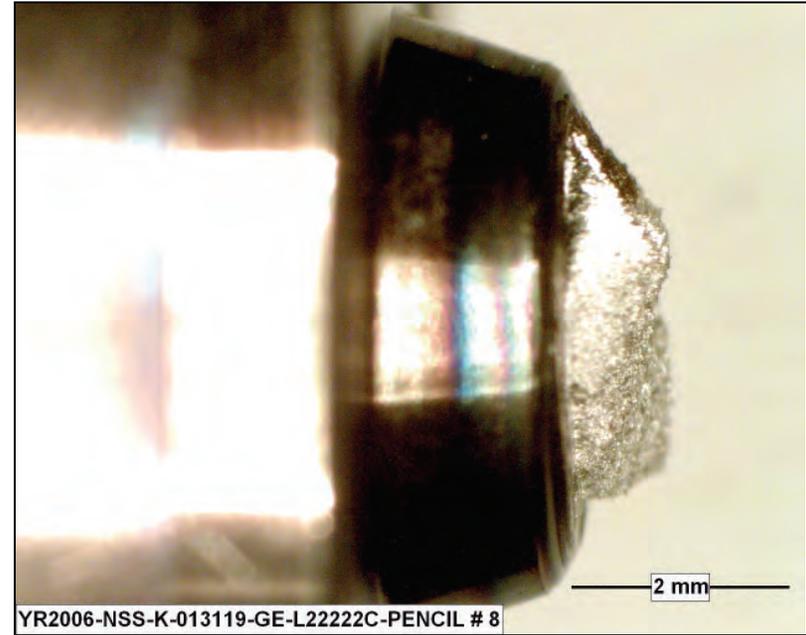
(b) Side view

**Figure 11: Fracture Surface Appearance of Sample (Test 06-134)**

The endplate strip was peeled off from the weld to expose the crack surface. Figure 11 shows the fracture surface on the endcap viewed from above and from the side. There were two zones of oxidized fracture surfaces, one represents the weld discontinuity and the other one represents the DHC crack. The DHC fracture surface appears to be "rougher" than the typical DHC crack in Zr-2.5Nb pressure tube material. This could be due to the difference in texture and microstructure of the two materials. It is expected that the Zircaloy weld would have more random texture and fewer reoriented hydrides in the crack path. The side view of the crack indicated that it grew at about  $30^\circ$  from the plane of the weld discontinuity into the weld region of the endplate.

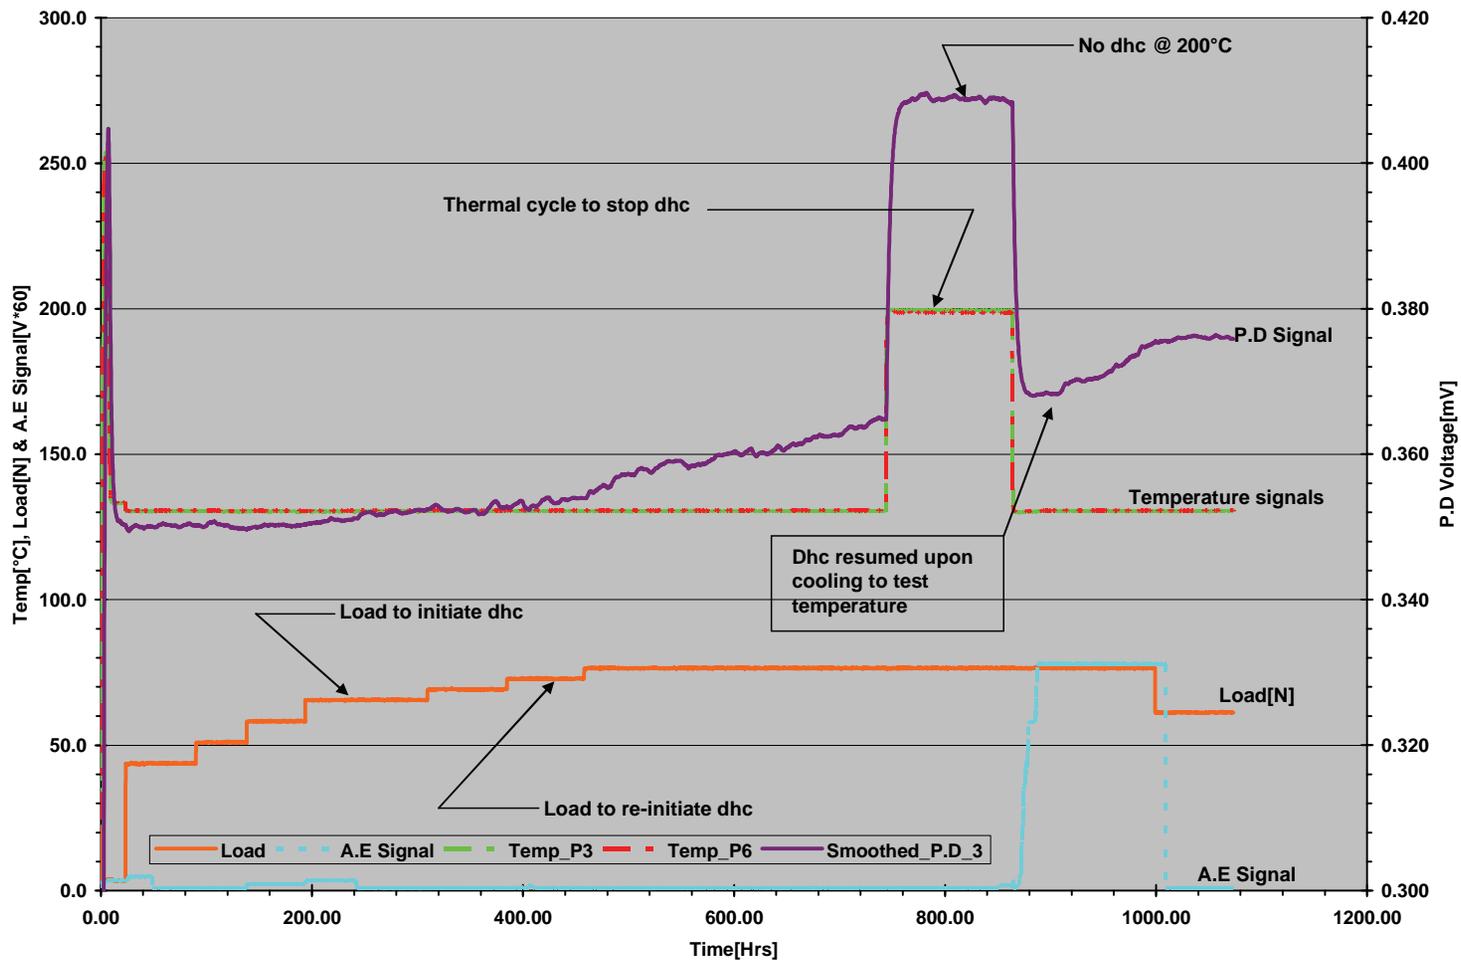
Year 2006.. K-013119.. Test: 07\_09.. Fuel Pencil: GE-L22222C Button # 6.. ~10 PPM.. Jan 14.2007.

Figure 12: Test Record (Commissioning Test 07-09)

Test 07-09: This test was performed at 130°C on the weld of element # 6 of the single-endplate bundle containing about 10 ppm hydrogen. Figure 12 shows the records of load, temperature, acoustic emission and potential drop of Test 07-09. The sample was heated to 250°C to mark the weld discontinuity and then cooled to the test temperature at 130°C. A load of about 45 N was applied which was equivalent to roughly 8 MPa $\sqrt{m}$ , assuming a crack depth of 0.5 mm. No cracking was detected by either PD or AE after about 70 hours. The load was increased in steps of 5% in 40-50 hours interval. It was observed that the PD started to increase at a load of 65 N. However, the increase in PD was sluggish at this load level. After increasing the load in steps to 78 N at 460 hours, the increase in PD became steady. To be conservative, the lower load of 65 N was used to calculate  $K_{IH}$  in the stress analysis of this test. Cracking continued until about 750 hours when the temperature was increased to 200°C to mark the DHC crack and to see whether cracking could be arrested. No cracking was detected during the 120 hours hold at 200°C.

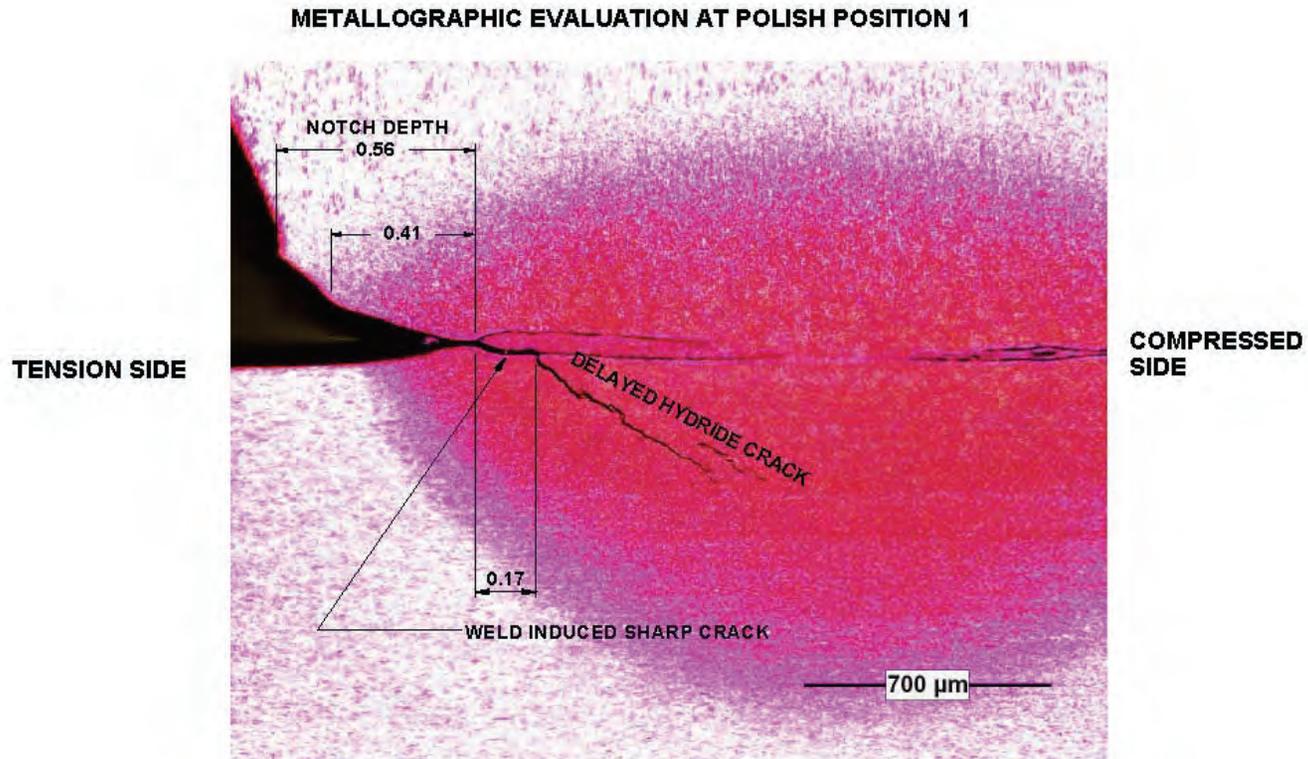
Figure 14: Metallographic Section of Sample Showing the Weld Notch. Weld Discontinuity and DHC Crack (Test 07-09)

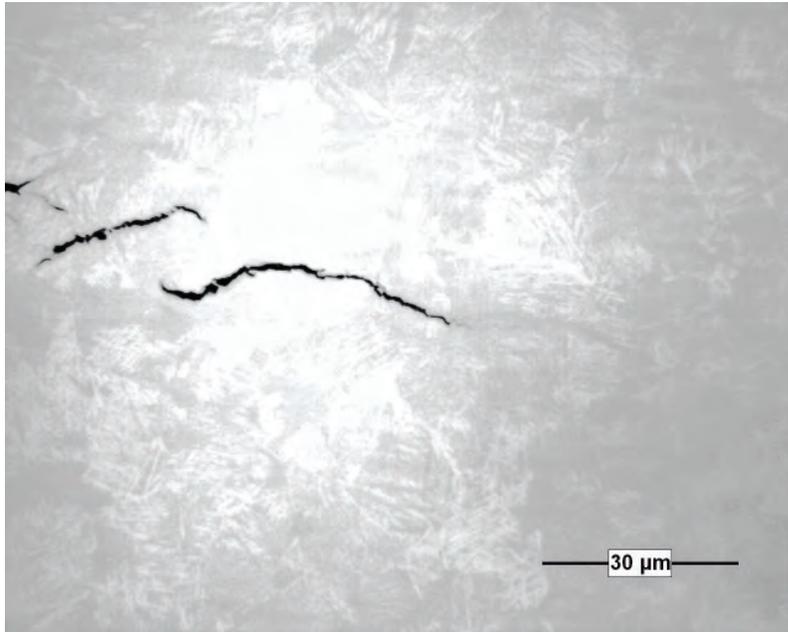
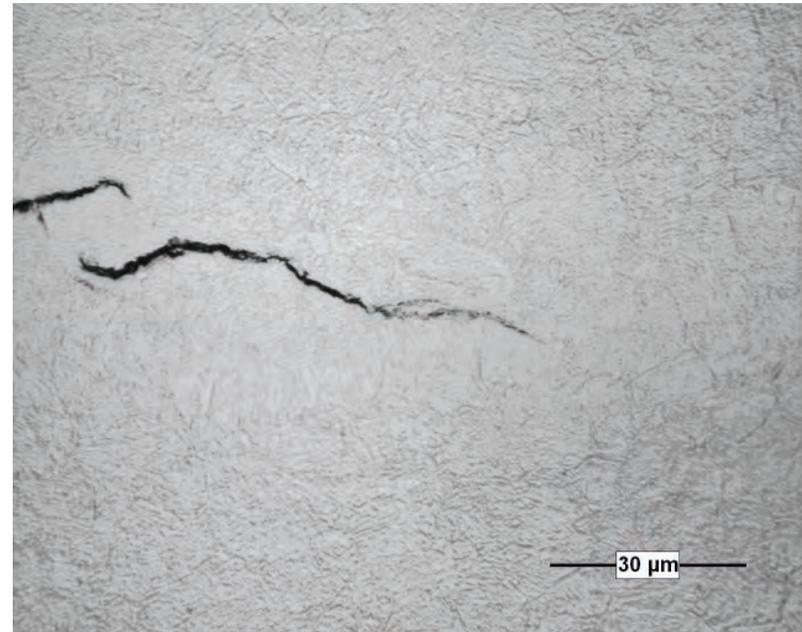
(a) as-polished

(b) chemically etched

**Figure 15: The Tip of the DHC Crack in the “as Polished” and “Etched” Condition Showing the Uncracked Hydride**

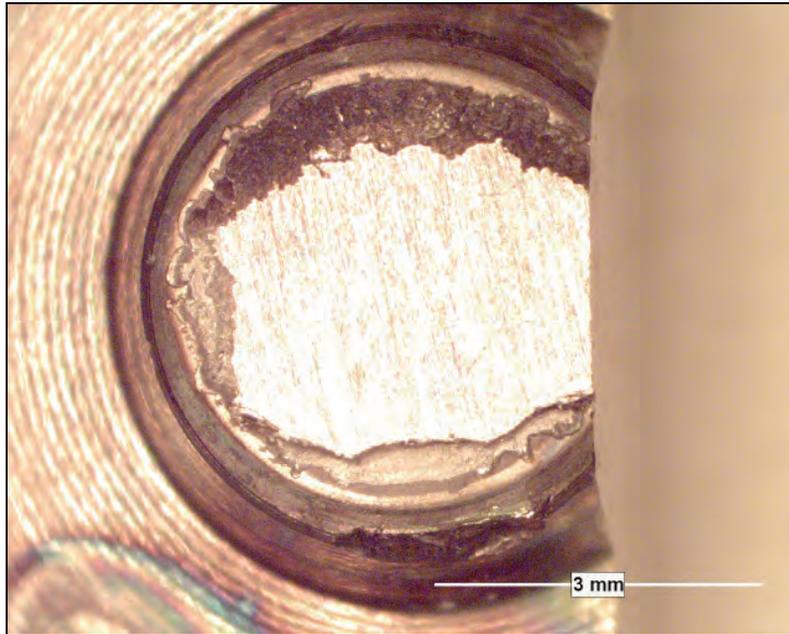
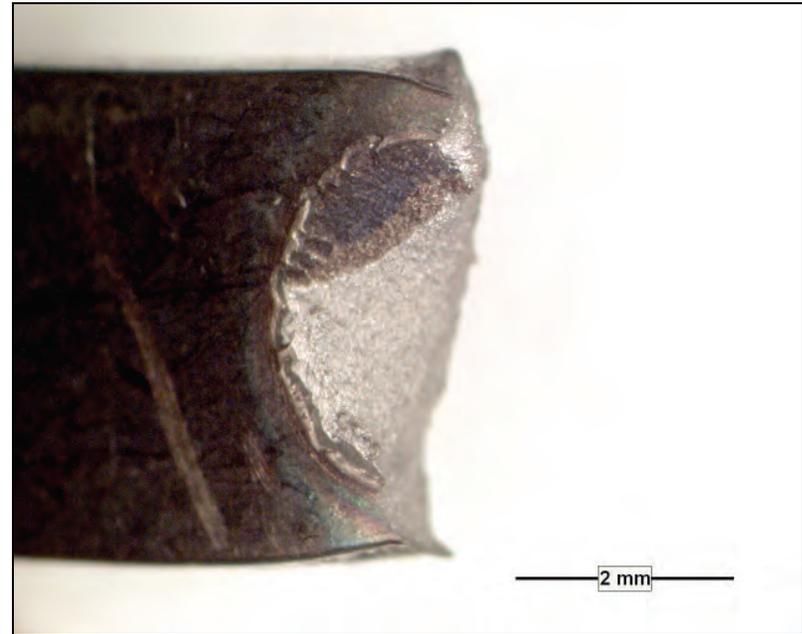
(a) DHC fracture surface on endcap

(b) DHC fracture surface on endplate

**Figure 16: Fracture Surface of DHC Crack of Sample (Test 07-09)**

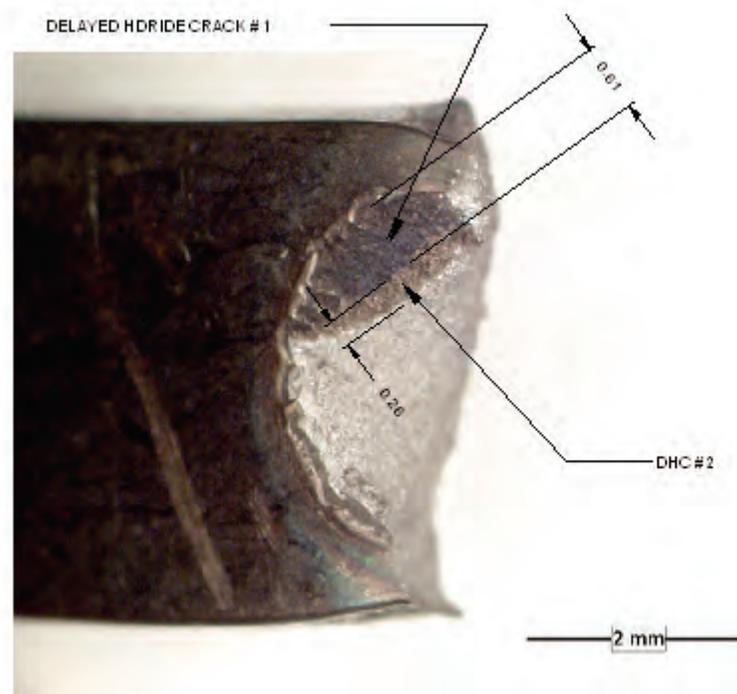
Figure 17: The Maximum Length of the Two DHC Crack Segments Measured from the Photograph (Test 07-09)

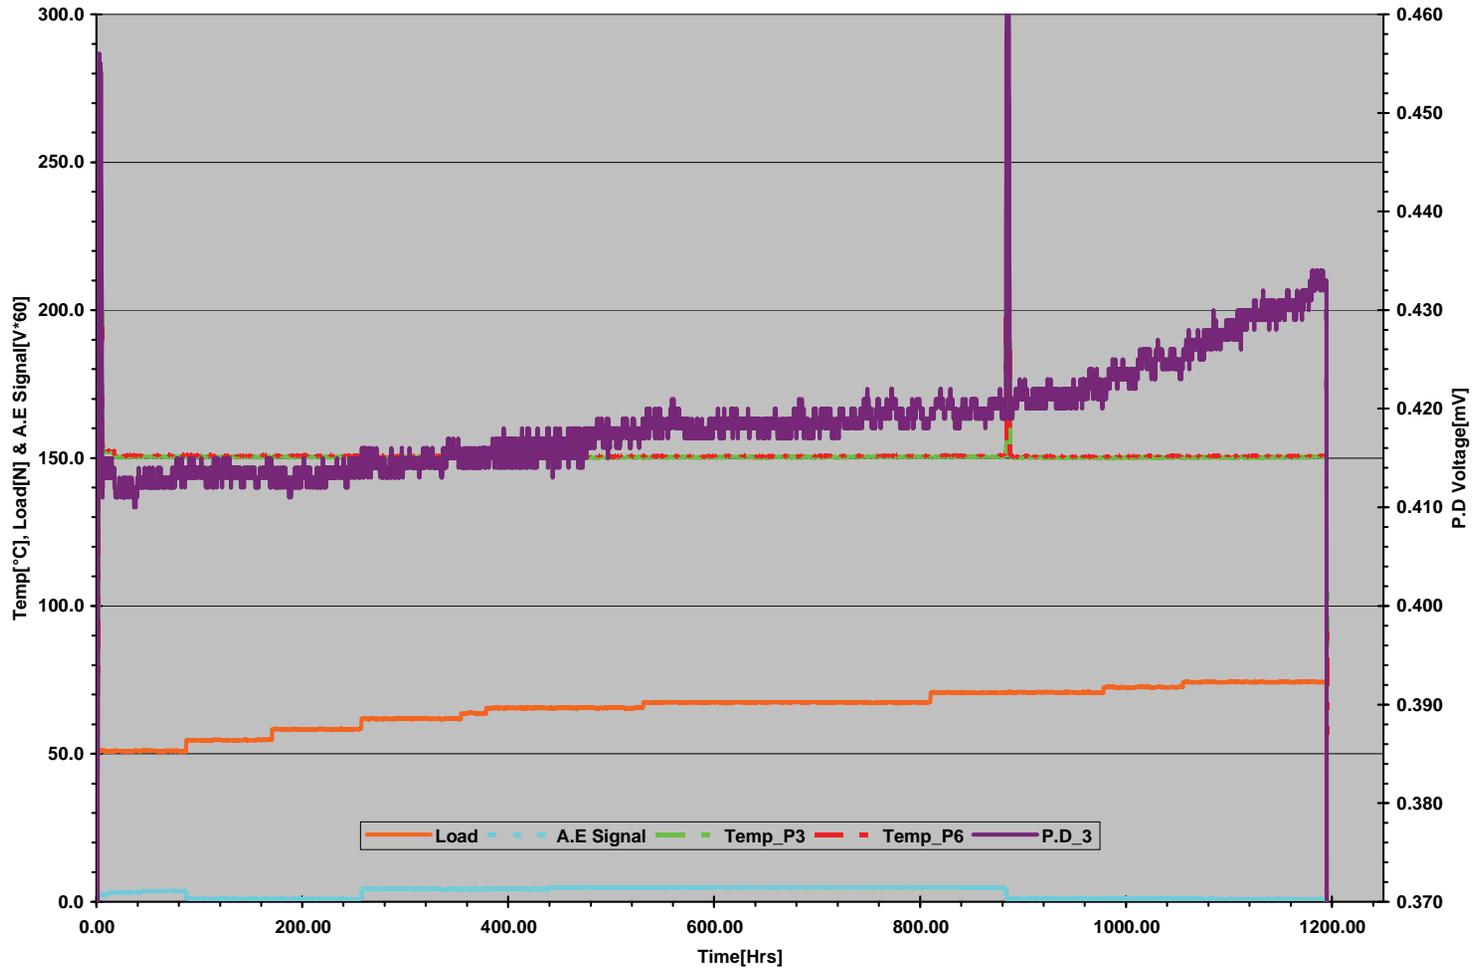
Year 2006.. K-013119.. Test: 07\_67.. Hydrided Fuel Pencil: Button # 2.. ~40 PPM + Layer.. Mar 20.2007.

Figure 18: Test Record of DHC. The Heat-Tinting Cycle Performed at about 900 Hours (Commissioning Test 07-67)

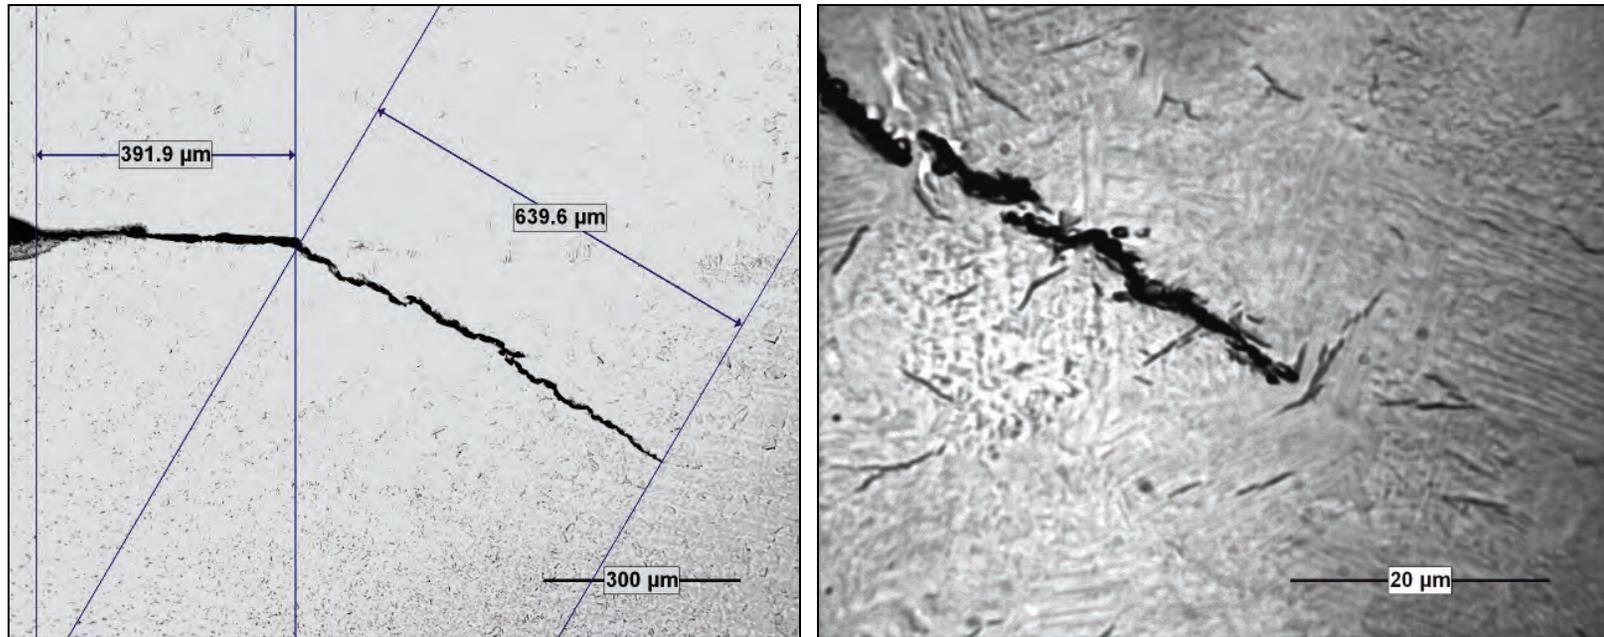
**Figure 19: Metallographic Section Showing the Weld Discontinuity and Hydrides along the Crack (Test 07-67)**

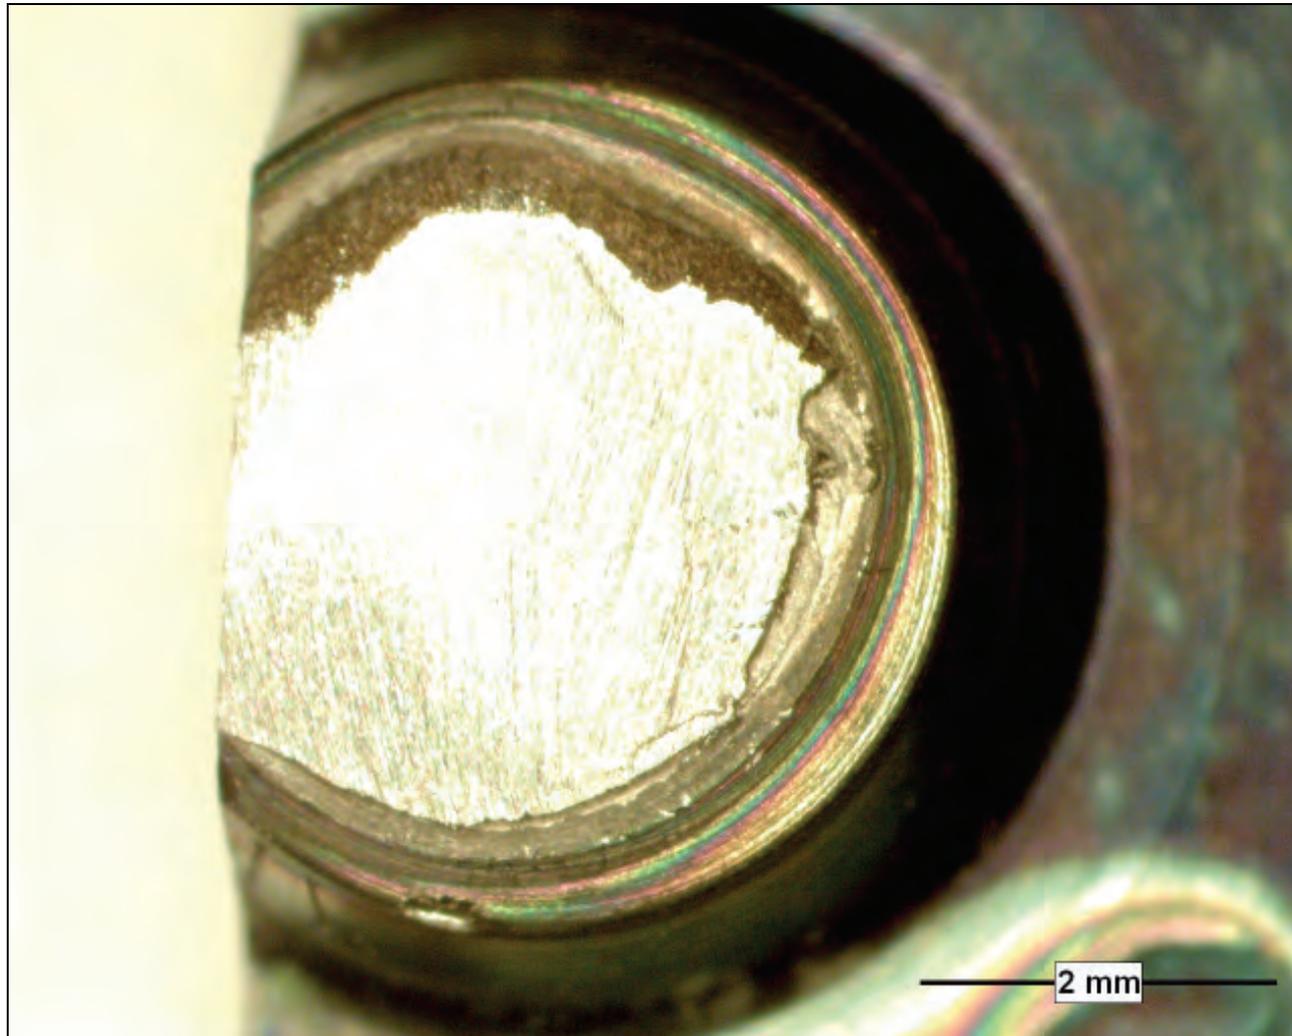
Figure 20: DHC Fracture Surface of Sample (Test 07-67)

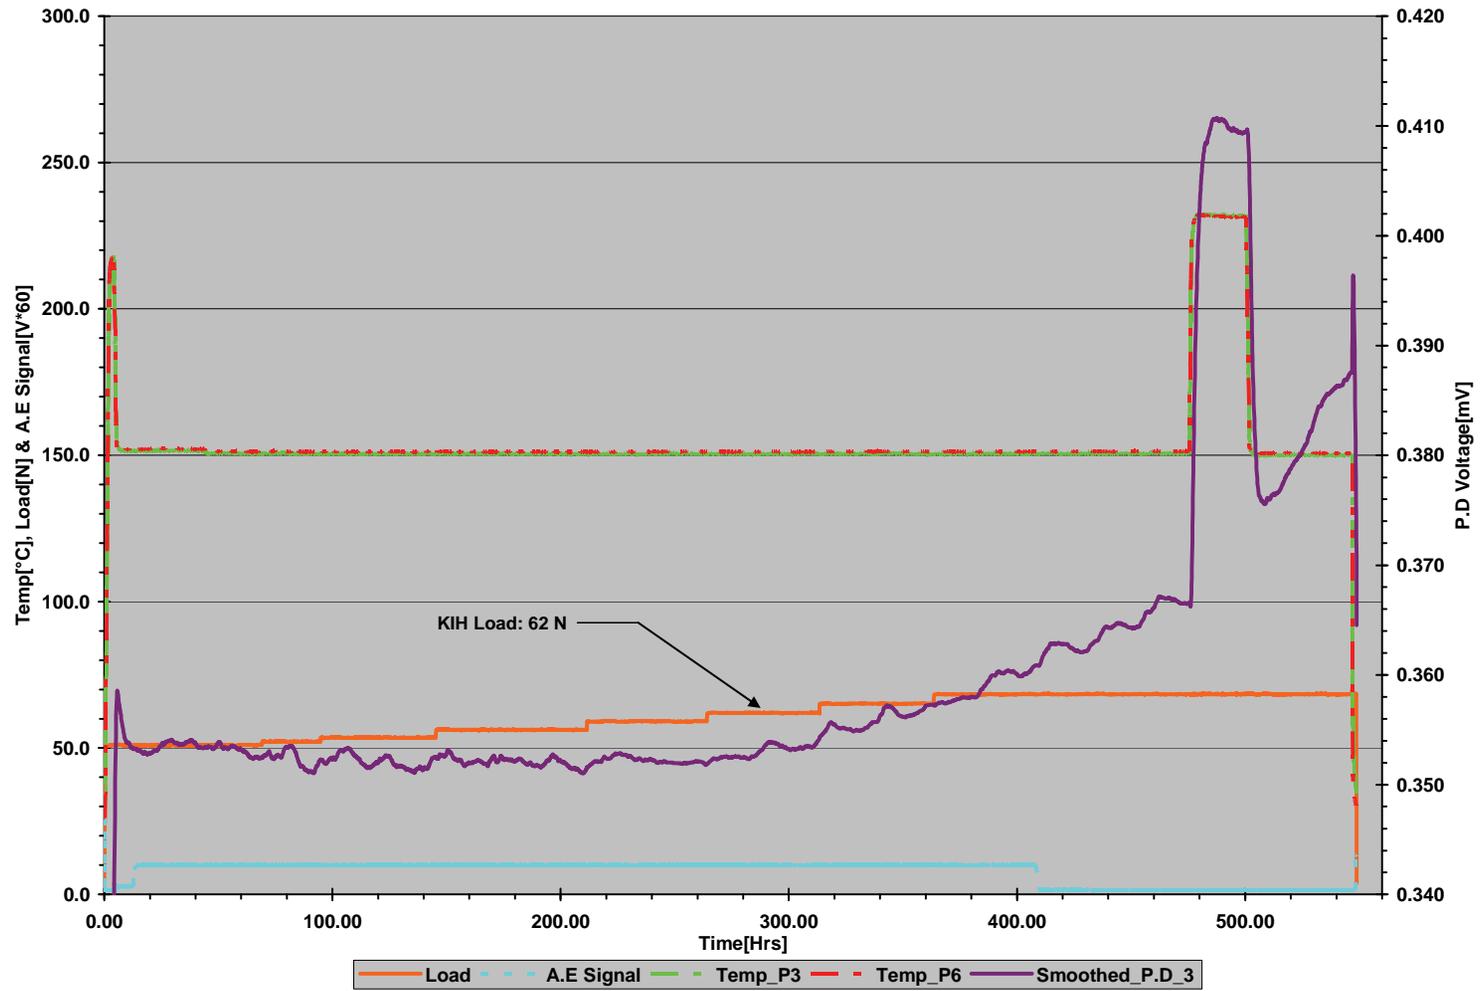
Year 2006.. K-013119.. Test: 07\_104.. Hydrided Fuel Pencil: Button # 13.. ~40 PPM + Layer.. Aug 10.2007.

Figure 21: Test Record of  $K_{IH}$  Test (Test 07-104)

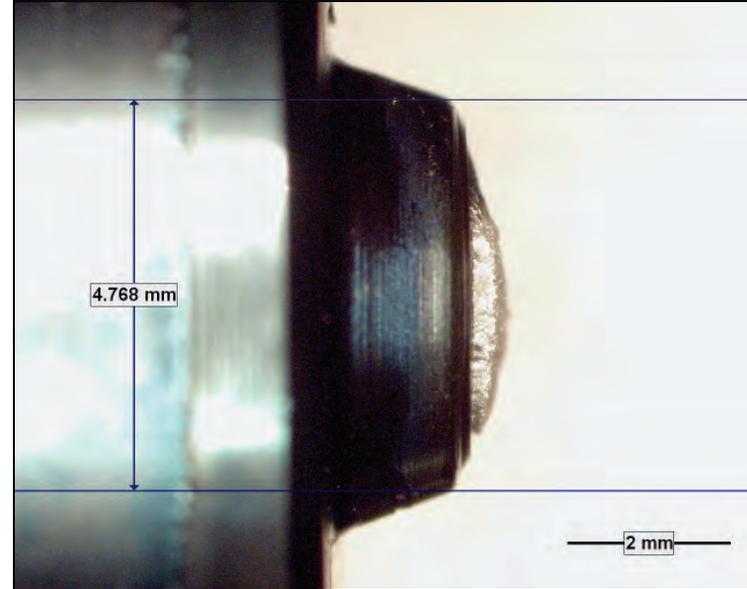
Side view

**Figure 22: Fracture Surface Appearance of Sample (Test 07-104)**
