# Development of Delayed Hydride Cracking Test Apparatus and Commissioning Tests for CANDU Fuel Bundle Assembly Welds

**NWMO TR-2009-08**

**October 2009**

Kinectrics Inc.

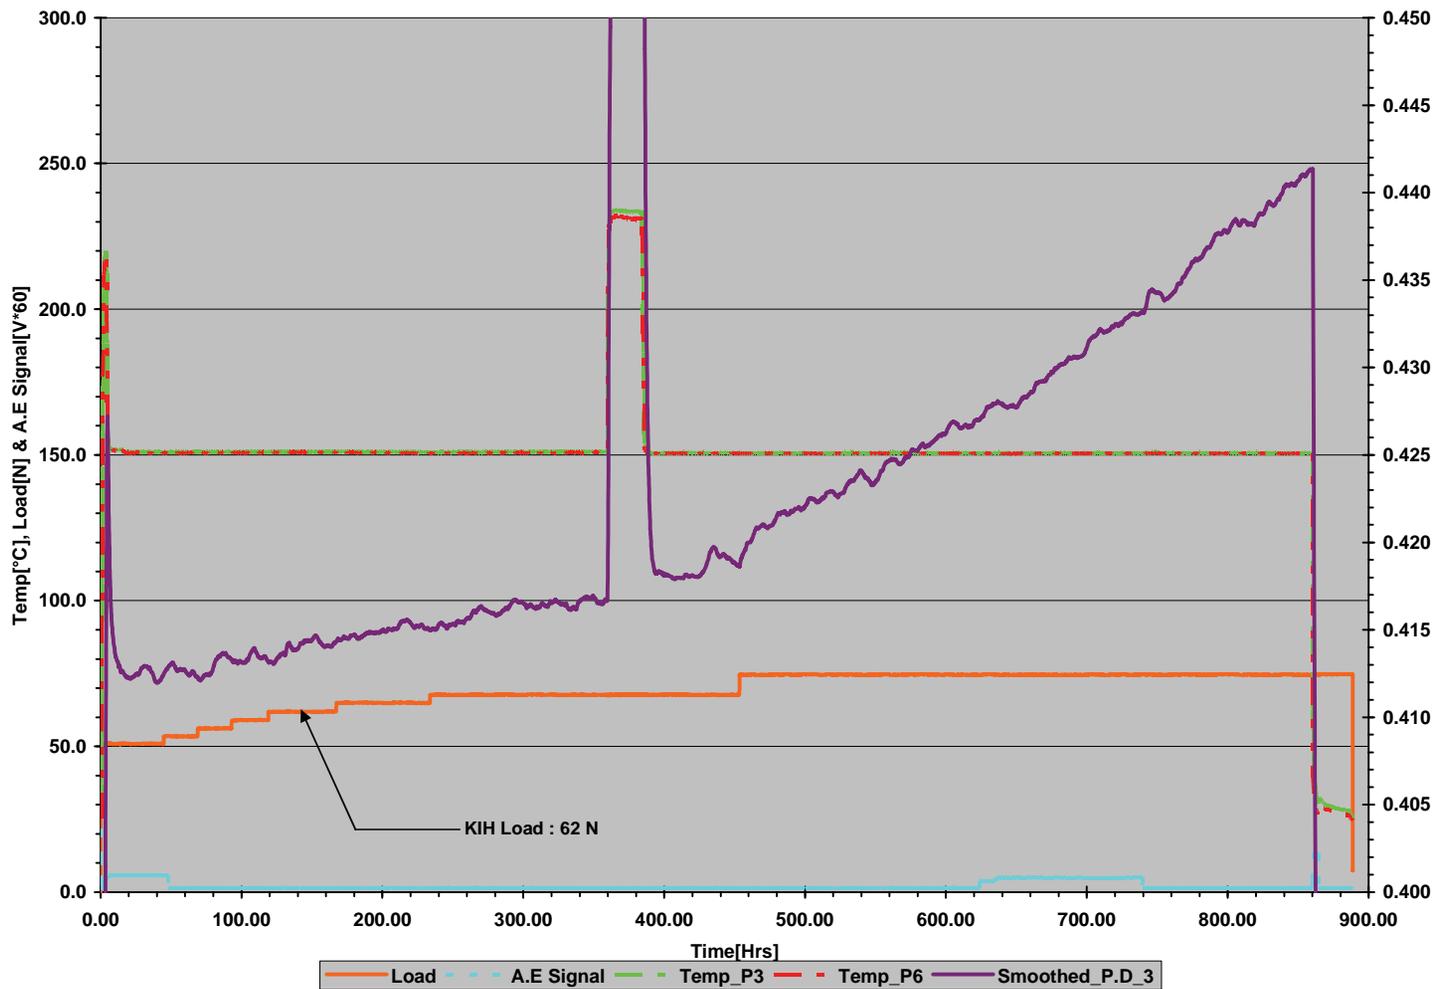
Year 2006.. K-013119.. Test: 07\_140.. Hydrided Fuel Pencil: Button # 15.. ~40 PPM + Layer.. Oct 10.2007.

Figure 23: Test Record of  $K_{IH}$  Test (Test 07-140)

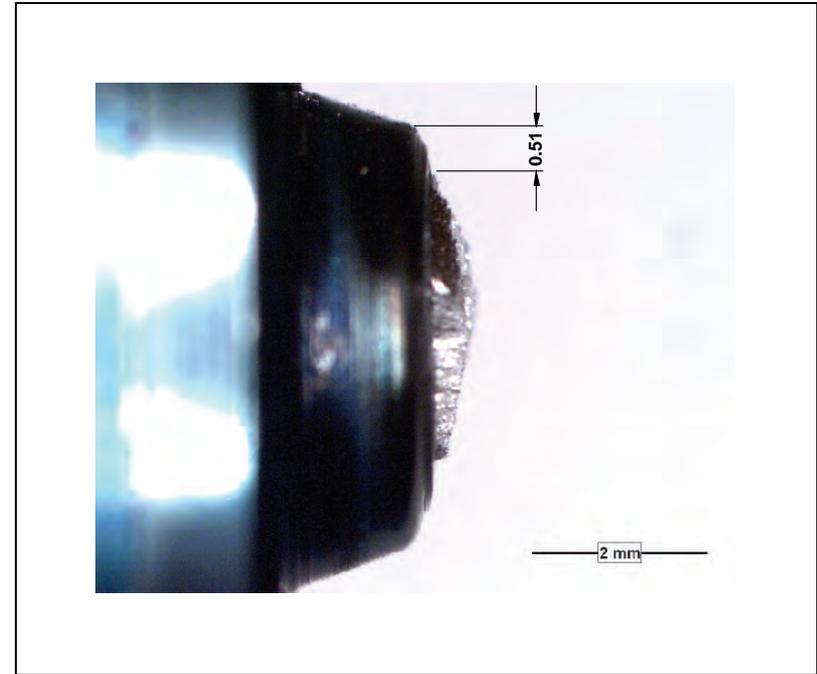
(b) Side view

**Figure 24: Fracture Surface of Sample from  $K_{IH}$  Test (Test 07-140)**

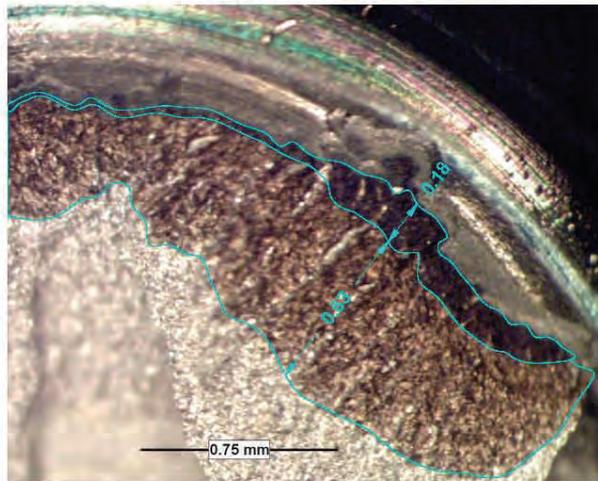
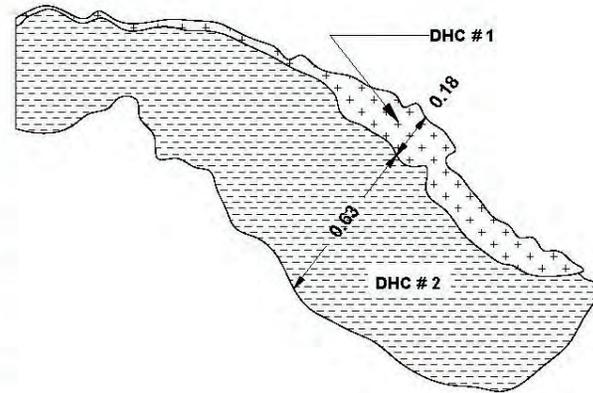
Figure 25: Higher Magnification of Fracture Surface of Sample Showing the Two DHC Segments (Test 07-140)

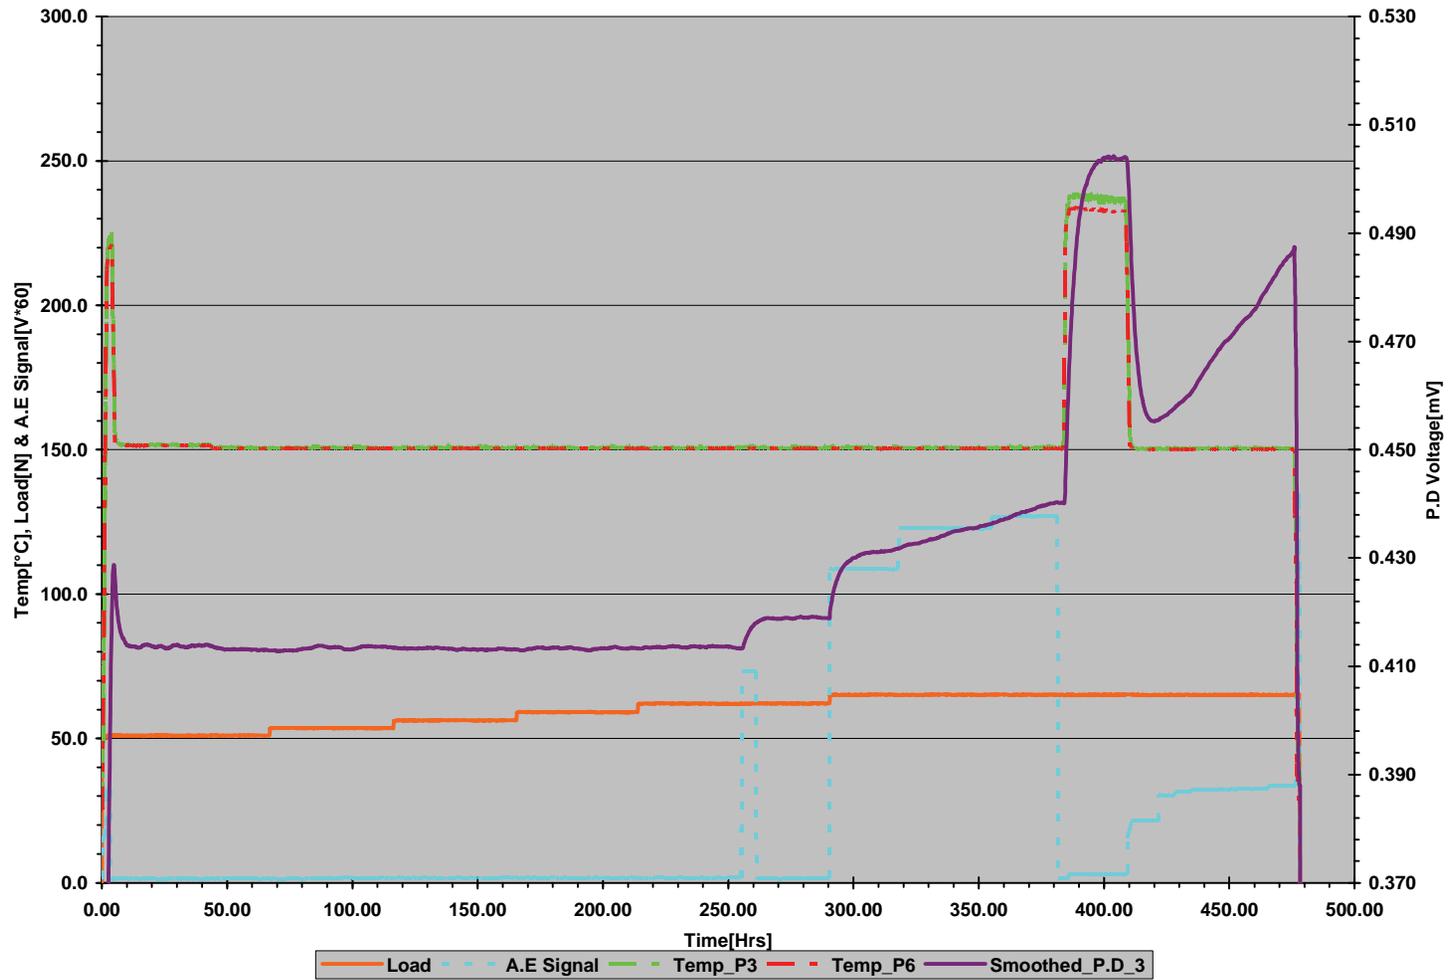
Year 2006.. K-013119.. Test: 07\_164.. Hydrided Fuel Pencil: Button # 8.. ~40 PPM + Layer.. Nov 17.2007.

Figure 26: Test Record of  $K_{IH}$  Test (Test 07-164)

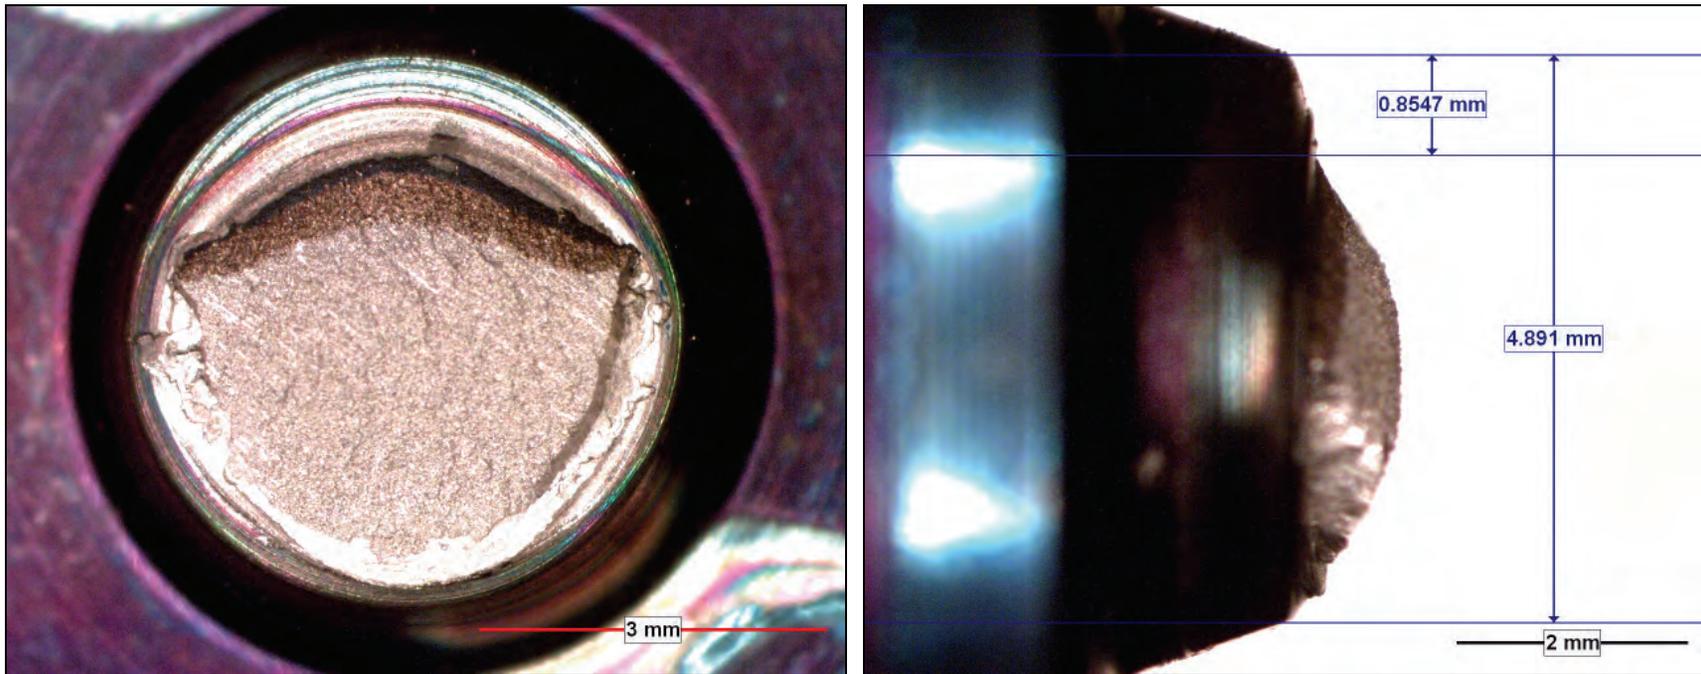
Top view

Side view

Figure 27: Fracture Surface of Sample (Test 07-164)

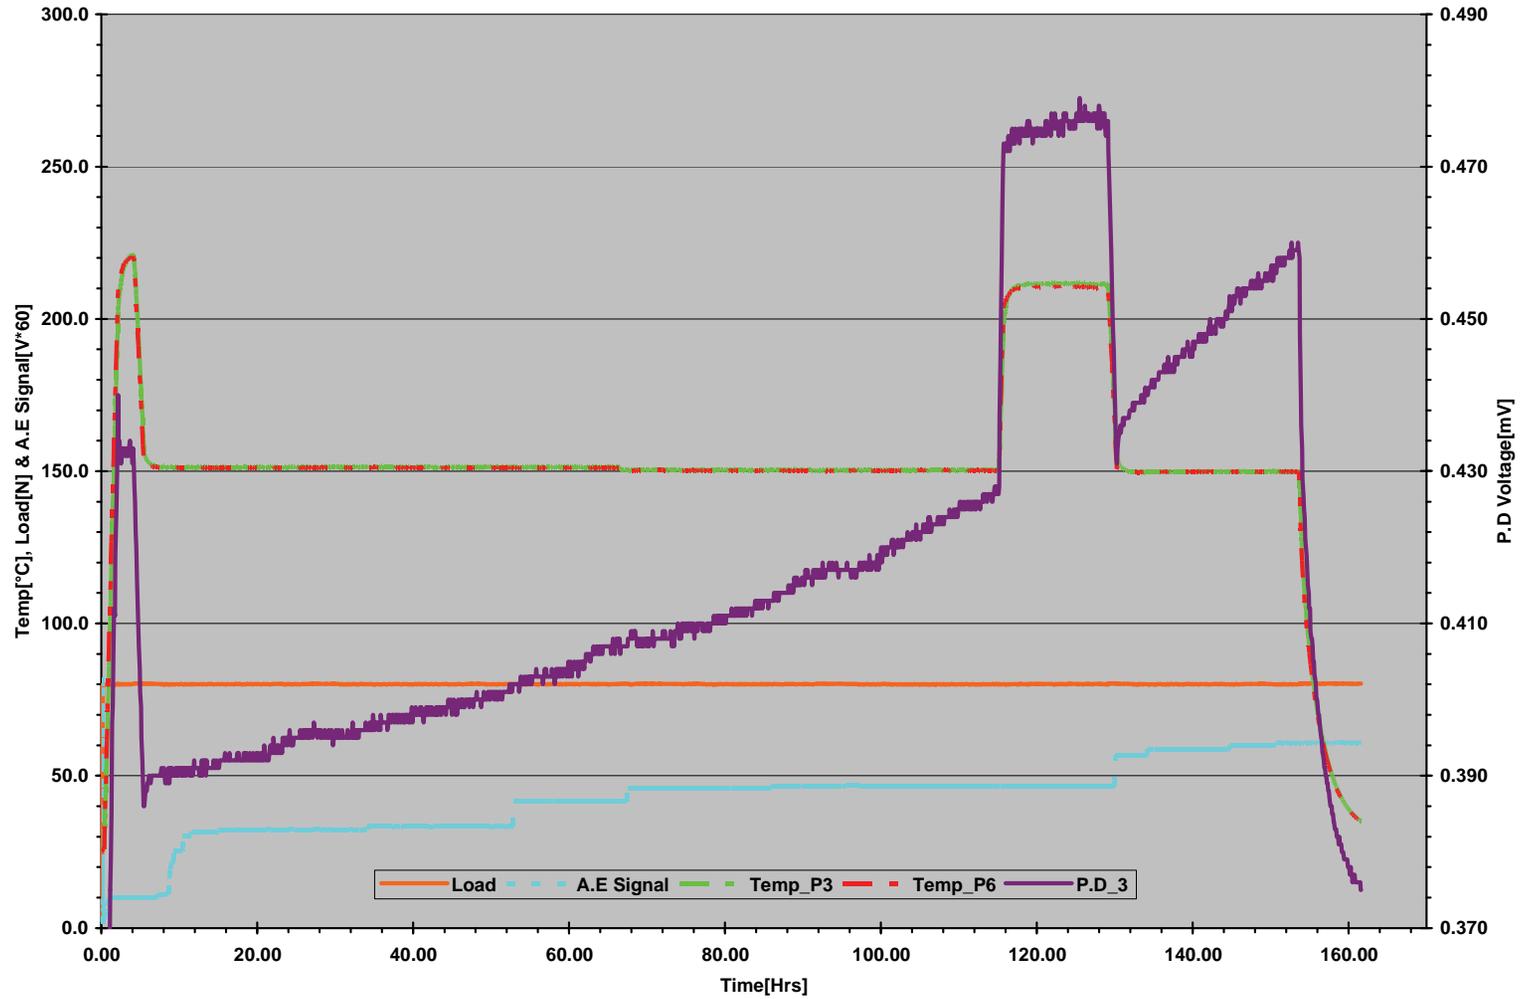
Year 2006.. K-013119.. Test: 07\_78.. Hydrided Fuel Pencil: Button # 4.. ~40 PPM + Layer.. Jun 01.2007.

Figure 28: Test Record of DHCV Test (Commissioning Test 07-78)

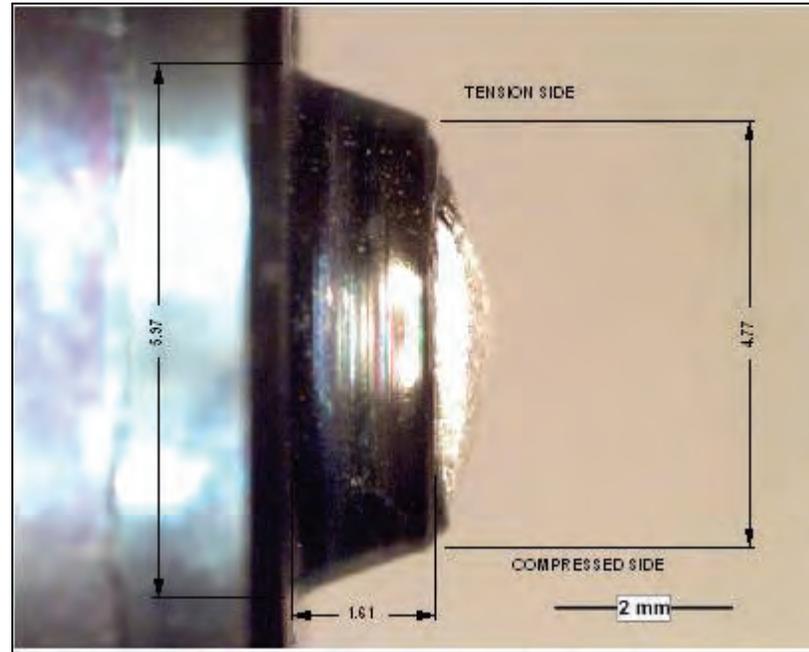
Side view

**Figure 29: Fracture Surface Appearance of Sample (Test 07-78)**

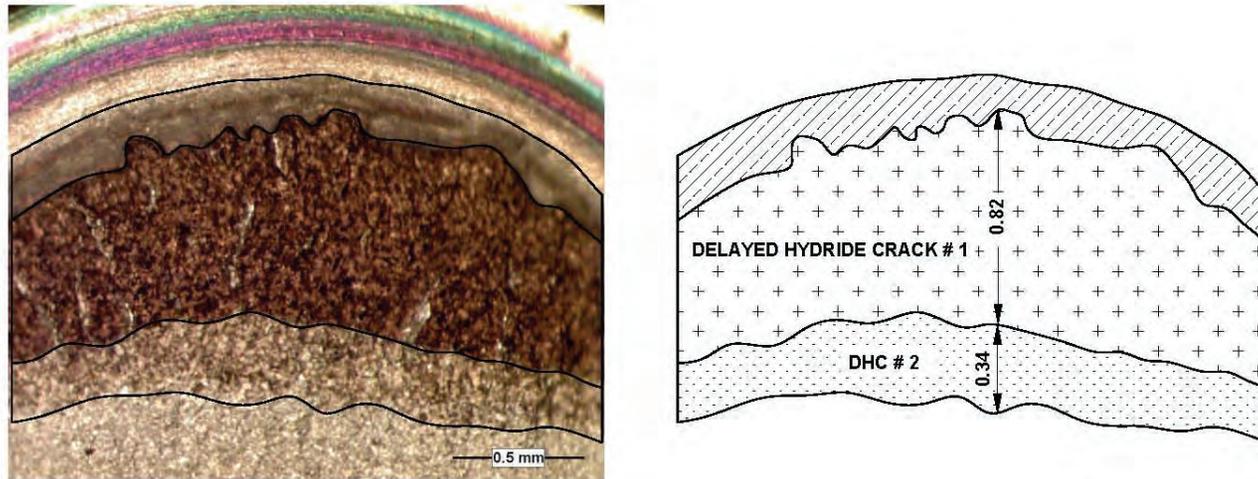
Figure 30: The Maximum Length of Each Crack Segment Was Measured from the Digitalized Picture (Test 07-78)

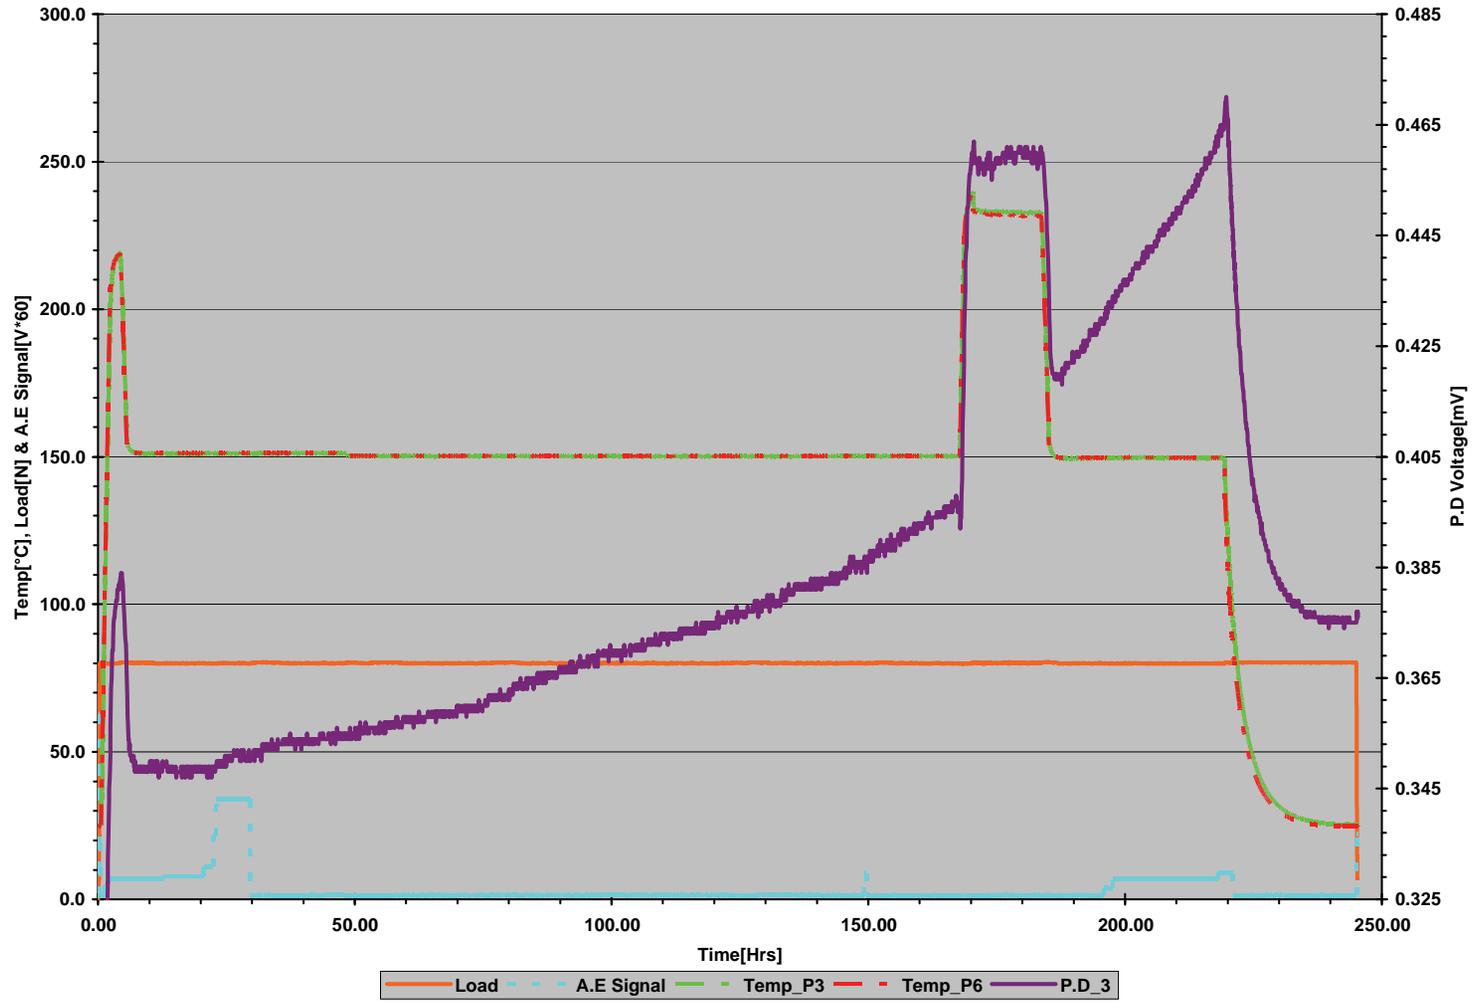
Year 2006.. K-013119.. Test: 07\_79.. Hydrided Fuel Pencil: Button # 6.. ~40 PPM + Layer.. Jun 12.2007.

Figure 31: Test Record of DHCV Test (Commissioning Test 07-79)

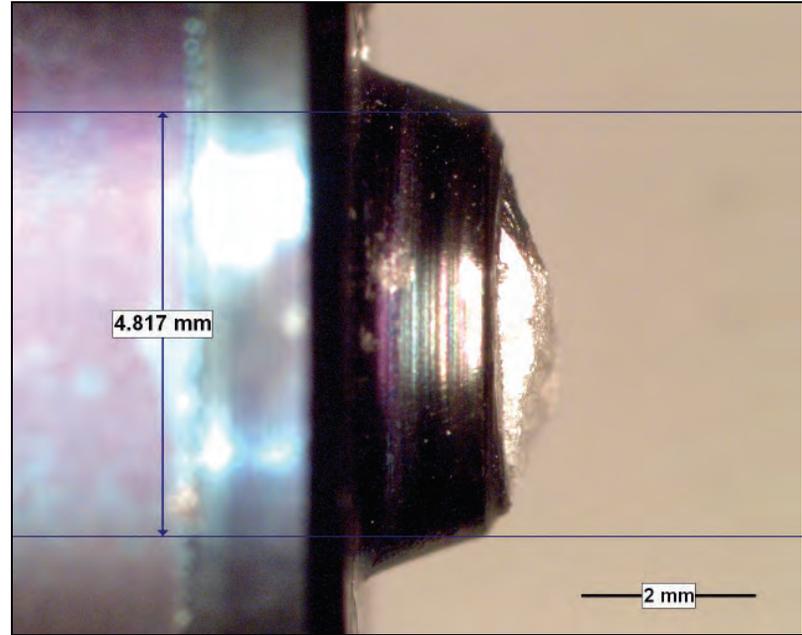
(b) Side view

**Figure 32: Fracture Surface Appearance of Sample (Test 07-79)**

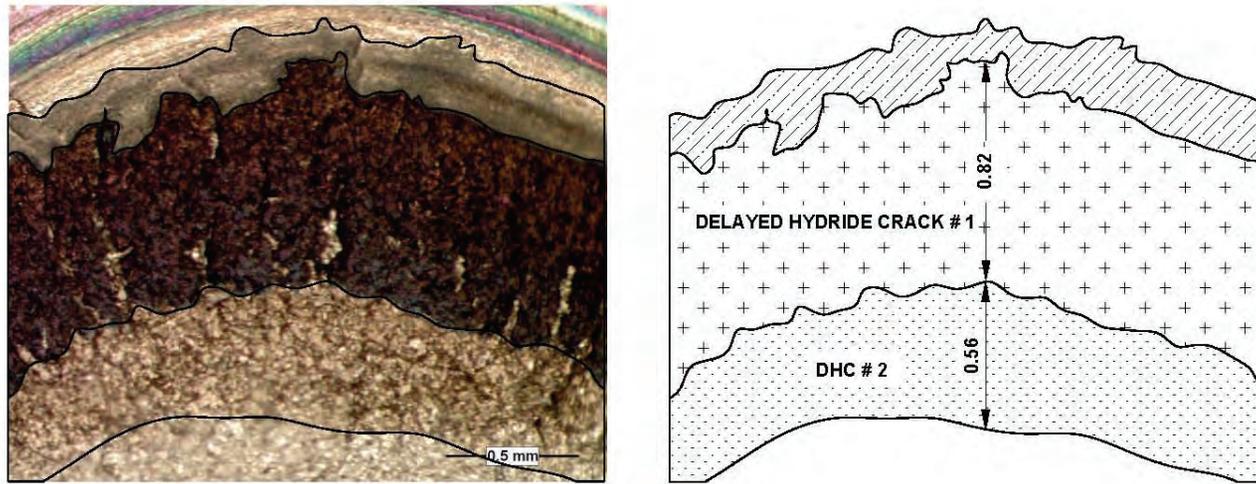
Figure 33: The Maximum Length of Each Crack Segment Measured from the Digitalized Picture (Test 07-79)

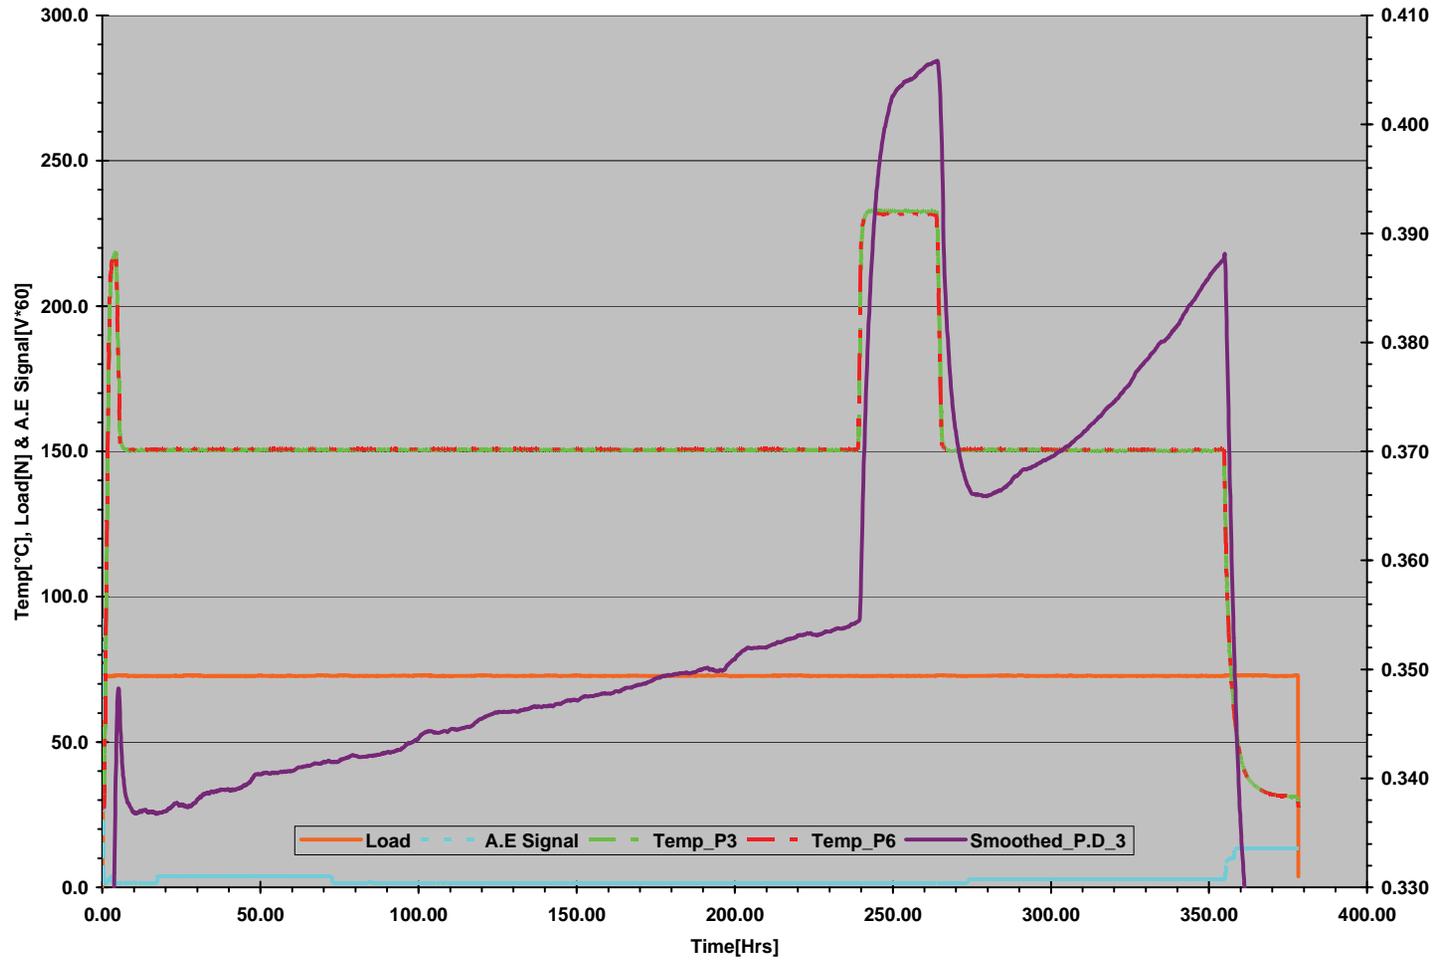
Year 2006.. K-013119.. Test: 07\_107.. Hydrided Fuel Pencil: Button # 21.. ~40 PPM + Layer.. Sep 02.2007.

Figure 34: Test Record of DHCV Test (Test 07-107)

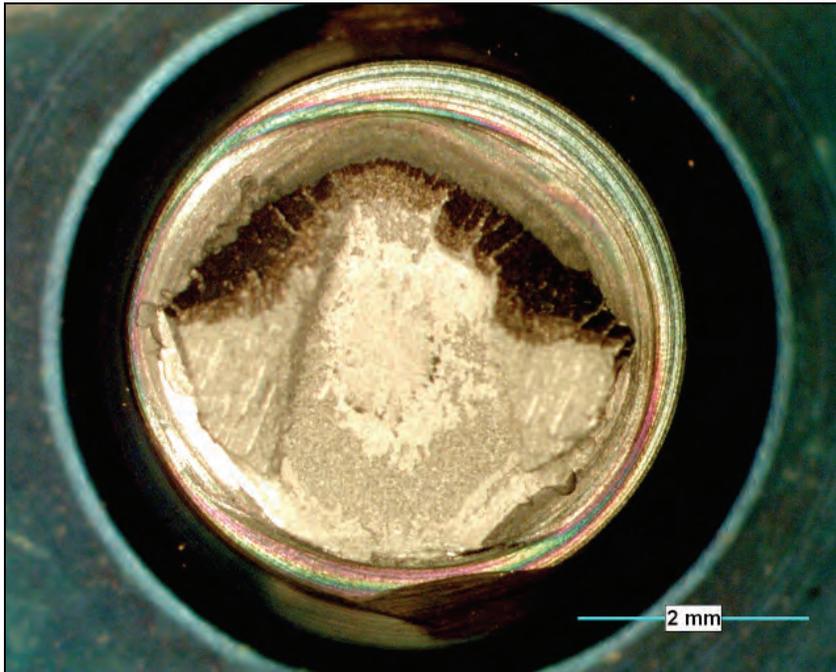
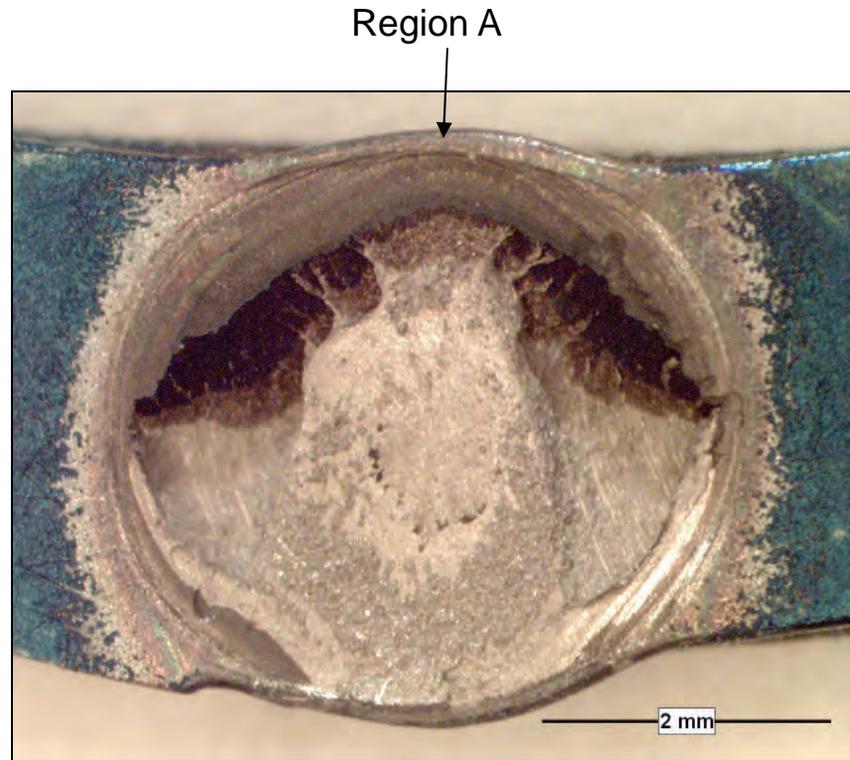
Fracture surface on endcap side

Fracture surface on endplate side

**Figure 35: Top View of Fracture Surface of Sample of DHCV Test (Test 07-107)**

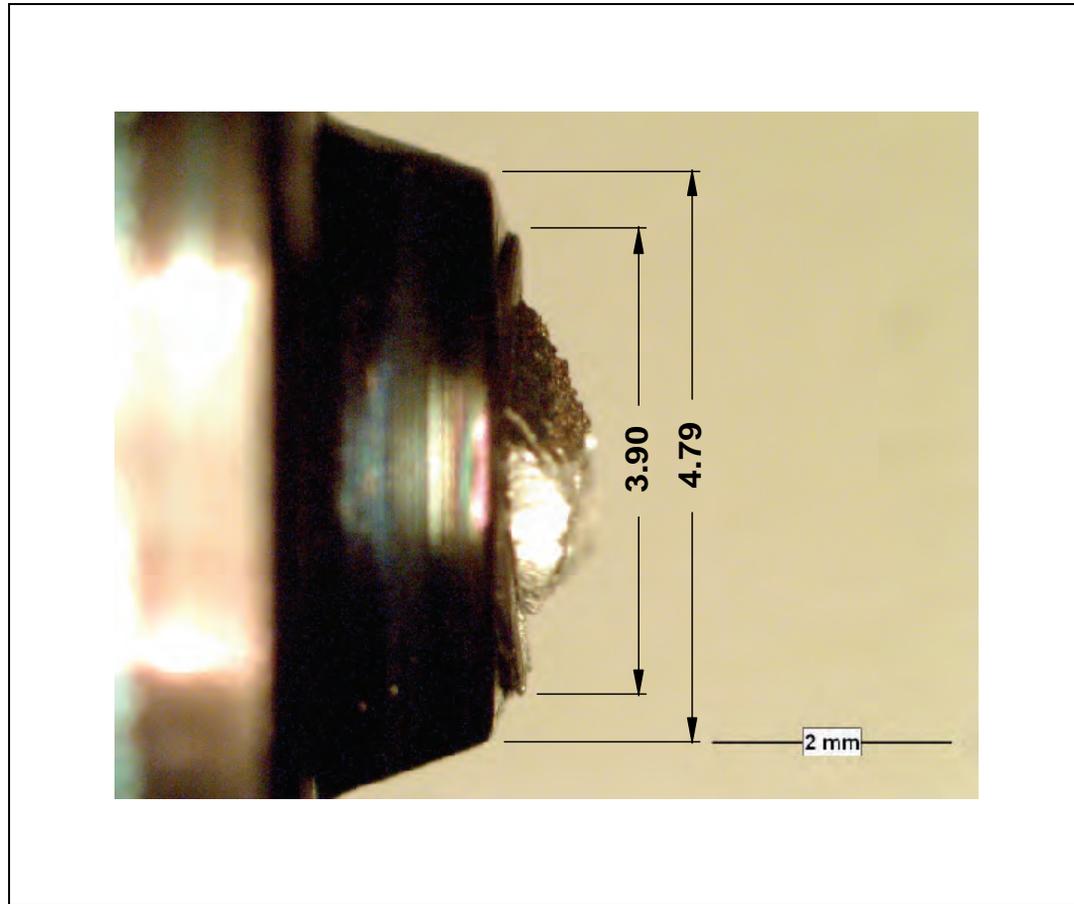
Figure 36: Side View of Fracture Surface (Test 07-107)

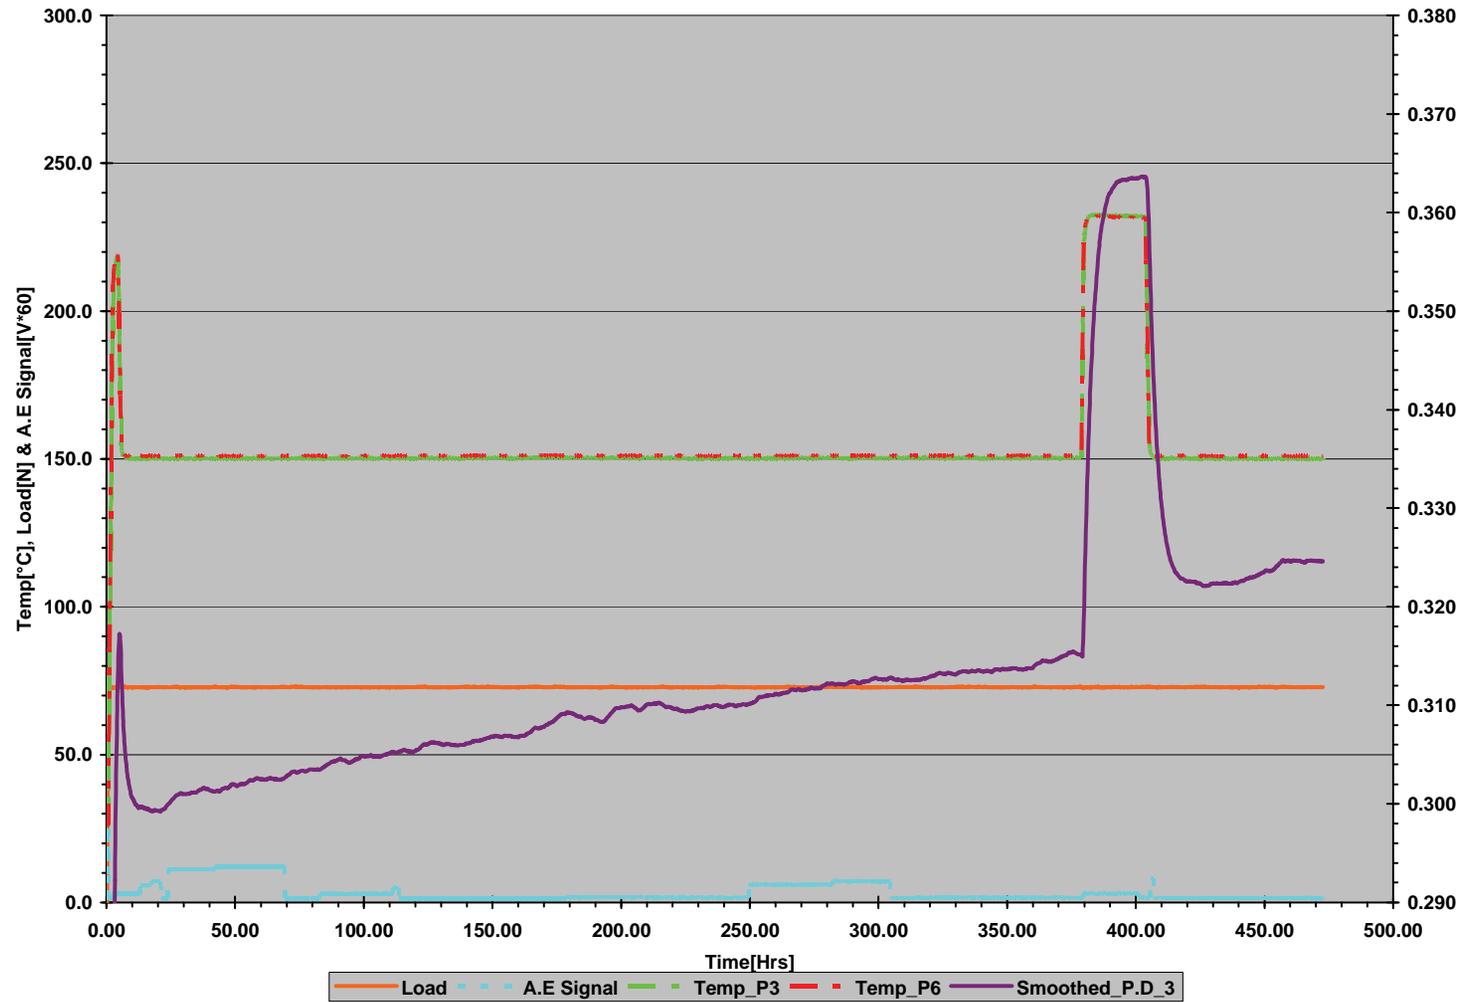
Year 2006.. K-013119.. Test: 07\_113.. Hydrided Fuel Pencil: Button # 26.. ~40 PPM + Layer.. Sep 19.2007.

Figure 37: Test Record of DHCV Test (Test 07-113)

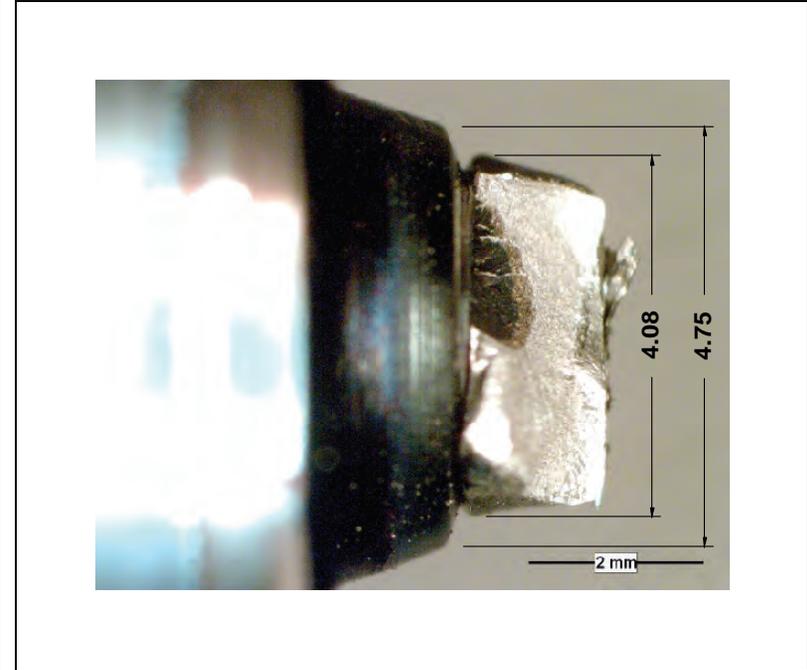
Side view

**Figure 38: Fracture Surface of Sample from DHCV Test (Test 07-113)**

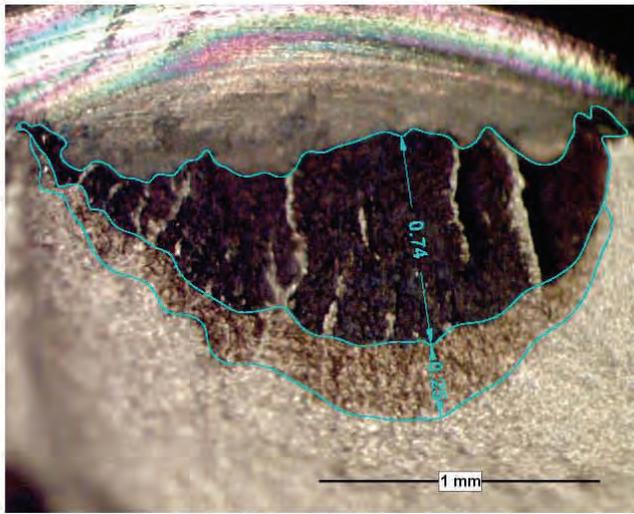
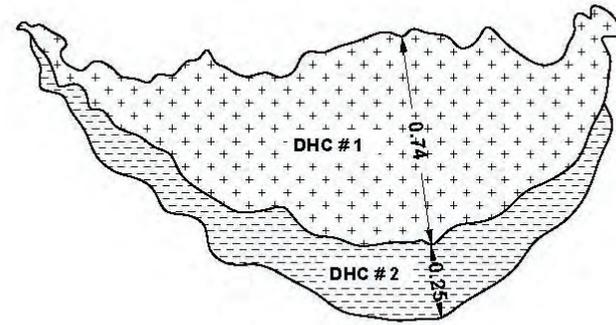
Figure 39: Fracture Surface of Sample Showing the Two DHC Segments (Test 07-113)

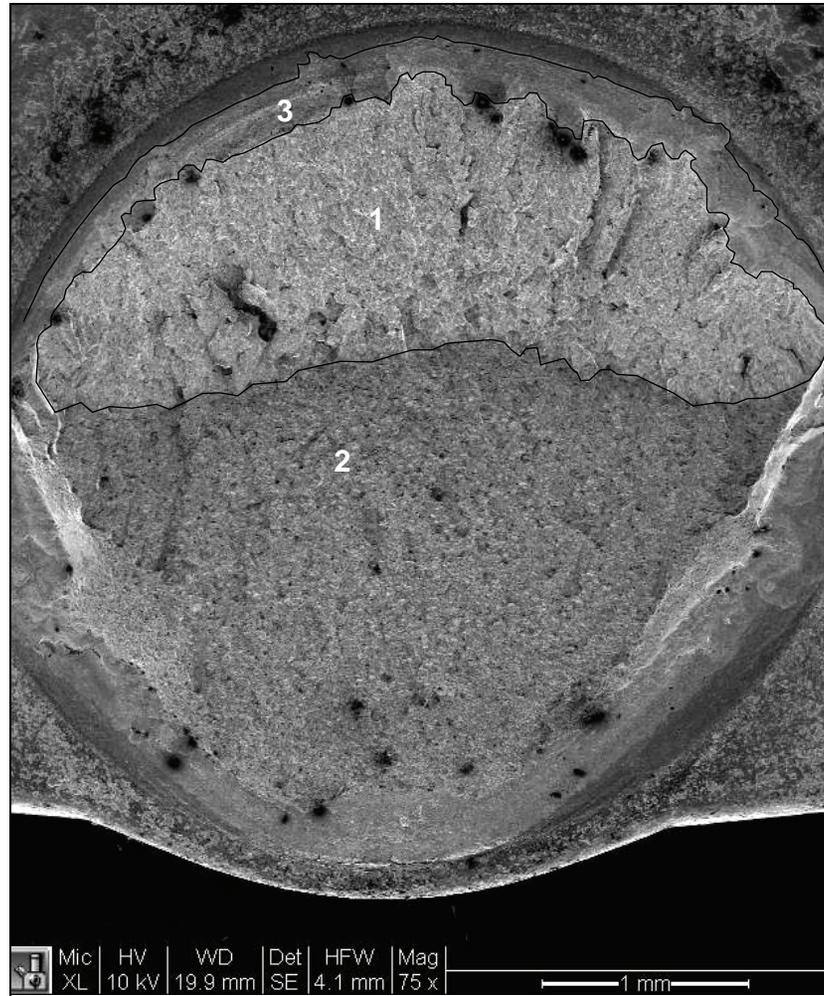
**Figure 40: Low Magnification SEM Micrograph of Fracture Surface on the Endplate of Sample Showing the Three Regions of Interest. Region “1” : DHC; Region “2” : Room Temperature Tearing; And Region “3”: Weld Discontinuity (Test 07-79)**

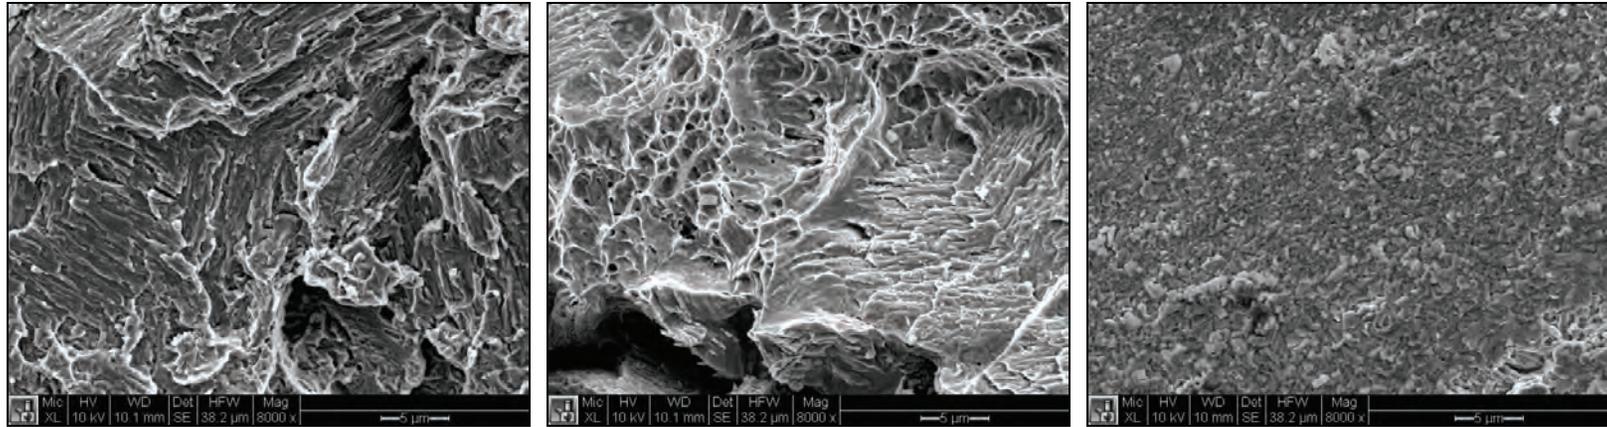
(a) Region "1": cleavage brittle fracture    (b) Region "2": ductile tearing features    (c) Region "3": weld discontinuity

**Figure 41: Higher Magnification of the Three Regions (Test 07-79)**

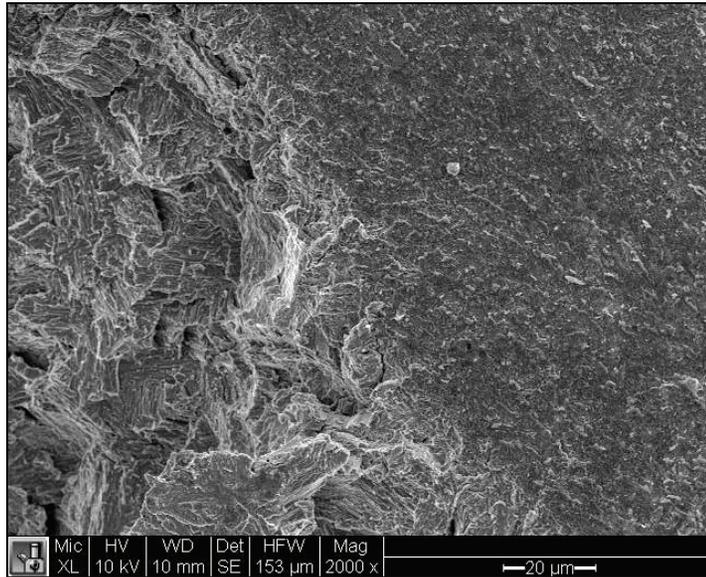
(a) Transition between weld discontinuity and DHC

(b) between weld discontinuity and ductile tearing

**Figure 42: Higher Magnification of the Transition Region (Test 07-79)**

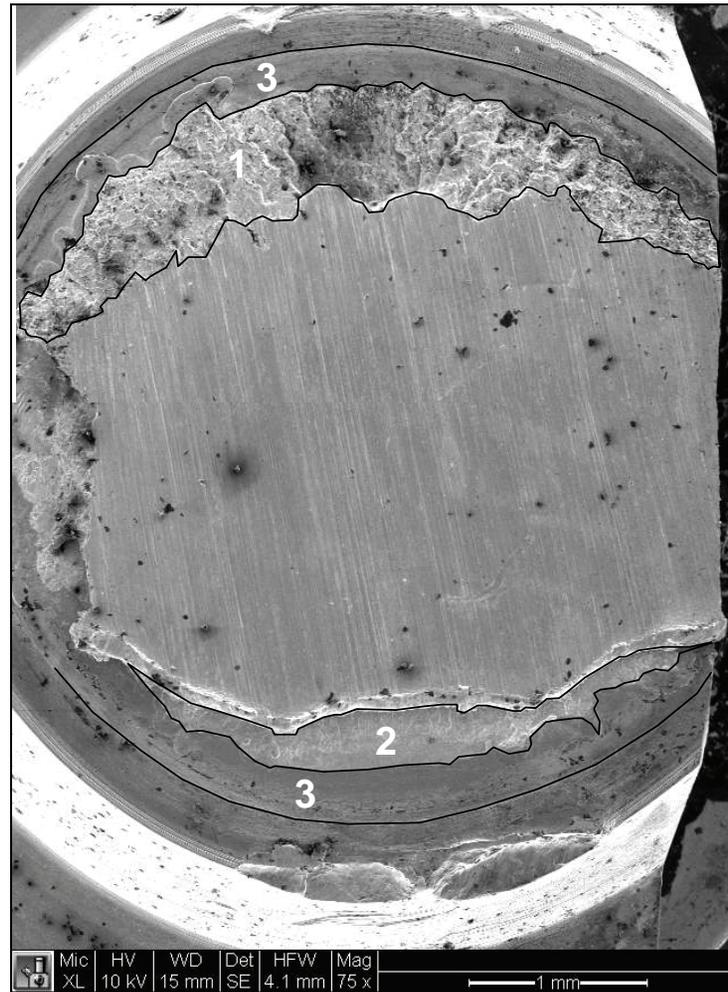
Figure 43: Low Magnification SEM Micrograph of the Fracture Surface of Sample (Test 07-09)

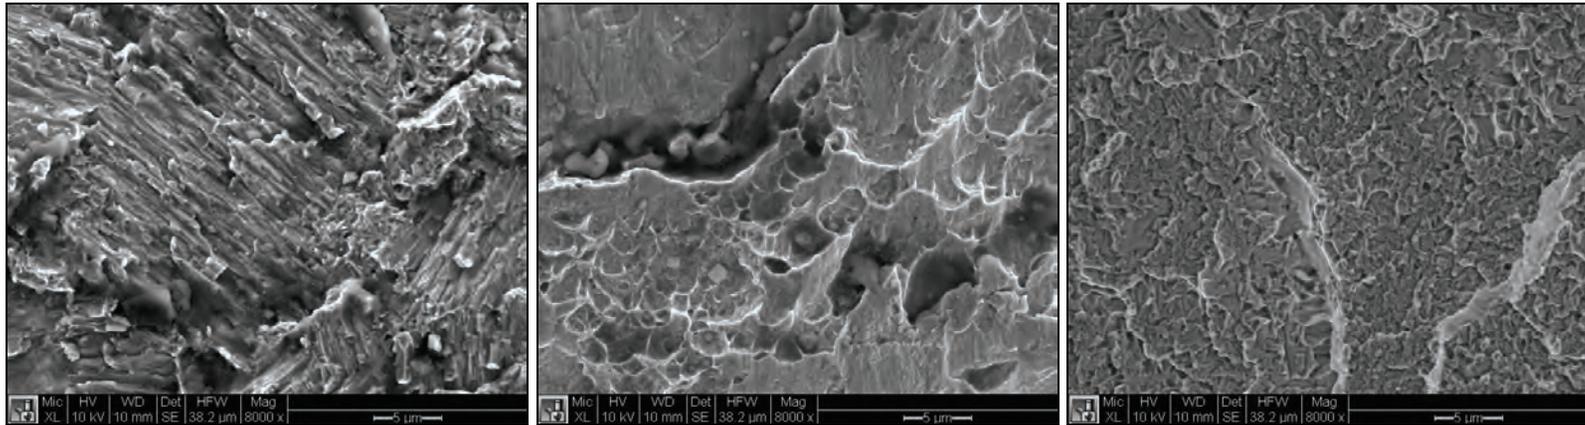
(a) Region "1": cleavage brittle fracture (b) Region "2": ductile tearing features (c) Region "3": weld discontinuity

**Figure 44: Higher Magnification SEM Micrographs of the Different Regions of Sample (Test 07-09)**

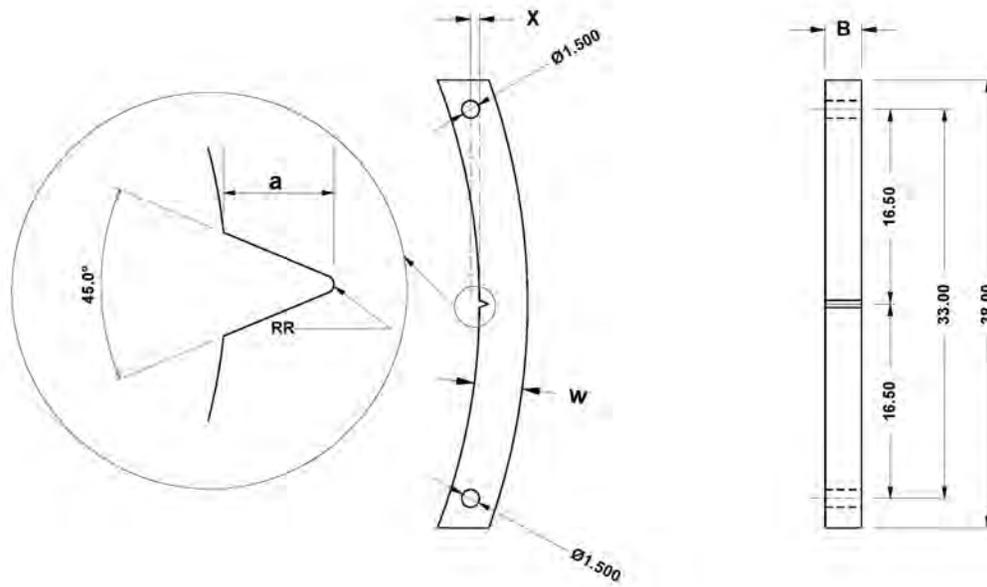
X = 0.75 mm  
a = 0.75 mm  
W = wall thickness = 4.1 mm nominal  
B = 3.2 mm nominal  
Notch root radius = 0.015 mm

**Figure 45: C-Shape Sample Machined from Zr-2.5Nb Pressure Tube**

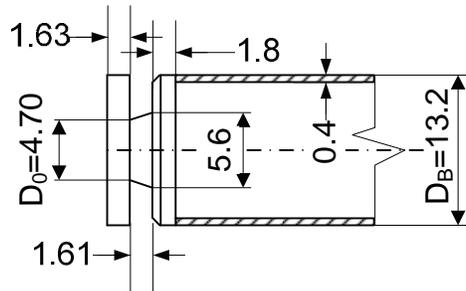
**Figure A-1: Fuel Element Dimensions (mm)**

The geometry of the fuel bundle element endcap/endplate region provided by Seahra (2007) is shown in Figure A-1. More detailed information on geometry, initial and final crack dimensions is provided in Section A9 (Appendix Aa).

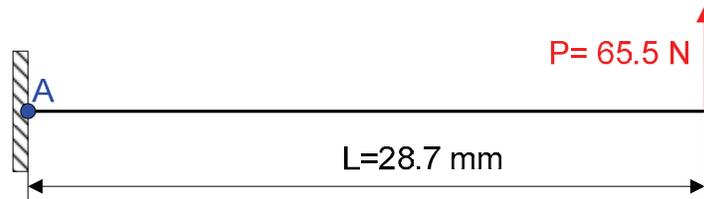
Force  $P$  was applied at a distance  $L$  from a circumferential crack (noted by point A). The loading scheme is illustrated in Figure A-2.

Figure A-2: Loading Scheme from Experiment

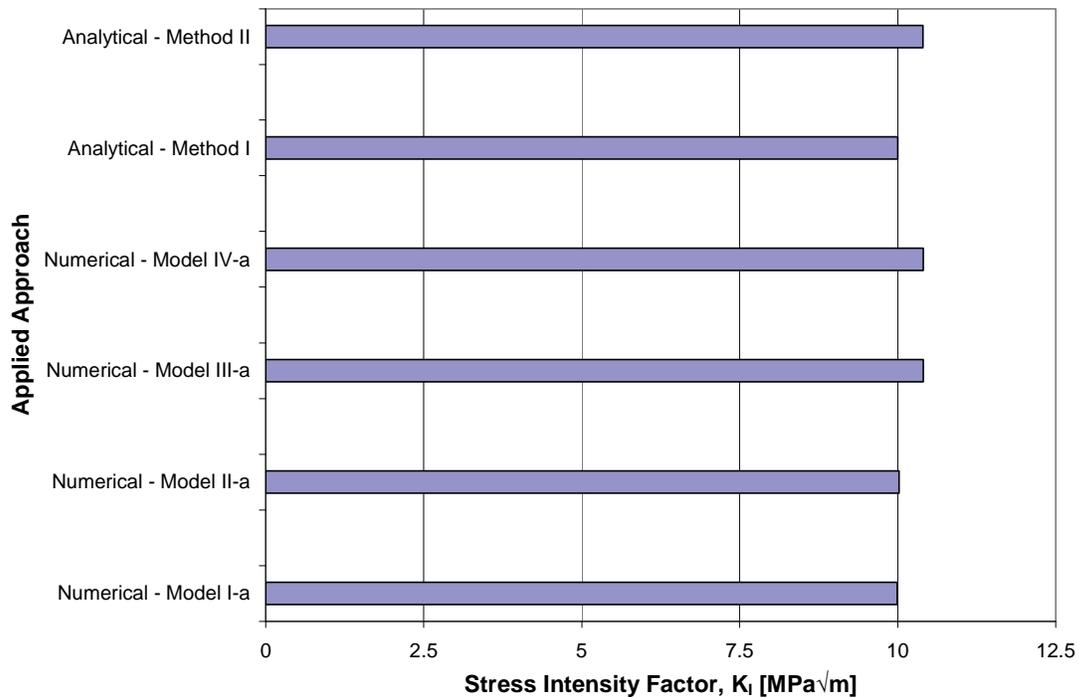
**Figure A-3: Stress Intensity Factors from Analytical and Numerical ('a' Type FE Models) Analyses**

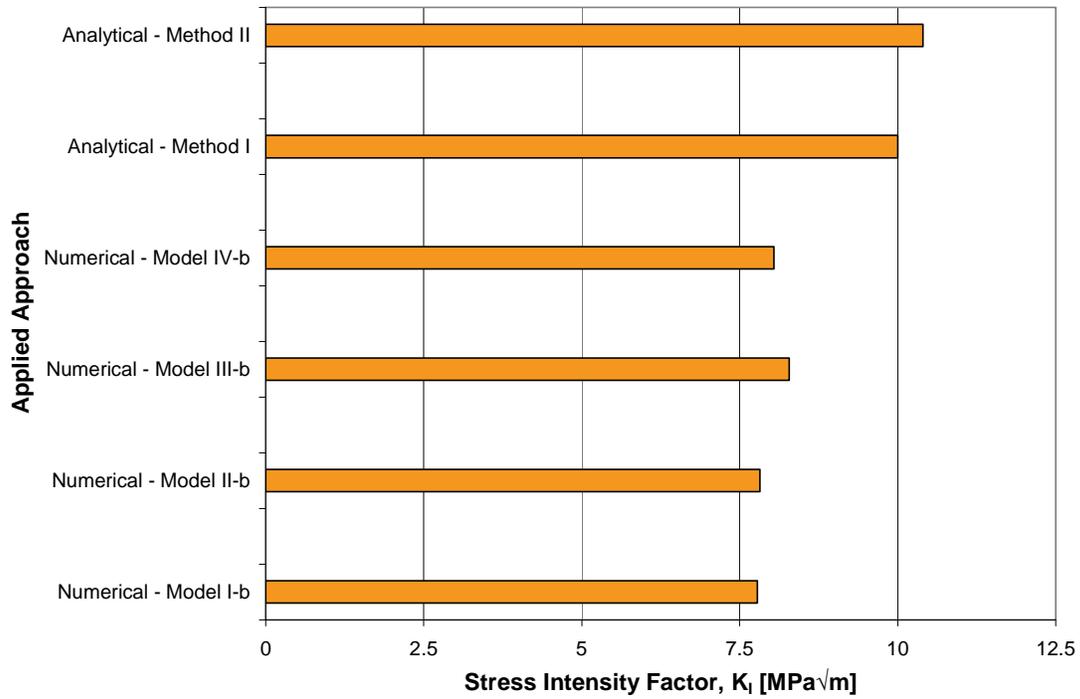
**Figure A-4: Stress Intensity Factors from Analytical and Numerical ('b' Type FE Models) Analyses**
