# Development of Delayed Hydride Cracking Test Apparatus and Commissioning Tests for CANDU Fuel Bundle Assembly Welds

**NWMO TR-2009-08**

**October 2009**

Kinectrics Inc.

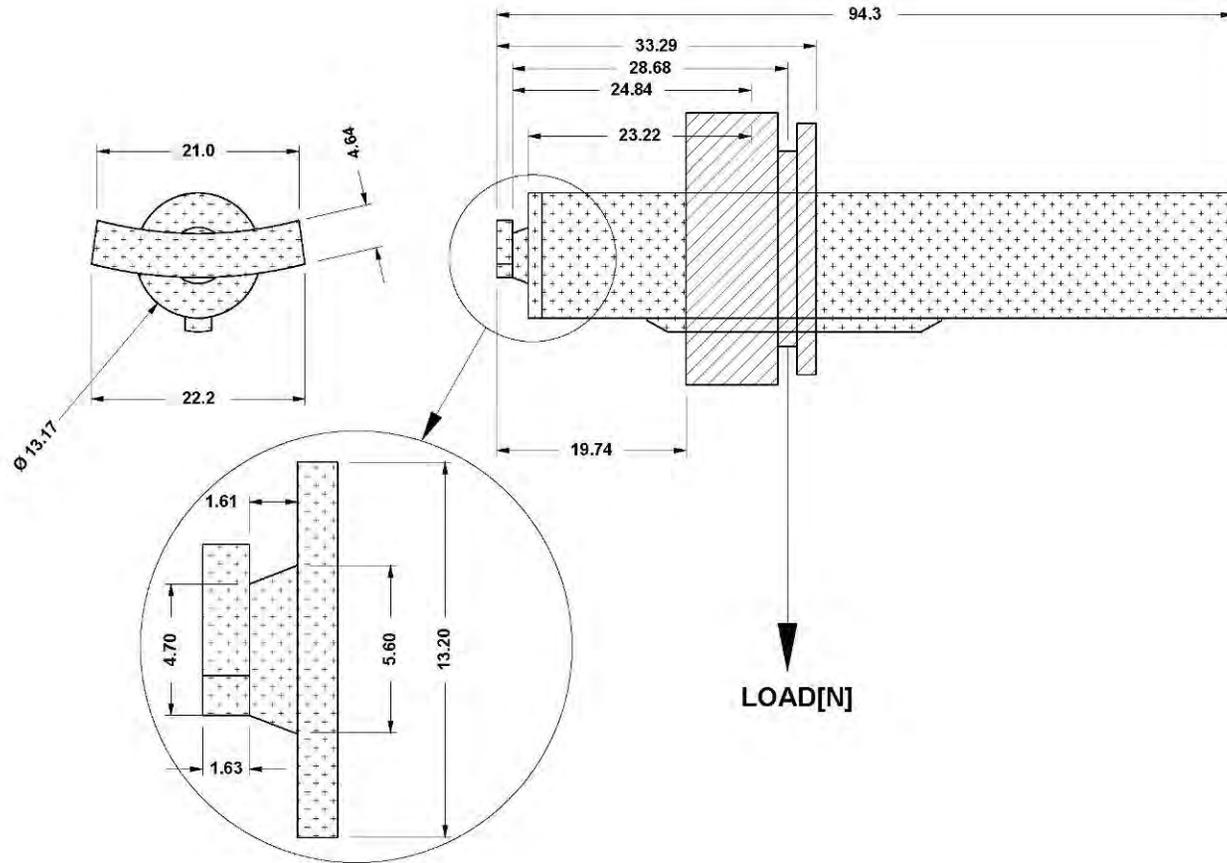
Figure Aa-1: Fuel Element (Test 07\_09)

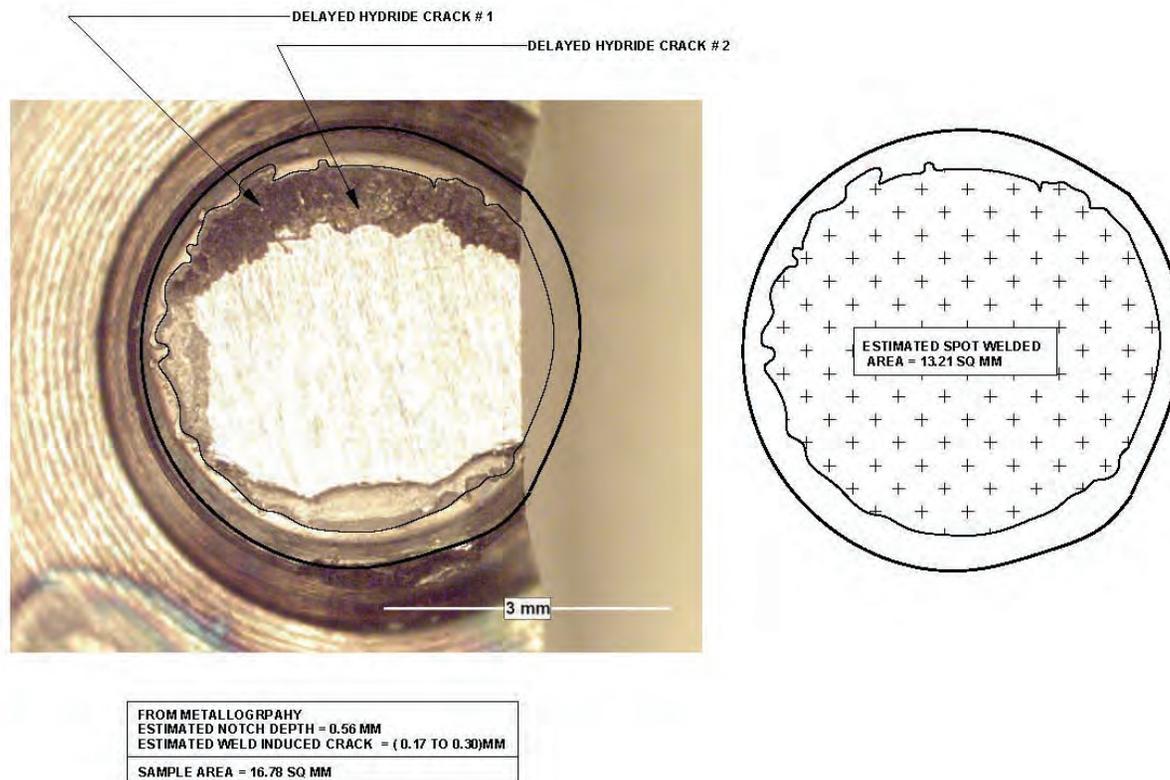
Figure Aa-3: Out-of-Plane View of a Crack Test (07\_09)

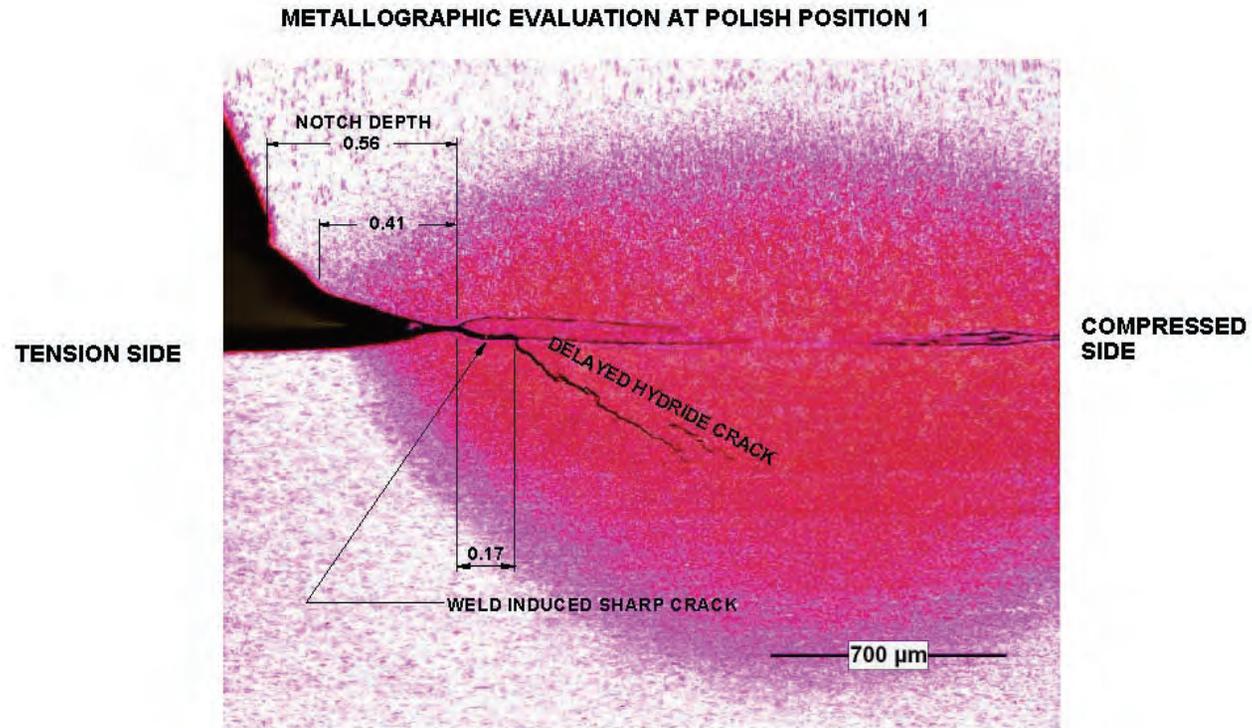
Figure Aa-4: Crack-Plane View of a Crack (Test 07\_09)

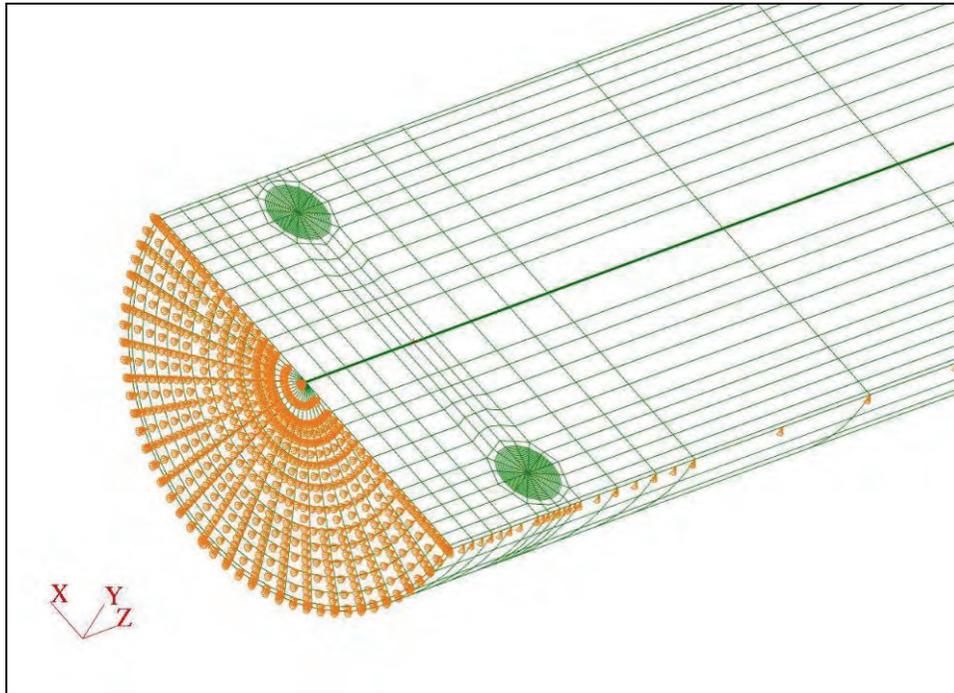
Figure Ac-1: Finite Element Model of a Fuel Bundle Element with a Circumferential Crack (Model I-a)

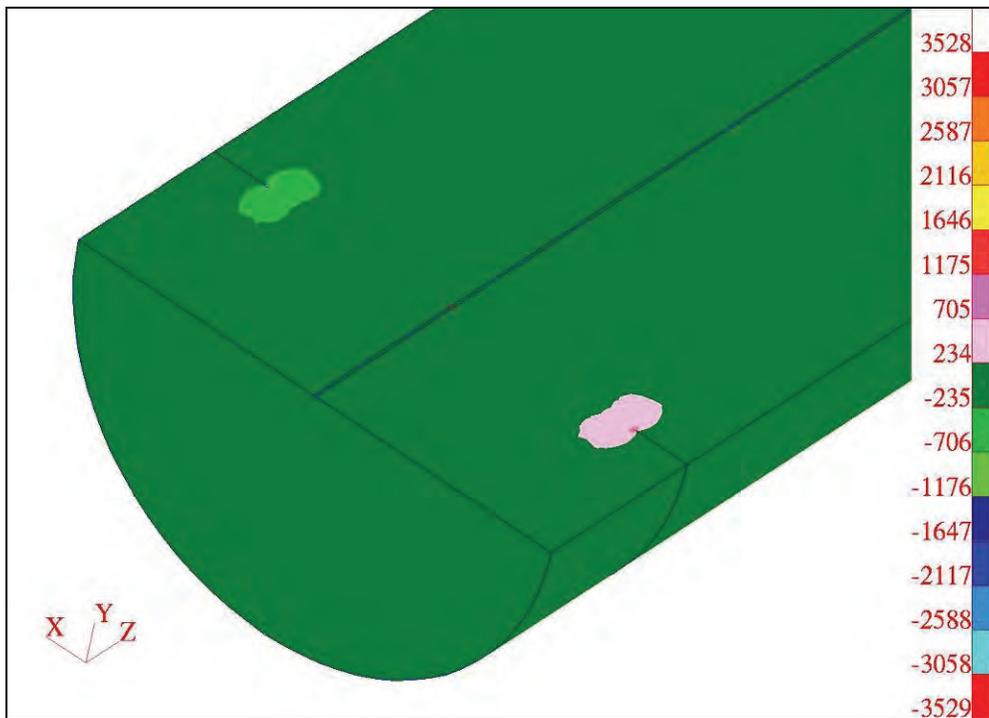
Figure Ac-2: Opening/Closing Stress Component (MPa) (Model I-a)

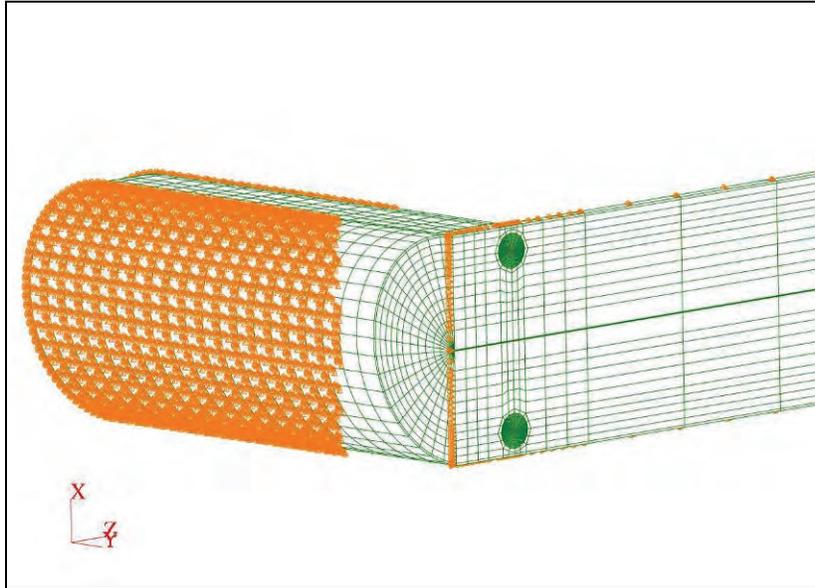
The fixed displacements (shown in orange colour in Fig. Ac-3) were applied to two side edge surfaces of the end plate portion attached to the fuel element endcap. Symmetry boundary conditions were applied at the symmetry plane of the fuel bundle element (XZ-plane at Figure Ac-3)

**Figure Ac-3: Finite Element Model of a Portion of the Endplate Attached to the Endcap/Endplate Weld (Model I-b, See Figure Ac-7 for an Overall Picture of This Area Including the Fuel Element)**

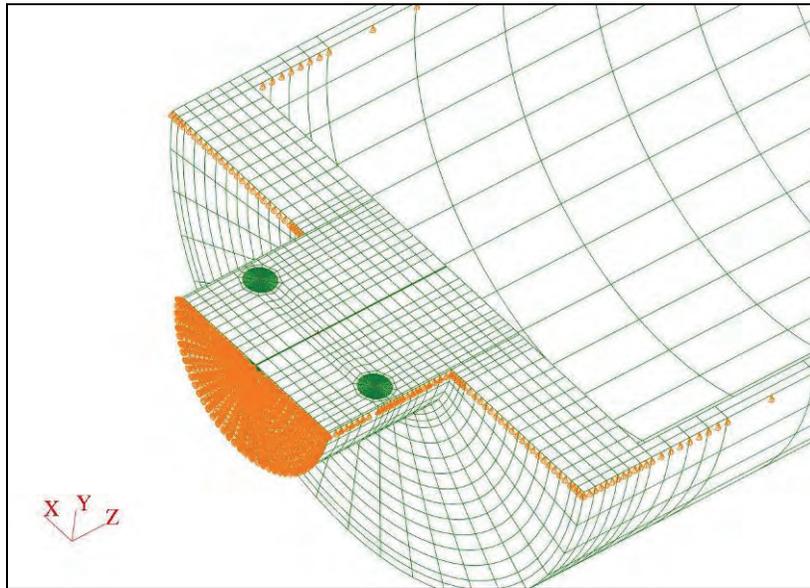
Figure Ac-5: Finite Element Model of a Fuel Bundle Element with a Circumferential Crack (Model II-a)

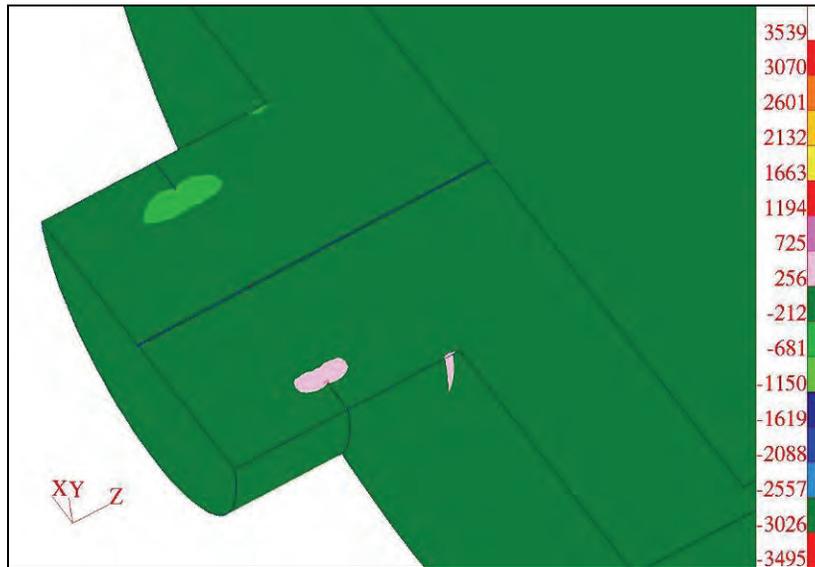
Figure Ac-6: Opening/Closing Stress Component (MPa) (Model II-a)

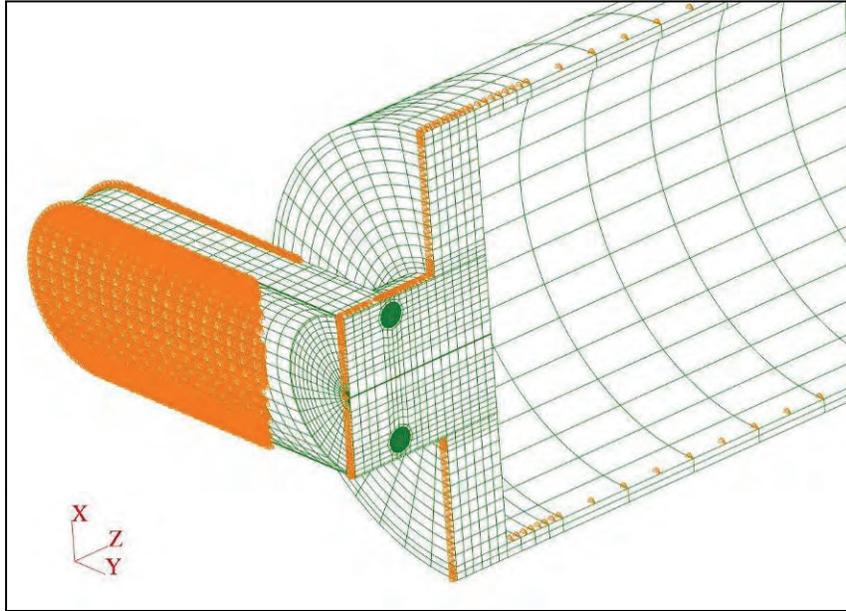
Figure Ac-7: Finite Element Model of a Fuel Bundle Element with a Circumferential Crack (Model II-b)

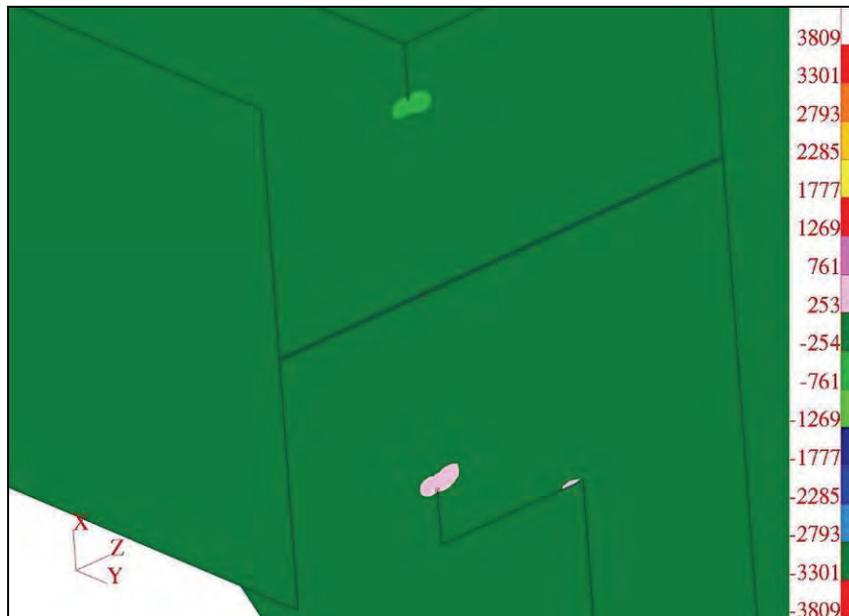
Figure Ac-8: Opening/Closing Stress Component (MPa) (Model II-b)

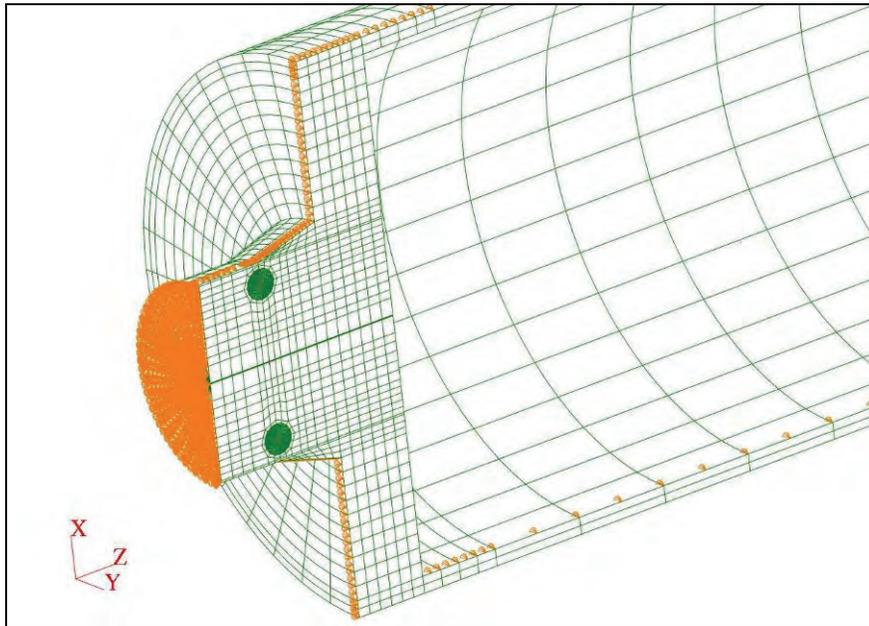
Figure Ac-9: Finite Element Model of a Fuel Bundle Element with a Circumferential Crack (Model III-a)

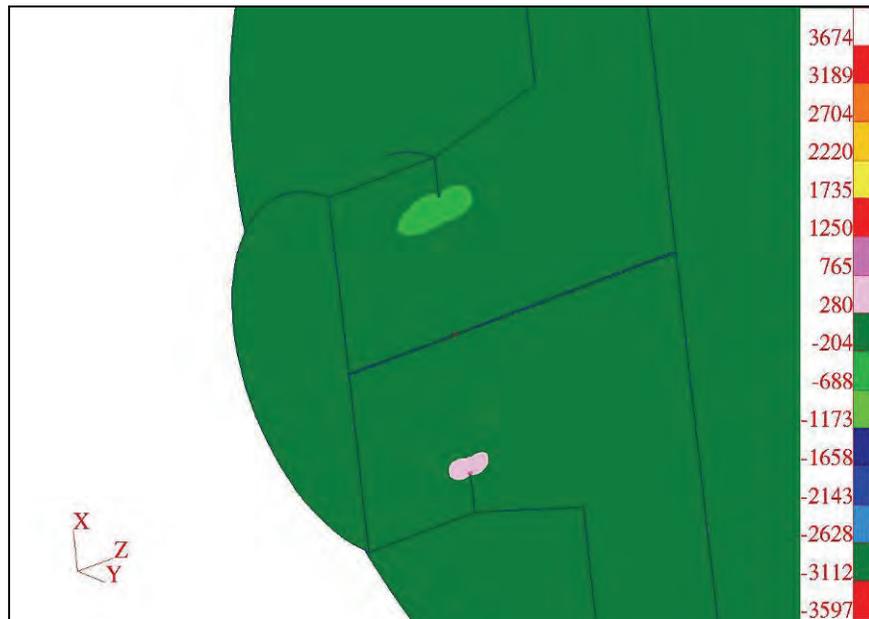
Figure Ac-10: Opening/Closing Stress Component (MPa) (Model III-a)

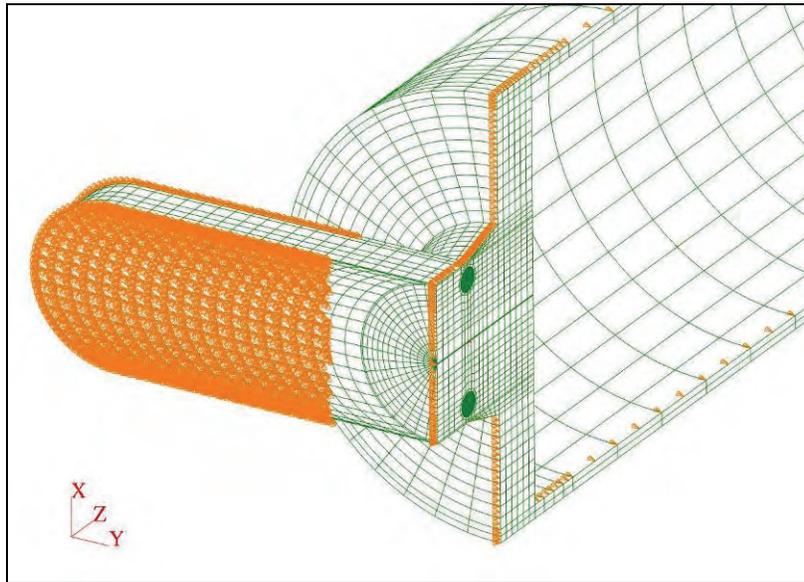
Figure Ac-11: Finite Element Model of a Fuel Bundle Element with a Circumferential Crack (Model III-b)

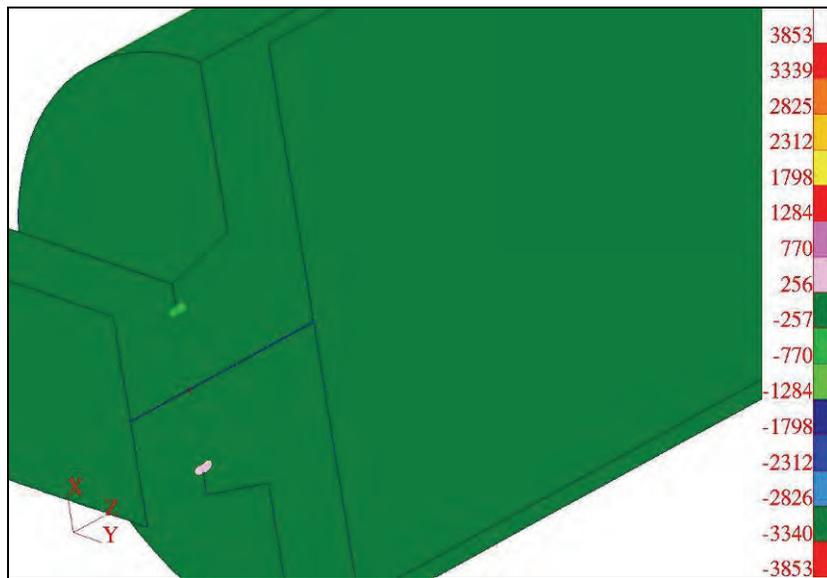
Figure Ac-12: Opening/Closing Stress Component (MPa) (Model III-b)

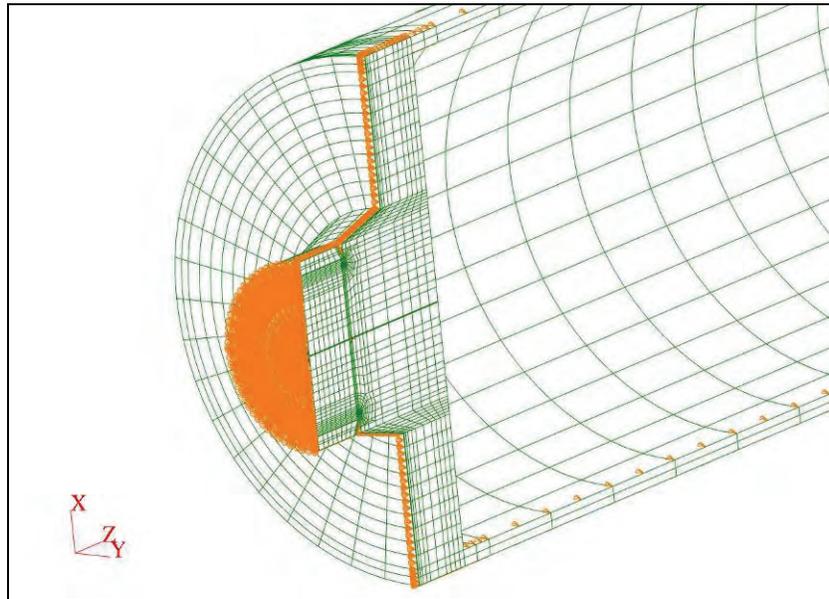
Figure Ac-13: Finite Element Model of a Fuel Bundle Element with a Circumferential Crack (Model IV-a)

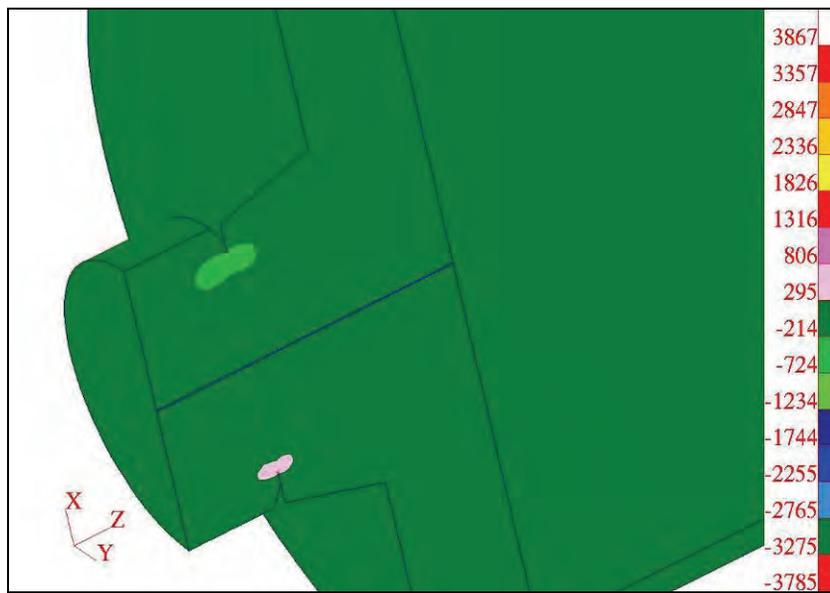
Figure Ac-14: Opening/Closing Stress Component (MPa) (Model IV-a)

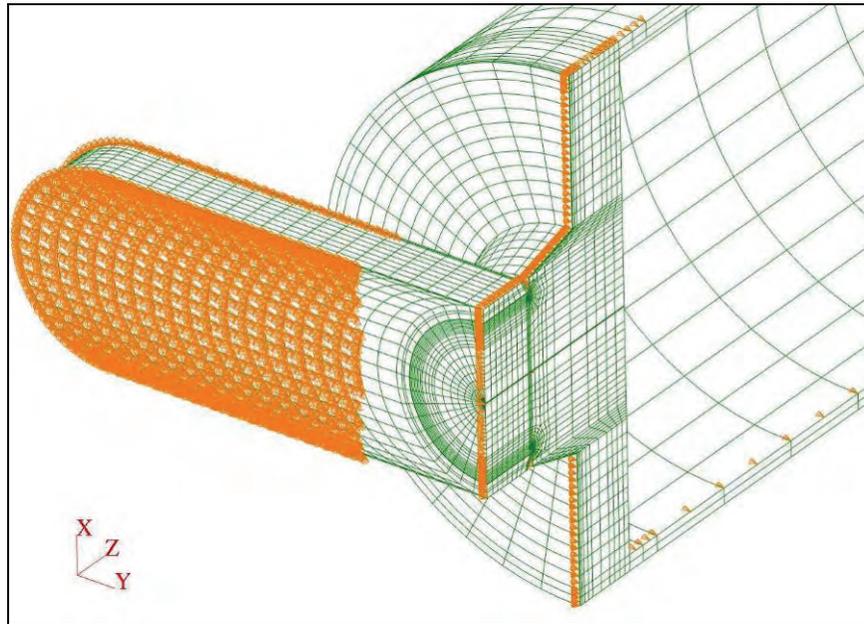
Figure Ac-15: Finite Element Model of a Fuel Bundle Element with a Circumferential Crack (Model IV-b)

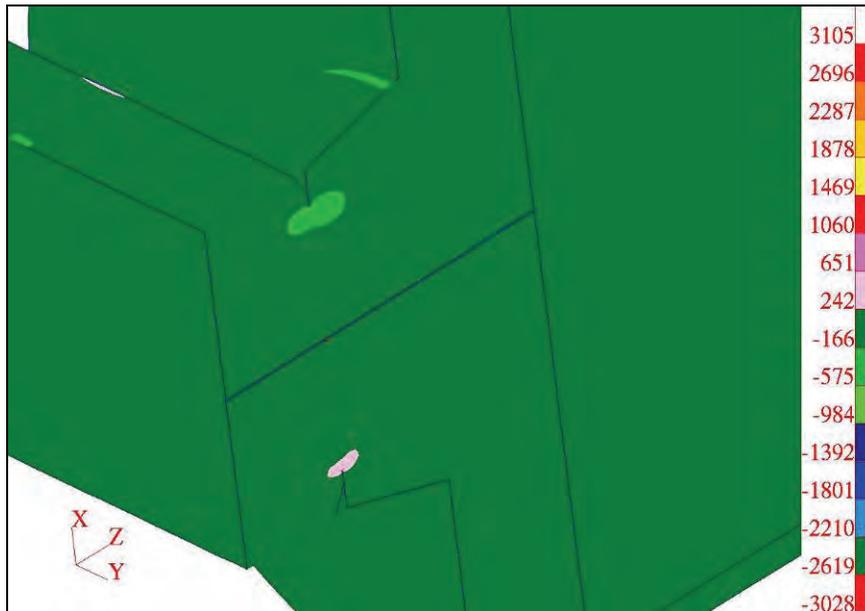
Figure Ac-16: Opening/Closing Stress Component (MPa) (Model IV-b)
