Anaerobic Corrosion Studies of Carbon Steel Used Fuel Containers

NWMO TR-2010-07

September 2010

Roger C. Newman¹, Steve Wang¹, and Gloria Kwong²

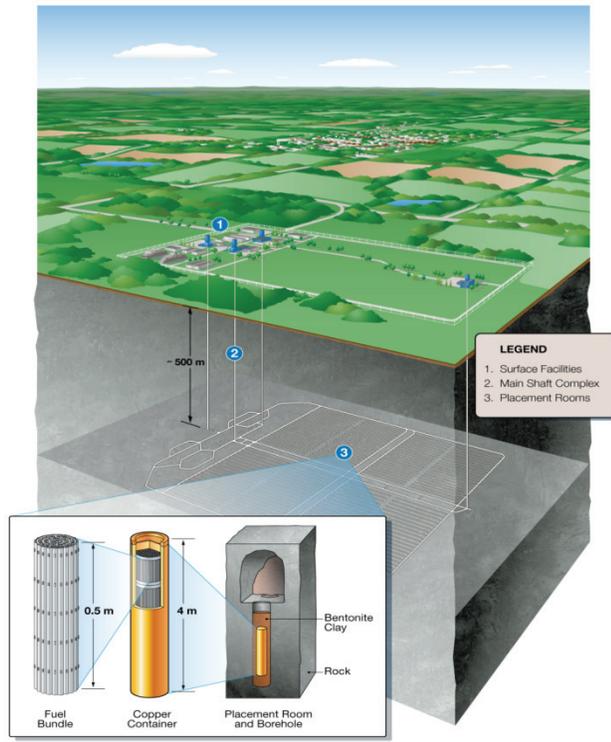
Figure 1: A conceptual DGR

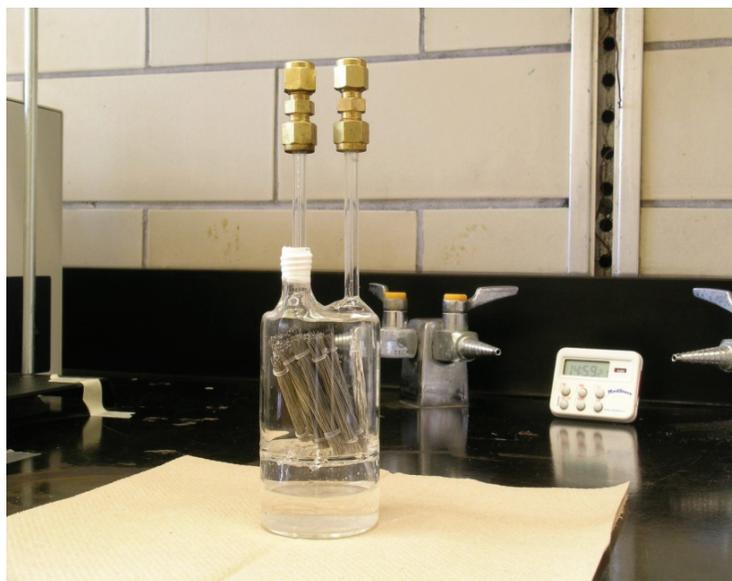
Figure 2 a: Wire bundles in the glass cell

Photographs of the assembled corrosion cell/pressure gauge system are shown in Figures 2a and 2b. The cell has an inner volume of 170 mL and is equipped with 3 openings, Openings 1 and 2, with an inside diameter of 1 mm, are provided for cell deaeration and pressure relief. Opening 3 connects the digital pressure gauge to the corrosion cell using 2 mm diameter stainless steel tubing about 500 mm long. The connection of the pressure gauge to Opening 3 was sealed with a rubber ring, PTFE tape, and Dow Corning high vacuum grease. Two models of digital pressure gauges were used in the experiments : (i) GE Druck DPI 104 – a micro-processor controlled digital pressure gauge with 0.01 kPa resolution and 0.05% full scale accuracy; and (ii) Accu-Cal Plus digital precision test gauge - supplied by 3D Instruments, with 0.04% full scale accuracy. Both pressure gauges have operation pressure range at 30 psia.

The wire bundles rested on a PTFE screen above the solution used for humidity control. Different solutions were used for humidity control. They are listed, along with their literature values of equilibrium relative humidity, in Table 4. Temperatures were controlled through the use of a water bath. A HH41 thermistor thermometer equipped with ON-403-PP immersion thermistor probe (manufactured by Omega Engineering Inc.) was used to provide continuous monitoring of temperature of the water bath. The thermistor has a resolution of 0.01°C, with an overall accuracy of $\pm 0.2^\circ\text{C}$.

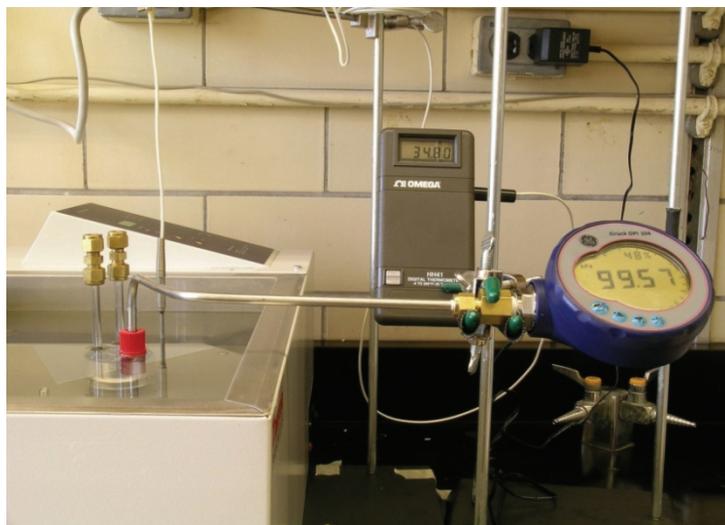
Figure 2 b: Glass cell - pressure gauge setup

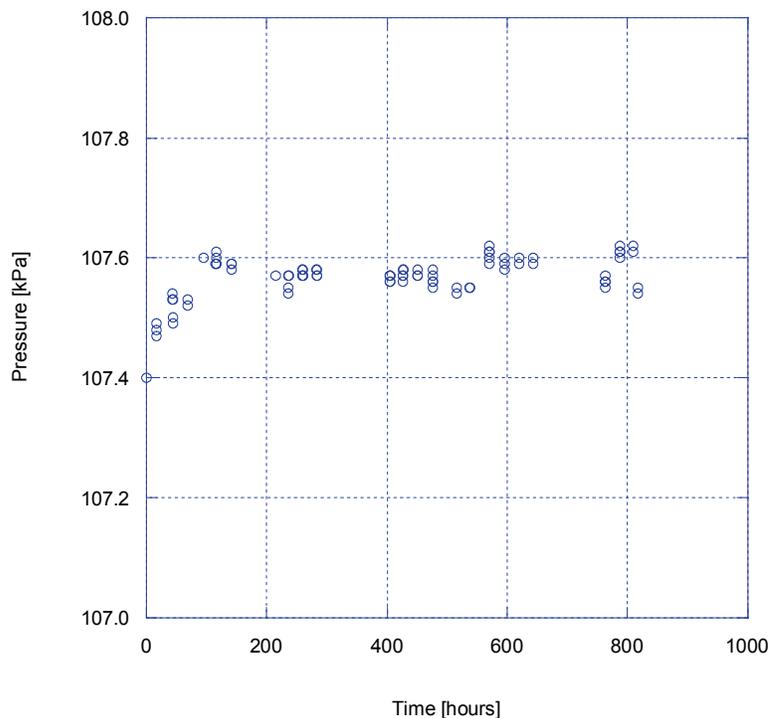
Figure 3 shows the result of one of the leak tests confirming the glass cell is air-leak tight and able to maintain a stable pressure for more than a month.

Figure 3: Typical leak test results

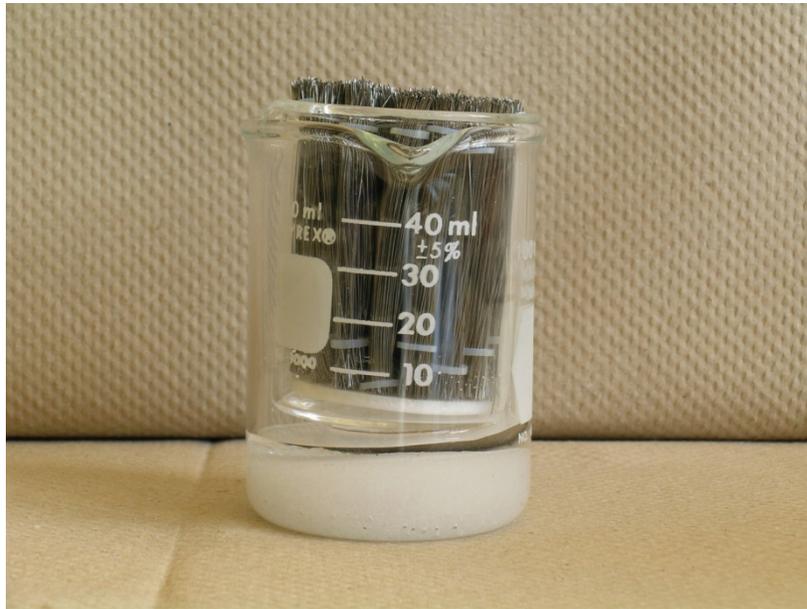
Figure 4: Prepared wires in beaker, on top of PTFE

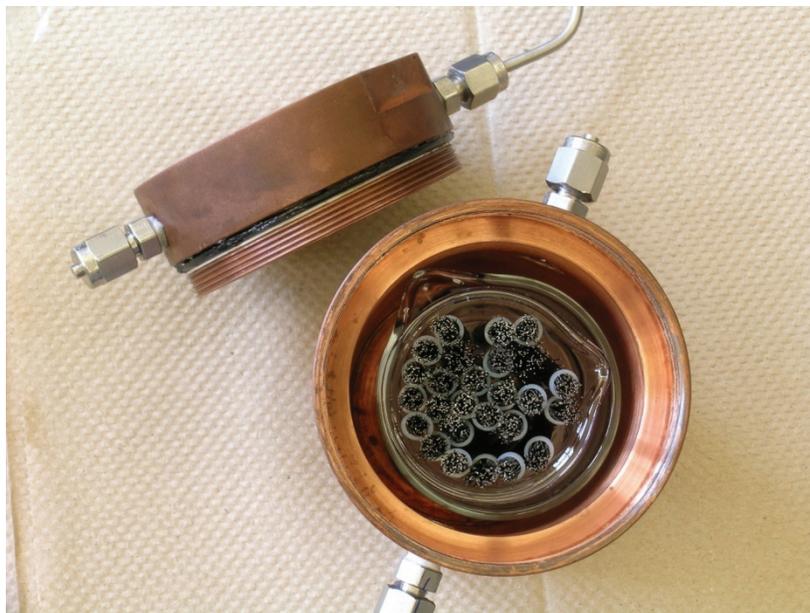
Figure 5: Prepared wires in beaker, placed in the copper cell

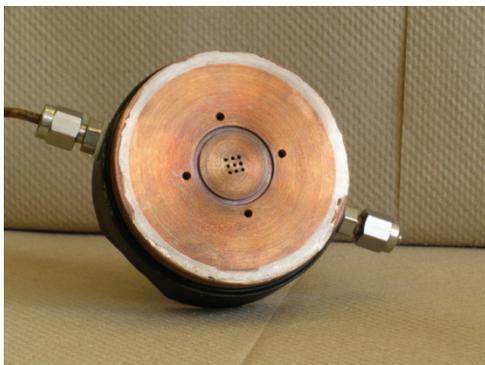
Figure 6 a: Upper compartment of the copper cell without the palladium membrane

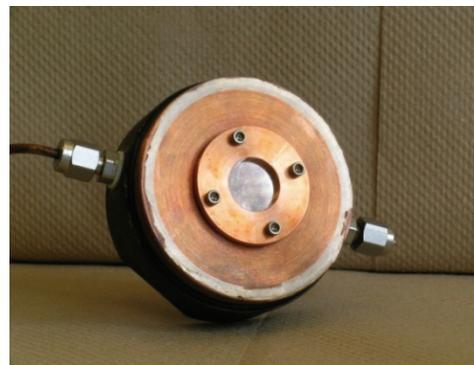
Figure 6 b: Upper compartment of the copper cell with the palladium membrane mounted

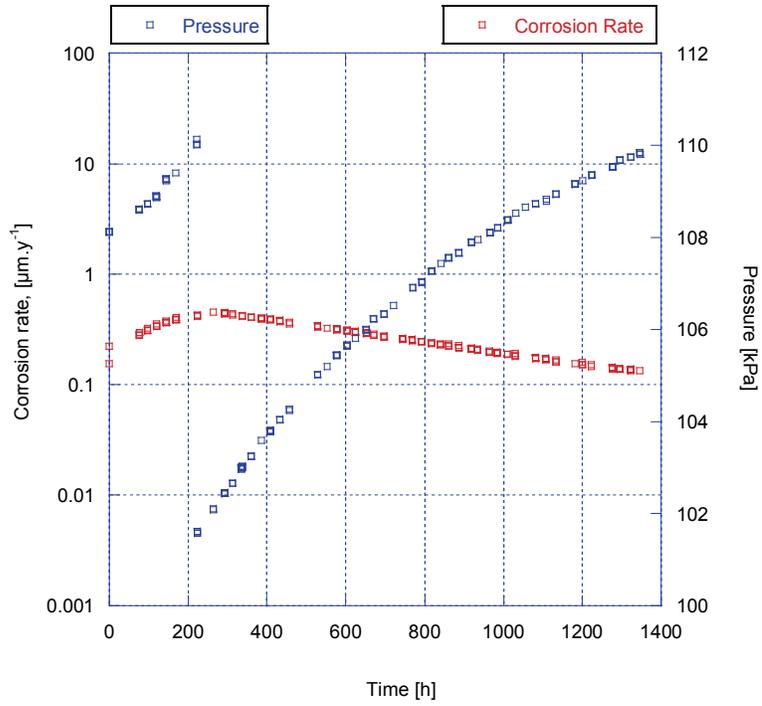
Figure 7: Corrosion behaviour of 0.5M NaCl dipped wires tested at 32°C and 68% RH

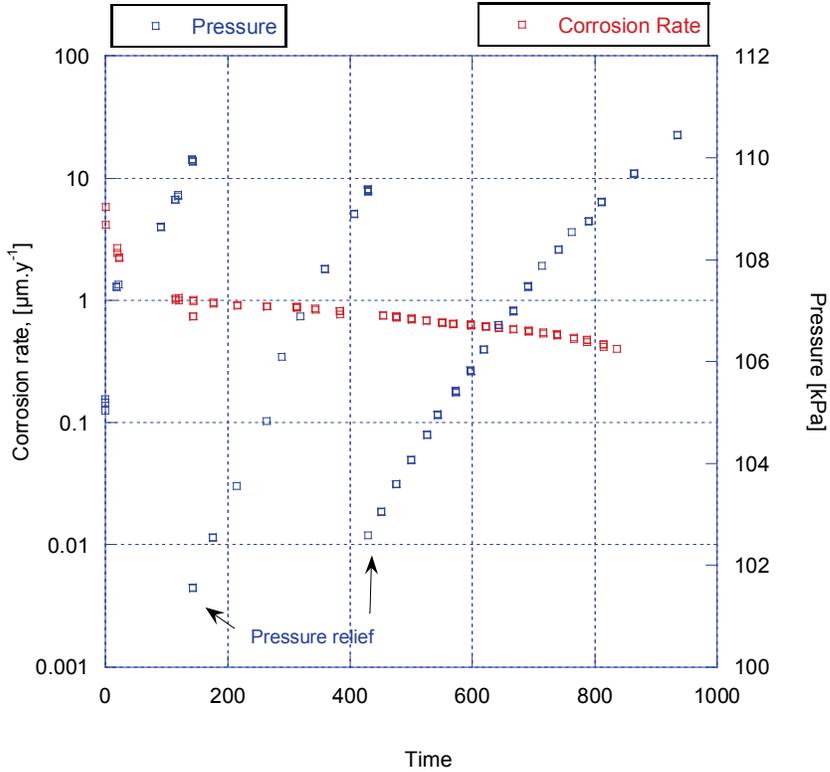
Figure 8: Corrosion behaviour of 0.5M NaCl dipped wires tested at 32°C and 71% RH

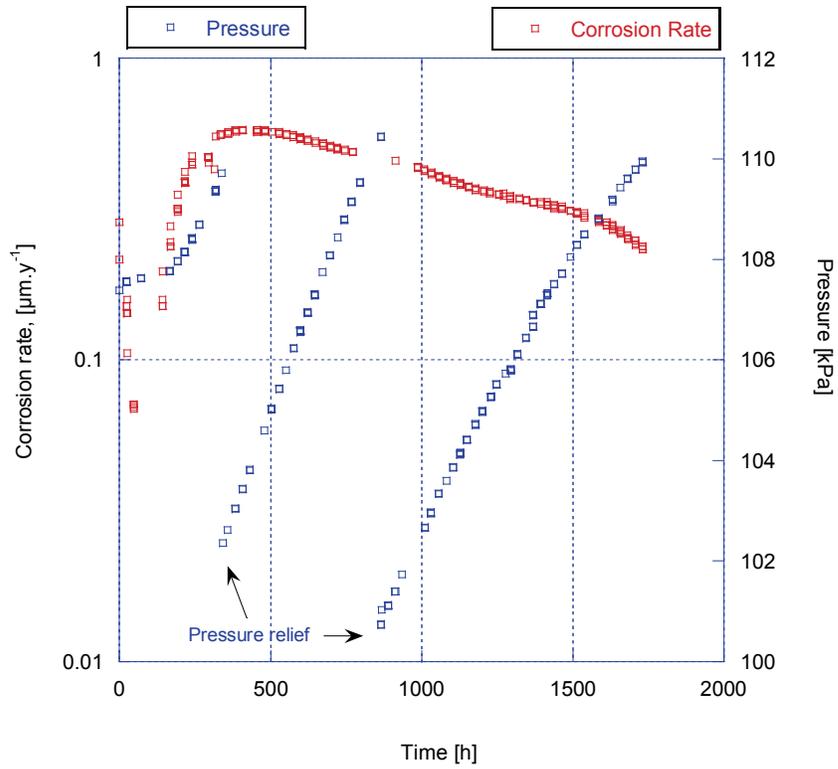
Figure 9: Corrosion behaviour of 0.5M NaCl dipped wires tested at 32°C and 75% RH

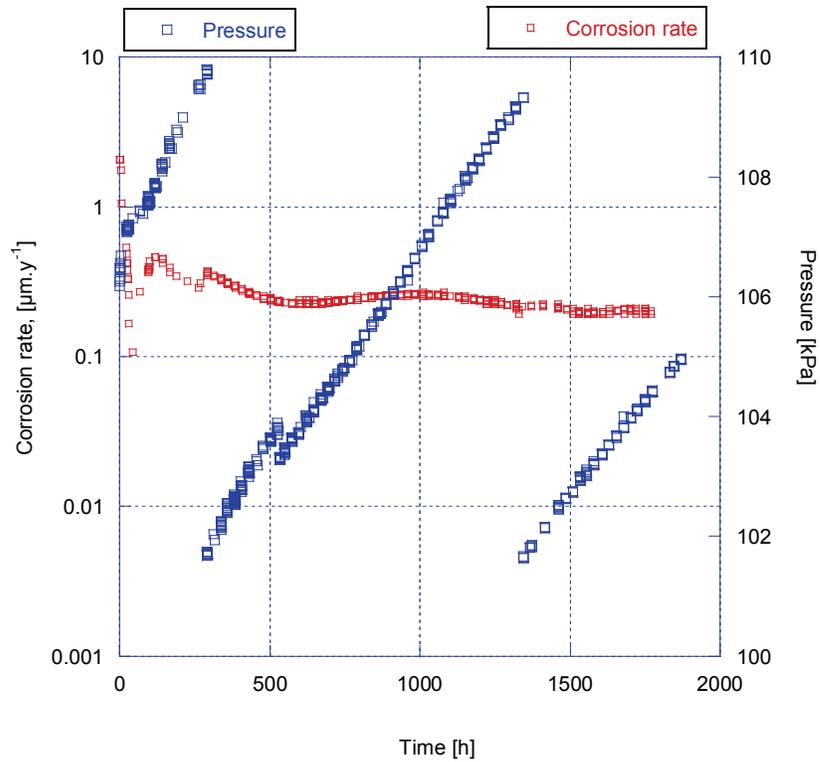
Figure 10: Corrosion behaviour of 0.5M NaCl dipped wires tested at 32°C and 100% RH

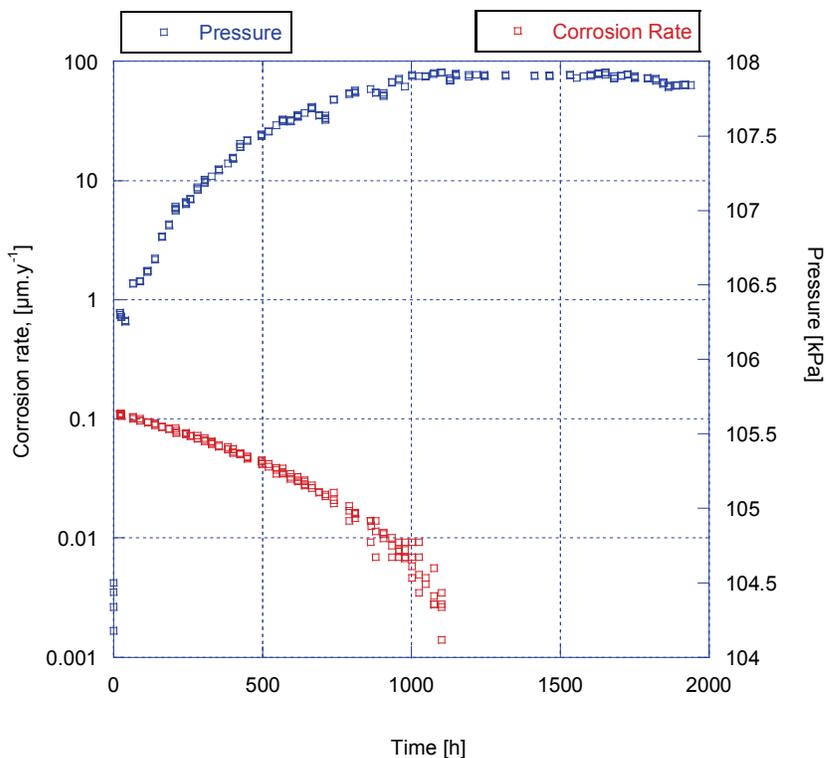
Figure 11: Corrosion behaviour of 0.5M NaCl dipped wires tested at 50°C and 30.5% RH

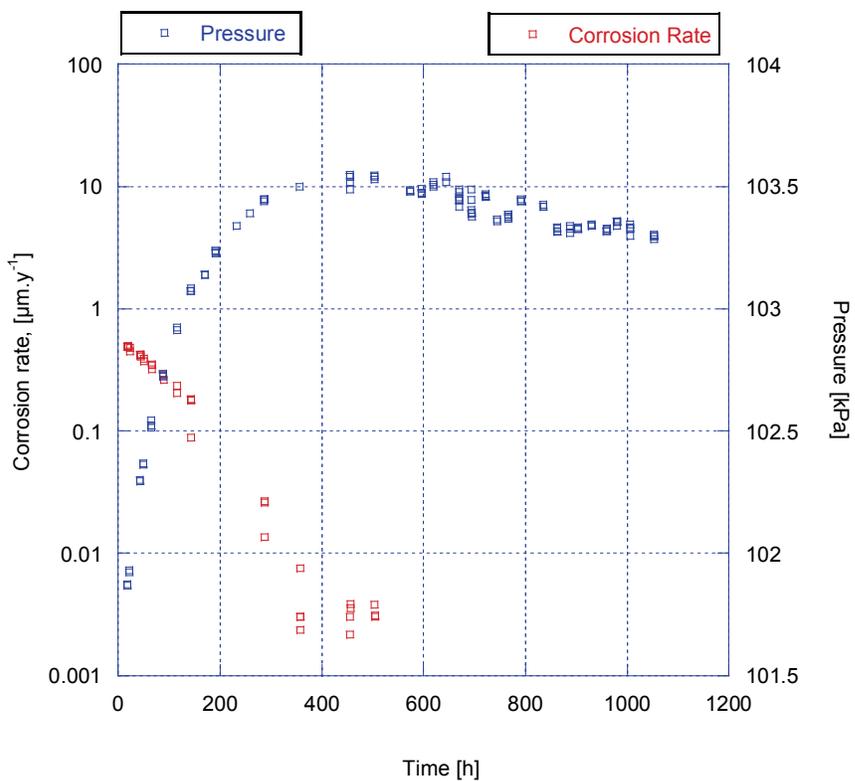
Figure 12: Corrosion behaviour of 0.5M NaCl dipped wires tested at 50°C and 51% RH

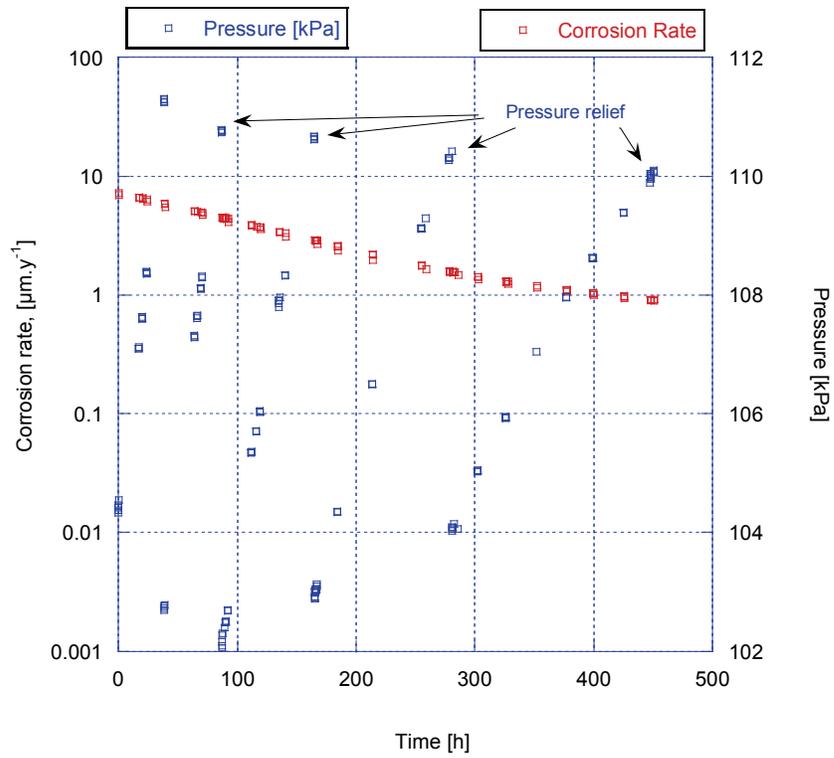
Figure 13: Corrosion behaviour of 0.5M NaCl dipped wires tested at 50°C and 75% RH

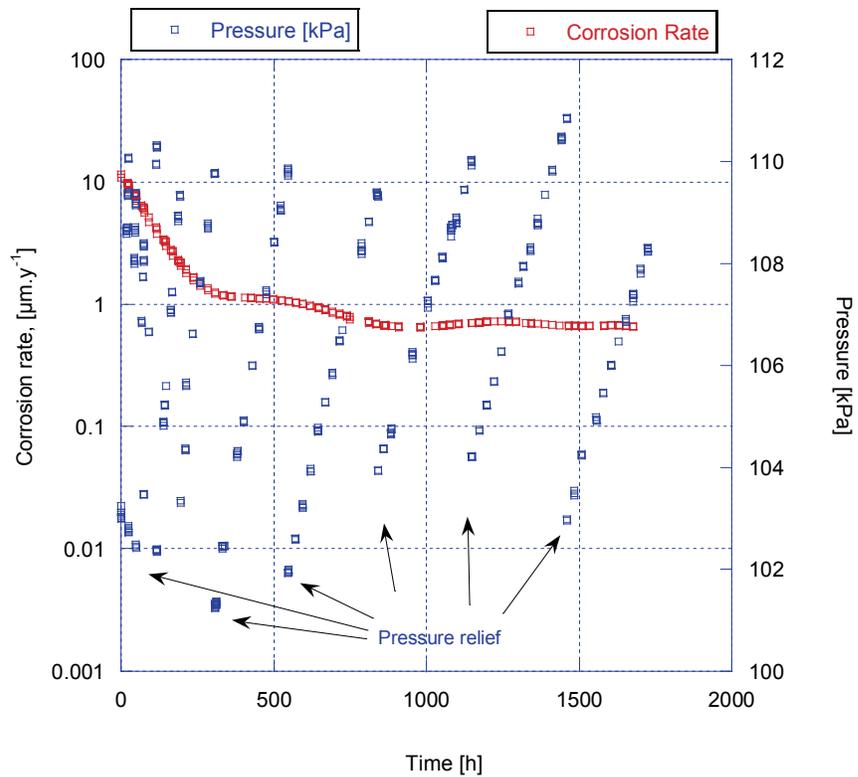
Figure 14: Corrosion behaviour of 0.5M NaCl dipped wires tested at 50°C and 100% RH

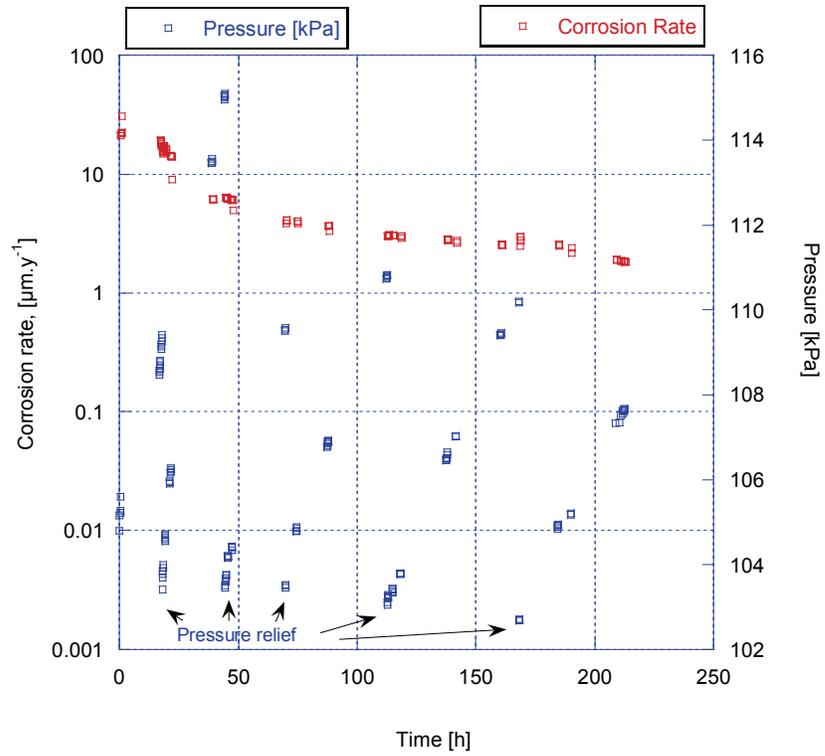
Figure 15: Corrosion behaviour of 0.5M NaCl dipped wires tested at 70°C and 100% RH

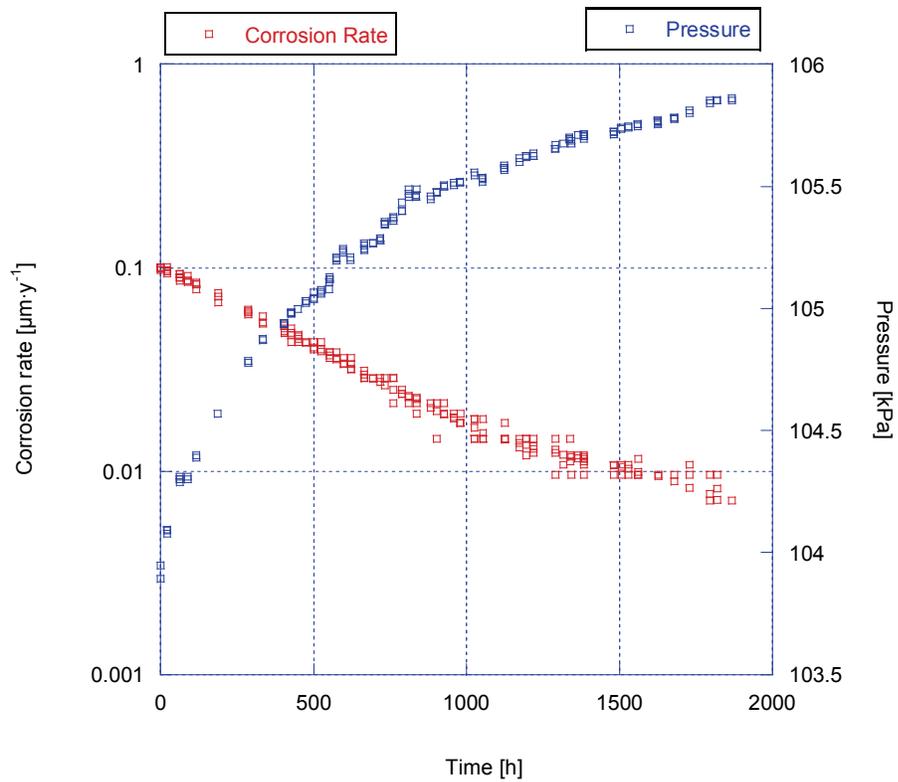
Figure 16: Corrosion behaviour of 0.05M NaCl dipped wires tested at 50°C and 51% RH

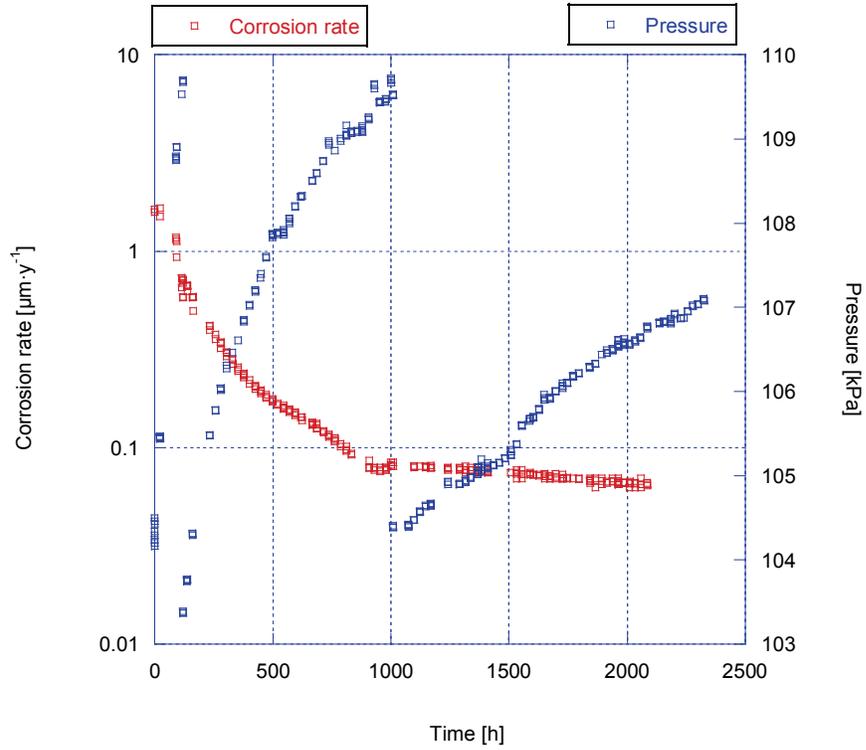
Figure 17: Corrosion behaviour of 0.05M NaCl dipped wires tested at 50°C and 75% RH

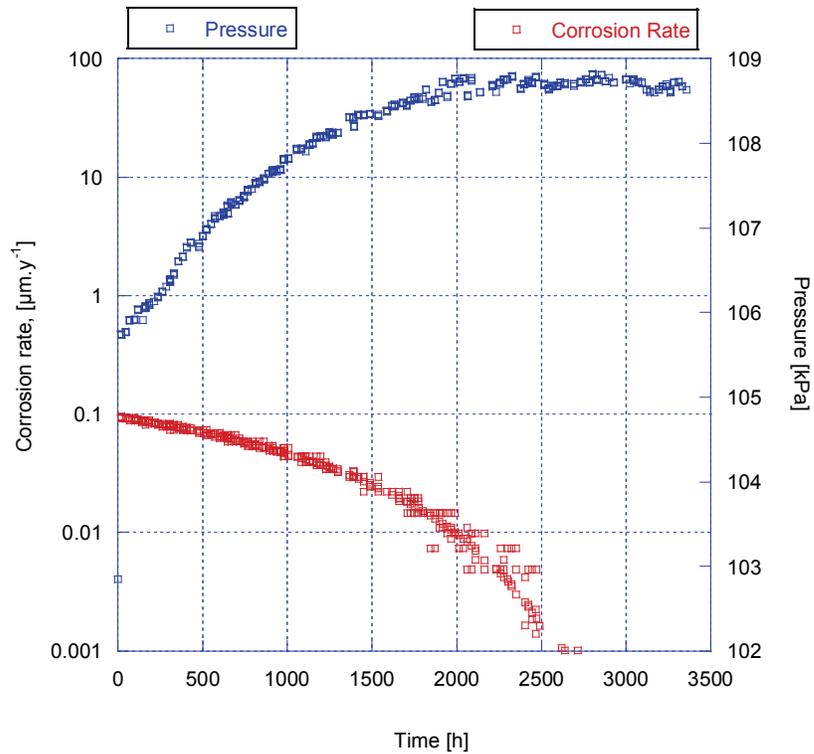
Figure 18: Corrosion behaviour of 0.05M NaCl dipped wires tested at 32°C and 75% RH

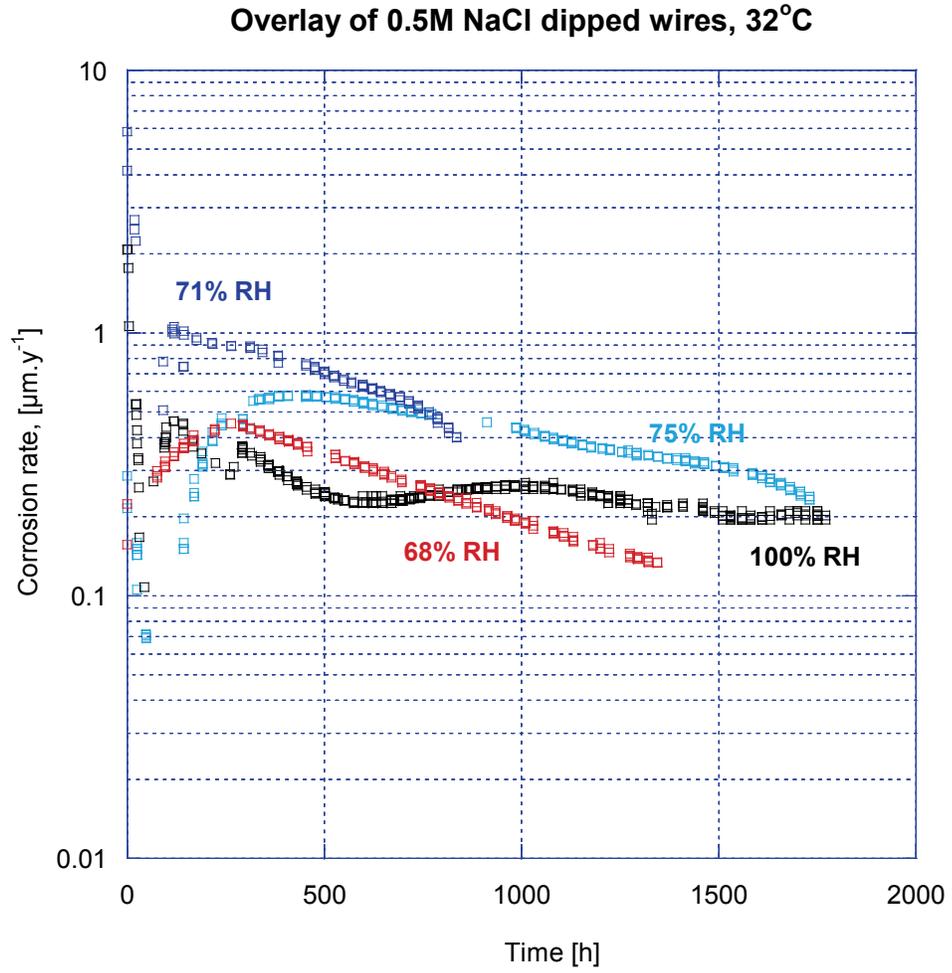
Figure 19: Corrosion behaviour of 0.5M NaCl dipped wires tested at 32°C and various RH

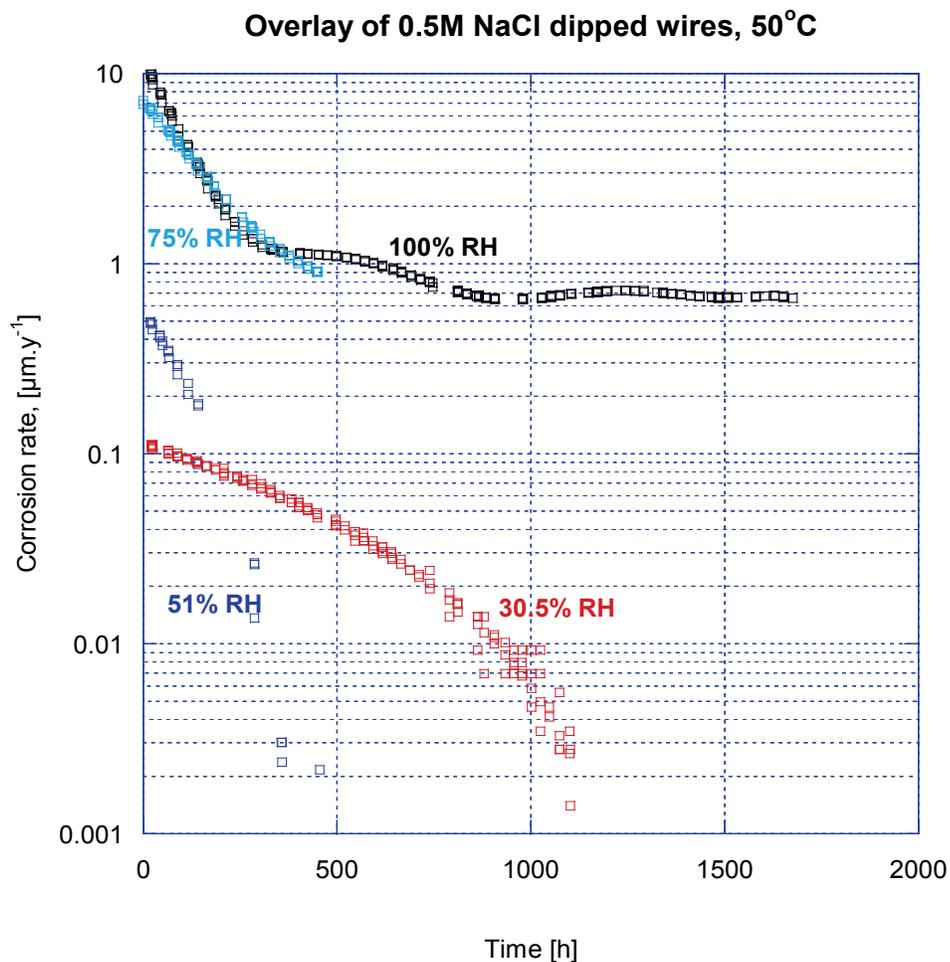
Figure 20: Corrosion behaviour of 0.5M NaCl dipped wires exposed to 50°C and various RH

At a higher temperature of 50 °C, the estimated corrosion rates were 1 and 0.8 $\mu\text{m}\cdot\text{y}^{-1}$ at 75% and 100% RH, respectively (Table 6). The test at 75% RH is still in its rapid transient stage since the test duration is short (450 hours) (Figure 20). At 30.5 and 50% RH, the estimated final corrosion rates were much lower, ca. 0.01 $\mu\text{m}\cdot\text{y}^{-1}$, which was still within the resolution range of the pressure gauge method (Table 6 and Figure 20).

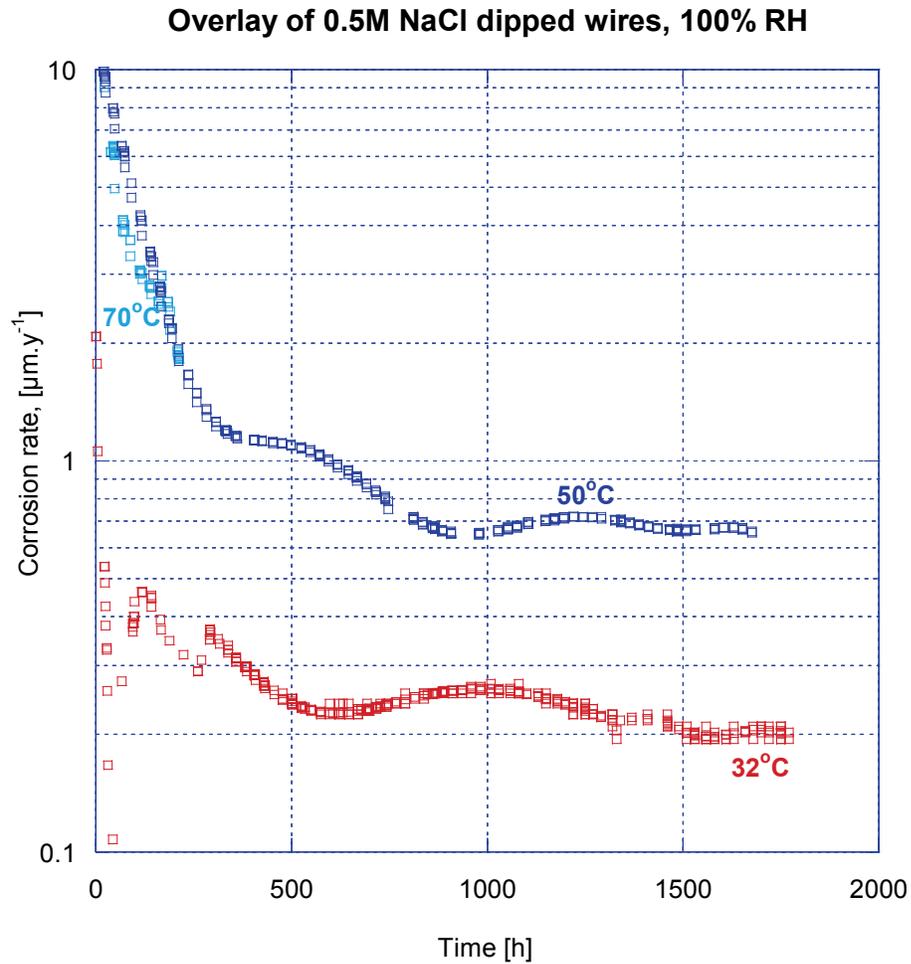
Figure 21: Corrosion behaviour of 0.5M NaCl dipped wires exposed to 100% RH and various temperatures

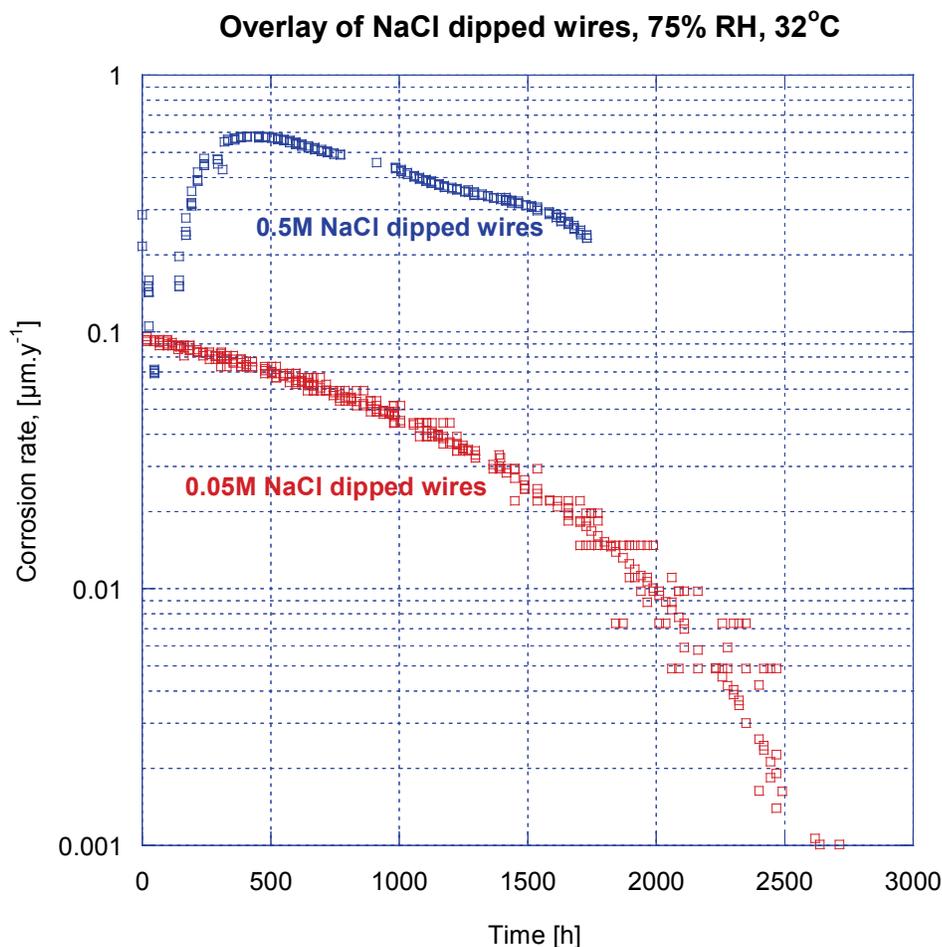
Interestingly, the tests at 32 °C and 75% RH indicate that soaking the wires in 0.05M NaCl solution was much less aggressive than soaking in 0.5M NaCl solution (Figure 22). With 0.05M NaCl soaking, the metal loss tended to level out with time, indicating that chloride is more than just a catalyst for corrosion – the thickness of liquid layer and absolute quantity of chloride in that layer are important. These test results appear to indicate that corrosion rates may increase quite sharply with increasing concentration of the NaCl solution and increasing amount of NaCl deposited on the wire surface.

Figure 22: Corrosion behaviour of NaCl dipped wires exposed to 75% RH, 32°C

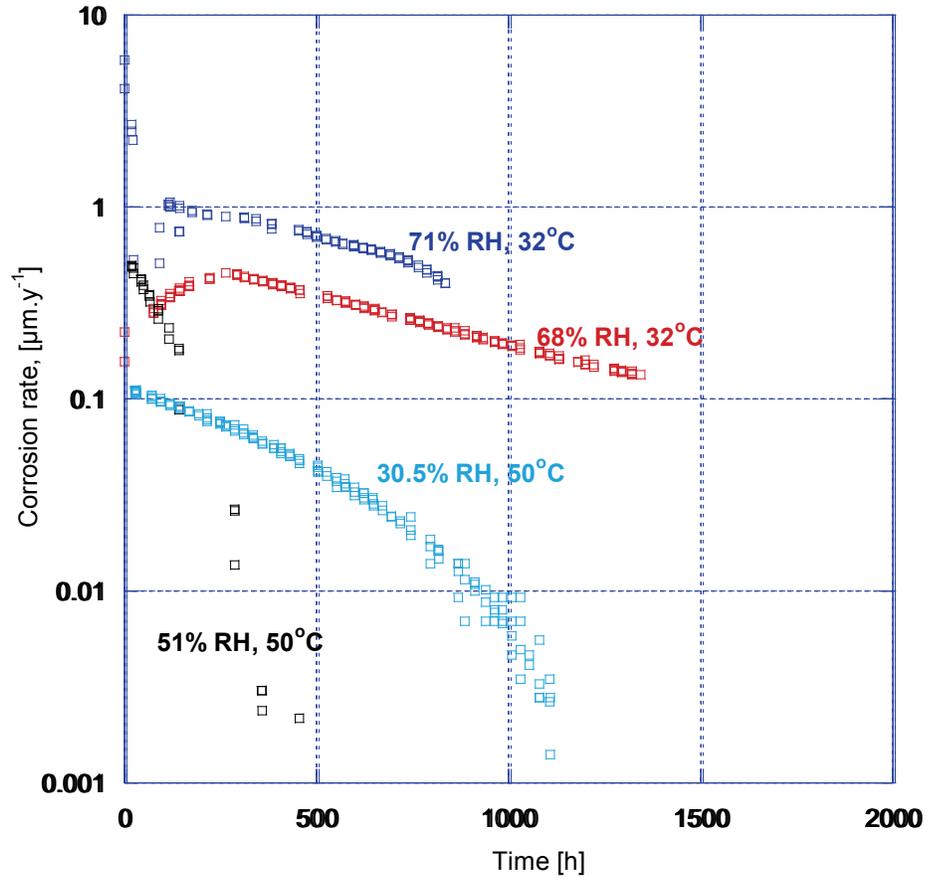
These test results appear to show that steel corrosion would not stop as the relative humidity was reduced to, or slightly below, the value that is in equilibrium with saturated NaCl (i.e. 75.5%RH at 30°C and 74.5%RH at 50°C) (Figure 23). This is a well-known finding for atmospheric corrosion in ordinary aerated environments - that 60-70% RH provides sufficient moisture to support electrochemical reactions - but this is probably the first such study in anoxic environments. Various explanations for this are possible, including simple gas-phase reaction with water vapour, reaction with multilayer adsorption of water, hydrous corrosion products, capillary condensation, and involvement of hygroscopic iron salts ($\text{FeCl}_2 \cdot x\text{H}_2\text{O}$). Nevertheless, there was a steep decline in corrosion rate as the RH was reduced to 30.5% and 51% (Figure 23). At these low RH values, corrosion is not well sustained.

Figure 23: Corrosion behaviour of 0.5M NaCl dipped wires exposed to $\text{RH} \leq \text{equilibrium RH}$

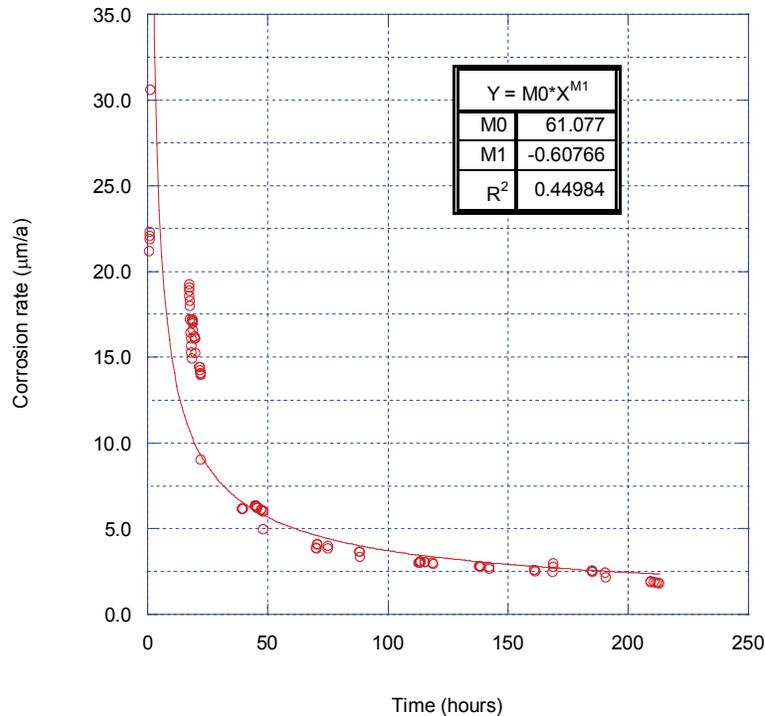
Other curves are better fitted by power laws, leading to more pessimistic predictions for long-term corrosion rates. Figure 24 shows a reasonable $t^{-0.6}$ fit for the data of Figure 15, but this may be too conservative as the corrosion rate shows a dip towards the end of the test. But even taking the fit at face value, the corrosion rate would fall to $0.24 \mu\text{m y}^{-1}$ after 1 year, and 3.7 nm y^{-1} after 1000 years. Is it legitimate to make such extrapolations? More testing would be required to sustain the speculation that this is an upper limit on the corrosion rate because of the dip seen at the end of the limited dataset!

Figure 24: Power curve fit of corrosion rates - 0.5M NaCl dipped wires, exposed to 70°C and 100% RH

The time dependence of corrosion rate for the tests that showed sustained corrosion in Figures 7 to 23 was not easy to fit to any rational law that might enable extrapolation to longer times. However it is evident, even from visual observation of the curves, that some corrosion rate decays approximate to exponentials with rather long time constants, e.g. the 68% RH data in Figure 23. We would not advise extrapolating such curves for predictive purposes, as we have seen both kinds of deviation – positive and negative – from such initially well-behaved lines. But just for illustrative purposes, the straight-line decay in Figure 24 approximates to the following:

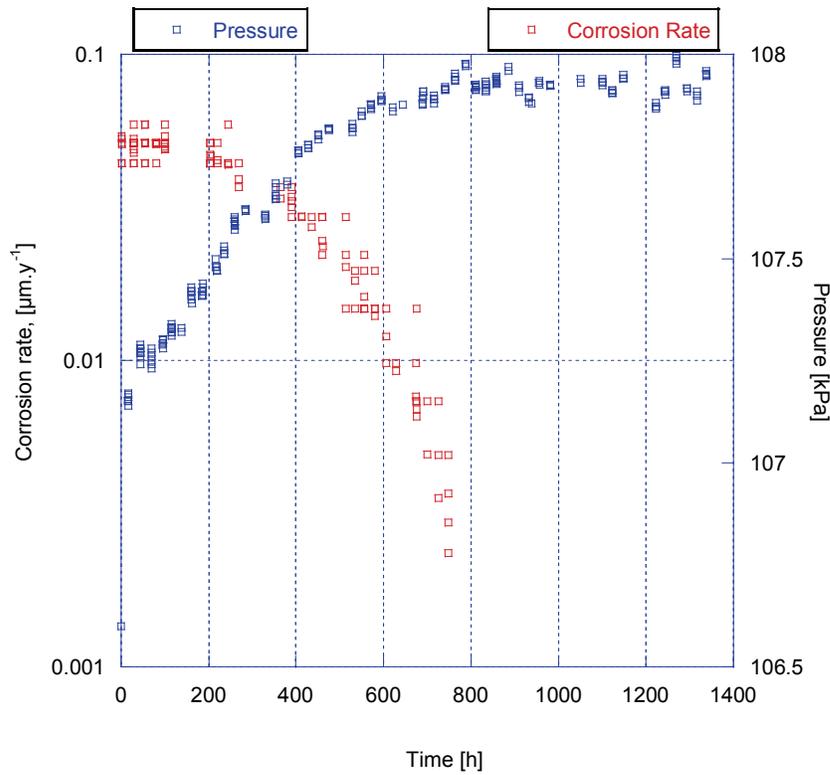
Figure 25: Corrosion behaviour of pickled wires exposed to 32°C, 100% RH

While similar behaviour was noticed for the pickled wires at 32, 50 and 70°C, 100% RH, none of these tests (Figures 25-28) showed any conclusive indication of long-term sustained corrosion, as the pressure changes became too difficult to detect shortly after the experiments started. A key application of the hydrogen sensor is to determine whether corrosion has really “stopped” after this sequence. [One might also ask, for the pickled-wire testing - could hydrogen be absorbed from the pickling, then effuse during the test – but if that were the case, this should happen in every test, which it did not.]

Some attempts were made to fit decay functions to the corrosion transients obtained in these tests. For the pickled wires at 32°C and 100% RH (data of Figure 25), the corrosion rate appeared to decay linearly to zero – not a normal functional form for a corrosion-rate decay, but perhaps informative – Figure 27. At 50°C, the decay took on a definite exponential form with a time constant of about 100 hours – Figure 30. At 70°C, the fit was less impressive but as the eye would indicate, the time constant was shorter – close to 10 hours - Figure 31.

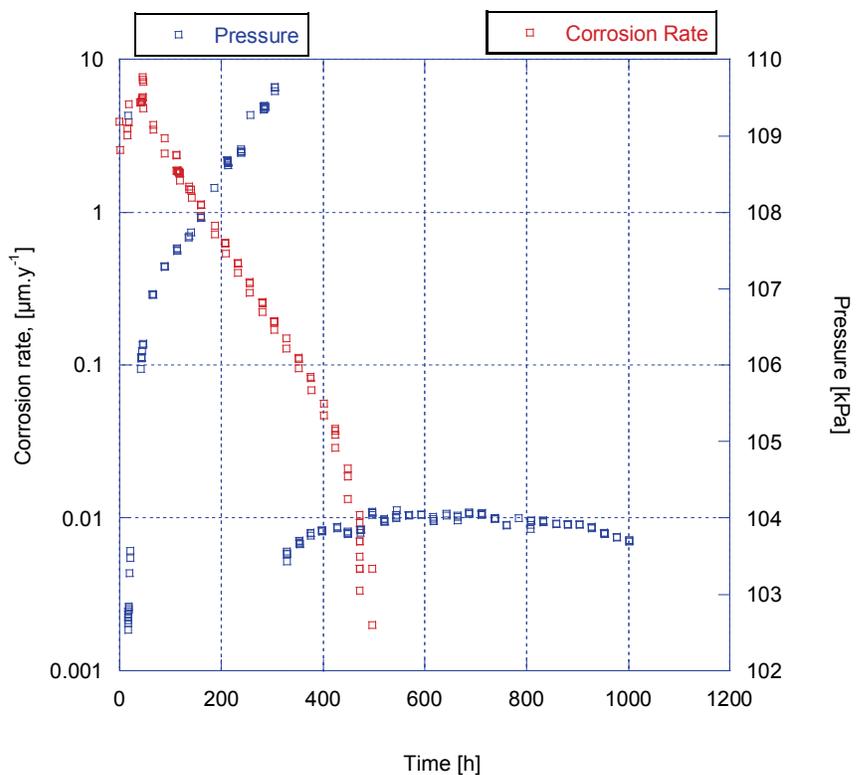
Figure 26: Corrosion behaviour of pickled wires exposed to 50°C, 100% RH

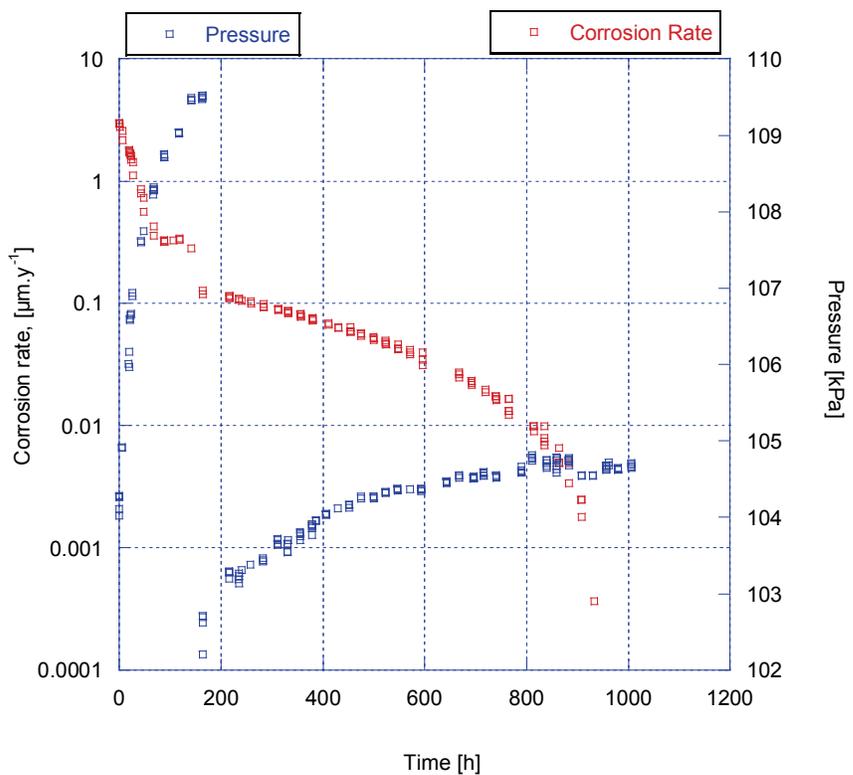
Figure 27: Corrosion behaviour of pickled wires exposed to 70°C, 100% RH

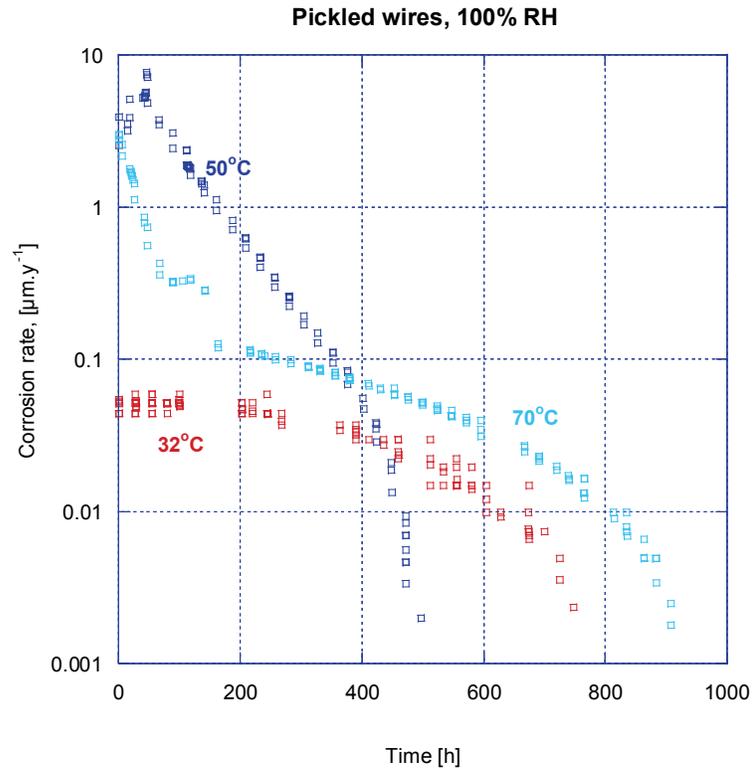
Figure 28: Corrosion behaviour of pickled wires exposed to 100% RH

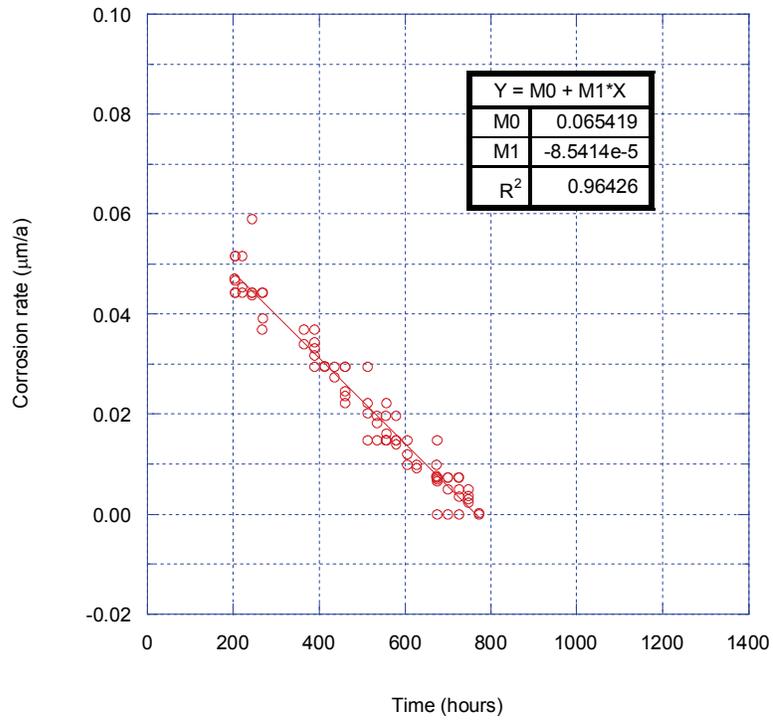
Figure 29: Linear curve fit of corrosion rates, pickled wires exposed to 32°C and 100% RH

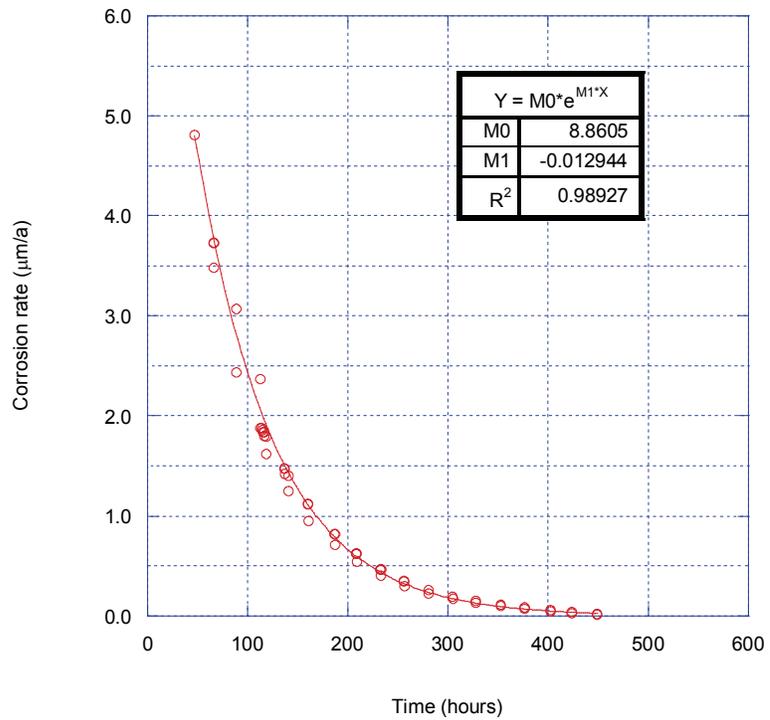
Figure 30: Exponential curve fit of corrosion rates, pickled wires exposed to 50°C and 100% RH

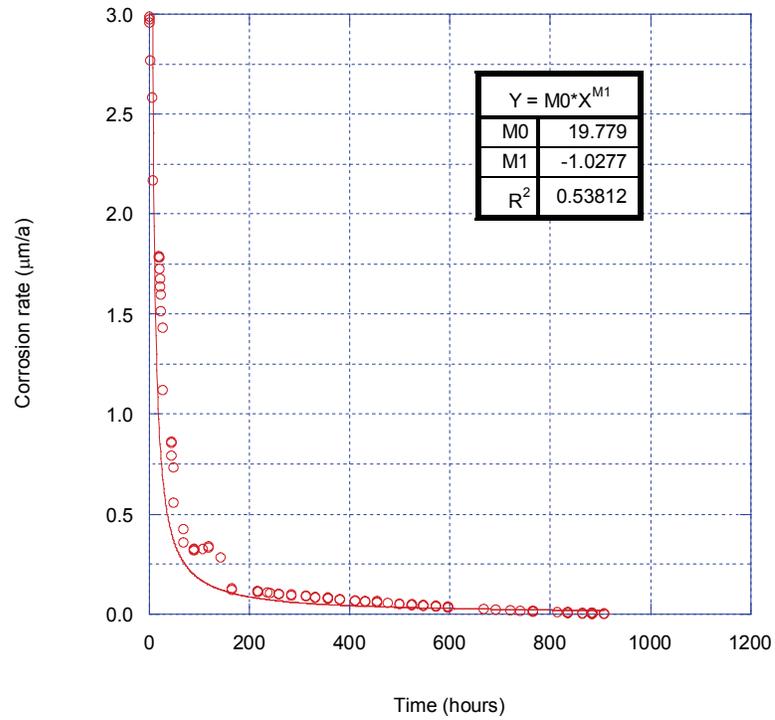
Figure 31: Power curve fit of corrosion rates, pickled wires, exposed to 70°C and 100% RH
