Anaerobic Corrosion Studies of Carbon Steel Used Fuel Containers

NWMO TR-2010-07

September 2010

Roger C. Newman¹, Steve Wang¹, and Gloria Kwong²

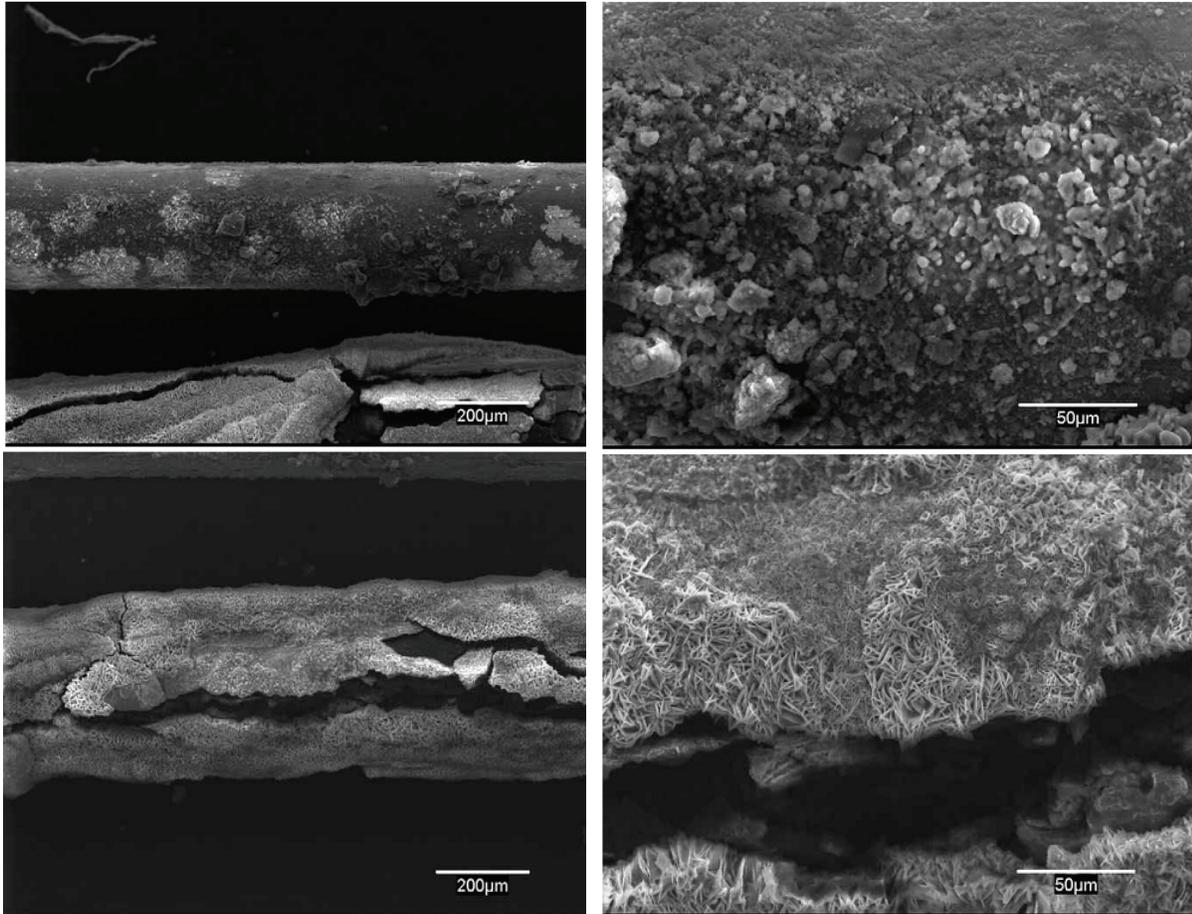
Figure 32 shows the mixture of salt deposit and corrosion product that was the starting point for the NaCl 'coated' or 'precorroded' tests (images of Sample 2). Heavy deposits are found on wires surfaces.

Figure 32: SEM images of Sample 2 (3rd and 4th wires) - 0.5M NaCl coated wires

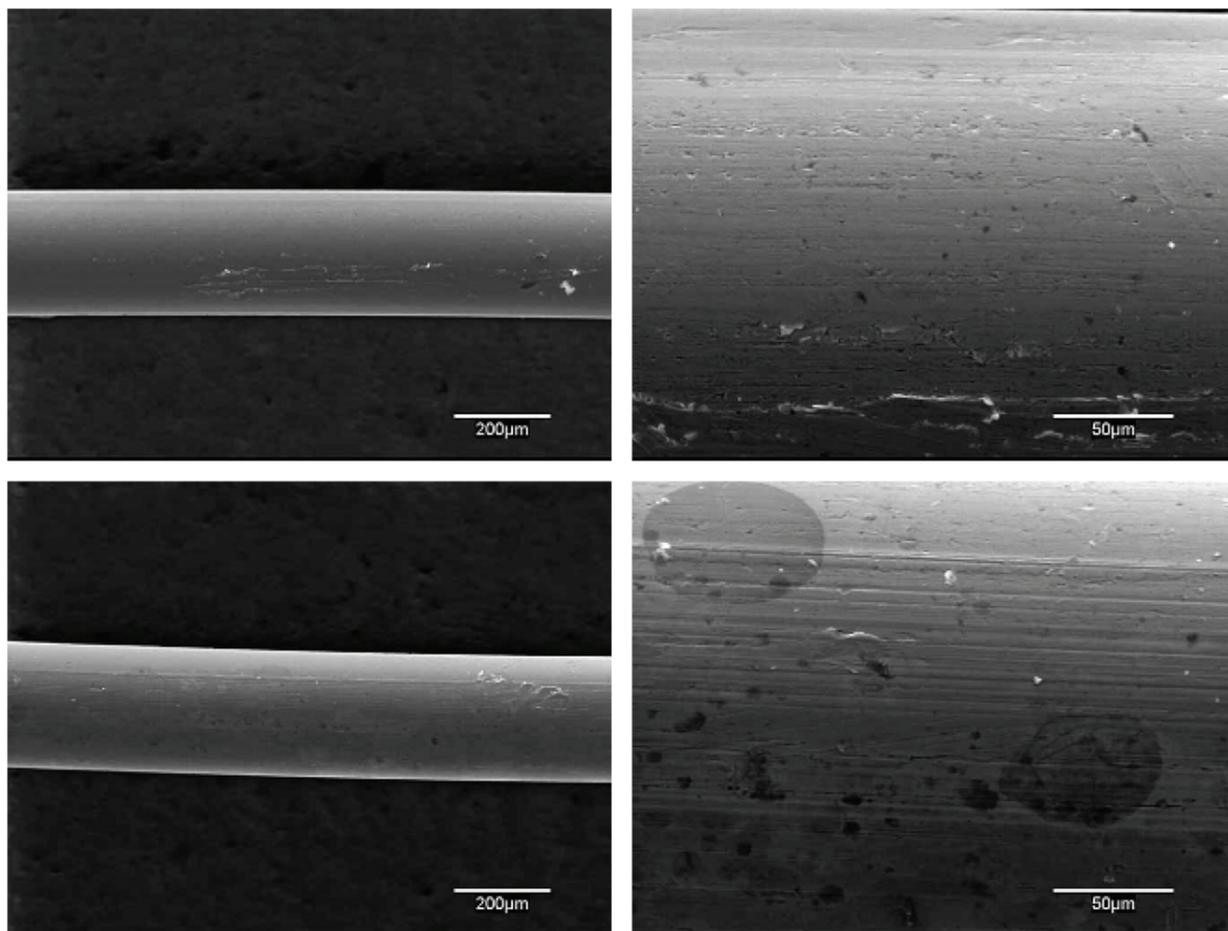
Figure 33 shows roughly circular patches that were found on some samples exposed to 100% RH without salt coating; these are possibly centred on manganese sulfide inclusions, but the necessary analyses (e.g. by spatially resolved XPS or Auger Electron Spectroscopy) were not carried out.

Figure 33: SEM images of Sample 3 - degreased wires, 50°C, 100% RH

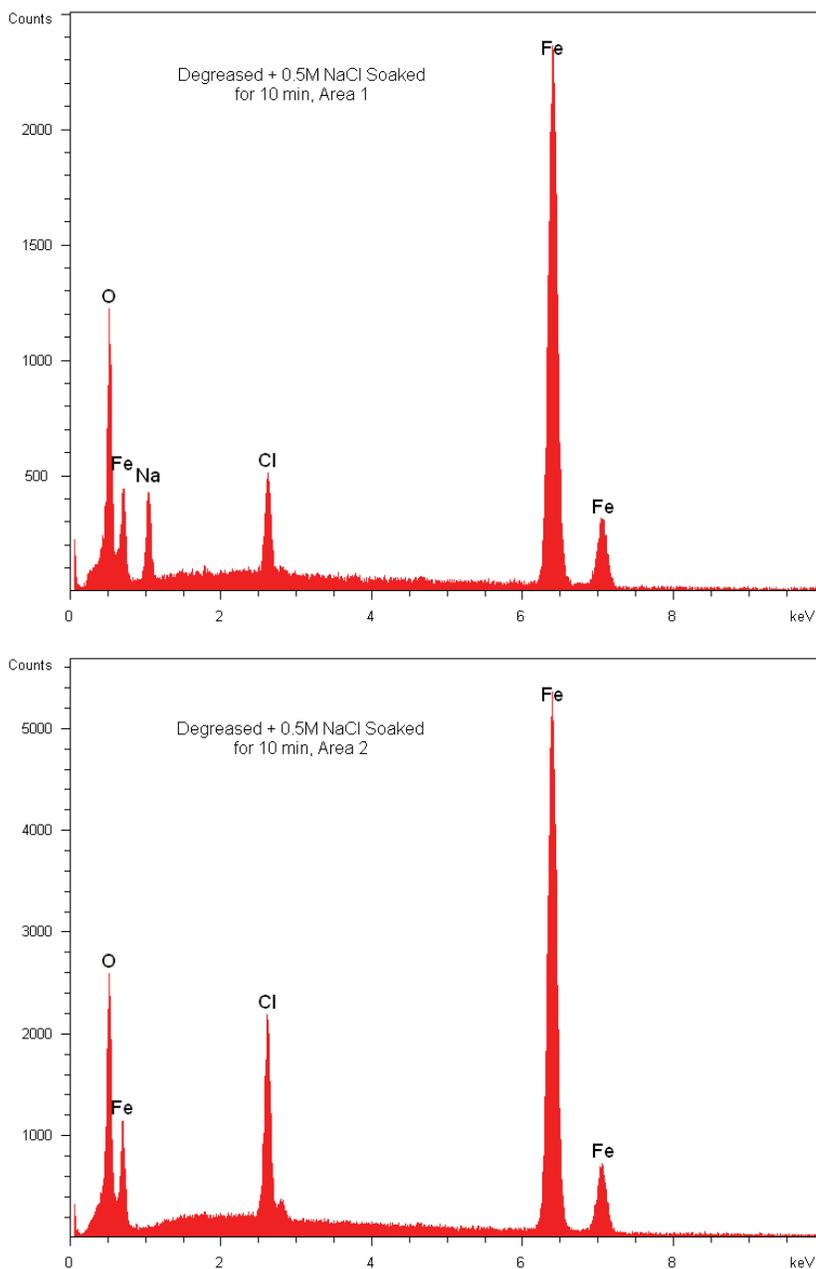
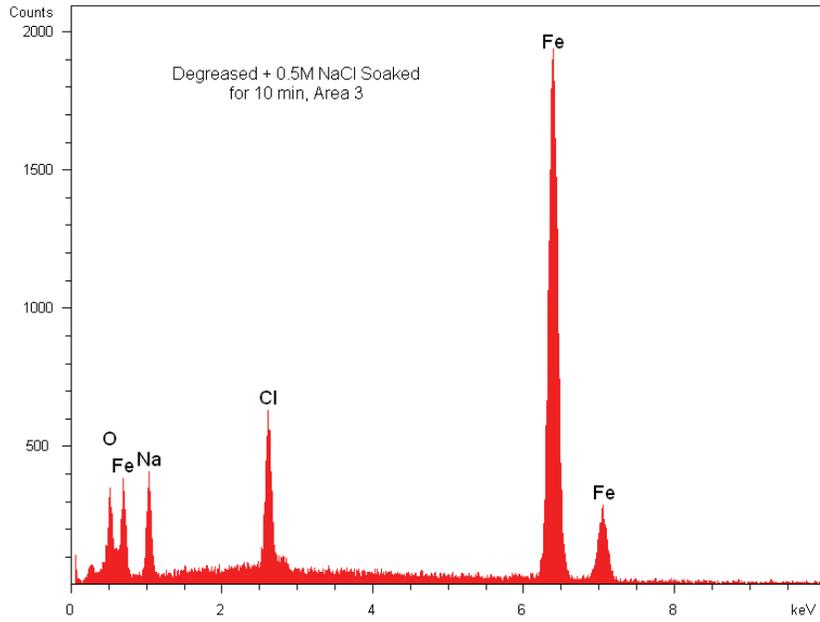
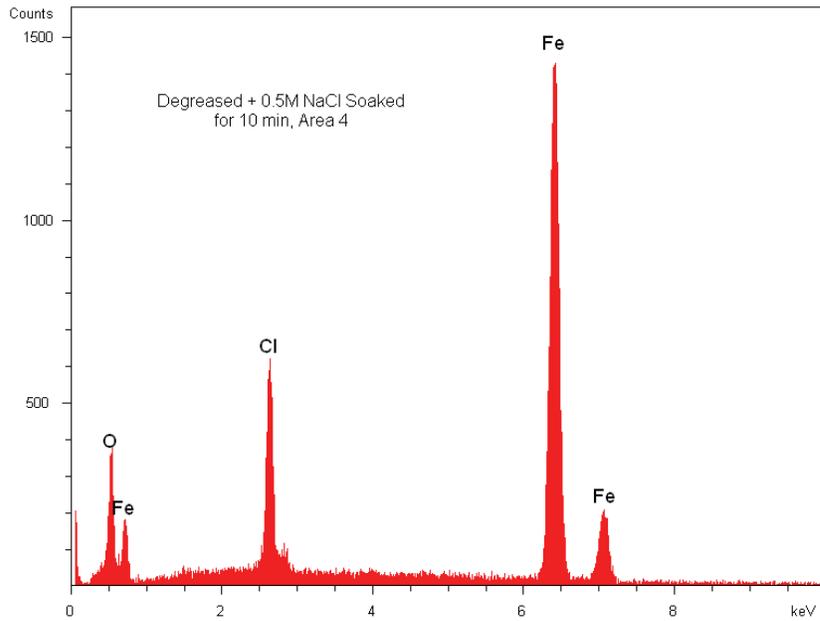
Figure 34 shows that regions can be isolated in the salt-coated surface that contain salt crystals or are composed purely of corrosion product. It should be noted that the use of ordinary air and water exposure for this NaCl pretreatment could account for the presence of Fe III species or carbonates in the corrosion products after anoxic exposure, but examination of the full range of data reveals that there must have been some post-air exposure as well. Regarding the Fe III species, it would be expected that hydrogen from anoxic corrosion would reduce these to magnetite or Fe II species, but such reactions may be slow.

EDX results in weight percent				
Analysis	O	Na	Cl	Fe
Analysis 1	27.7	8.5	3.2	60.7
Analysis 2	30.7		6.9	62.4
Analysis 3	11.7	11.0	6.1	71.3
Analysis 4	19.7		8.5	71.8

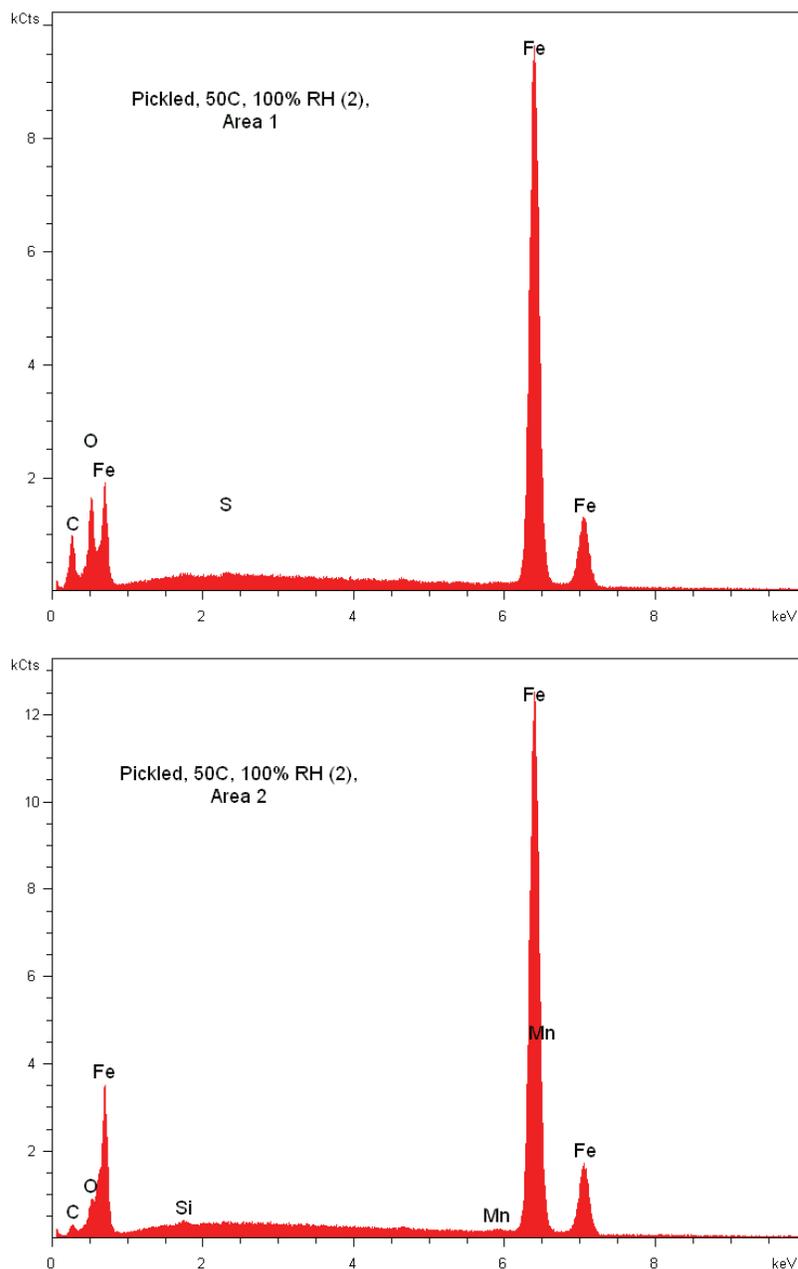
Generally EDX did not give much information on samples that were exposed to anoxic conditions without a salt deposit, but oxygen was detectable in some cases, as shown in Figure 35.

EDX results in weight percent						
Analysis	C	O	Si	S	Mn	Fe
Analysis 1	25.3	18.9		0.1		55.7
Analysis 2	11.6	6.1	0.2		0.3	81.8

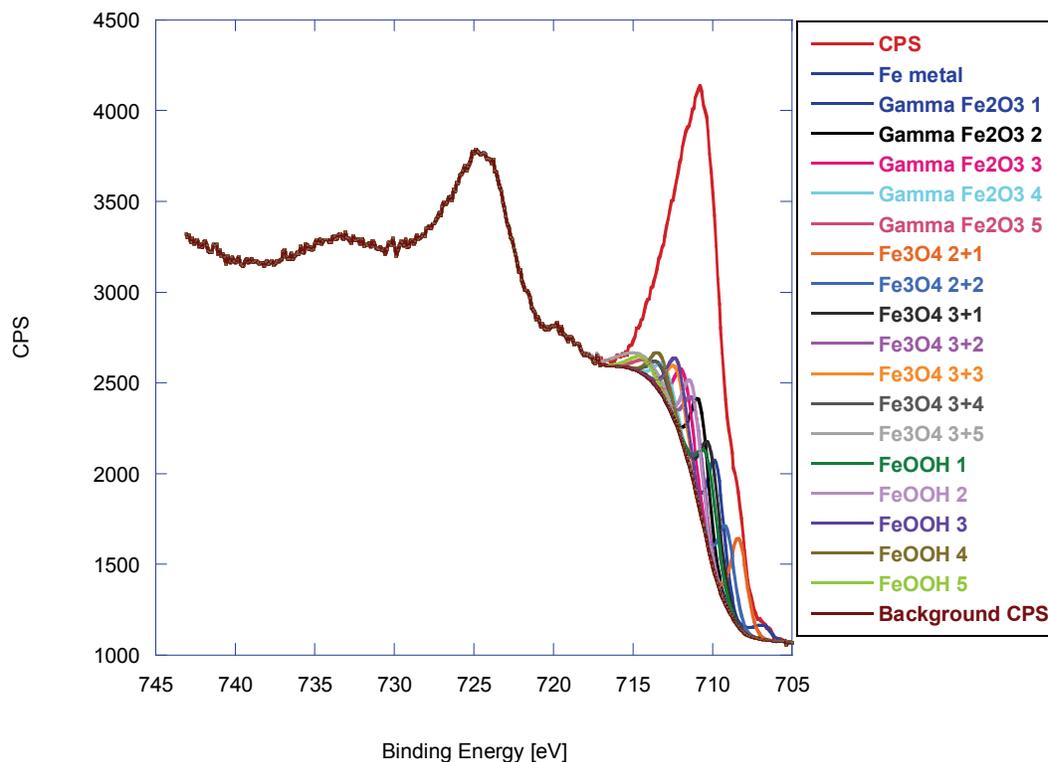
Sample 5 - Pickled wires, 50°C, 100%RH, Fe(2p) high resolution spectrum

Name	Pos.	FWHM	L.Sh.	Area	% Area
Fe metal	706.79	0.95	LA(1.2,4.8,3)	161.6	1.8
Gamma Fe ₂ O ₃ 1	709.78	1.20	GL(30)	828.7	9.1
Gamma Fe ₂ O ₃ 2	710.78	1.30	GL(30)	828.7	9.1
Gamma Fe ₂ O ₃ 3	711.78	1.40	GL(30)	613.9	6.7
Gamma Fe ₂ O ₃ 4	712.98	1.40	GL(30)	275.2	3.0
Gamma Fe ₂ O ₃ 5	714.08	1.70	GL(30)	154.2	1.7
Fe ₃ O ₄ 2+1	708.35	1.20	GL(30)	631.6	6.9
Fe ₃ O ₄ 2+2	709.15	1.20	GL(30)	563.1	6.2
Fe ₃ O ₄ 3+1	710.15	1.40	GL(30)	901.7	9.9
Fe ₃ O ₄ 3+2	711.15	1.40	GL(30)	677.2	7.4
Fe ₃ O ₄ 3+3	712.25	1.40	GL(30)	464.2	5.1
Fe ₃ O ₄ 3+4	713.35	1.40	GL(30)	216.9	2.4
Fe ₃ O ₄ 3+5	714.45	3.30	GL(30)	346.2	3.8
FeOOH 1	710.30	1.40	GL(30)	720.2	7.9
FeOOH 2	711.30	1.30	GL(30)	706.8	7.8
FeOOH 3	712.20	1.40	GL(30)	549.5	6.0
FeOOH 4	713.3	1.40	GL(30)	308.6	3.4
FeOOH 5	714.40	1.80	GL(30)	168.0	1.8

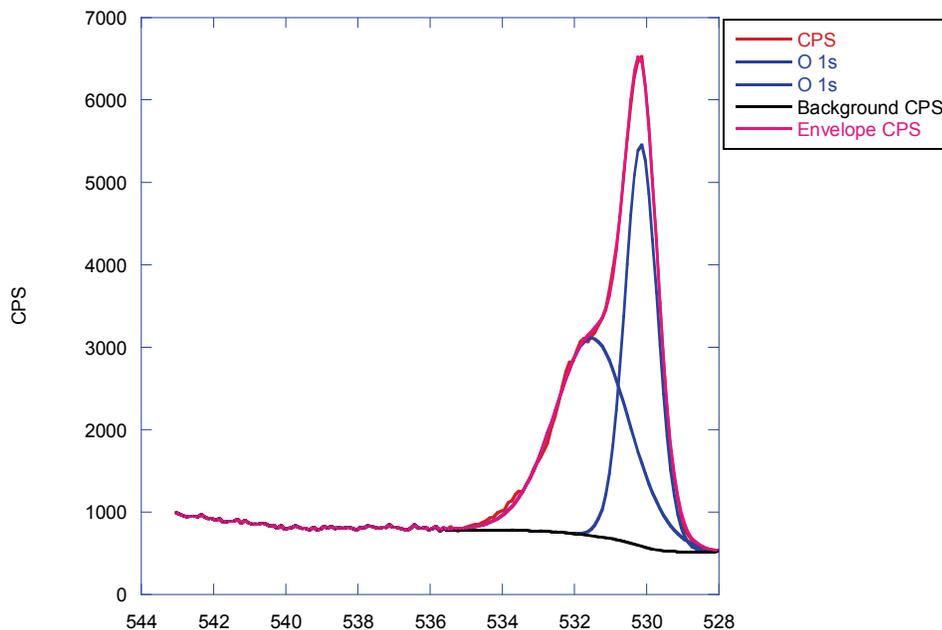
Sample 5 - Pickled wires, 50°C, 100%RH, O 1s high resolution spectrum

Name	Pos.	FWHM	L.Sh.	Area	% Area
O 1s	531.51	2.45	GL(30)	6365.8	53.3
O 1s	530.16	1.06	GL(30)	5572.8	46.7

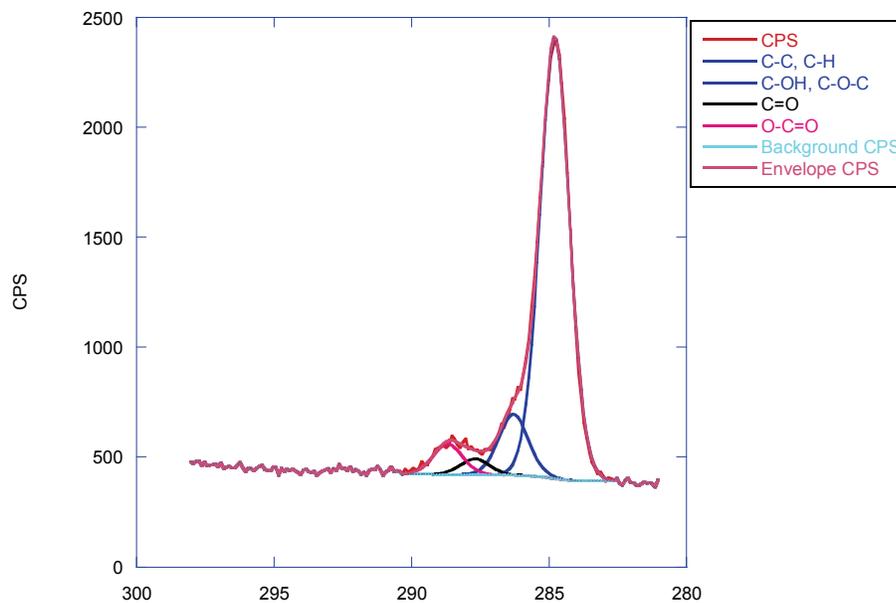
Sample 5 - Pickled wires, 50°C, 100%RH, C 1s high resolution spectrum

Name	Pos.	FWHM	L.Sh.	Area	% Area
C-C, C-H	284.80	1.25	GL(30)	2711.4	80.3
C-OH, C-O-C	286.30	1.25	GL(30)	377.3	11.2
C=O	287.70	1.25	GL(30)	97.9	2.9
O-C=O	288.69	1.25	GL(30)	188.7	5.6

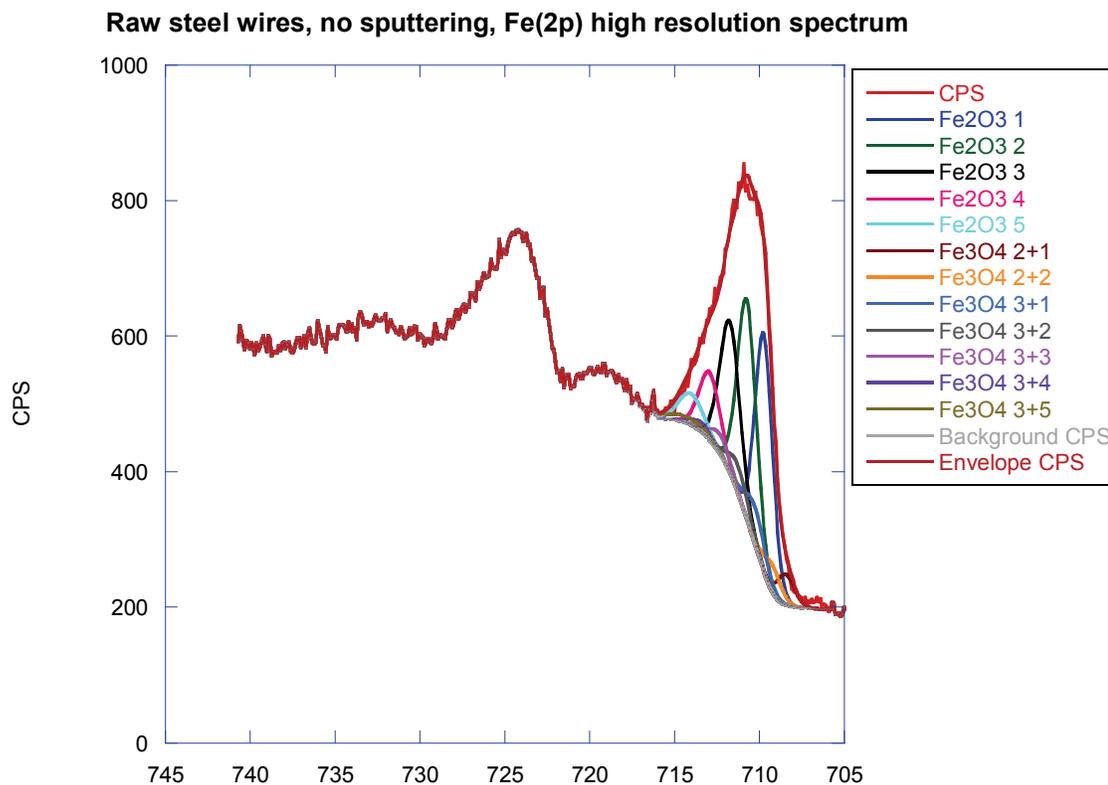
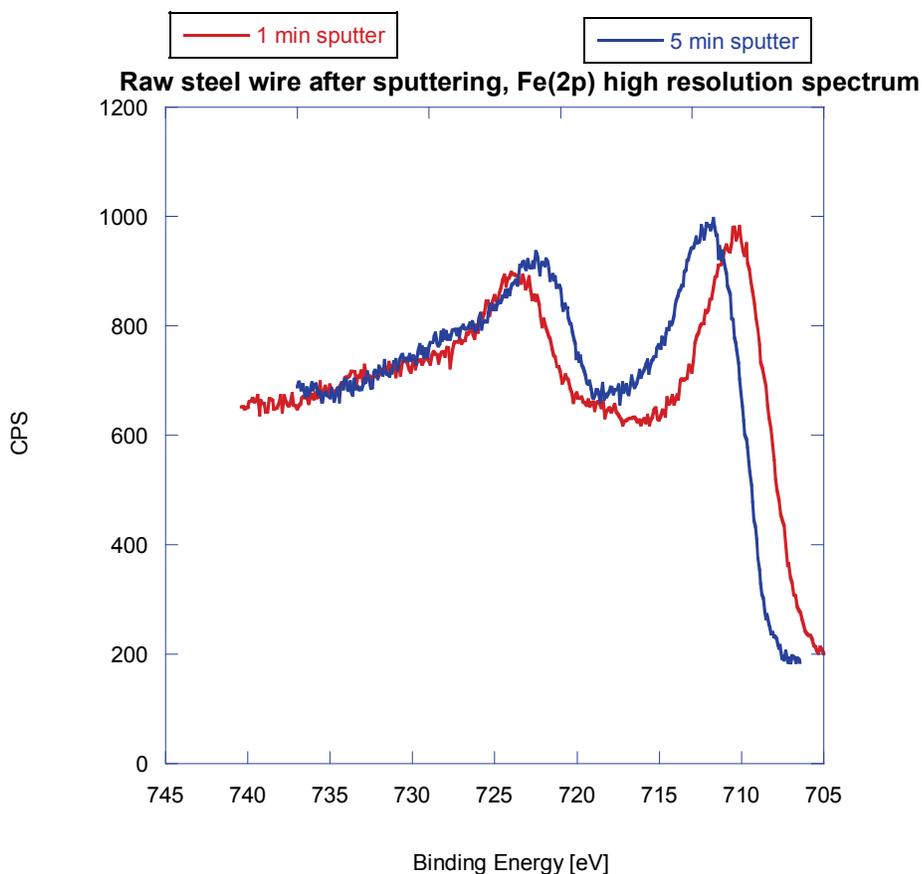
High-resolution XPS spectra of the iron wire heated at 400°C, before and after sputter etching, are shown in Figure 37. No metallic Fe is found on the outer surface, but partial film reduction occurs during sputtering. These spectra are however useful for interpretation of the spectra of the corroded surfaces.

Name	Pos.	FWHM	L.Sh.	Area	% Area
Fe ₂ O ₃ 1	709.75	1.20	GL(30)	457.3	24.8
Fe ₂ O ₃ 2	710.75	1.30	GL(30)	457.3	24.8
Fe ₂ O ₃ 3	711.75	1.40	GL(30)	338.8	18.4
Fe ₂ O ₃ 4	712.95	1.40	GL(30)	151.9	8.2
Fe ₂ O ₃ 5	714.05	1.70	GL(30)	85.1	4.6
Fe ₃ O ₄ 2+1	708.45	1.20	GL(30)	58.8	3.2
Fe ₃ O ₄ 2+2	709.25	1.20	GL(30)	52.4	2.8
Fe ₃ O ₄ 3+1	710.25	1.40	GL(30)	84.0	4.6
Fe ₃ O ₄ 3+2	711.25	1.40	GL(30)	63.1	3.4
Fe ₃ O ₄ 3+3	712.35	1.40	GL(30)	43.2	2.3
Fe ₃ O ₄ 3+4	713.45	1.40	GL(30)	20.2	1.1
Fe ₃ O ₄ 3+5	714.55	3.30	GL(30)	32.2	1.7

Figure 37: XPS analysis of raw steel wires

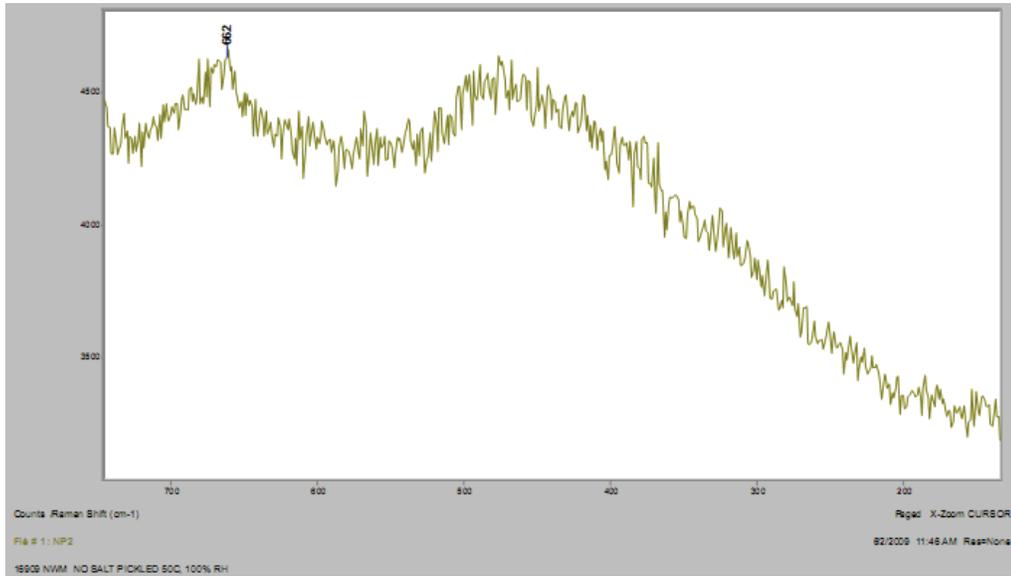
Figure 38a shows an example of a Raman spectrum for an anoxic test without salt coating that gave a relatively thin oxide film, showing a well-resolved feature ascribed to Fe_3O_4 . A total of 5 areas on different wires were analyzed. All spectra consistently show a peak near 667 cm^{-1} , typical of Fe_3O_4 . The broad undifferentiated feature around 450 cm^{-1} comes from the NMR tube in which the sample was encapsulated. Another area of the same sample showed a more intense peak typical of Fe_3O_4 – Figure 38b. More representative spectra were obtained by subtracting the spectrum of the NMR tube – Figure 38c.

Figure 38 a: Raman spectrum of Sample 4 - pickled wires, 50°C, 100% RH

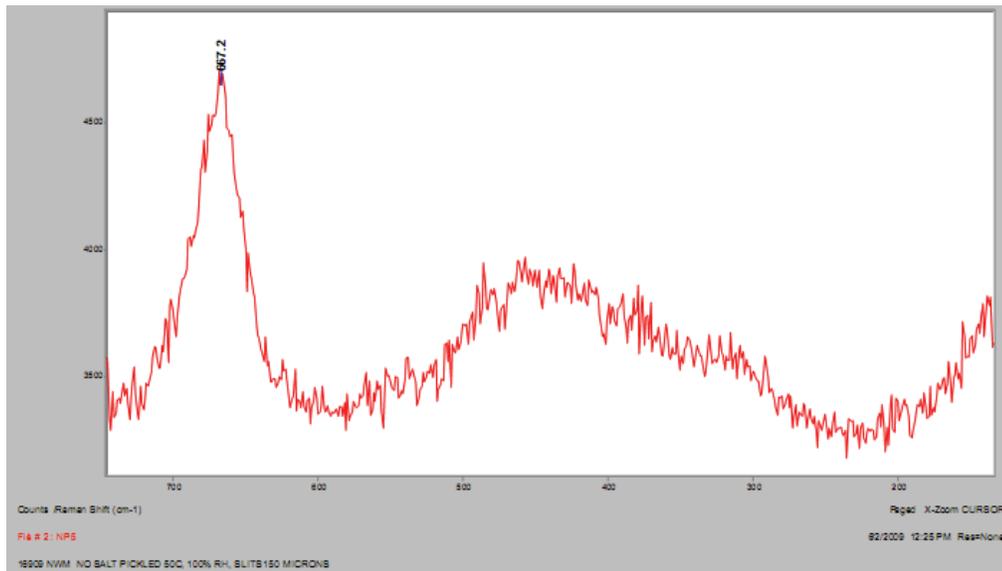
Figure 38 b: Raman spectrum of Sample 4 - pickled wires, 50°C, 100% RH

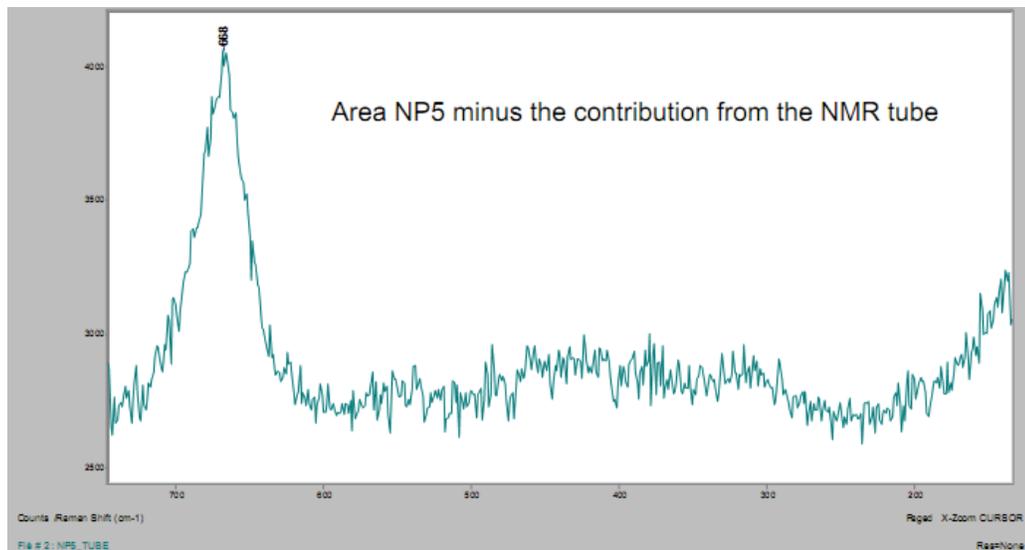
Figure 38 c: Raman spectrum of Sample 4 - pickled wires, 50°C, 100% RH

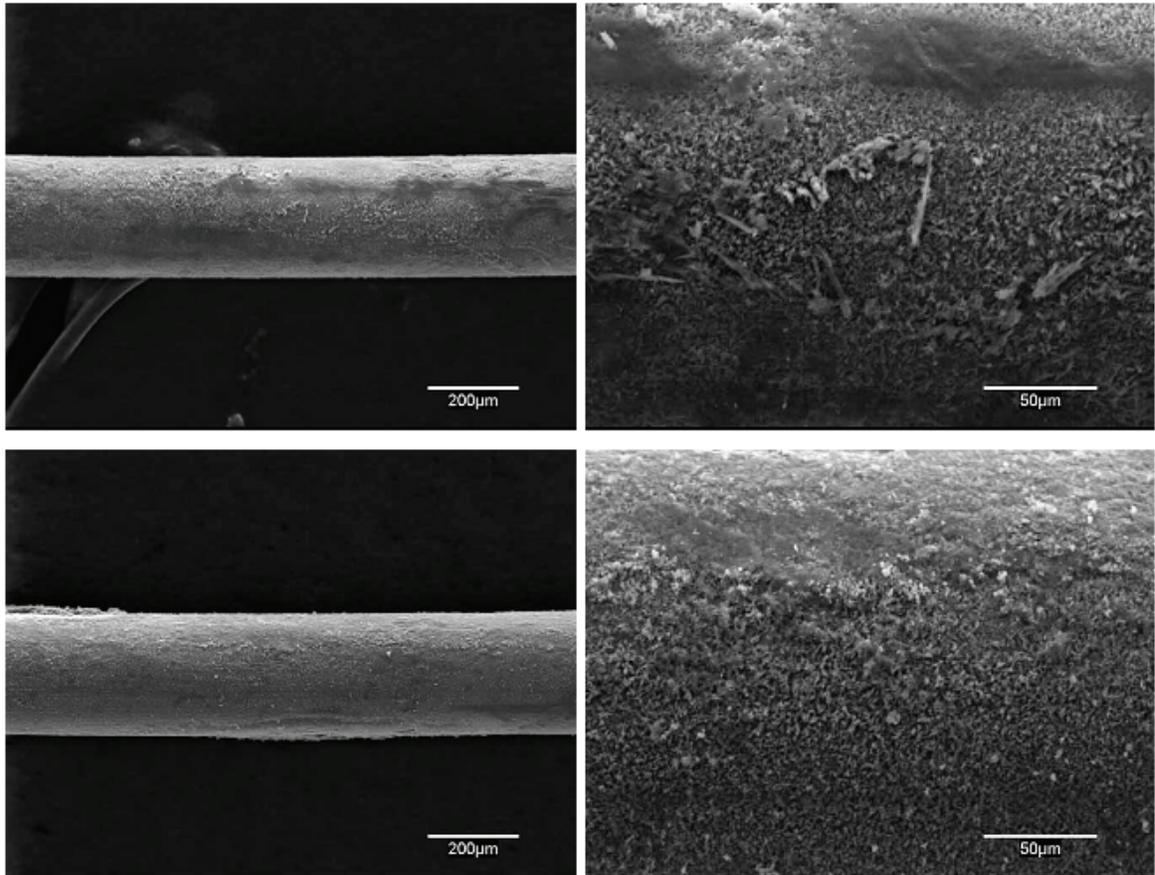
Figure 39a shows the SEM images of Sample 7 – 0.5M NaCl coated wires, exposed to 75% RH and 50°C for ~ 370 hours. Samples rinsed after anoxic testing with a salt coating showed significant development of corrosion products compared with their condition before exposure, consistent with the amount of metal oxidized as deduced from hydrogen pressure increase. Large oxygen peaks are shown in EDX spectra, Figure 39b.

Figure 39 a: SEM images of Sample 7 - 0.5M NaCl coated wires, 50°C, 75% RH

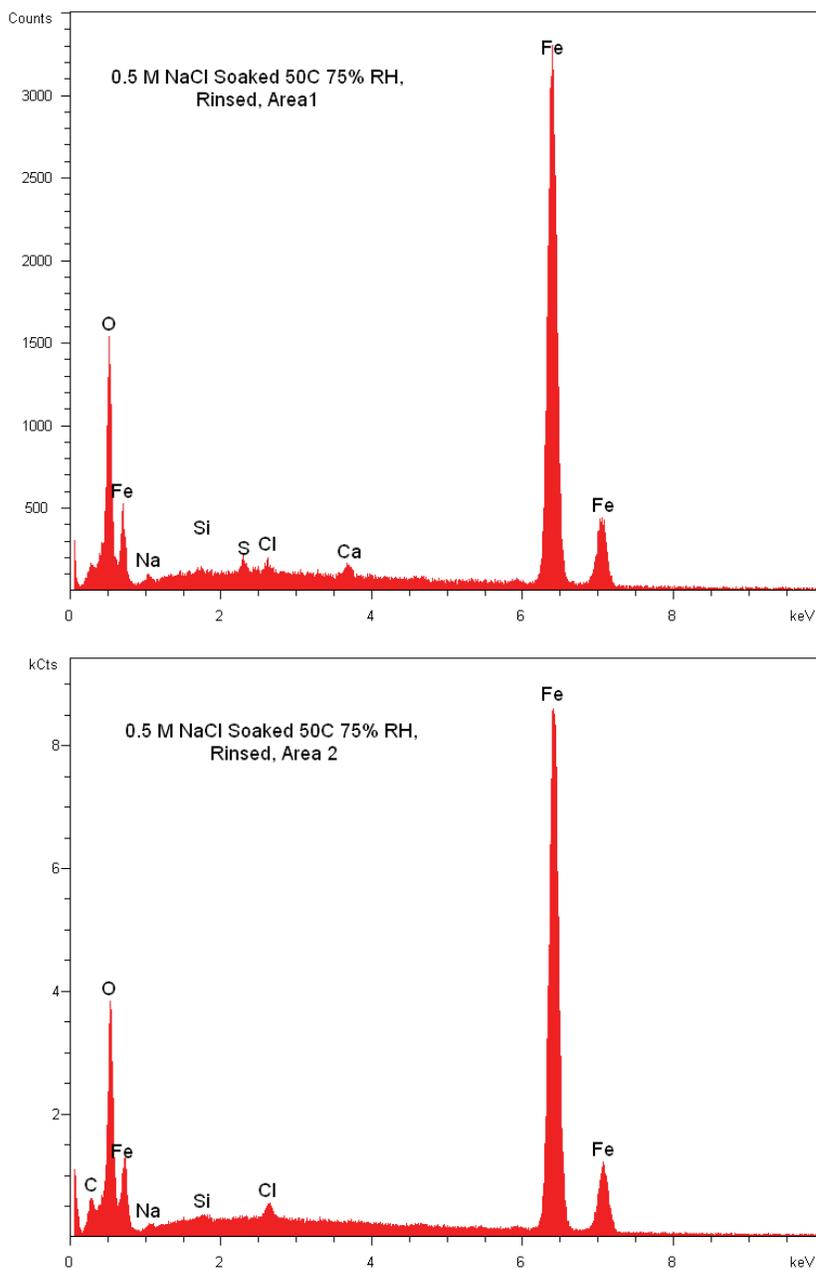
EDX results in weight percent								
Analysis	C	O	Na	Si	S	Cl	Ca	Fe
Analysis 1		33.5	1.1	0.2	0.4	0.4	0.5	64.0
Analysis 2	14.4	35.1	0.4	0.1		0.4		49.5

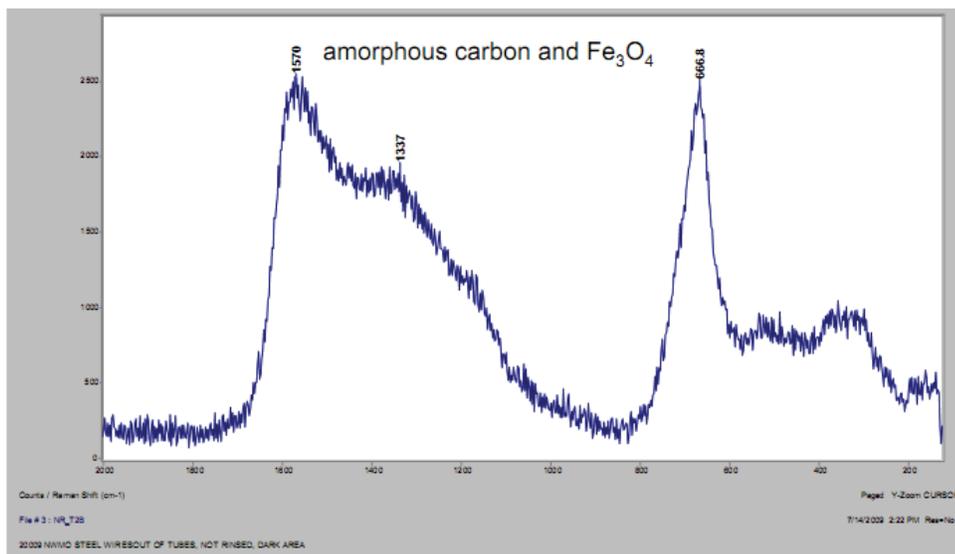
wires were analyzed. All spectra show the most common species observed were Fe_2O_3 and Fe_3O_4 . Three areas analyzed showed amorphous carbon.

Figure 40 a: Raman spectrum of Sample 6 - 0.5M NaCl coated wires, 50°C, 75% RH (no rinse)

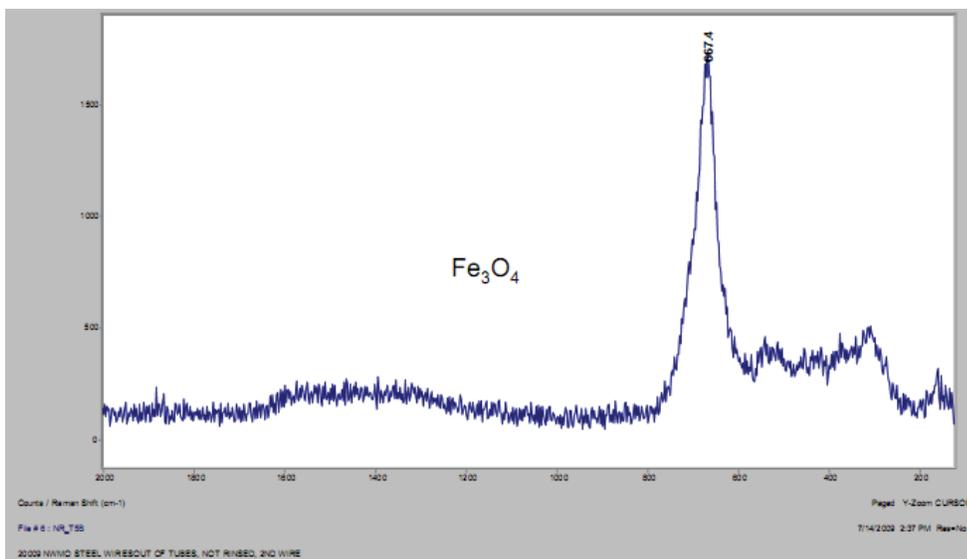
Figure 40 b: Raman spectrum of Sample 6 - 0.5M NaCl coated wires, 50°C, 75%RH

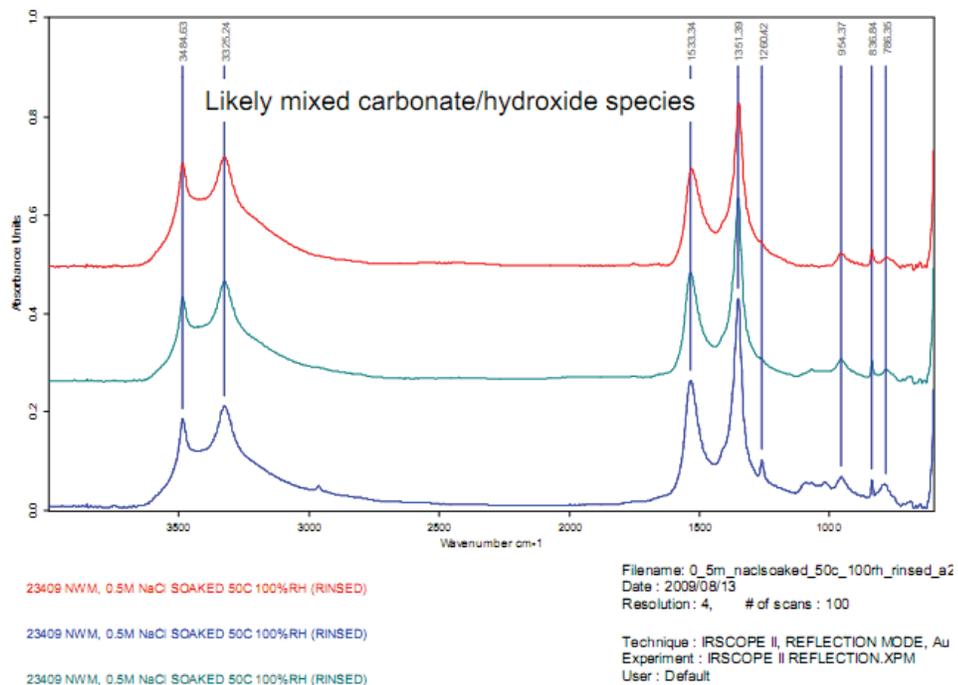
FTIR gave useful information on the thicker films formed on salt-coated samples. As shown in Figure 41, FTIR indicated the likely presence of a mixed carbonate / hydroxide species on the surface.

Figure 41: FTIR spectrum of Sample 10 – 0.5M NaCl coated wires, 100% RH, 50°C (rinsed)

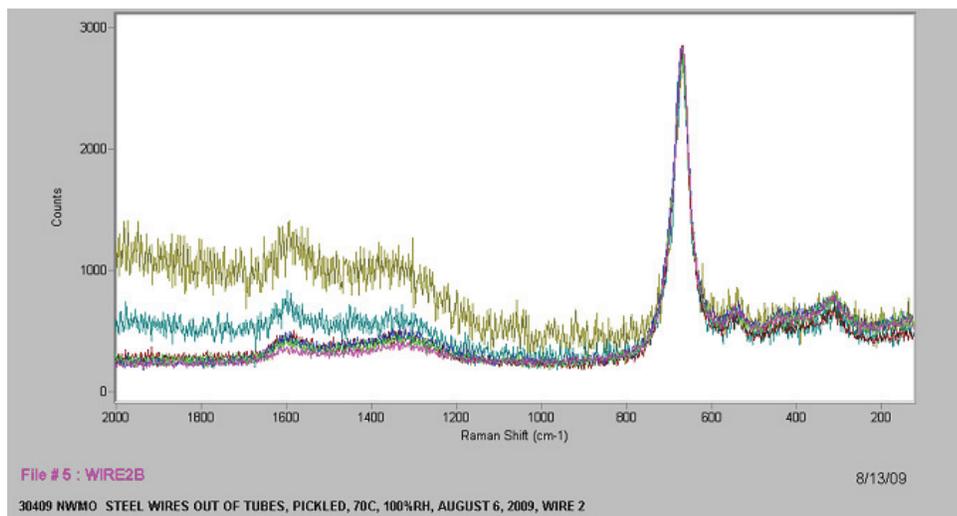
Films formed at higher temperatures in anoxic conditions without a salt coating showed very well-resolved magnetite Raman spectrum – Figure 42a. A total of six (6) areas were analysed and all analyzed areas overlay nicely which showed significant consistency between the spectra. All spectra indicate the presence of Fe_3O_4 with some contribution from amorphous carbon. The six (6) spectra were averaged and the averaged spectrum is shown in Figure 42b, which clearly shows the dominance of magnetite.

Figure 42 a: Raman spectrum of Sample 11 - pickled wires, 70°C, 100% RH

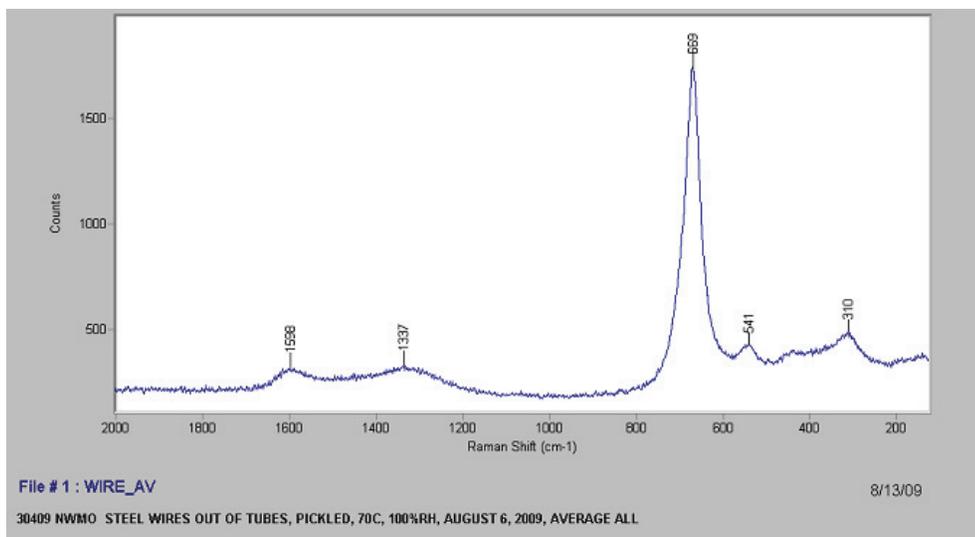
Figure 42 b: Raman spectrum (average) of Sample 11 - pickled wires, 70°C, 100% RH

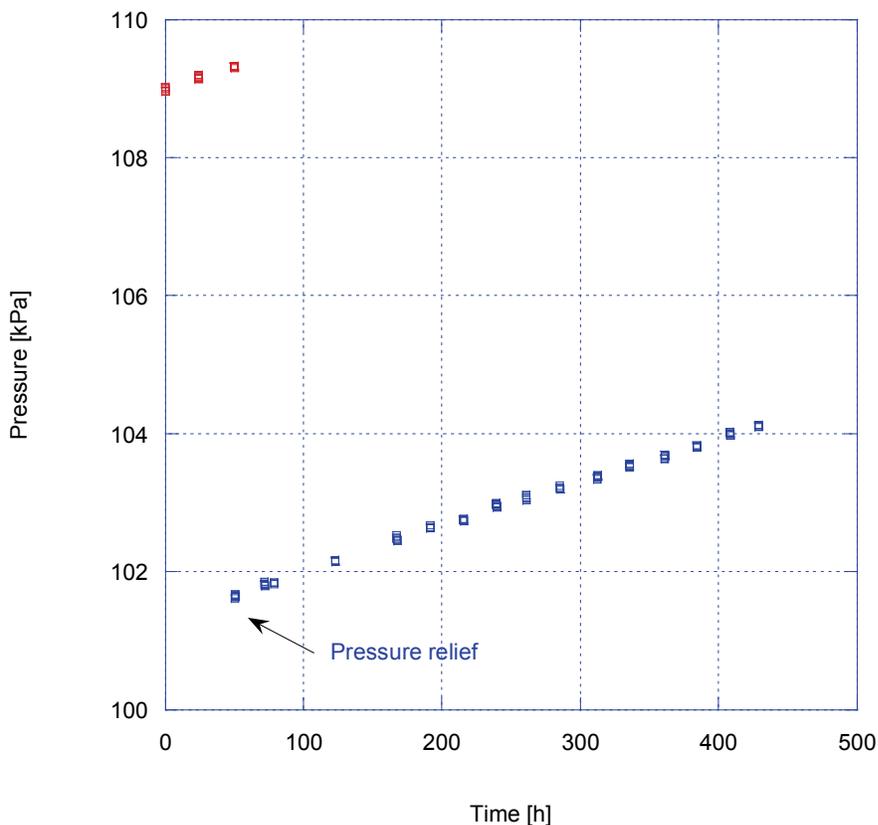
Figure A1 Leak Test (I)

Note: steady pressure increase observed in the first leak test which was likely caused by unsteady temperature control. To improve temperature control, the water bath was covered with foam board to reduce evaporation and additional leak tests were performed to verify the suspected error.

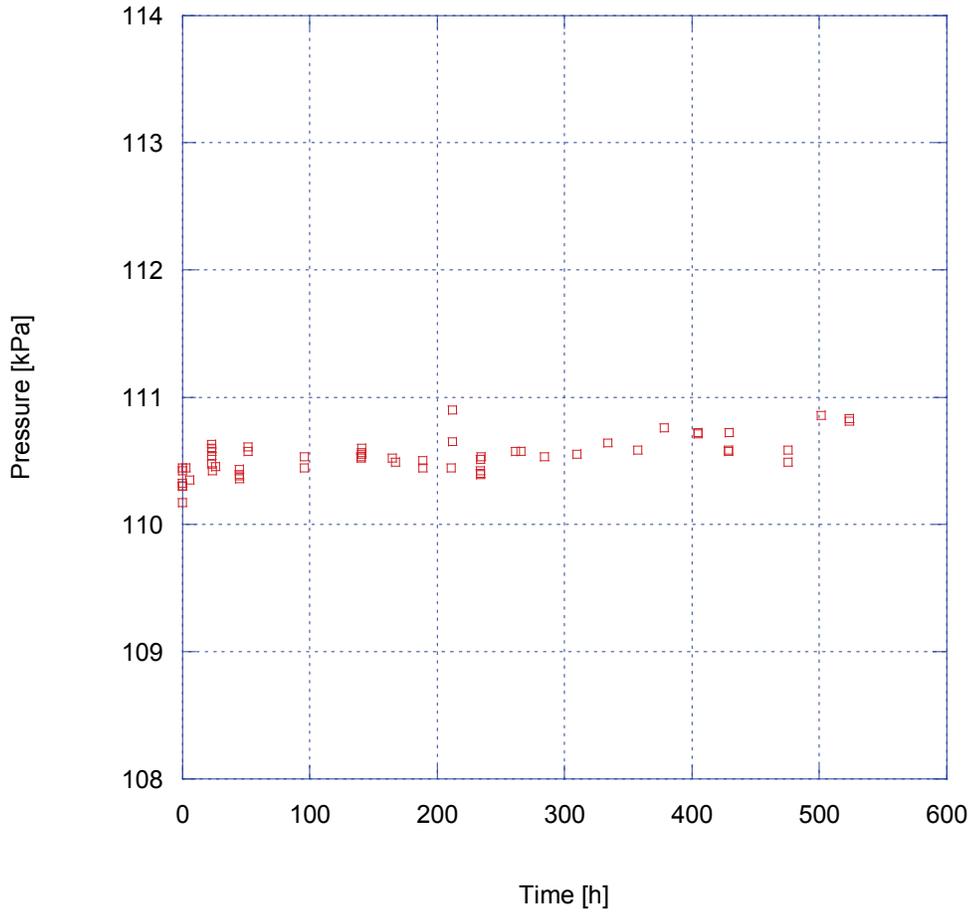
Figure A2 Leak Test (II)

Note: Relatively stable pressure indications were obtained in the second leak test, suggesting proper sealing and air tightness of the glass cell.

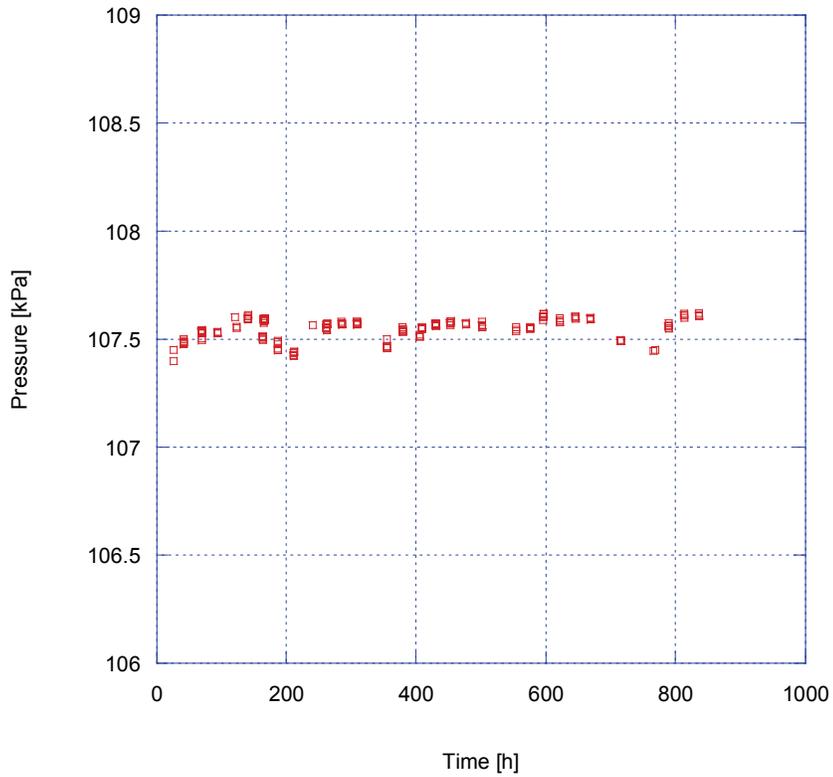
Figure A3 Leak Test (III)

Note: Similar to leak test (II), pressure was stable for over 800 hours, confirming the glass cell was sealed and gas leak tight.

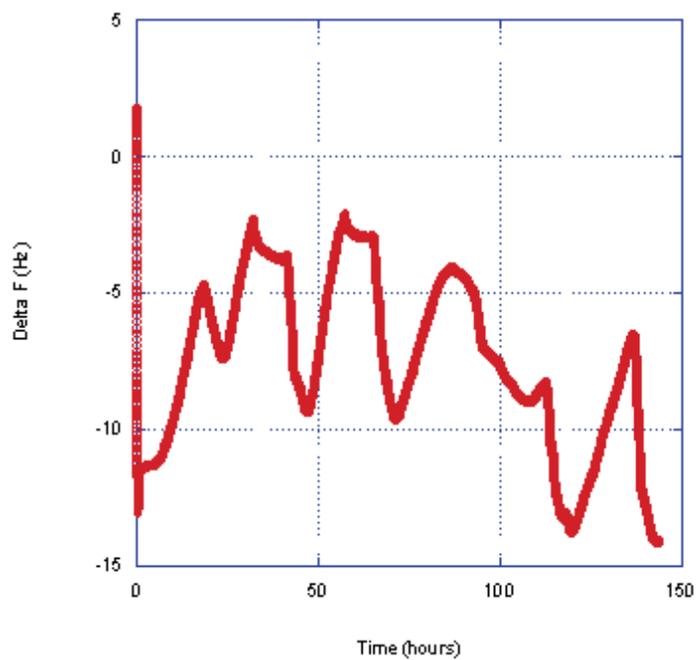
It turns out that for a corrosion rate of ca. $0.01 \mu\text{m} \cdot \text{y}^{-1}$, the QCM is adequately sensitive if well calibrated, but (omitting the details of many tedious investigations) has a day-to-day drift, especially in humid conditions, that swamps the signal from the corrosion reaction, far beyond any possible effect (1 Hz or so) of temperature fluctuation – Figure C1.

Figure C1: Change of the frequency of the crystal without any deposit in an environment of 100% RH at 30°C
