# PHASE 2 INITIAL BOREHOLE DRILLING AND TESTING, IGNACE AREA

*Completion of Demobilization and Decommissioning  
activities at IG\_BH01 Test Site, Ignace, ON*

**APM-REP-01332-0228**

### COMPLETION OF DEMOBILIZATION AND DECOMMISSIONING ACTIVITIES AT IG\_BH01 TEST SITE, IGNACE, ON

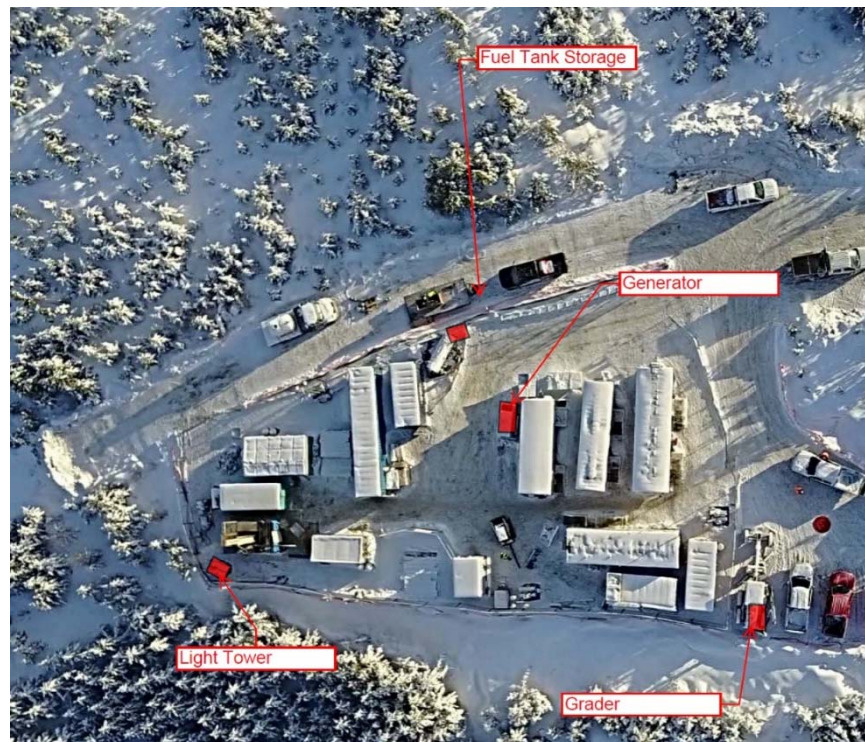
**Figure 1: Location of four areas where hydrocarbon stained fill was removed on March 16, 2018**

Following demobilization of equipment and facilities at IG\_BH01, hydrocarbon staining was observed at four locations shown on Figure 1: the fuel storage tank area, main site generator, northwest light tower, and the grader parking area.

The staining at the fuel tank, generator and light tower were the result of the inadvertent release of small amounts of diesel to the ground during fuel handling. The staining in the grader parking area is presumed to be related to a small oil leak from the grader which was parked on site and used to clear snow from the roadways over the winter. The leak is assumed to be related to the loss of brake fluid, which was documented to have occurred on January 7, 2017. Because of the small volumes of these leaks (< 1L), they were not classified as reportable spills.

The fill removal was carried out under Golder supervision by Ricci's Trucking (Ricci), who were under contract to Rodren Drilling, using a track-mounted John Deere 2454D excavator. Approximately 5.7 m<sup>3</sup> of stained fill material in total was removed from the four locations and placed directly into lined soil storage totes. Details of the areas excavated, fill volume removed, and confirmatory samples taken for each area are summarized below, and are illustrated in Appendix A – Remedial Excavation Diagrams. The center of each excavation was surveyed using a Leica Viva GNSS, which was operated by Altus Geomatics on March 15, 2018.

The impacted fill in each area was excavated and removed until there was no visual indication of PHC remaining at that location. Following the removal of stained fill materials, a series confirmatory fill samples were collected from the base of each area, as noted in Table 1, and field screened for PHC vapours to help assess whether the PHC impacts had been removed.

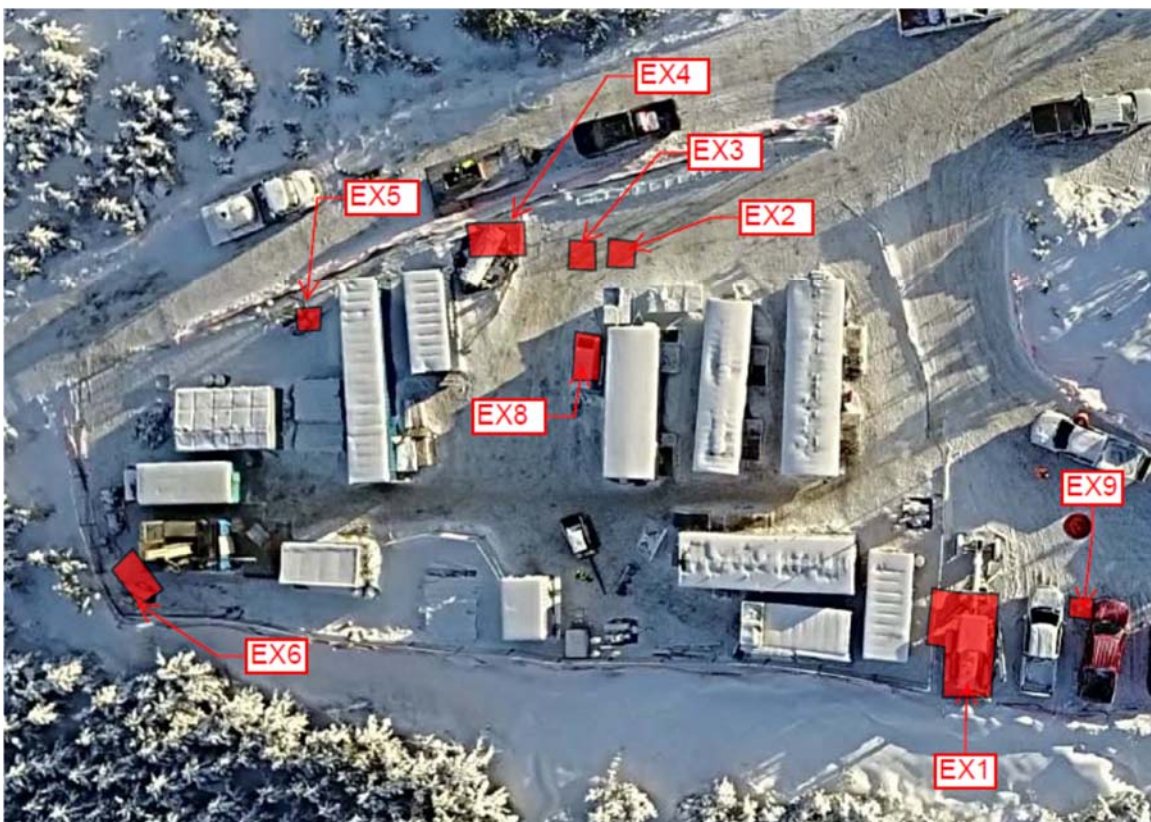
During the site walk-over by Golder and NWMO, residual staining of the surface fill was observed at nine locations, some of which were initially identified and excavated in March 2018, and some of which were not observed in March due to the snow and ice cover at surface.

These locations (EX1 to EX9) are shown on Figure 2 (below) and are described as follows.

- The staining at location EX1 was located in the same area as the previous excavation beneath the grader parking area and is presumed to be related to the same small oil leak that led to the March 2018 excavation.
- The staining at locations EX2 through EX8 are presumed to be the result of fueling activities for diesel powered equipment used during the drilling and testing program. Diesel powered equipment on site included light towers, generators, the drill rig, diesel fueled heaters, and one skid steer.
- The footprint of EX7 expanded into EX6, and all sample names were labelled as EX6 thereafter. The staining was located in the fueling areas of one light tower, and of the drill rig.
- The discolouration of fill at location EX9 may have been the result of organic rich fill materials and was removed and sampled as a precautionary measure.

**Figure 2: Location of the areas at the IG\_BH01 drill site where PHC stained fill was observed and removed on May 23, 2018**

The fill removal was carried out under Golder supervision by Ricci Trucking (Ricci), who were under contract to Rodren Drilling, using a track-mounted Hyundai 60CR-9R excavator. The centre of each excavation was geospatially located using a handheld Garmin GPSMap 60CSx, which had 3m location accuracy on the day of sampling.

An estimated 8.1 m<sup>3</sup> of stained fill material was removed from the locations listed below and placed directly into a tri-axle dump truck owned by Ricci's. The stained fill material was taken to the Township of Ignace waste disposal

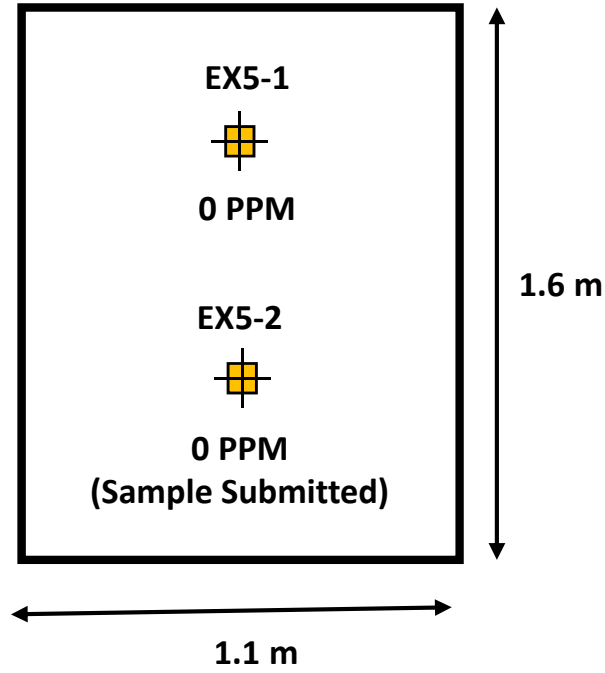
**FIGURE A-9**  
**Schematic of EX5 - Location of Confirmatory Fill Samples**  
**May 23, 2018**
