PHASE 2 INITIAL BOREHOLE DRILLING AND TESTING, IGNACE AREA

*WP01 Site Demobilization Report – Site
Infrastructure for IG_BH03*

APM-REP-01332-0262

November 2020

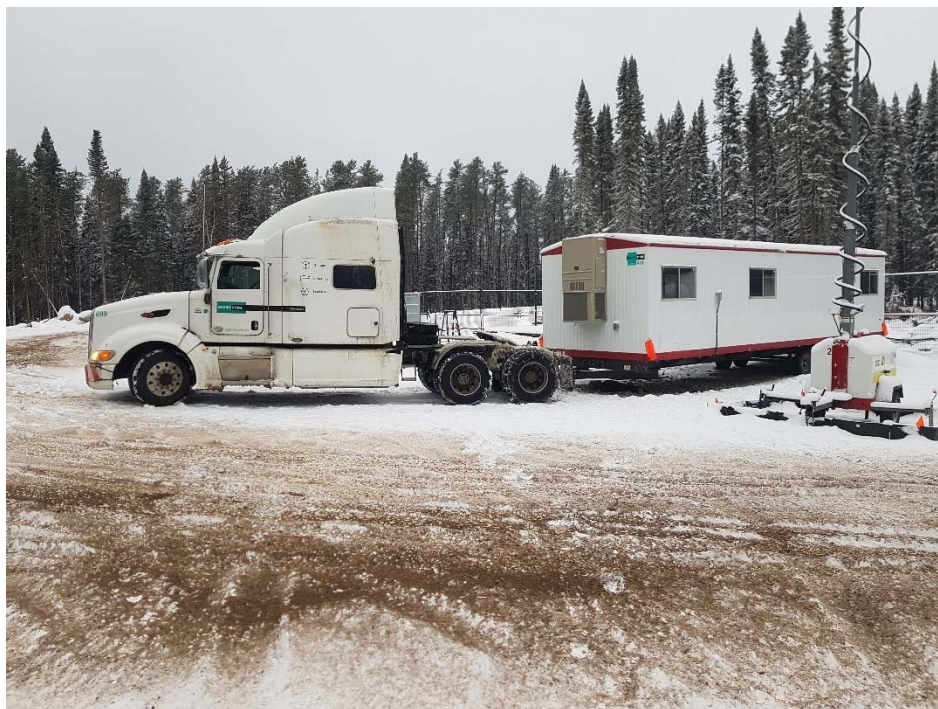
Photo 2: Facing West towards the Golder office trailer being removed from the north side of the site, November 26, 2019.

Three mobile office trailers were located on the north side of site for use as field offices for Golder, the NWMO, and Rodren. The three office trailers were removed by SecureStore (a Taranis subcontractor) on November 26, 2019, and were transported to their facility in Shuniah, Ontario. A photo of the Golder office trailer being removed is shown in Appendix A (Photo 2).

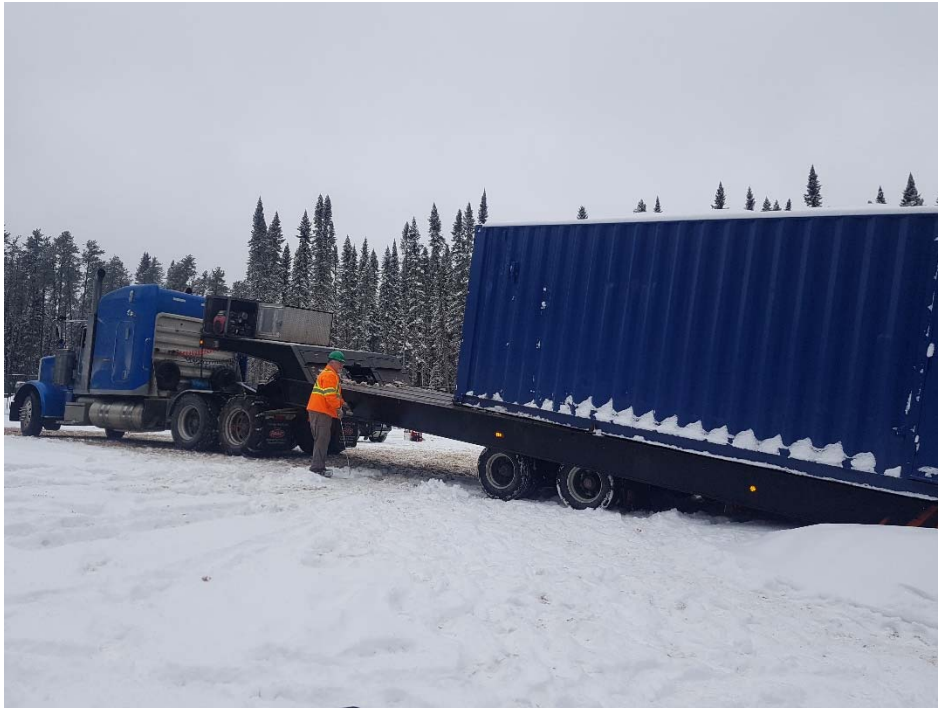
Photo 3: Facing northeast towards the core storage seacan as it is being removed, November 26, 2019.

Two 12 m long modified shipping containers (seacans) were located at the southeast corner of site near the drill rig for use as work areas during WP02 through WP09. Upon completion of drilling and testing at IG_BH03, the two seacans were removed by SecureStore on November 26, 2019, and transported to their facility in Shuniah, Ontario. A photo of the core storage seacan being removed is shown in Appendix A (Photo 3).

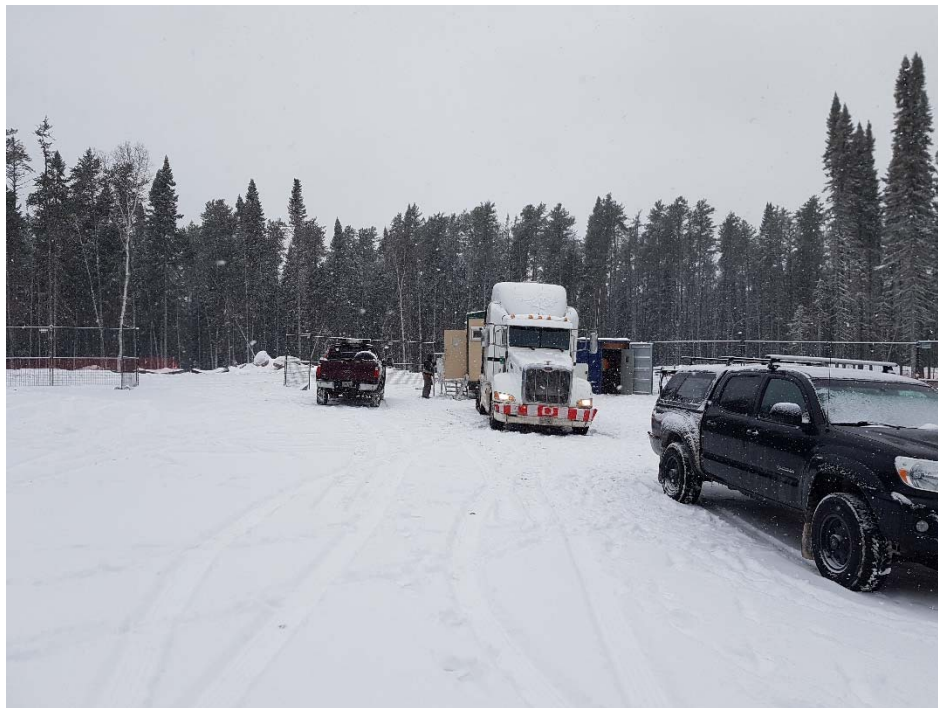
Photo 4: Facing west towards the washcart as it is being removed, November 26, 2019.

The site washroom system consisted of three separate structures. The heated / insulated washcart was divided into men's and women's sections with separate entrances. Wastewater from the washcart flowed into the exterior 6,000 L septic tank located directly west of the washcart. Fresh water was supplied from a heated seacan containing a water storage tank. The washcart, wastewater tank and freshwater seacan were removed by SecureStore on November 26, 2019. A photo of the washcart removal is shown in Appendix A (Photo 4).

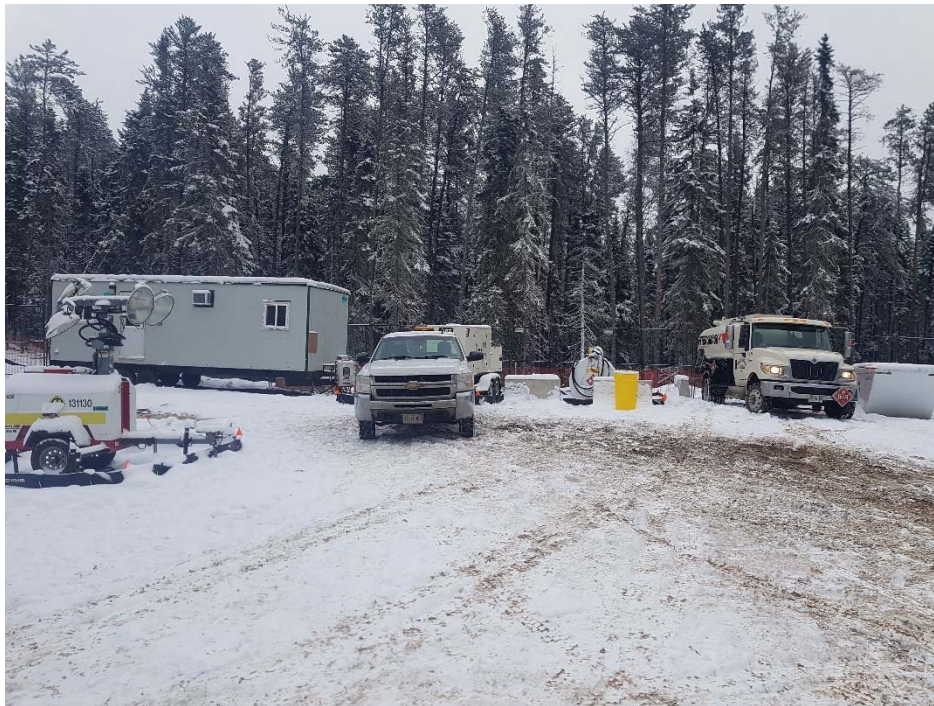
Photo 5: Facing East towards the generator and fuel storage tank. The fuel storage tank is being emptied prior to removal, November 26, 2019.

On November 26, 2019 the generator, fuel storage tank, and protective barricades were removed from site and taken by Taranis to their facility in Thunder Bay, Ontario. The secondary containment berms were folded up and transported to IG_BH02 for additional spill protection capacity. The fibre matting and concrete pads were discarded as non-hazardous waste. A photo showing the generator removal and emptying of the fuel tank prior to removal is shown in Appendix A (Photo 5).

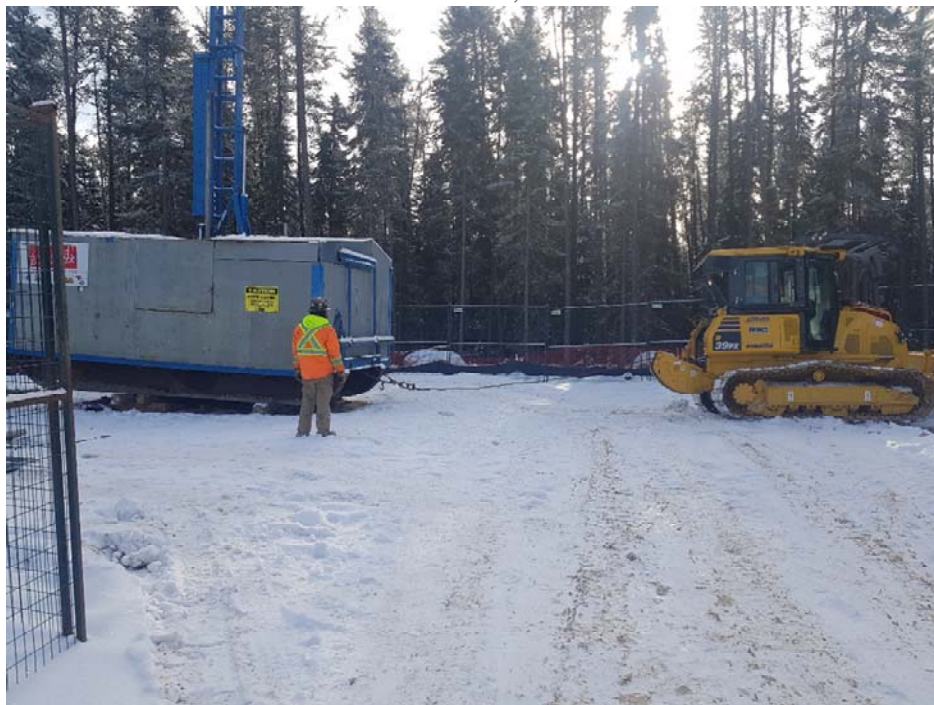
Photo 6: Facing south towards the workover rig as it is removed from the IG_BH03 drill pad, and moved to the IG_BH02 drill pad, November 30, 2019.

The Rodren workover rig was removed on November 29, 2019 and transported directly to IG_BH02 for use at that location. Beneath the workover rig was a secondary containment system with a central sump which captured any drill fluid spills that could potentially occur in the drill rig or drill fluid circulation system. Rig matting was placed over top of the central sump system, to provide a level and solid foundation for the drill rig infrastructure. The rig matting and secondary containment system was removed on November 30, 2019, and transported to Rodren's facility in Winnipeg, Manitoba. A photo of the workover rig removal is shown in Appendix A (Photo 6).

No evidence of staining was observed beneath the workover rig or secondary containment system during removal. Approximately 3 m³ of pit run aggregate was later brought to site by Ricci on July 7, 2020 and used to backfill and level the sump area around the borehole.

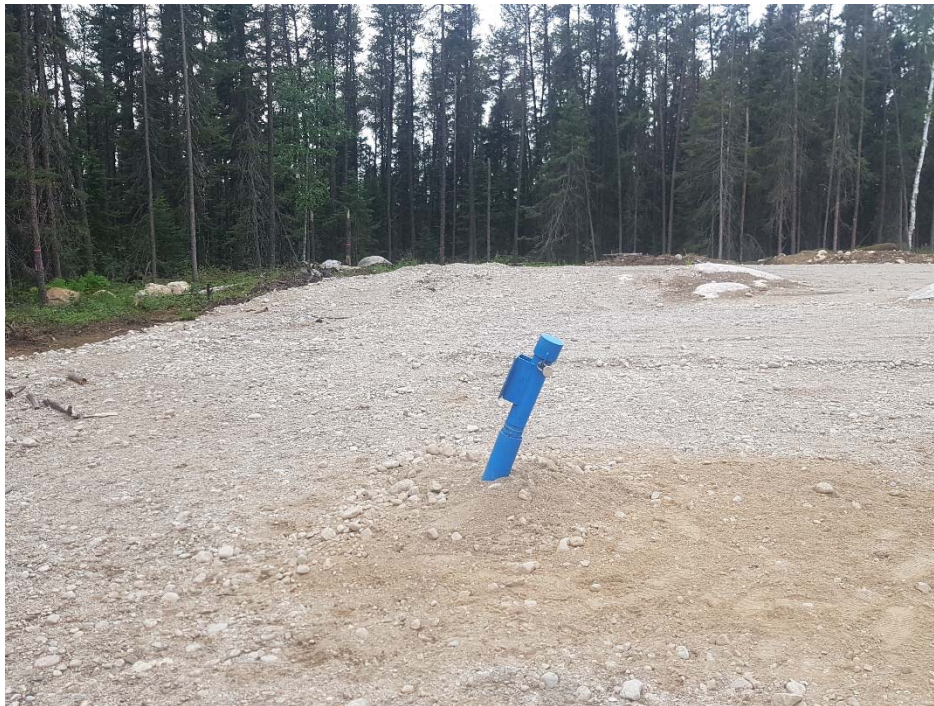
Photo 7: Facing east towards IG_BH03 with locking protective casing and monopod bracket, and backfilled drilling sump, July 7, 2020.

A locking protective casing was custom fabricated and installed at the IG_BH03 well head. The protective casing included a monopod bracket to allow for mounting of a Westbay monopod during future testing programs, to access the Westbay MP-38 monitoring system. The protective casing was installed on December 10, 2019 as shown in Appendix A (Photo 7). A final as-built survey of the borehole was performed by Rugged Geomatics Inc. on January 14, 2020, after the protective casing was installed.

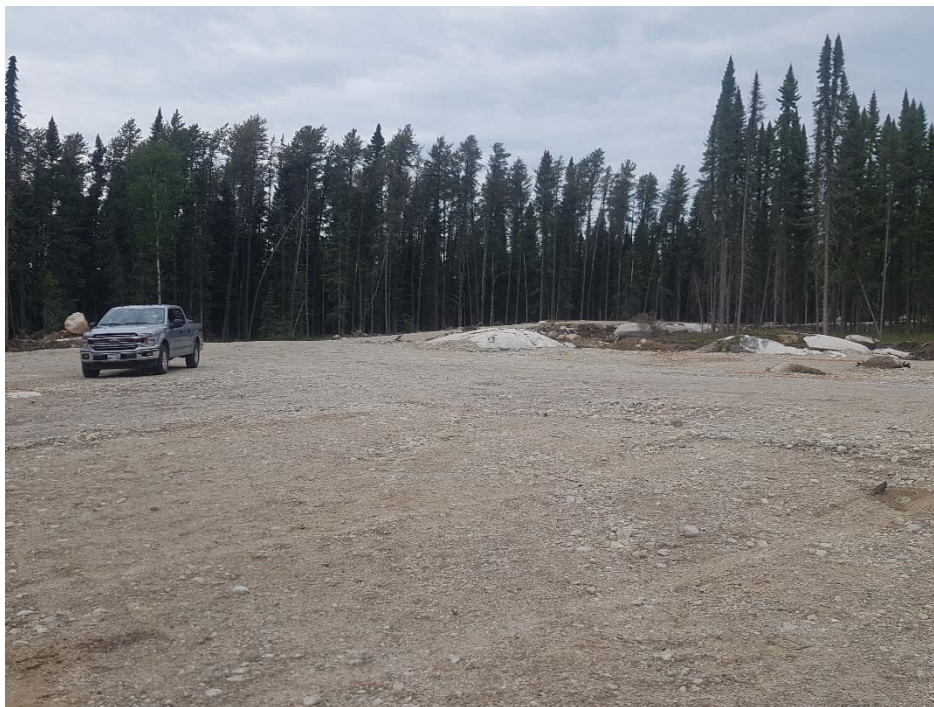
Photo 4: Facing northwest at IG_BH03 during the final site walkover performed, July 8, 2020.

Following completion of all site demobilization and decommissioning activities, a site walkover inspection was performed by Golder on July 8, 2020 accompanied by an NWMO representative. The objective of the inspection was to check for the presence of any remaining stained soils or litter which may still be present but had been obscured by the snow during the initial demobilization in December 2019. A grid pattern was walked across the entire site and it was visually confirmed that there was no remaining soil staining or litter at the site.

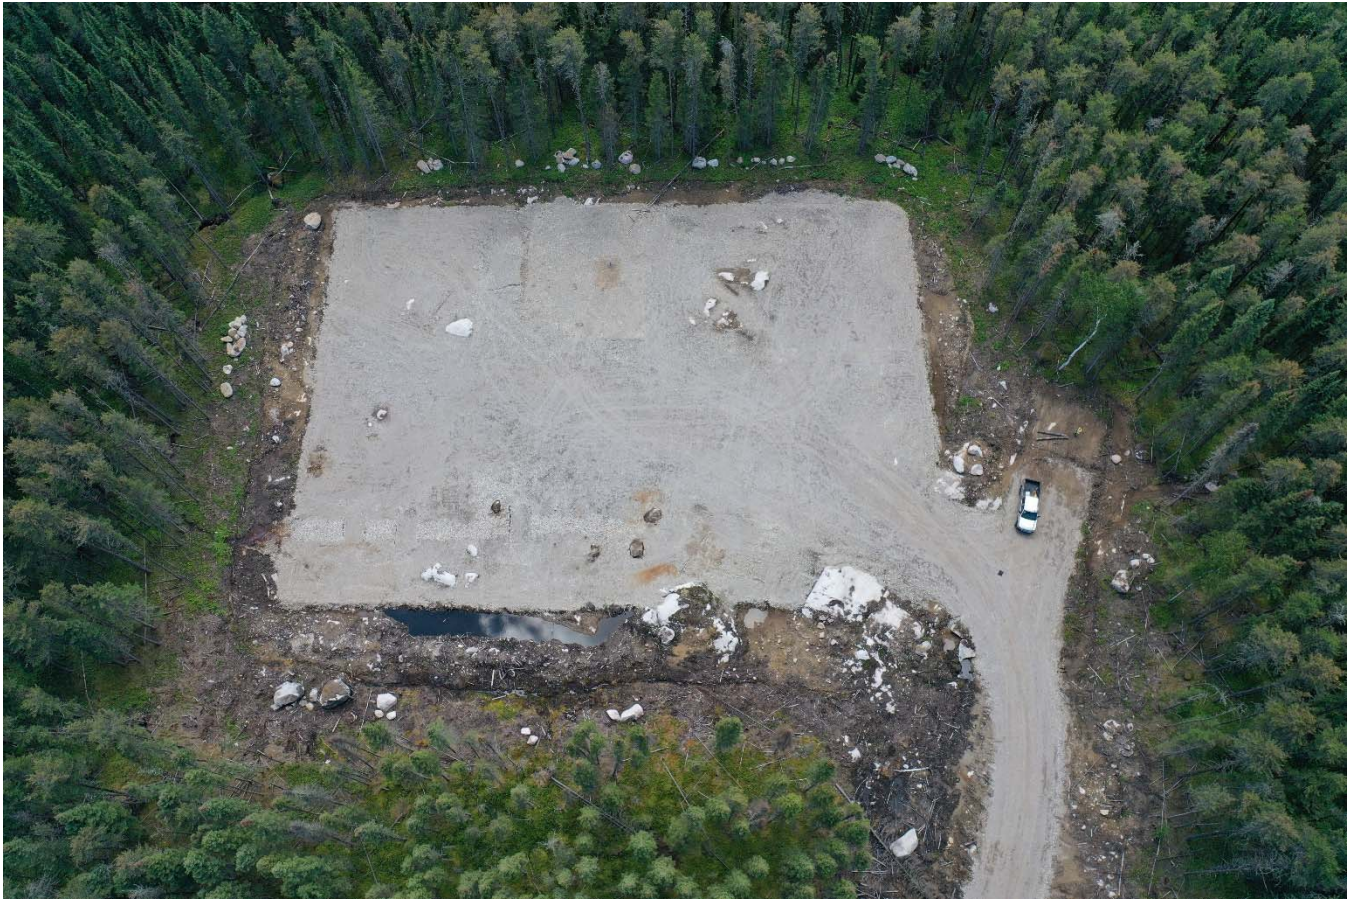
Photo 9: Aerial drone photo of the IG_BH03 site (facing south) following demobilization. Photo was taken in July 2020. Discolorations visible in the gravel fill were caused by recent digging to remove underground infrastructure.

The completion of demobilization and decommissioning activities was documented as they took place and the results recorded on a site decommissioning checklist. The checklist was signed off by Golder representatives upon completion and is provided in Appendix C. A photo of the IG_BH03 drill site taken on July 8, 2020 upon completion of demobilization and decommissioning is provided in Appendix A (Photo 8). An aerial photo of the IG_BH03 drill site taken after Golder's July 8, 2020 departure is provided in Appendix A (Photo 9).

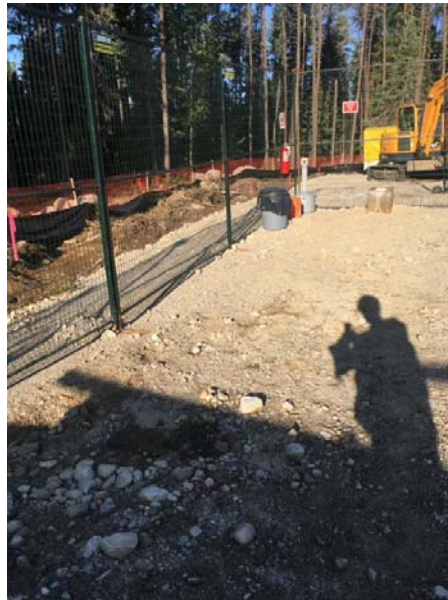
The source of the spill was leakage from a skid steer machine owned and operated by Rodren Drilling Inc. (Rodren) and was first noticed in July 2019 in the area where the skid steer was parked (see Figure 1). The excavation of the impacted soils was carried out by Ricci's Trucking Inc. ("Ricci") with support from Rodren, under the direction of the Golder Site Supervisor, who was also responsible for directing and documenting remedial activities, and collecting samples for laboratory analysis.

Photo 1 – General view of the skid steer parking location area and stained soil, facing west.

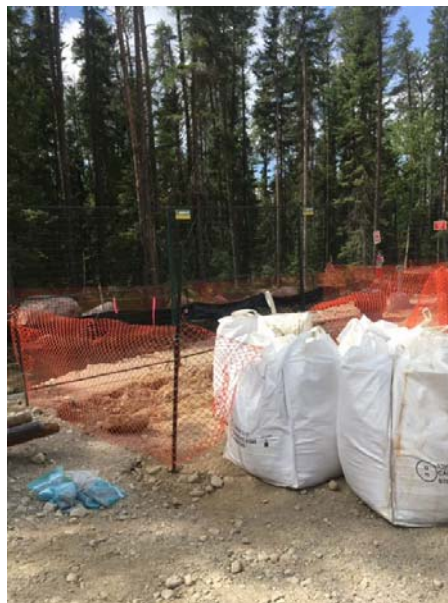
Photo 2 – View of the initial excavation and impacted soil stored in soil bags

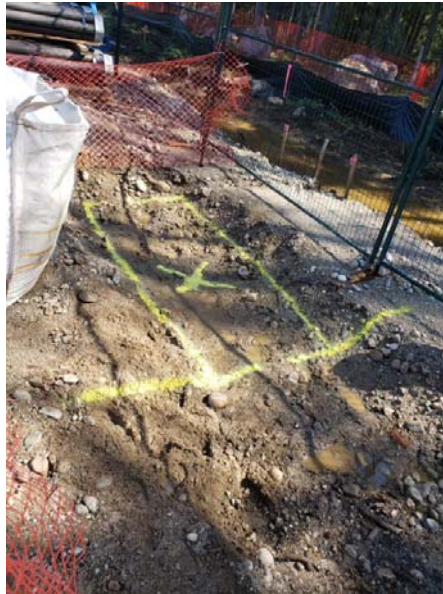
Photo 3 – View of follow-up excavation dig area prior to digging

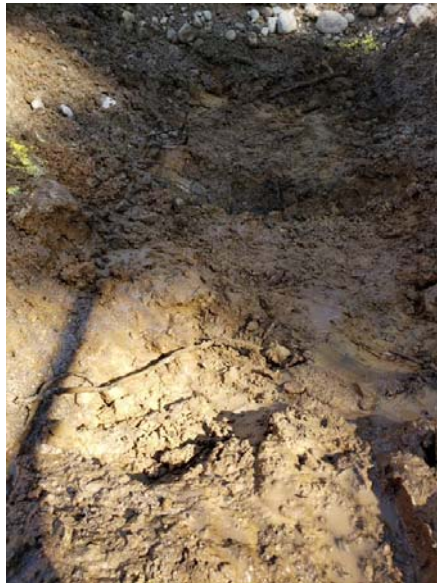
Photo 4 – View of the completed follow-up excavation
