PHASE 2 INITIAL BOREHOLE DRILLING AND TESTING, IGNACE AREA

WP01 Site Demobilization Report – Site Infrastructure for IG_BH02

APM-REP-01332-0264

December 2020

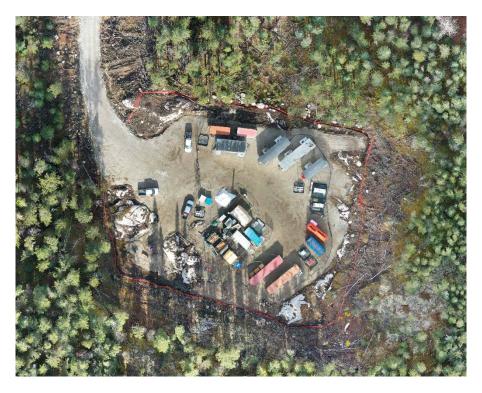
Photo 1: Aerial drone photo of the commissioned IG_BH02 site, taken in November 2019.

This report describes the site infrastructure demobilization and site decommissioning activities that took place at IG_BH02 in January and July 2020. An aerial photo of the IG_BH02 site while in operation during in November 2019 is provided in Appendix A (Photo 1).

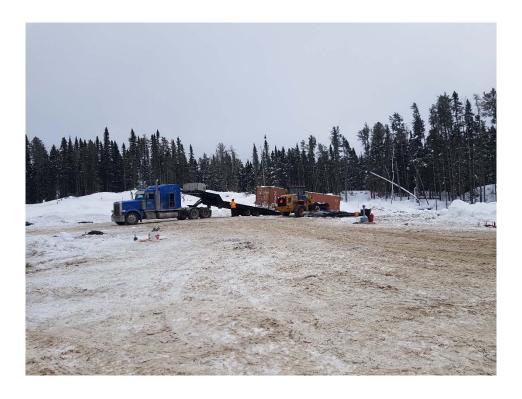
Photo 2: Facing southeast towards the core storage seacan as it is being removed on January 30, 2020.

Two 12 m long modified shipping containers (seacans) were located at the southeast corner of site near the drill rig for use as work areas during WP02 through WP09. Upon completion of drilling and testing at IG_BH02, the two seacans were removed by Secure Store on January 30, 2020, and transported to their facility in Shuniah, Ontario. A photo of the core storage seacan being removed is shown in Appendix A (Photo 2).

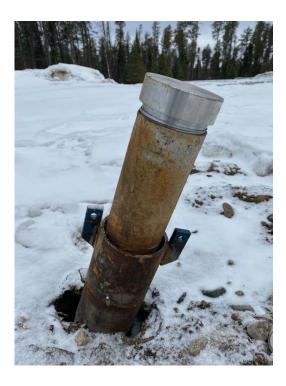
Photo 3: Facing west towards the aluminum plug fabricated to temporarily seal the top of the IG_BH02 borehole casing.

The plug was installed on March 18, 2020

A final as-built survey of the borehole was performed by Rugged Geomatics Inc. on January 31, 2020, after the workover rig was removed. An aluminum plug and a locking protective casing was custom fabricated and installed at the IG_BH02 borehole collar on March 18, 2020. The aluminum plug is shown in Photo 3, and the protective casing is shown in Photo 4 of Appendix A.

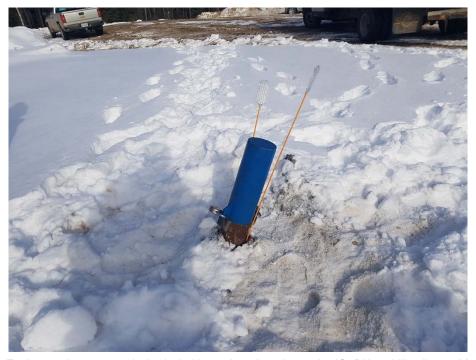
Photo 4: Facing northeast towards the lockable casing placed over the IG_BH02 drill collar on March 18, 2020.

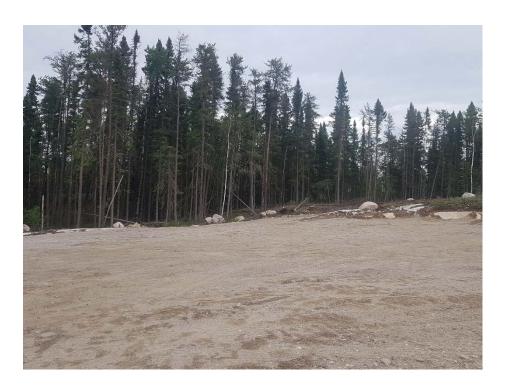
Photo 5: Facing Northeast towards where the IG_BH02 office trailers and main site generator were placed, during the final site walkover on July 8, 2020.

Following completion of all site demobilization and decommissioning activities, a site walkover inspection was performed by Golder on July 9, 2020 accompanied by an NWMO representative. The objective of the inspection was to check for the presence of any remaining stained soils or litter which may still be present but had been obscured by the snow during the initial demobilization in January 2020. A grid pattern was walked across the entire site and it was visually confirmed that there was no remaining soil staining or litter at the site.

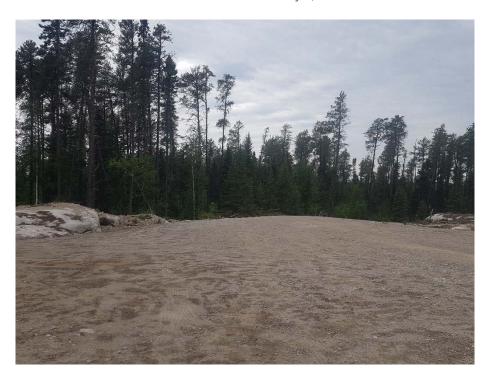
Photo 6: Facing northwest towards the parking area for IG_BH02 during the final site walkover performed, July 8, 2020.

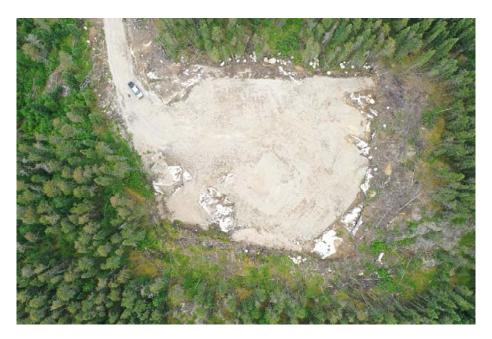
Photo 7: Aerial drone photo of the IG_BH02 site following the July 2020 demobilization.

The completion of demobilization and decommissioning activities was documented as they took place and the results recorded on a site decommissioning checklist. The checklist was signed off by Golder representatives upon completion and is provided in Appendix C. Photos of the IG_BH02 drill site taken on July 8, 2020 upon completion of demobilization and decommissioning are provided in Appendix A (Photos 5 and 6). An aerial photo of the IG_BH02 drill site taken after Golder's July 8, 2020 departure is provided in Appendix A (Photo 7).
