PHASE 2 INITIAL BOREHOLE DRILLING AND TESTING AT IG_BH04/05/06 - IGNACE AREA

*WP01 Commissioning Report - Site Infrastructure
Setup for IG_BH05*

APM-REP-01332-0294

September 2021

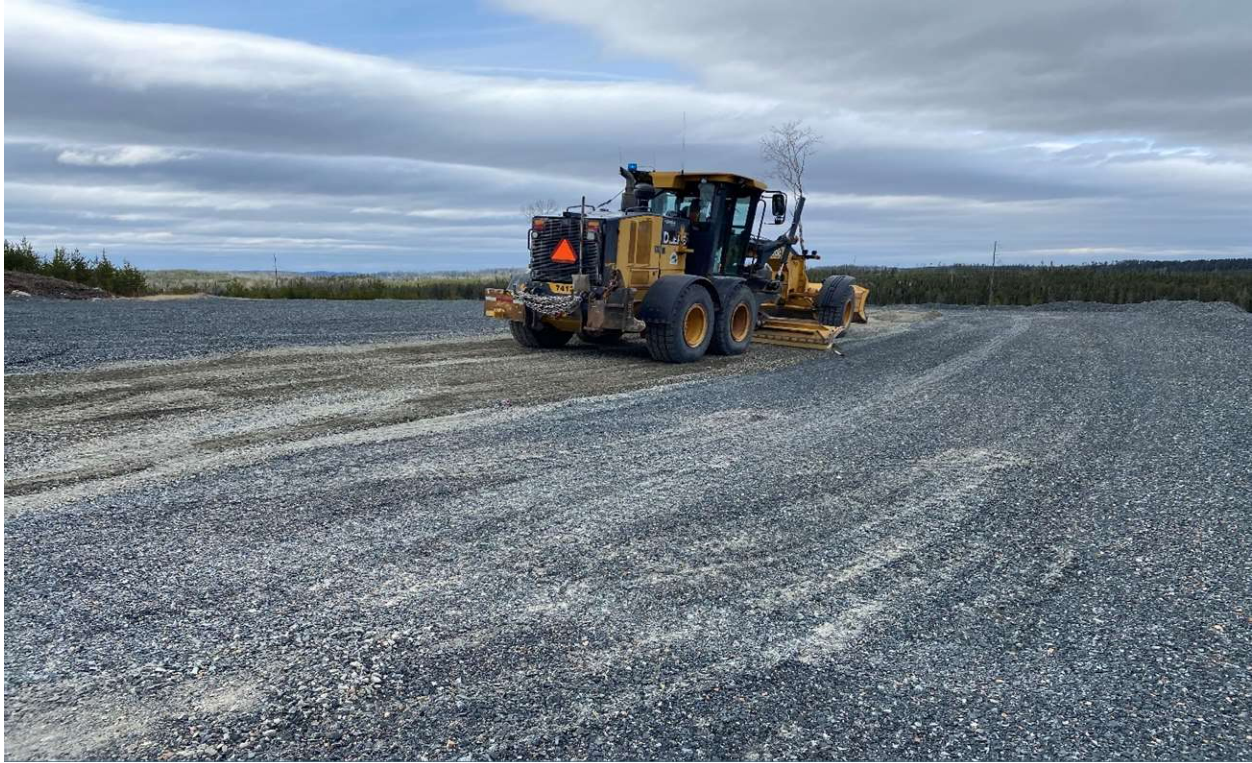
On April 23, 2021, Ricci's Trucking graded out the 0.3 m ledge surrounding the drill pad area at a slope of 10:1. (Appendix B, Photo 1). The work was conducted as a scope change to the project under Golder supervision.

Photo 1 - Grading out the edge of the drilling pad for easy access and setup

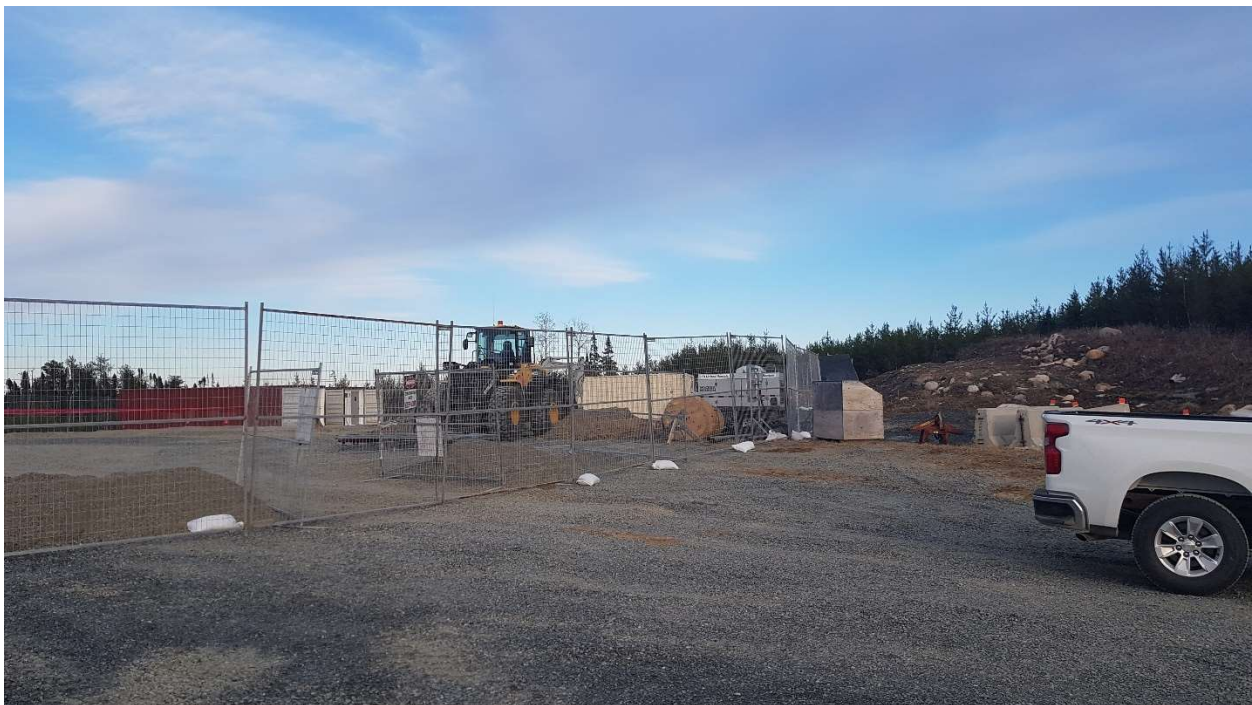
Approximately 220 m (704') of 2.1 m (8") tall fencing was installed around the perimeter of the site to define the work area, provide security, and to discourage wildlife from entering the site. A lockable gate was installed on the west side of the site, to allow worker access to the site from the parking lot. (Appendix B, Photo 2).

Photo 2 – 2.1 m Tall site security fence with lockable gate

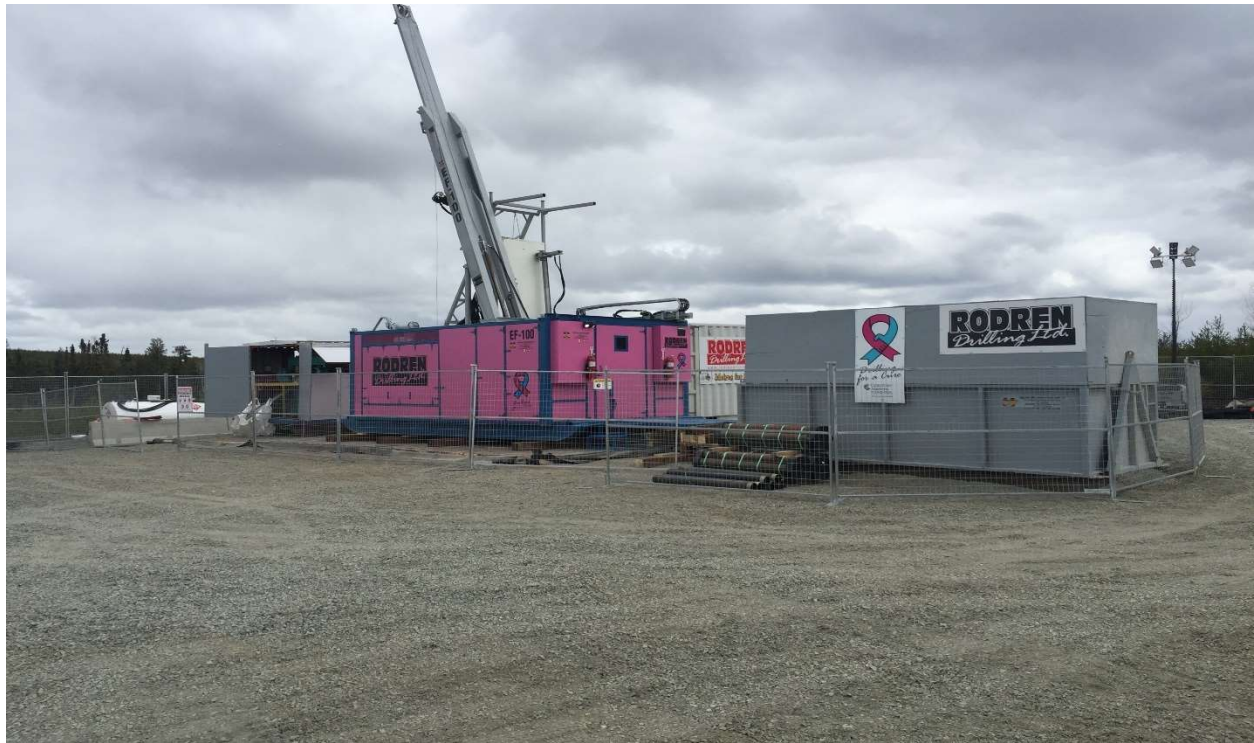
In addition to the perimeter fencing, approximately 70 m (230') of 1.8 m (6") tall fencing was installed around the drill rig area to define an exclusion zone. (Appendix B, Photo 3).

photo 3 - 1.8 m Tall drilling zone fence

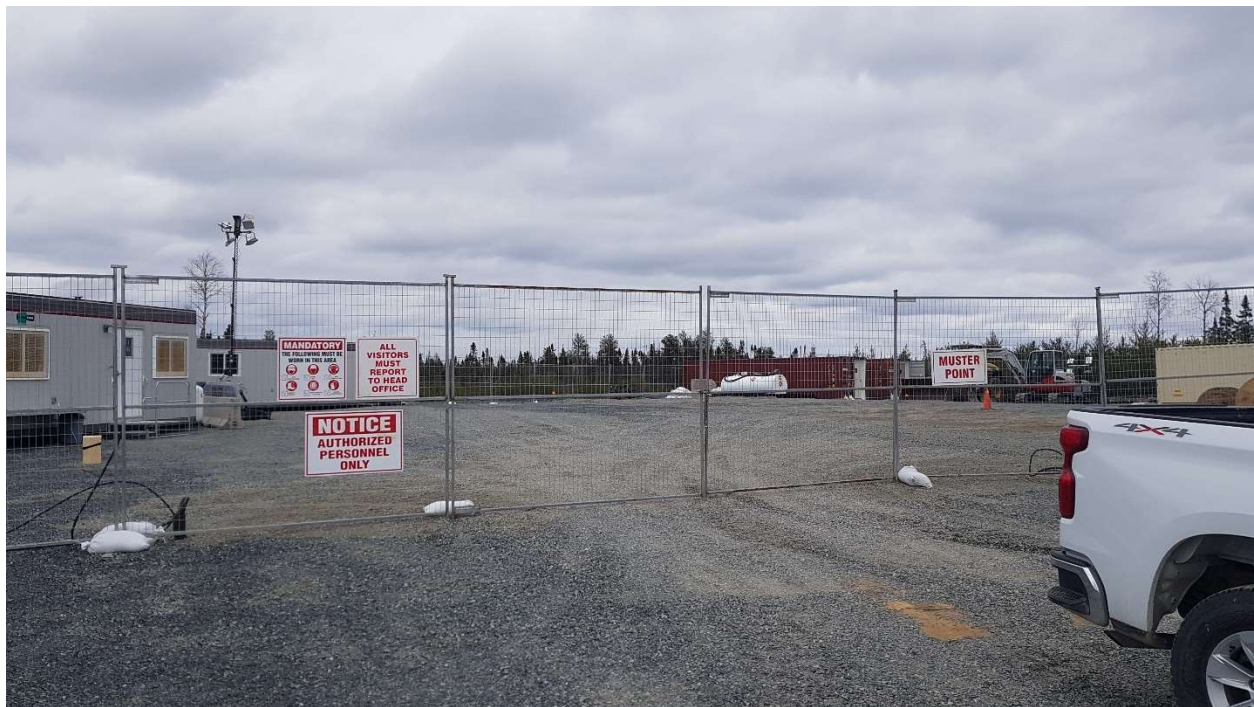
Safety signage was installed at the entrances to site, and at defined areas such as the muster station, no-smoking areas, and designated smoking areas. The safety signage posted at the entrance gate is shown in Appendix B, Photo 4.

Photo 4 - Site entrance with safety signages.

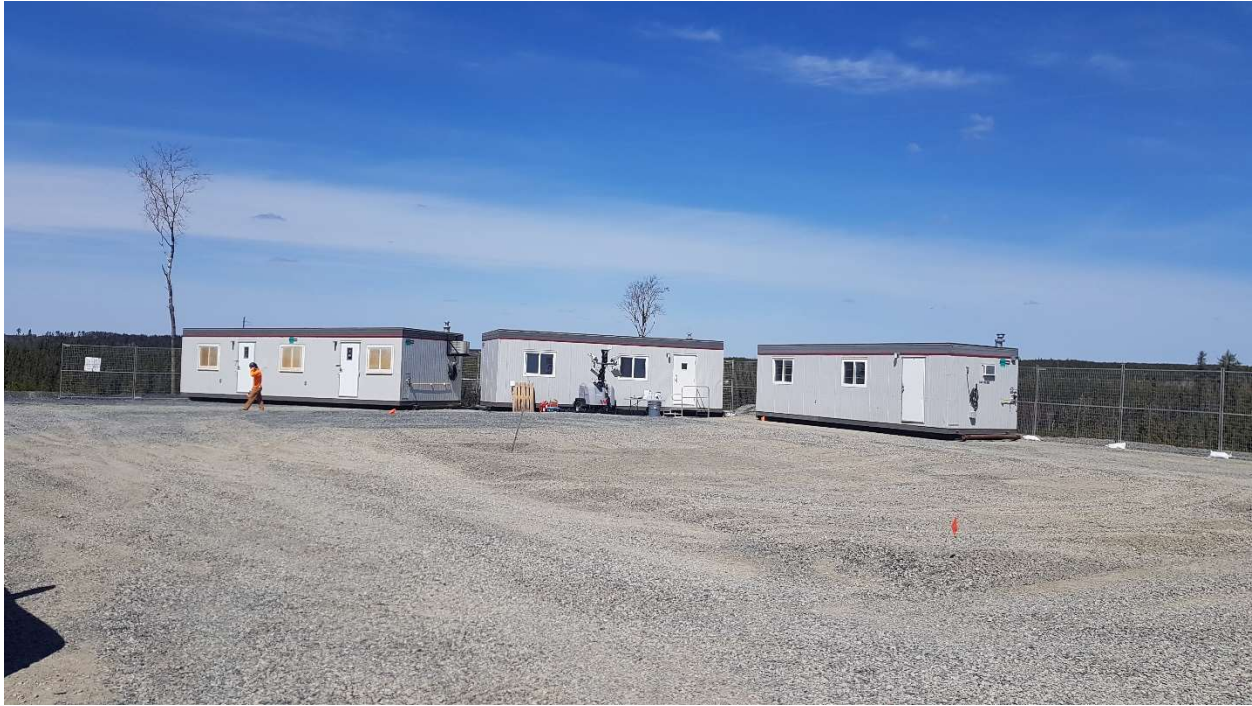
A 12 x 3m (40 x 10') mobile office trailer was set up on the north side of the site and two 9.75 x 3m (32 x 10') mobile office trailers were set up on the northeast corner of the site. The office trailers functioned as field offices for Golder, NWMO/WLON, and Rodren, respectively. The office trailers were heated and air conditioned, had electrical power, cellular communication, and internet service via the local cellular network (Appendix B, Photo 5).

Photo 5 - Golder, NWMO/WLON and Rodren drilling site trailers.

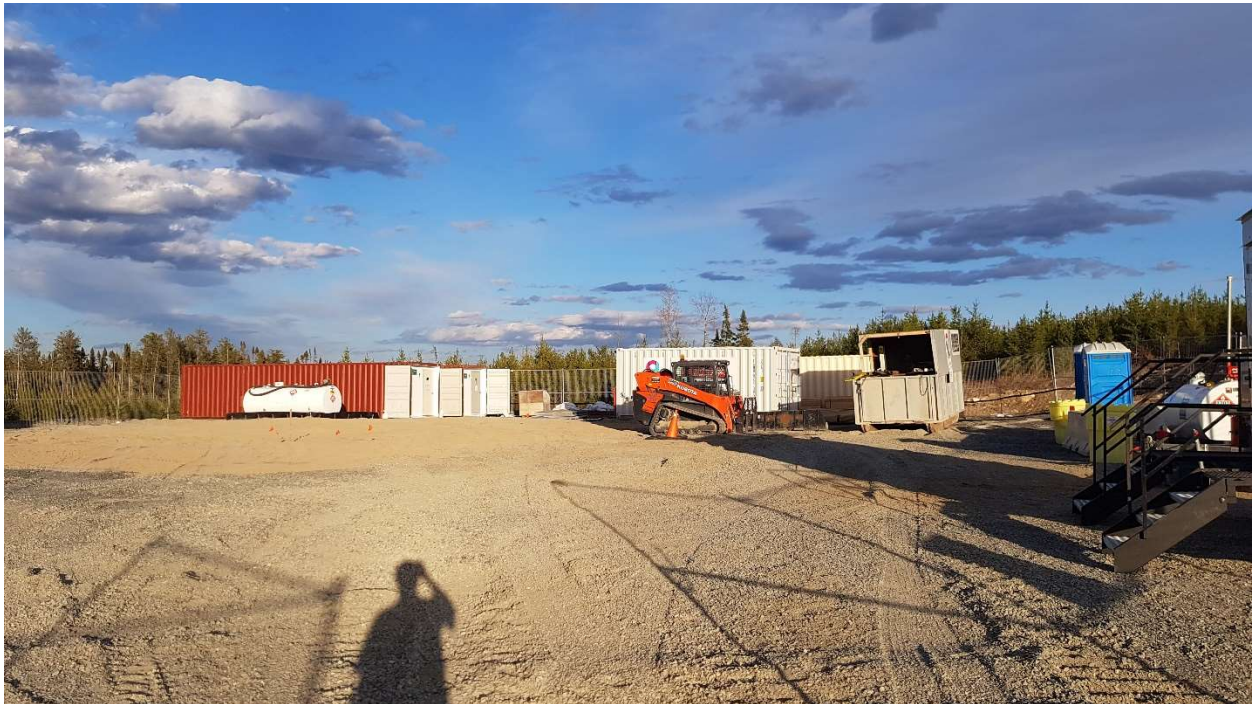
Two 12 x 2.5 m (40' x 8') modified shipping containers (seacans) were placed at the east corner of site near the drill rig and functioned as a working space for the all the work package activities. The seacans were modified with doors, insulation, electrical power, heating, and air conditioning (Appendix B, Photo 6). Internet communication was provided to the seacans through a Wi-Fi repeater which was connected to the cellular internet system mounted on the light tower located at the east corner of the time that helped in boosting the internet speed. The seacans were used as working, office, and laboratory space, and for the storage of equipment and samples. One seacan was designated as the WP03 Core Logging Seacan (Core Logging Seacan) and the other was designated as the WP02 Core Storage Seacan (Core Storage Seacan).

Photo 6 - Core logging and storage seacans.

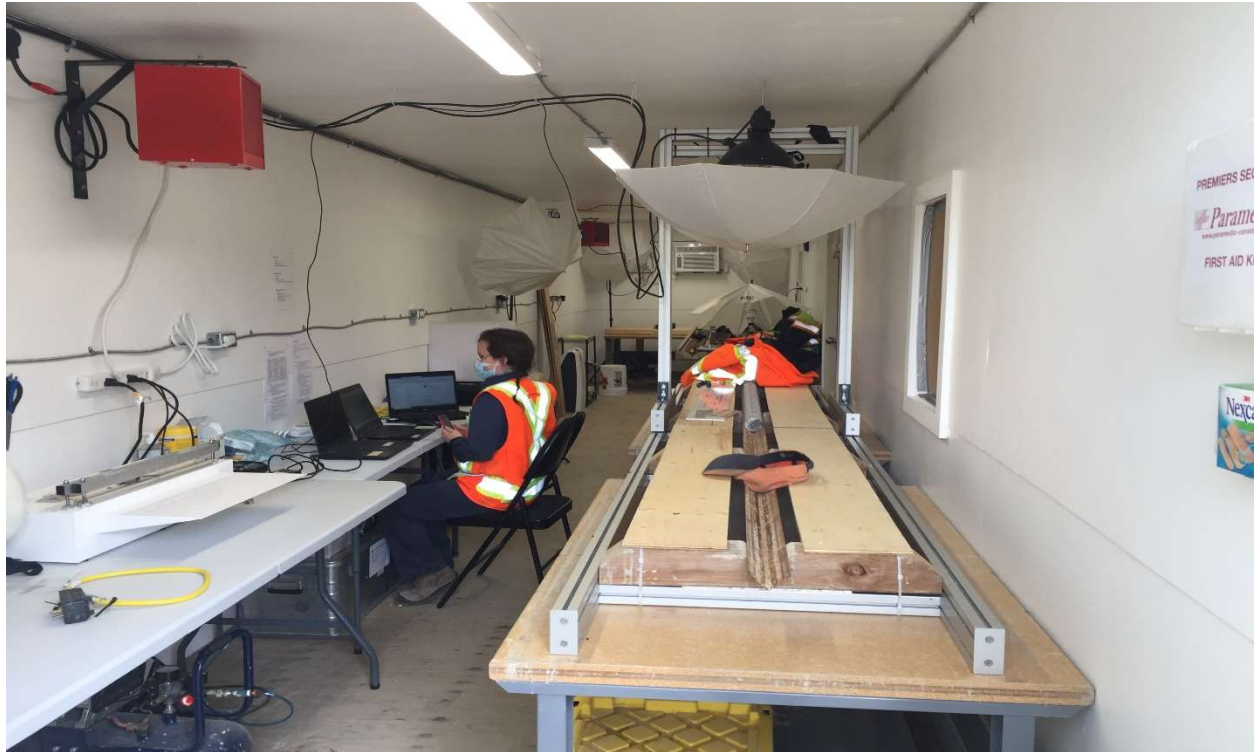
Two custom built core photography systems were set up in the seacan designated at the Core Logging Seacan and consist of aluminum frames with suspended cameras for taking core photos (Appendix B, Photo 7). Refrigeration for water samples and select drill core samples was provided by two refrigerators located in the Core Storage Seacan. The refrigeration system was used for temporary sample storage until the samples could be shipped off site to the appropriate laboratories or archives. (Appendix B Photo 8).

Photo 7 - Inside the core logging seacan.

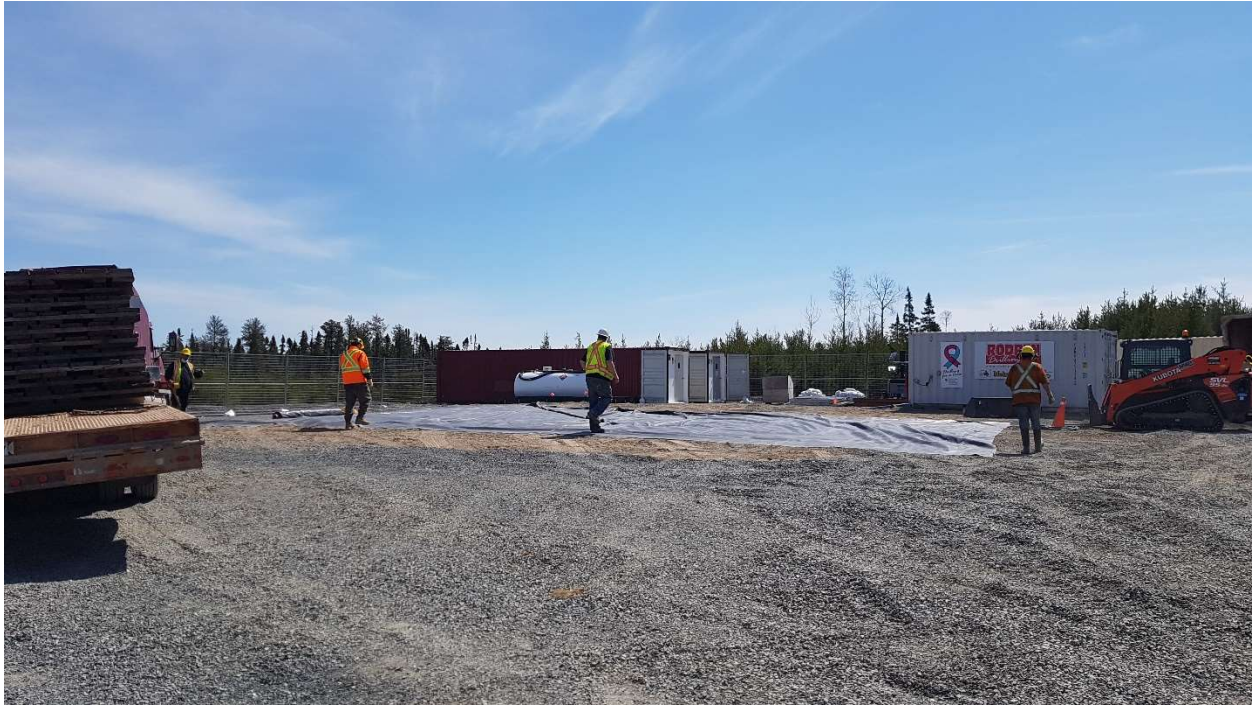
Prior to arrival of the drill rig on site, the drill pad was set up with a secondary containment system which was constructed on site to capture any drill fluid spills that could potentially occur at the drill or drill fluid circulation system (Appendix B, Photo 9). The drill pad was graded to slope into the central sump location followed by placing a sand layer approximately 0.10 to 0.15 m (4" to 6") in depth below the location of the secondary containment system to prevent any potential punctures (Appendix B, Photo 10). The containment liner was sealed to the outer casing of the borehole to prevent leaks through the. Wooden rig mats were placed overtop of the drill pad area, to provide a level and solid foundation for the drill rig infrastructure. (Appendix B, Photo 11).

Photo 9 - Drill pad secondary containment construction.

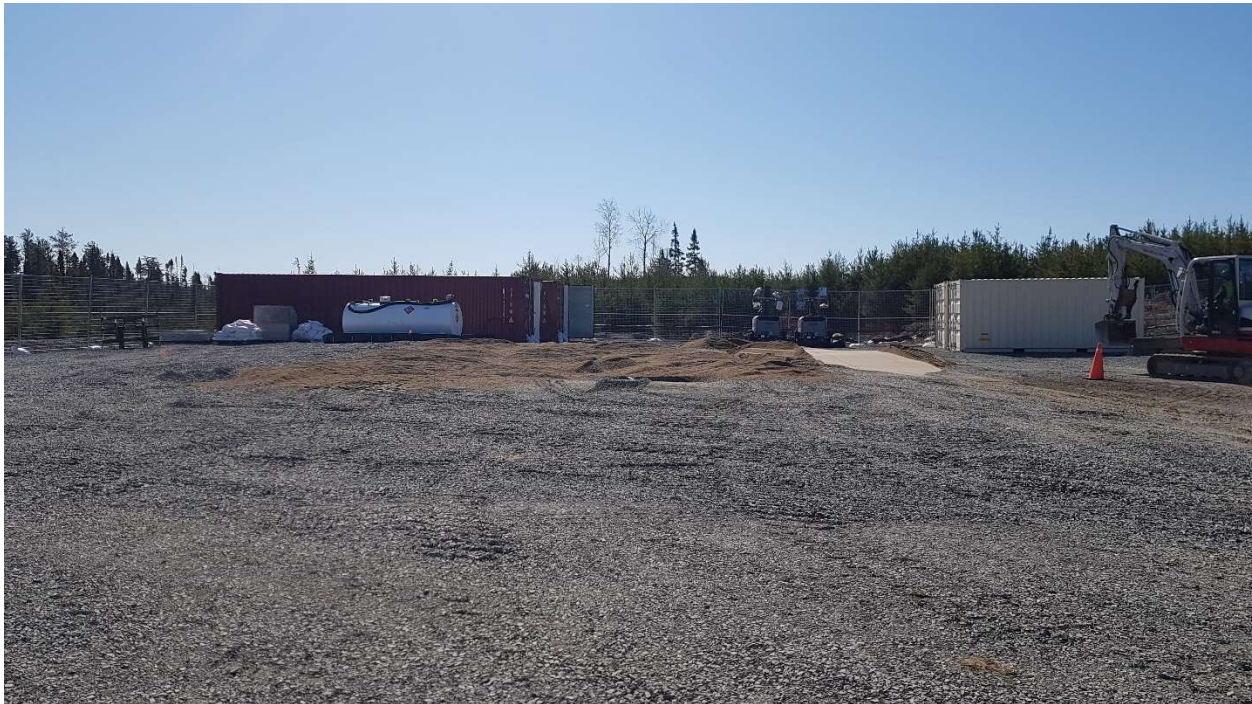
Photo 10 – Placement of the sand layer prior to the secondary containment construction.

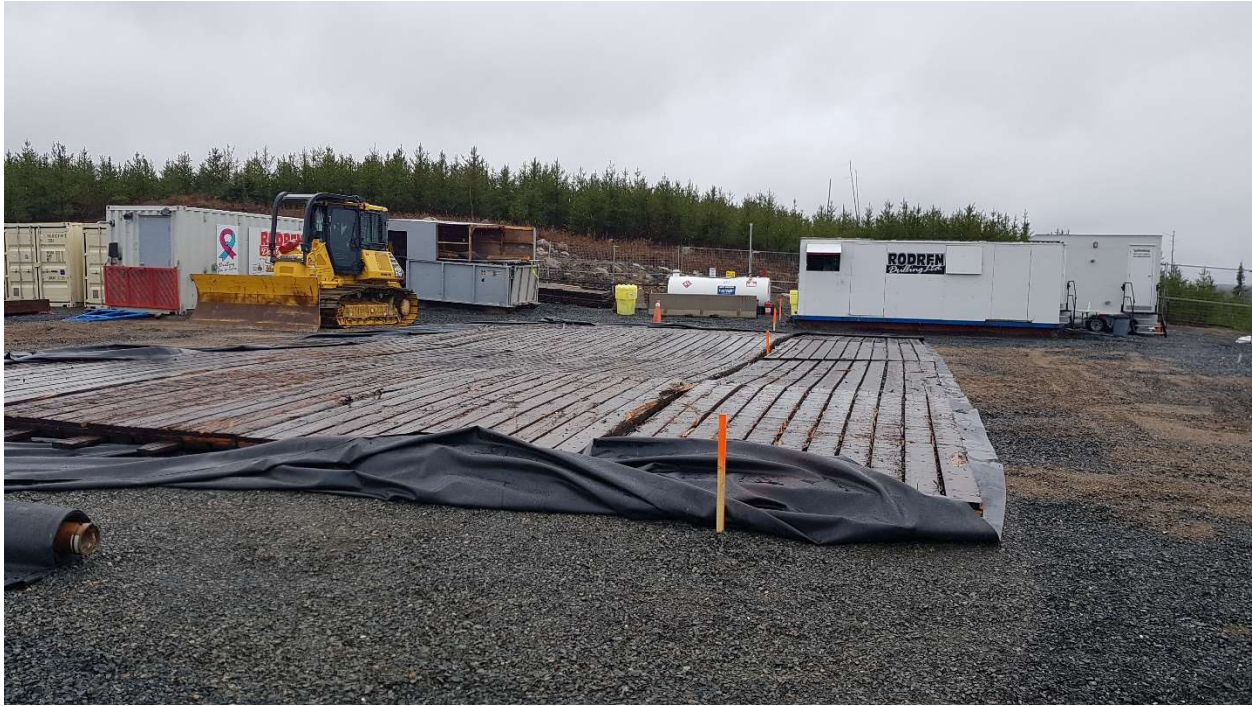
Photo 11 - Placing wooden rig mats.

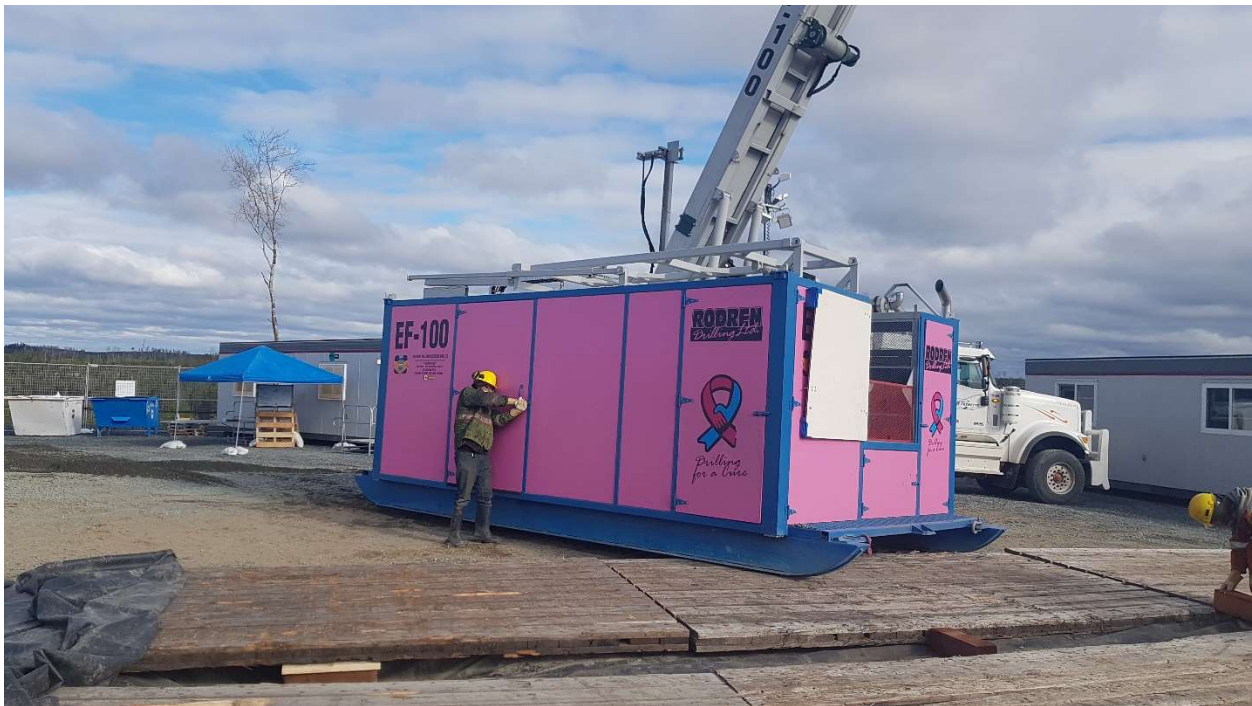
The drill rig was a rotary EF-100 manufactured by Discovery Drill Manufacturer (DDM) Ltd. (Appendix B, Photo 12). The drill was positioned over the proposed borehole location at a dip of -70° from horizontal and azimuth of 220° (Appendix B, Photo 13).

Photo 12 - Positioning the drill rig at IG_BH05.

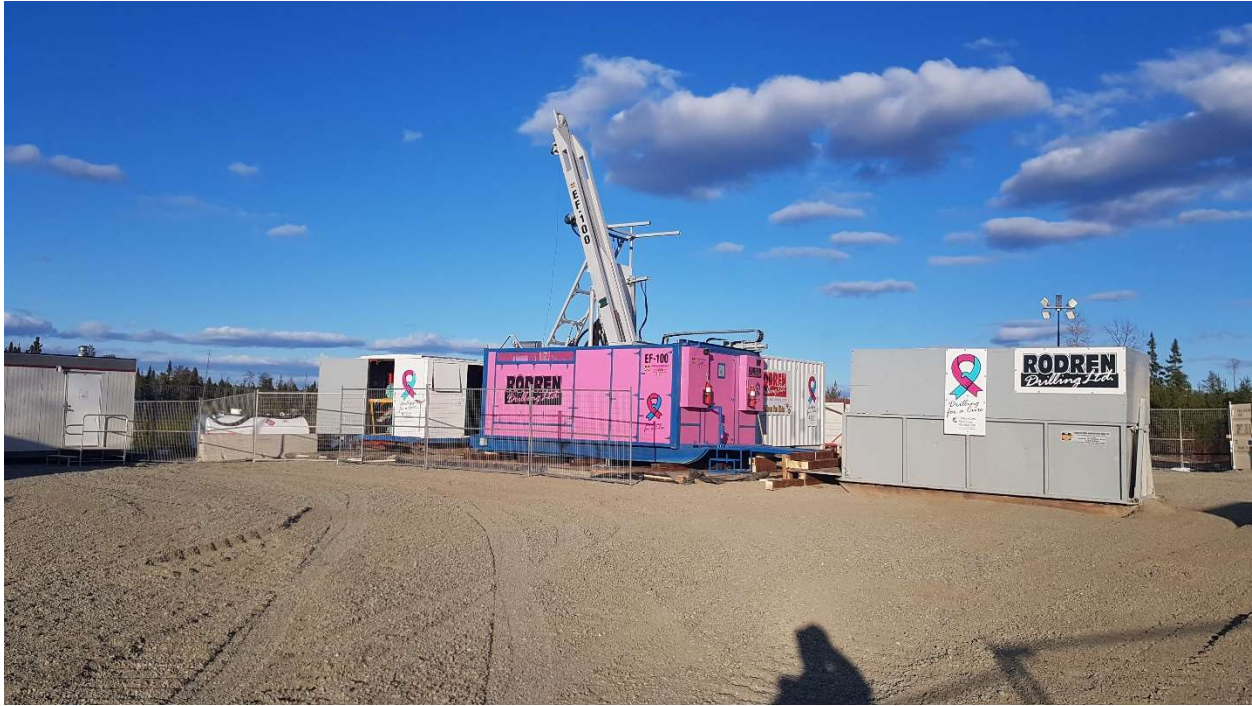
Photo 13 - Drill rig after positioning on IG_BH05 at the desired orientation.

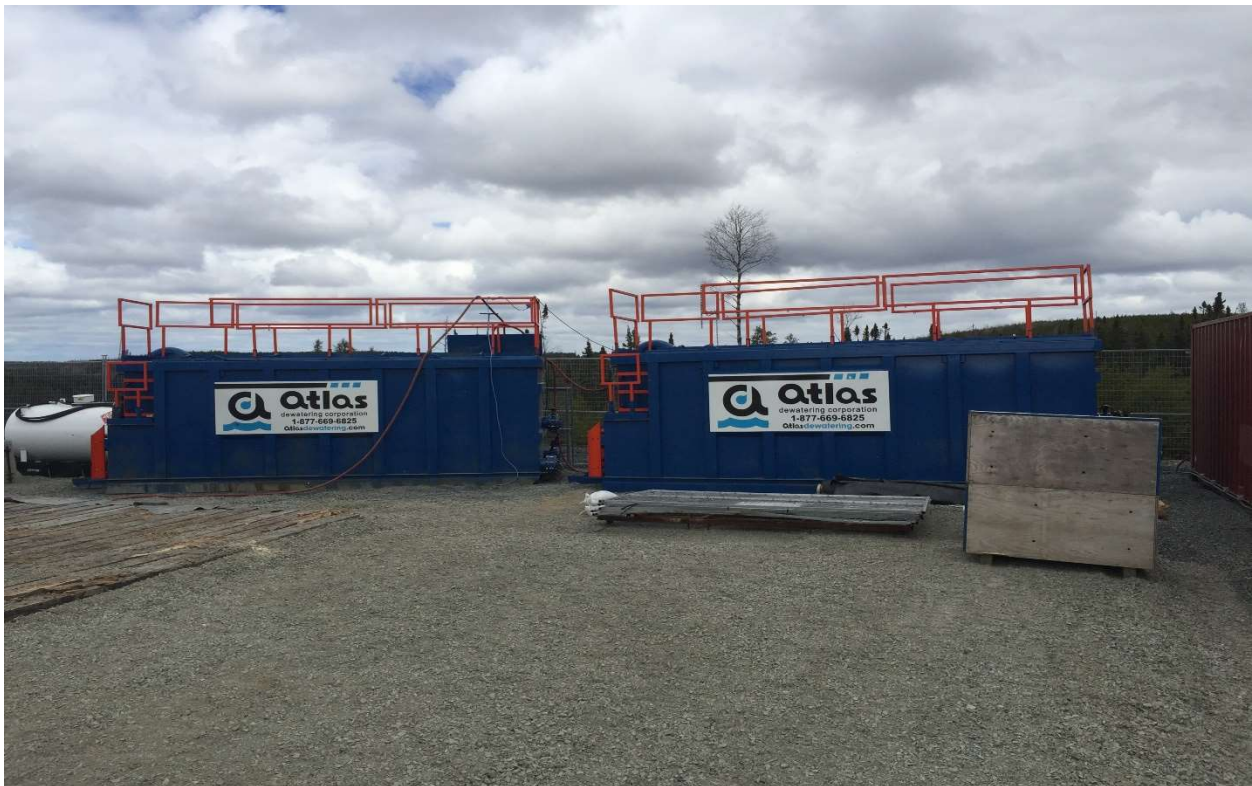
Drill water was stored in two 28,350 litre (7,500 US gallon) Baker tanks located on the west side of the site (Appendix B, Photo 14). The Baker tanks were initially filled with fresh water sourced from the Township of Ignace municipal supply. One tank (primary tank) was primarily dedicated to receiving the source water, while the other (secondary tank) was primarily dedicated to the storage of fluorescein traced drill water.

Photo 14 - Two 28,350 litre baker tanks.

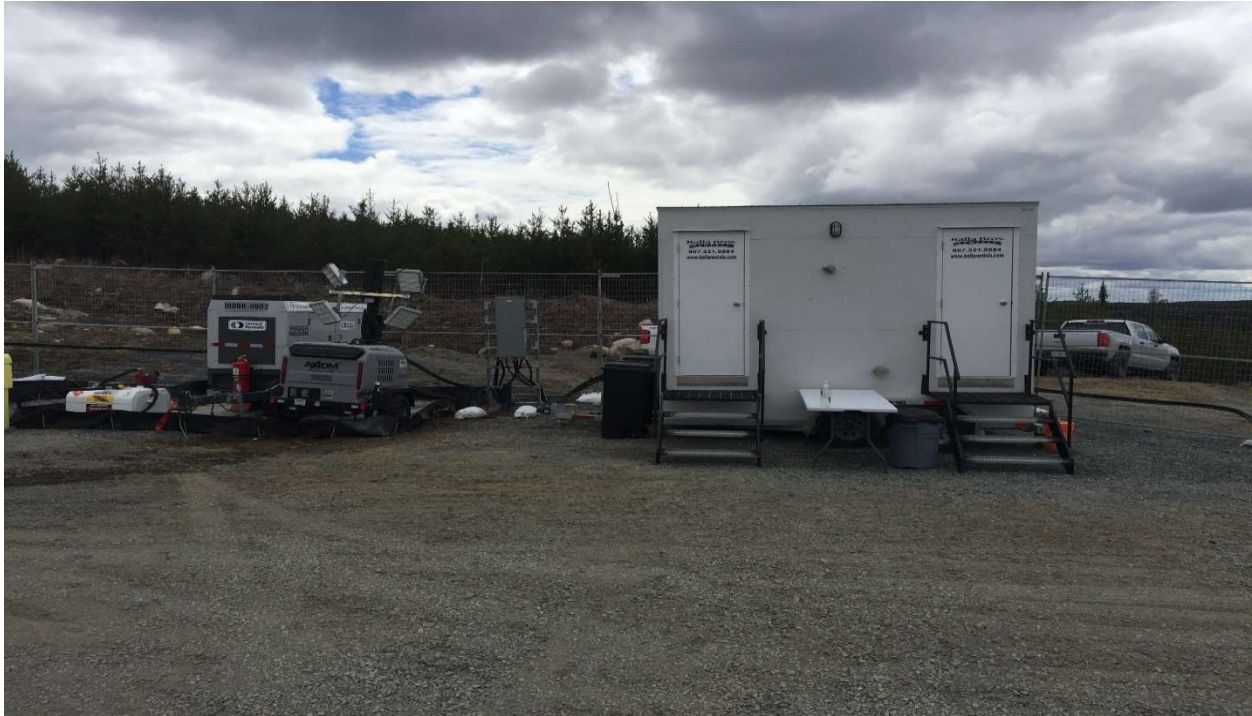
During the setup of the site facilities, two temporary portable toilets were provided for use by site workers. A heated and self-contained washroom trailer was later delivered to site once the electrical distribution system was operational. The washroom trailer was divided into two units with separate entrances, each containing one toilet and one sink. The washrooms were serviced for water and waste once a week and cleaned twice per week (Appendix B, Photo 15).

Photo 15- Self-contained washroom trailer

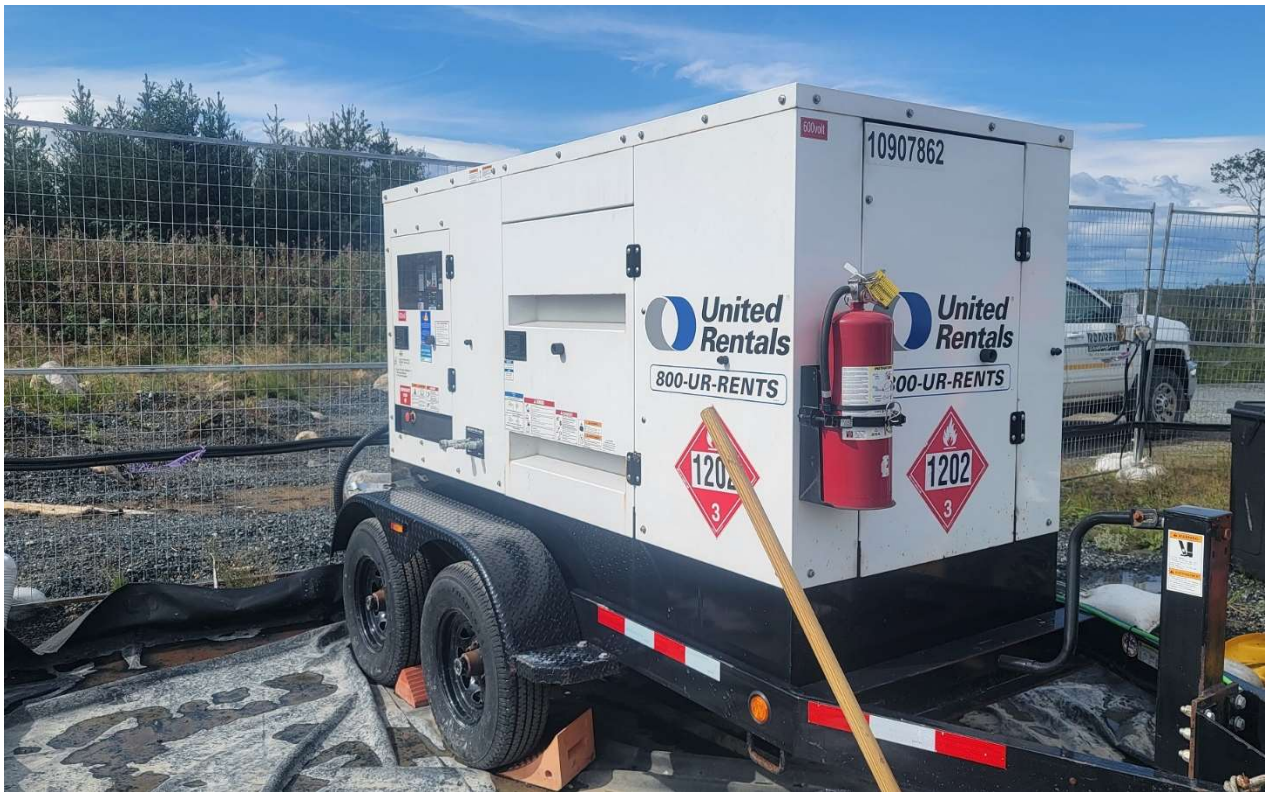
The site was powered by Cummins mobile diesel generator (model C60D6R) generator, which supplied 40.2 kW of 120 V single-phase output. It was used to power the site office trailers, core logging and storage seacans, washroom trailer, and a portable power system on the drill pad. The location of the generator was chosen to minimize the length of electrical distribution cables, to protect the generator from vehicular traffic, and to allow for access by truck if the generator required repairs or replacement. The generator was placed inside a secondary containment berm with a containment capacity of 4800 L (1265 US gallons), sufficient to contain approximately six times the amount of fuel and oil in the system.

Photo 16 - Cummins mobile diesel generator (model C60D6R) in secondary containment with a fire extinguisher.

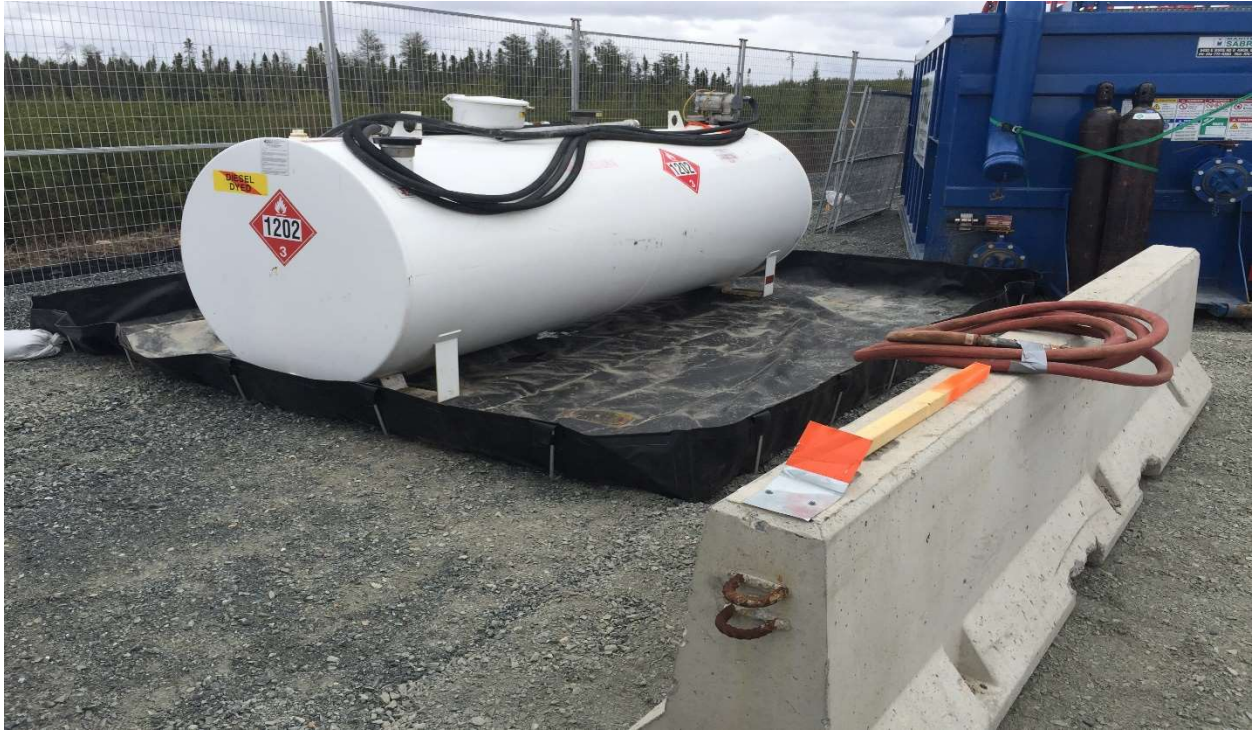
One 4,500 L (1,190 US gallon) double-walled fuel storage tank was located adjacent to the generator, so that refueling of the generator can be performed directly from the fuel storage tank. Another 4,500 L double-walled fuel storage tank was placed near the drill rig area which was used to fuel the drill rig and centrifuge. The fuel tank was placed inside a secondary containment berm with a containment capacity of 5,460 L (1,440 US gallons), sufficient to contain the maximum amount of fuel and oil in the system plus a contingency factor of approximately 20%. The fuel tanks were surrounded by concrete barricades to protect them from vehicular traffic and heavy machinery.

Photo 17 - Double-walled fuel tank - 4500 Litres.

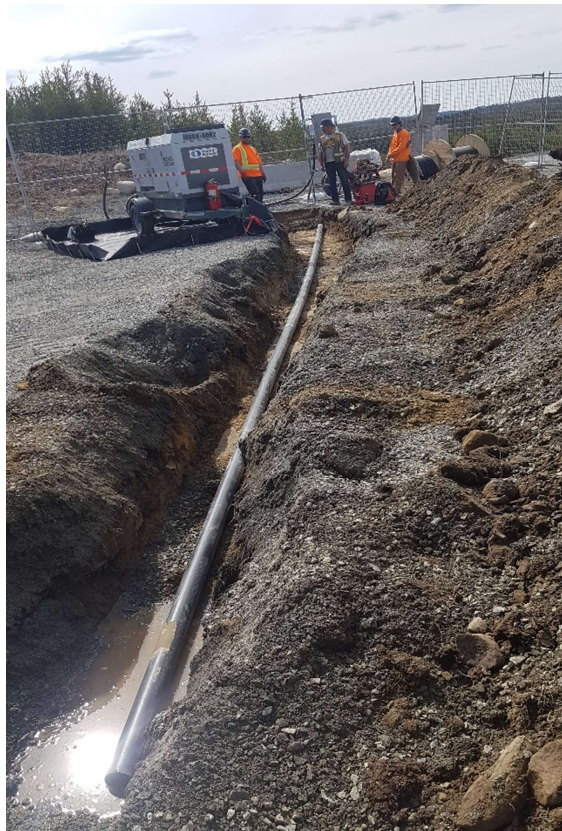
Set up of the electrical distribution system from the generator to the site facilities was performed by Fediuk Electric (Fediuk) under the direction of Justin Fediuk, Master Electrician License #6002843. Power was distributed to the site facilities via double jacketed electrical cables. Most of the power lines were mounted to the site perimeter fencing. In areas where the electrical cables pass through a trafficable area, they were buried underground inside an ABS conduit at 1.0 m depth (3 feet)

Photo 18 - Trench construction to bury the power cables.

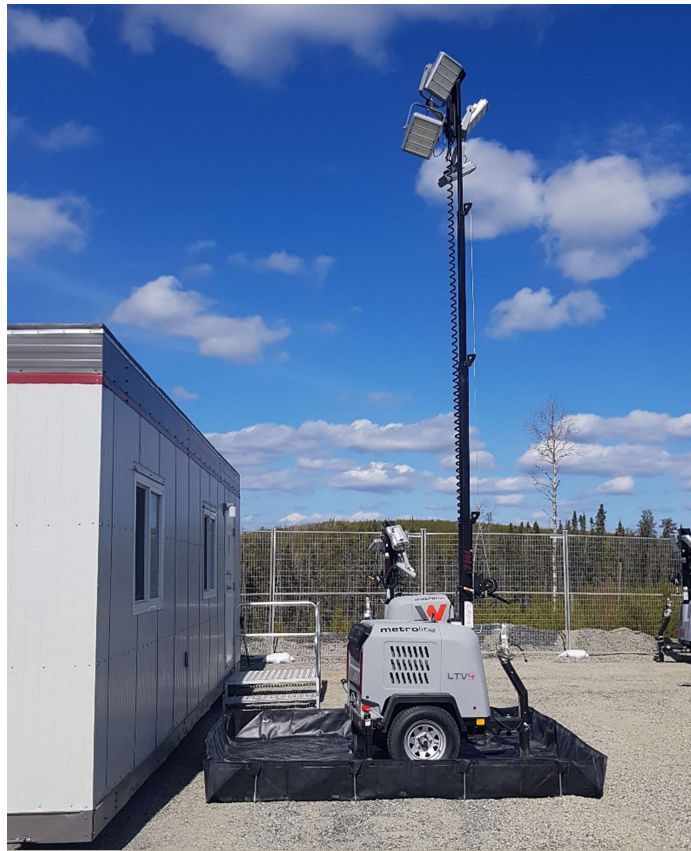
Three 4-kW - Wacker Neuson Metrolite LTV4 diesel powered light towers with LED lights were installed at the site to provide outside illumination during work at night. The light towers were positioned to allow for an even distribution of light. The light tower placement also considered: ground stability, level of activity in the area, and the ability to access the light towers by truck for refueling or repairs. The light towers were all placed within their own secondary spill containment. The containments were sized so that the entire light tower footprint would be within containment. The containment capacities of 2,800 L (740 US Gallons) and 1,150 L (304 US Gallons) exceeded the maximum volume of fuel and oil within the light towers of 180 L (47.5 US Gallons).

Photo 19 - Light tower in a secondary containment.

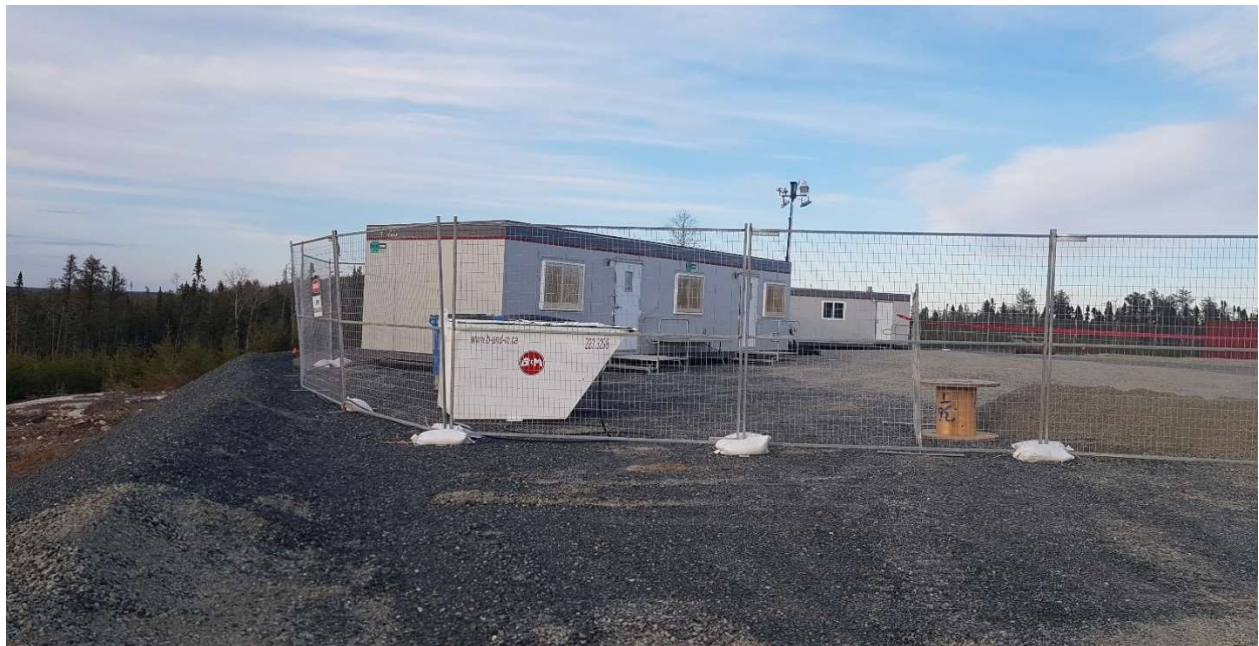
Non-hazardous solid waste was managed using one garbage bin and one recycling bin located near the front entrance to the site, for ease of access by the garbage and recycling truck. The bins were both located inside the fenced area and had lids which could be secured to prevent access by animals. The bins were sourced by B&M Deliveries of Dryden, Ontario, and waste material was transported by B&M Deliveries to the Dryden Landfill Site, located southwest of Dryden, Ontario (Appendix B, Photo 20).

Photo 20 - Location of the garbage and recycling bins near the site entrance.

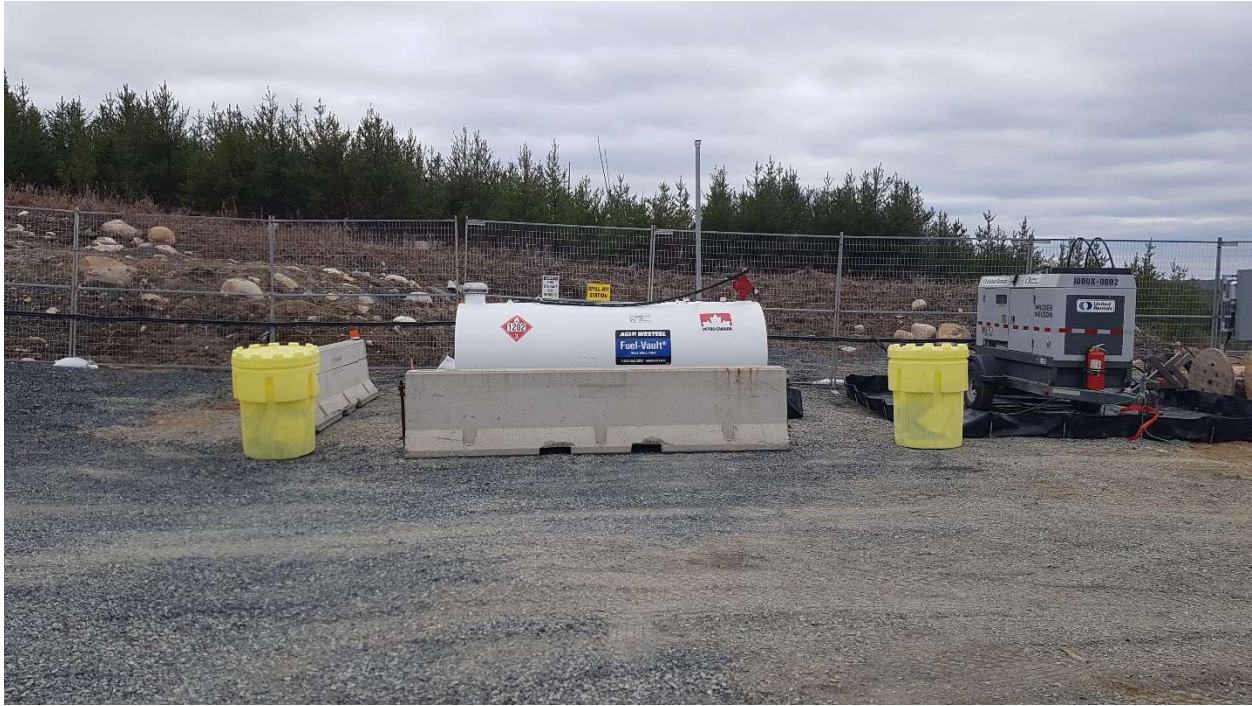
Photo 21 - Spill kits around the fuel tank.

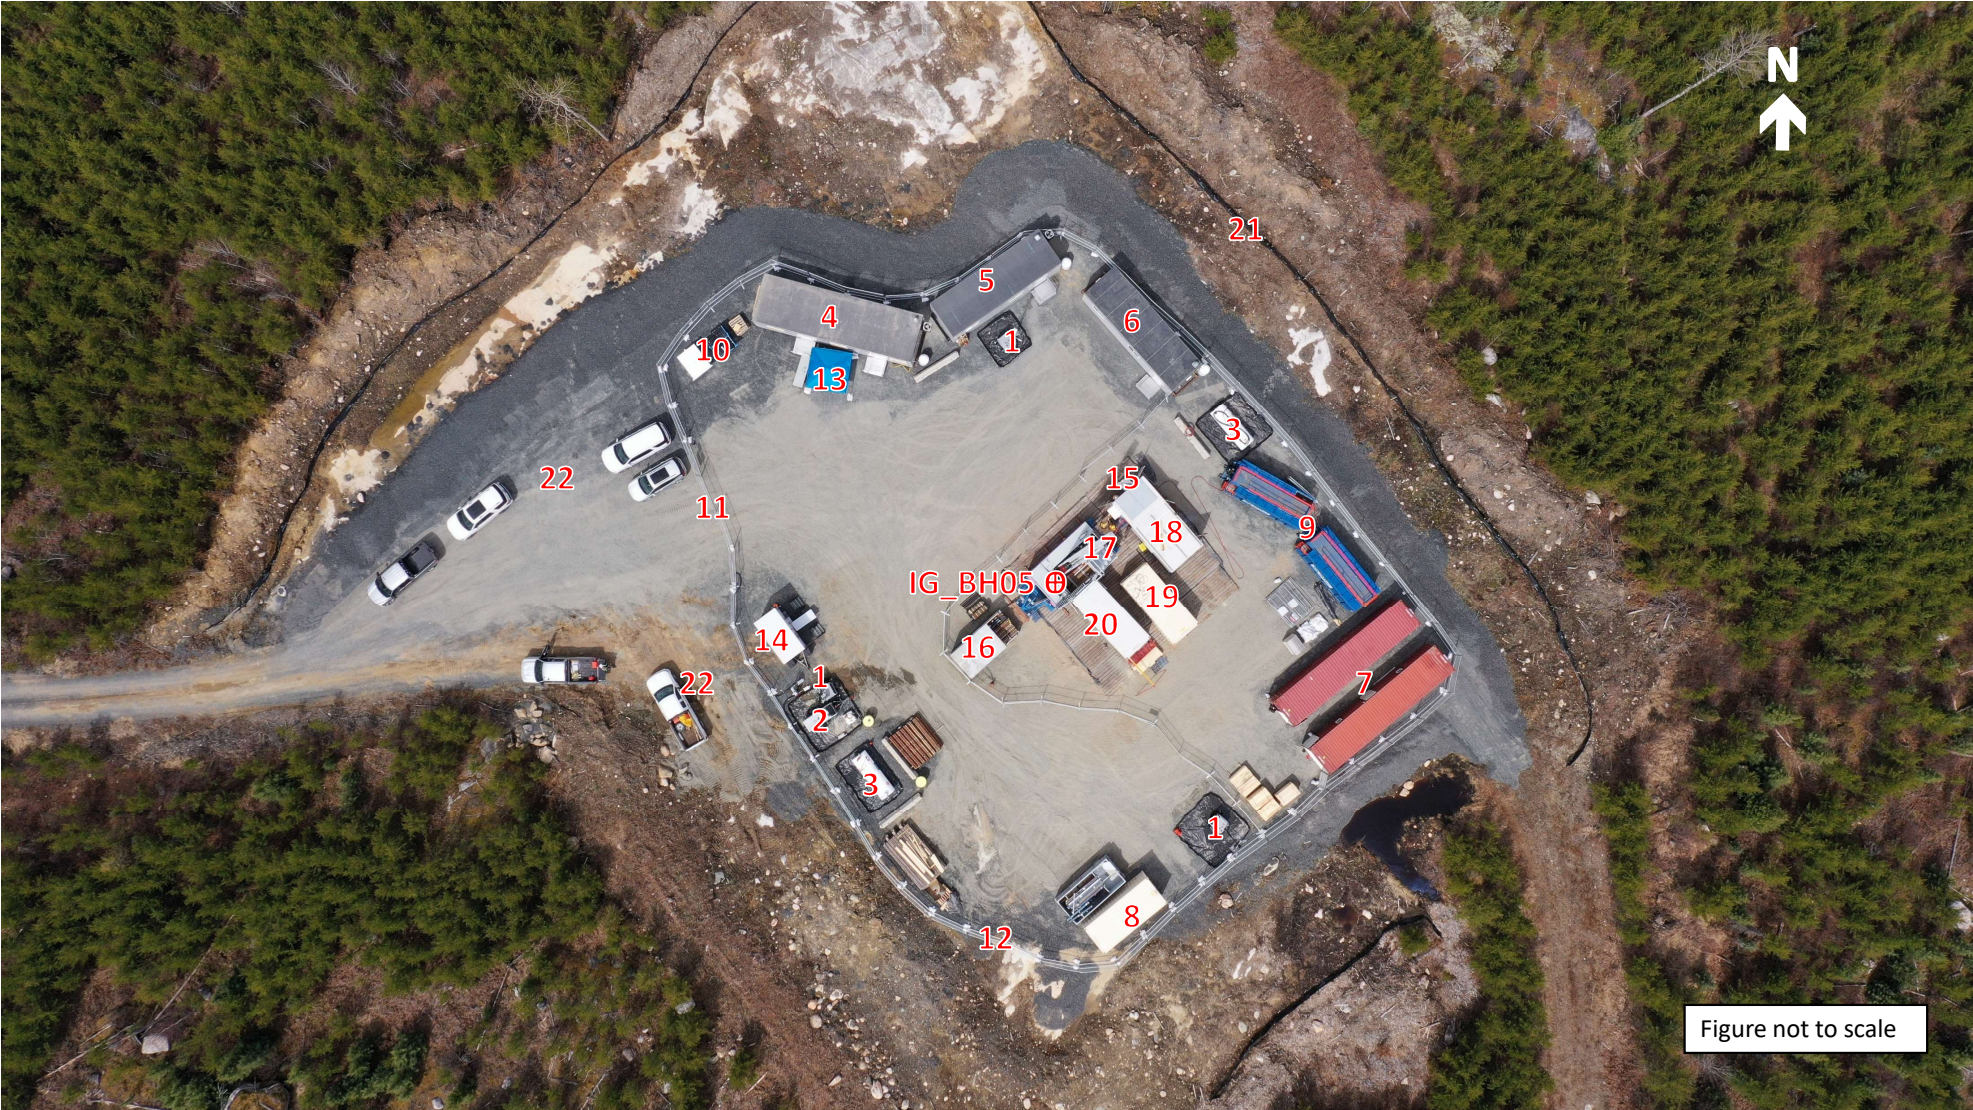
As-Built Site Facilities Layout - IG_BH05

An aerial image showing the as-built site layout, along with with a listing of the main site infrastructure elements, is provided in Appendix C.
