PHASE 2 INITIAL BOREHOLE DRILLING AND TESTING AT IG BH04/05/06 IGNACE AREA

*WP12 Data Report – Vertical Seismic Profiling for
IG BH05*

APM-REP-01332-0368

WSP Canada Inc.

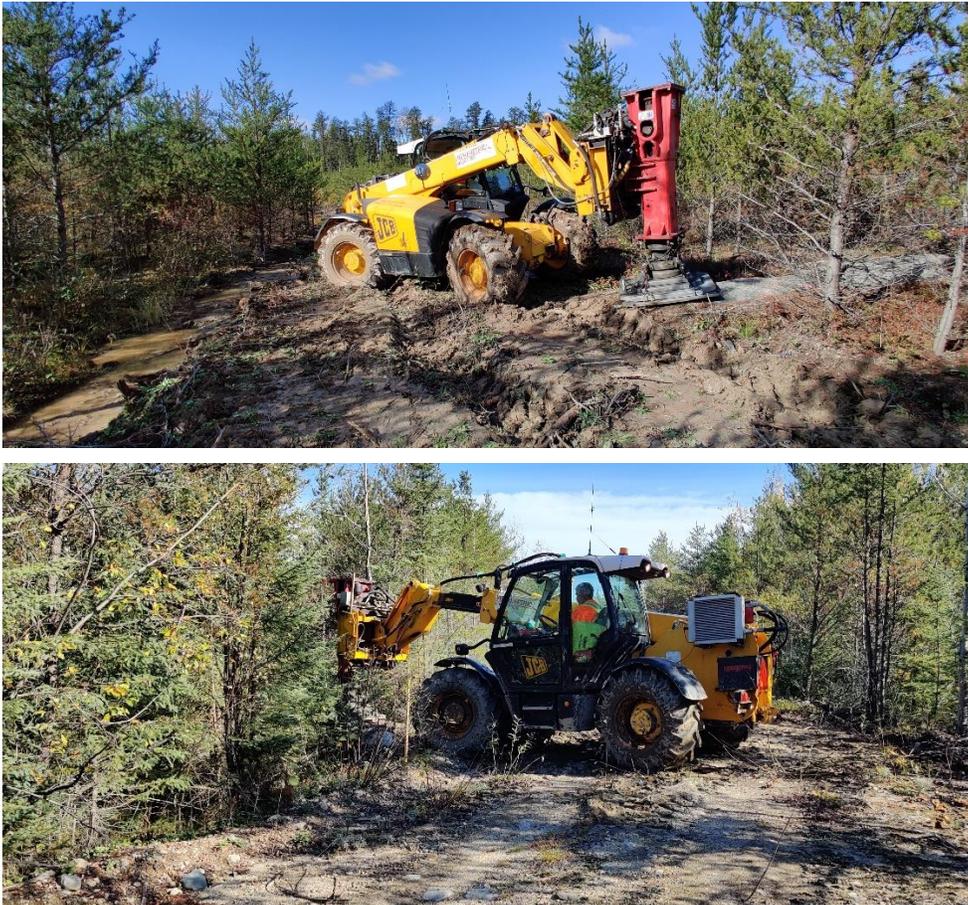
Figure 3: The VIBSIST-3000 seismic source used for the VSP survey in IG_BH05. A thick rubber mat was used for the source, in order to avoid direct contact with outcrops.

The VIBSIST-3000 source uses a large-size hydraulic impact hammer, powered through a computer-controlled regulator that is mounted on an all-wheel drive/all-wheel steering 7-tonne tool carrier, as shown on Figure 3. The seismic source can handle topography at a reasonable speed while providing high energy and a stable source signature. The hydraulic hammer is capable of delivering 2500 – 3250 J/impact at 400-800 impacts/minute. At each shot point, the VIBSIST-3000 source was activated three times for a period of 20 seconds each, with the impact frequency being varied to generate a swept impact sequence. Each sweep contains ~100 impacts. Based on data inspection in the field, the number of sweep repetitions was sufficient to obtain high-quality seismic signal for the desired investigation depth.

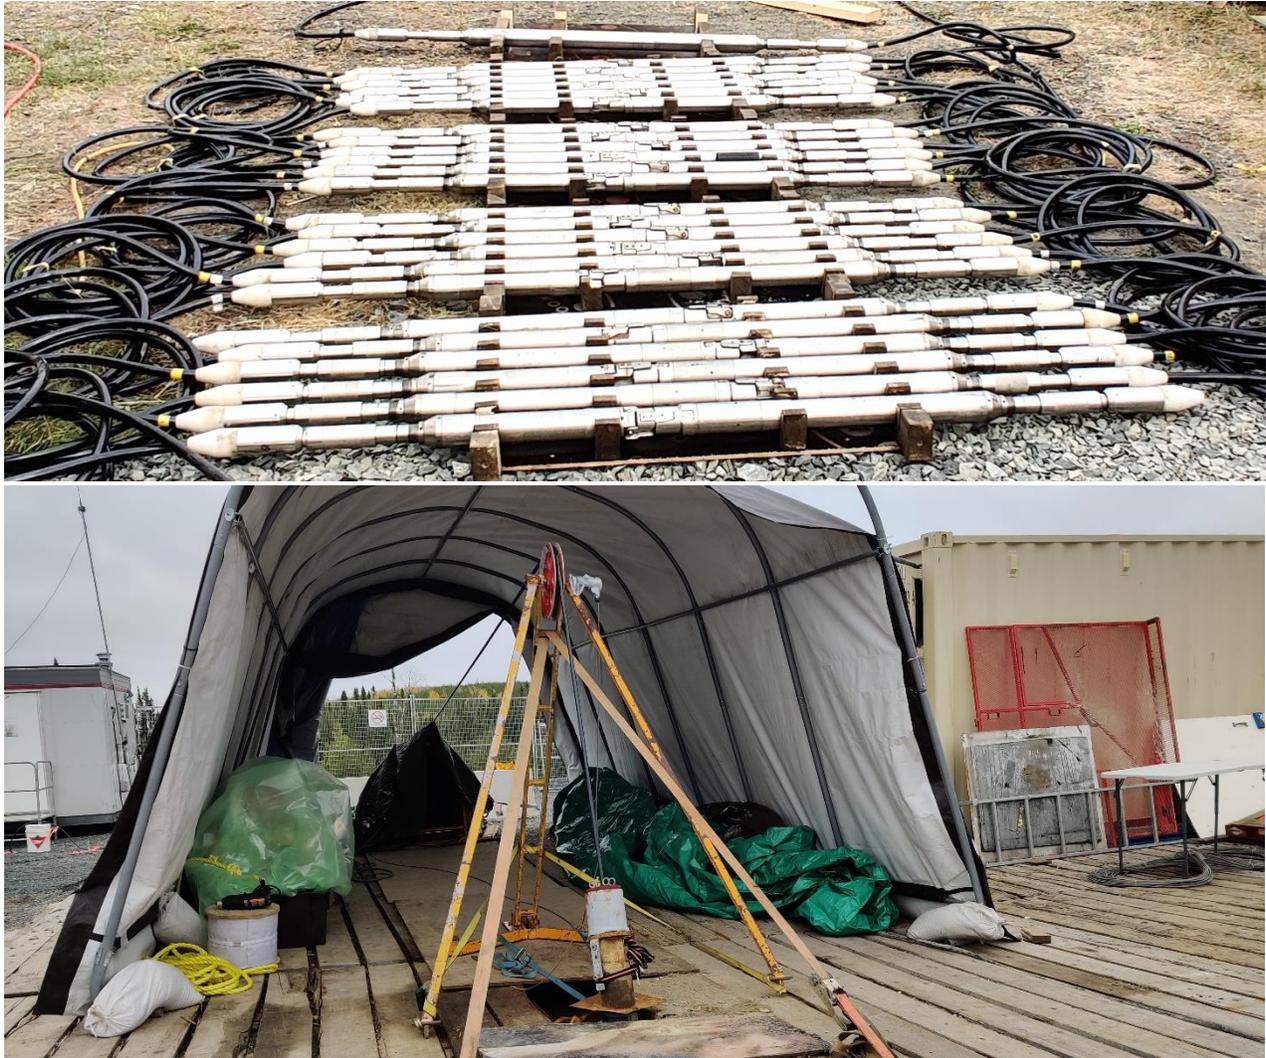
Figure 4: Detail of the 3-component modules with clamping arms for the RD-XYZH geophone receiver system and picture of the receiver cable winch, together with the acquisition setup at borehole IG_BH05.

A 3-component digital geophone chain was used for the VSP measurements. This is shown on Figure 4. The RD-XYZH consists of up to 24 3-component modules spaced at 5 m intervals. The signal digitizing is done down-hole, within each module. For logistic reasons, the survey was carried out with 12 levels. The frequency band is from 14 to 500 Hz. The units are equipped with side arms for clamping, activated by DC motors. The clamping control is independent for each unit.

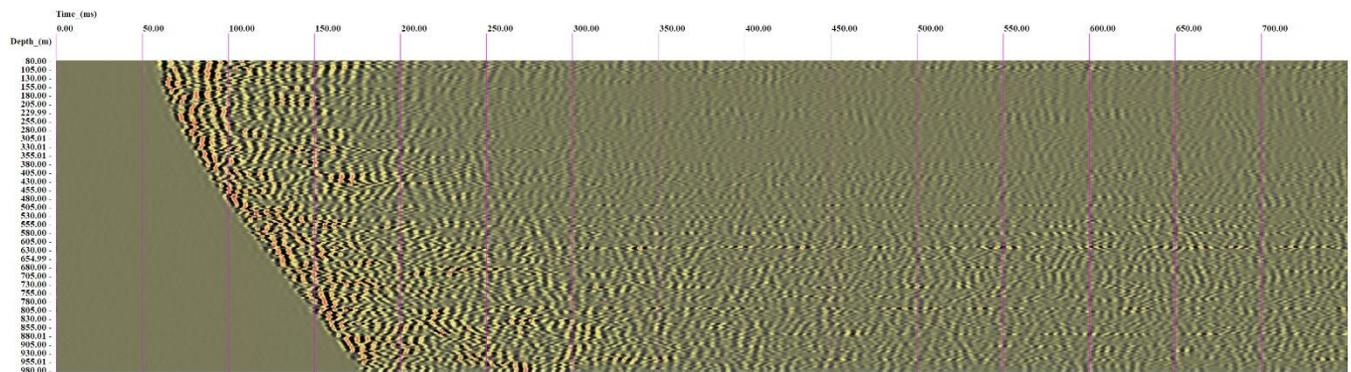
Figure 20: Profile (R) shown on Figure 13, after removal of direct P- & S-wave fields and static corrections.

Figure 19 to Figure 21 show the (Z R T) profiles where the direct P- and S-arrivals have been suppressed and static corrections applied, inferred by tomographic inversion (see Section 5.1.4), as described by the standard pre-processing sequence in Table 5.

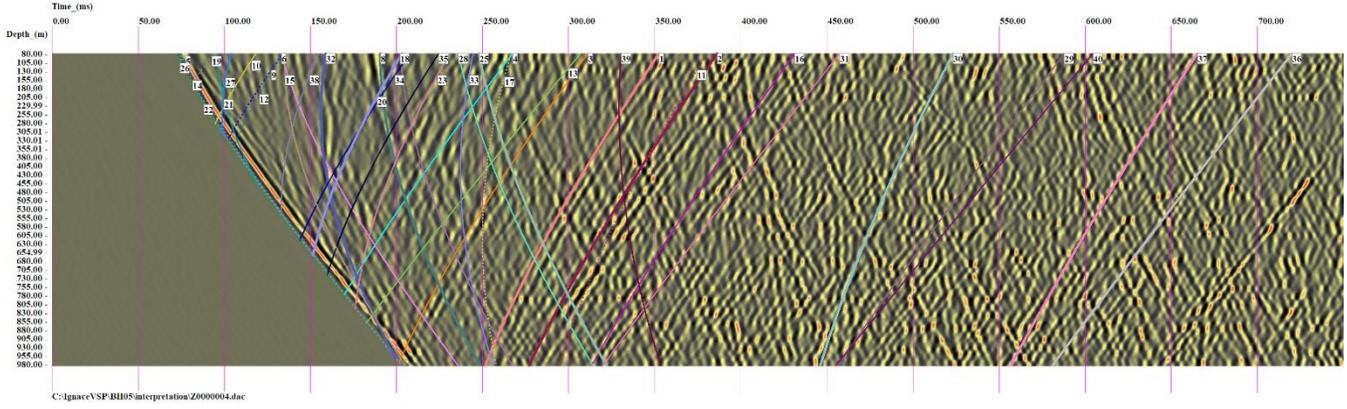
Figure 2. Axial component profile from V04.
