Determination of the Threshold Stress Intensity Factor and Velocity of Delayed Hydride Cracking of Endplate Welds in CANDU Fuel Bundles with Different Design and Manufacturers

NWMO TR-2010-25

G. K. Shek

Kinectrics Inc.

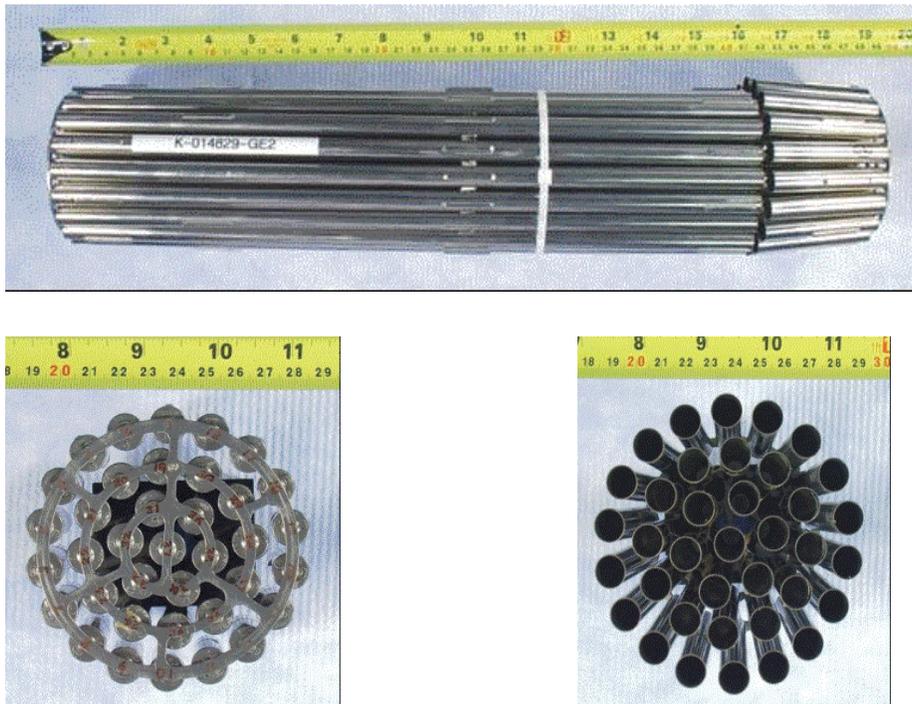
Figure 1: The empty fuel bundle elements sprung out after being parted from the bundle

In order for DHC to occur, the welds must have sufficient hydrogen for hydrides to form at the flaw tip. The endplate welds of one end of the fuel bundles were hydrided to a target hydrogen concentration of 40 ppm by weight using the electrolytic hydriding/thermal diffusion method, similar to that used in previous test program (Shek and Wasiluk, 2009). In this hydriding procedure, a solid hydride layer was deposited electrolytically on the surfaces on one end of the bundle submerged in a 0.1 Molar sulphuric acid electrolyte. After electrolytic hydriding, a 75 mm long portion of the bundle was parted by wire electrical discharge machining from the three bundles (Figure 1). It was noted that the fuel elements in all three end portions sprung out after cutting, likely due to

the presence of residual stresses in the endplate assembly. The three end portion of the bundles were placed in a large oven (Figure 2) and annealed at 266°C for 47 hours to diffuse the hydrogen from the surface hydride layer into the bulk of the component to obtain a target hydrogen concentration of 40 ppm. It was noted that the CAMECO bundle had a different oxide colour than the GE bundles after the diffusion anneal. A coupon was taken from the endplate weld of each bundle for hydrogen concentration measurements. The remnant of the hydride layer on the coupon was removed by pickling and grinding. The Terminal Solid Solubility for hydride dissolution (TSSD) temperature of each coupon was measured by differential scanning calorimetry. The coupons were then sent to Nu-Tech to measure the hydrogen concentration by

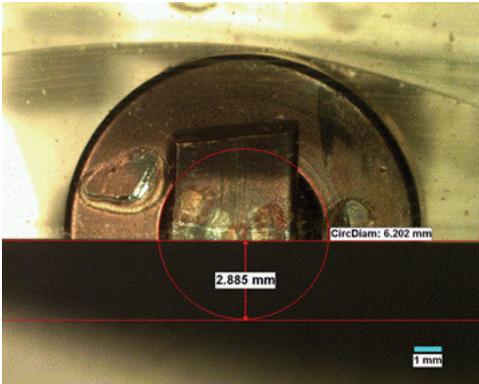
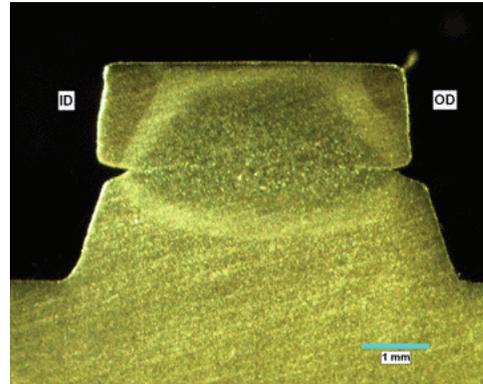
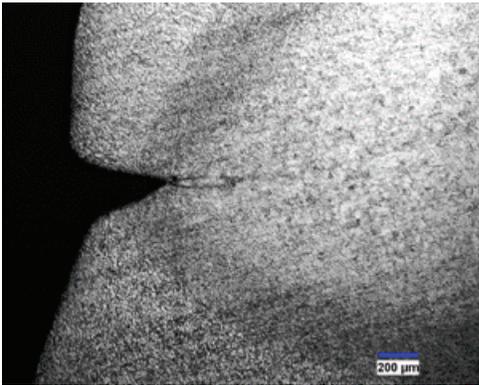
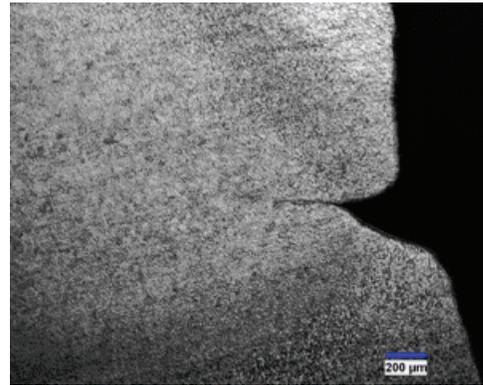
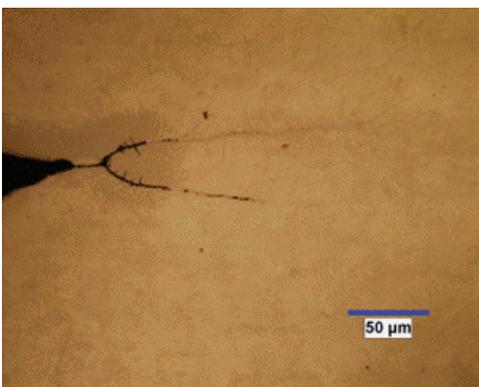
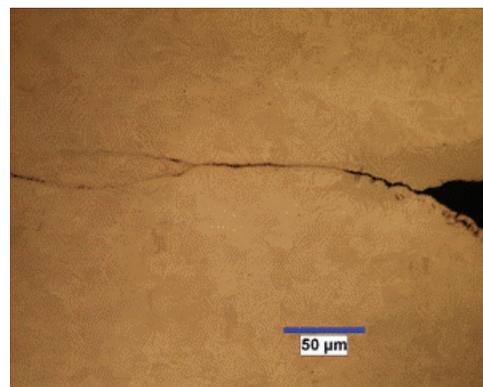
Figure 3: Endplate weld of element # 1 of the GE 37-element bundle

Figure 3 shows the cut section and the micrographs of the endplate weld from element #1 of the GE 37-element bundle at different magnifications. The elements are identified using the convention shown in Figure 2b (see also Figure 22 in later discussion). In Figure 3b, the OD

and ID side represents the outer diameter and inner diameter side of the outer ring of the endplate respectively. During manufacturing, a notch was formed between the endplate and the button-shape portion of the endcap. In this cross-section of the weld, it appears that the notch

on the ID side was slightly deeper than that on the OD side (compare Figure 3c and 3d). A crack-like weld discontinuity was present at the notch tip. Overall, the notch geometry and weld discontinuity are similar to that observed in the endplate welds of the GE 37-element bundle tested by Shek and Wasiluk (2009).

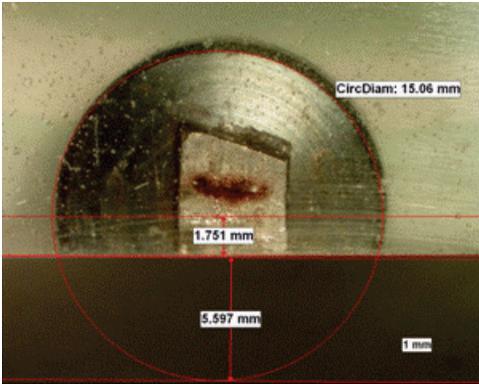
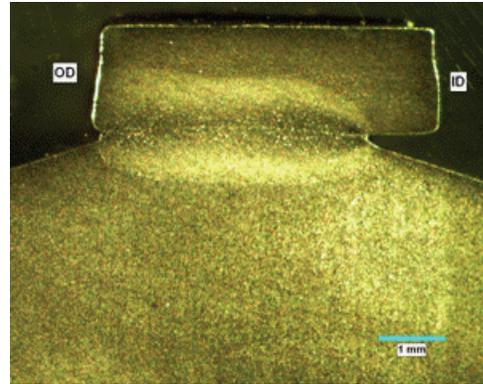
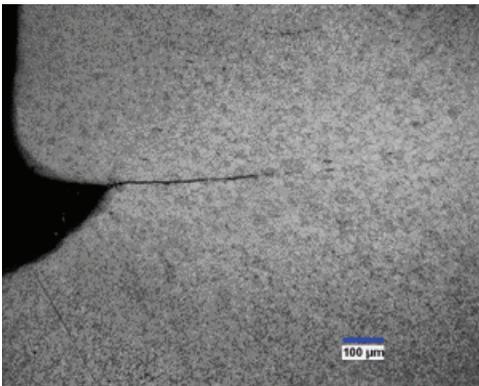
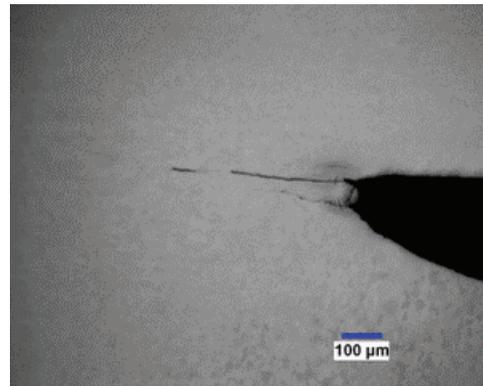
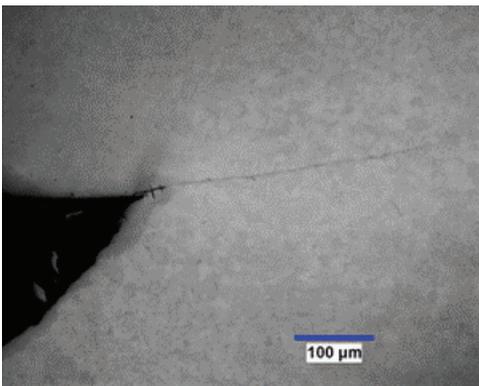
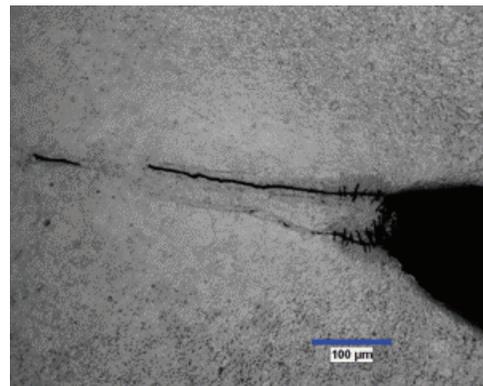
Figure 4: Endplate weld of element # 1 of the GE 28-element bundle

Figure 4 shows the metallographic section of the endplate weld of element #1 of the GE 28-element bundle. The endcap has a conical shape which is different than the button-shape endcap of the GE 37-element bundle. In this particular element, the weld was skewed towards the OD side of the endplate and therefore the notch depth on the OD side was a lot smaller than that on the ID side. The notch on the ID side of the GE 28-element bundle was deeper than that of the GE 37-element bundle welds. The notch radius and weld discontinuity appear to be similar to that of the GE 37-element bundle.

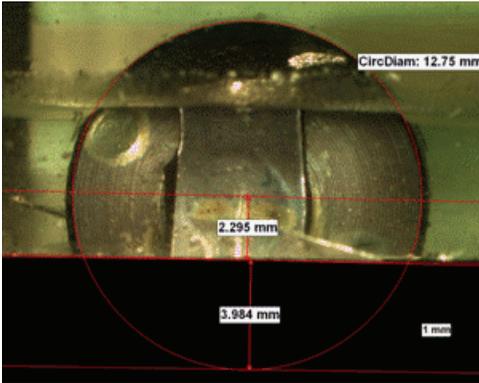
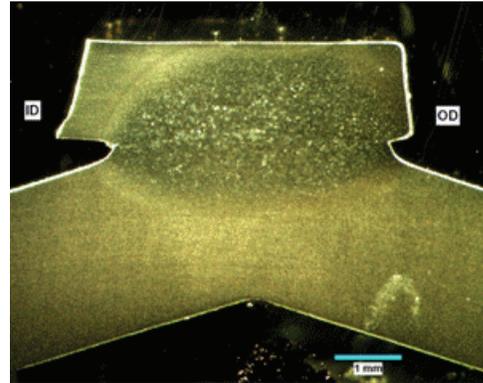
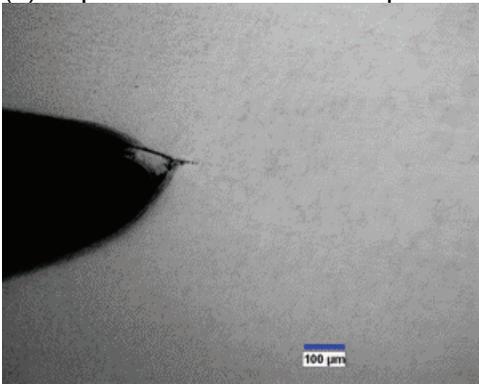
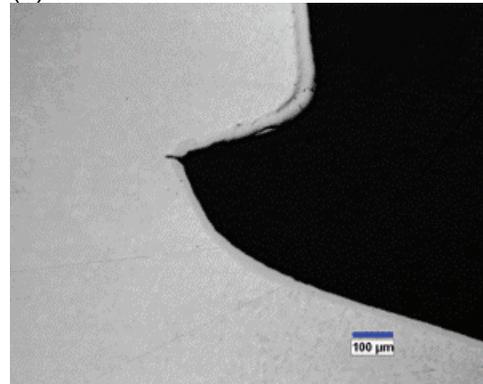
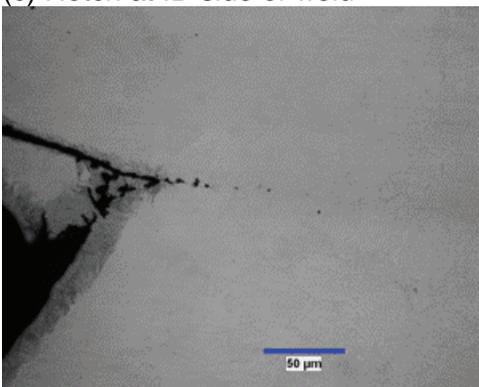
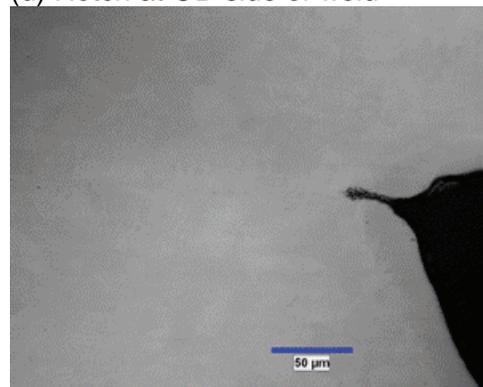
Figure 5: Endplate weld of element # 3 of the CAMECO 37-element bundle

Figure 5 shows the metallographic section of the endplate weld of element # 3 of the CAMECO 37-element bundle. In this particular element and cross-section, the weld was skewed towards the OD side of the endplate which reduced the notch depth. The endcap has a conical shape similar to that of the GE 28-element bundle. However, the notch radius appears to be blunter than that of the GE 37-element and 28-element bundles. In addition, the weld discontinuity was either non-existent or much smaller than that of the GE bundles. Overall, the endplate weld of the CAMECO bundle is larger in weld area than those of the GE bundles (see also Figure 38 in a later discussion).

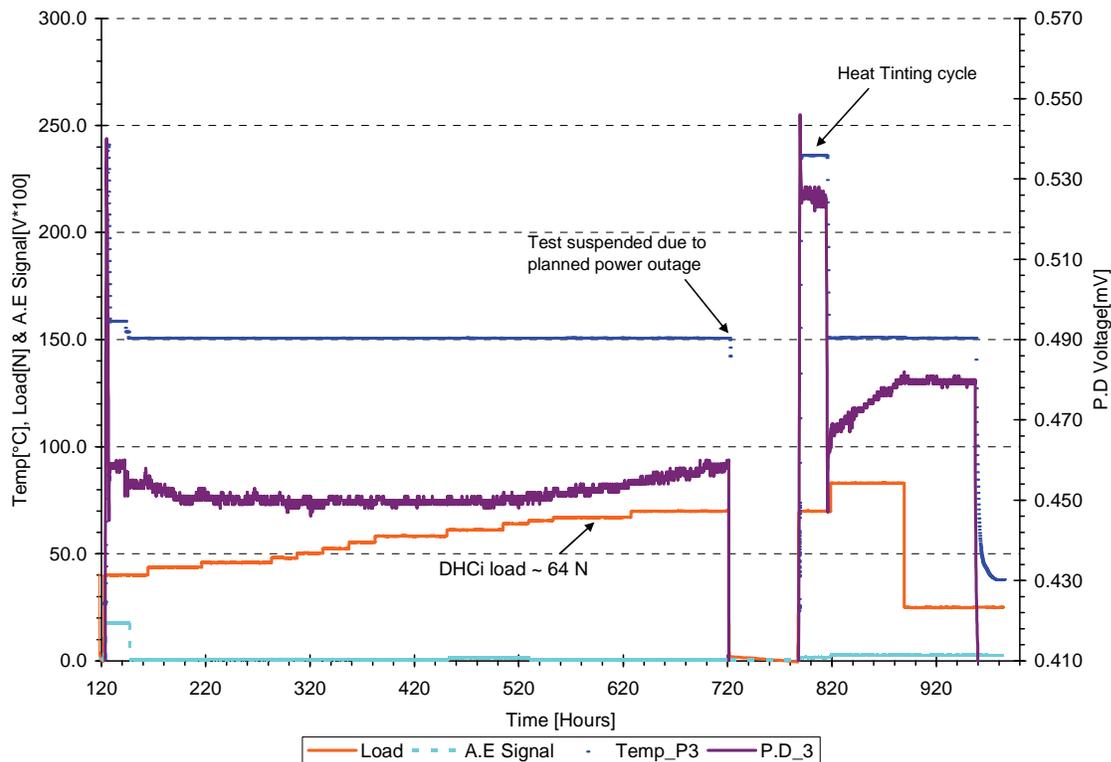
Figure 9: Record of K_{IH} and DHCV tests in Test 09-106 on element #2 the GE 37-element bundle; sample loaded on ID side of endplate

Test 09-106: This test was performed on the endplate weld of element #2 in DHC rig # 4 with the ID side of the endplate loaded under tension. The sample was subjected to both the K_{IH} and DHCV test procedures. Figure 9 shows the records of load, temperature, potential drop and acoustic emission of Test 09-106. The sample was loaded to about 43 N and then heated to 240°C, cooled and held at 150°C.

The load was increased incrementally at regular time intervals. The potential drop started to increase when the load was increased to 64 N. This was taken to be the crack initiation load. As observed in Shek and Wasiluk (2009), the acoustic emission technique was ineffective in detecting hydride cracking. The K_{IH} test was terminated after about 213 hours of crack growth

in which the load was raised to a final level of 70 N to obtain a steady crack growth, prior to a scheduled power outage. After the power outage, the DHC test was re-started by loading to 70 N and heated to 236°C, held for about 20 hours to heat-tint the DHC fracture surface. During the heat-tinting period, there was no increase in DHC growth as the temperature was approached by heating, similar to that observed in Shek and Wasiluk (2009). The temperature was then lowered to 150°C and the load was increased to 83 N for the DHCV portion of test. Cracking re-initiated without incubation time, as indicated by the steady increase in potential drop. The DHC test was terminated after 73 hours of crack growth.

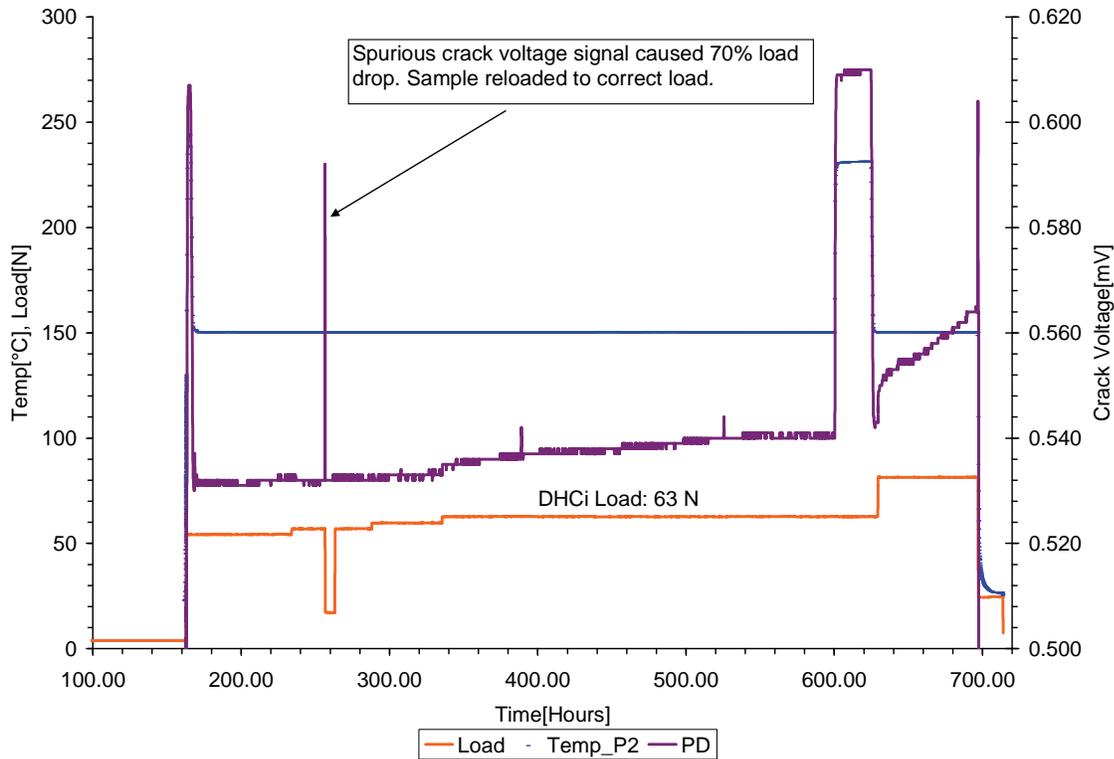
Figure 12: Record of K_{IH} and DHCV tests in Test 09-120 on element # 5 of the GE 37-element bundle; sample loaded on the ID side of endplate

There were spurious spikes in the d.c. potential drop during the test. A large spike occurred during the early part of the K_{IH} test which triggered a load-reduction. The load was restored to the same level prior to the load-reduction and testing was continued. Cracking was detected at an applied load of 63 N. This load was maintained for the remainder of the K_{IH} test. A couple of small voltage spikes occurred during this period after cracking has been initiated. The sample was then subjected to the heat-tinting cycle, followed by the DHCV test. It is judged that the spurious voltage spikes did not affect the test results, as they occurred either at a load level significantly below the crack initiation load or occurred after cracking has already been initiated.

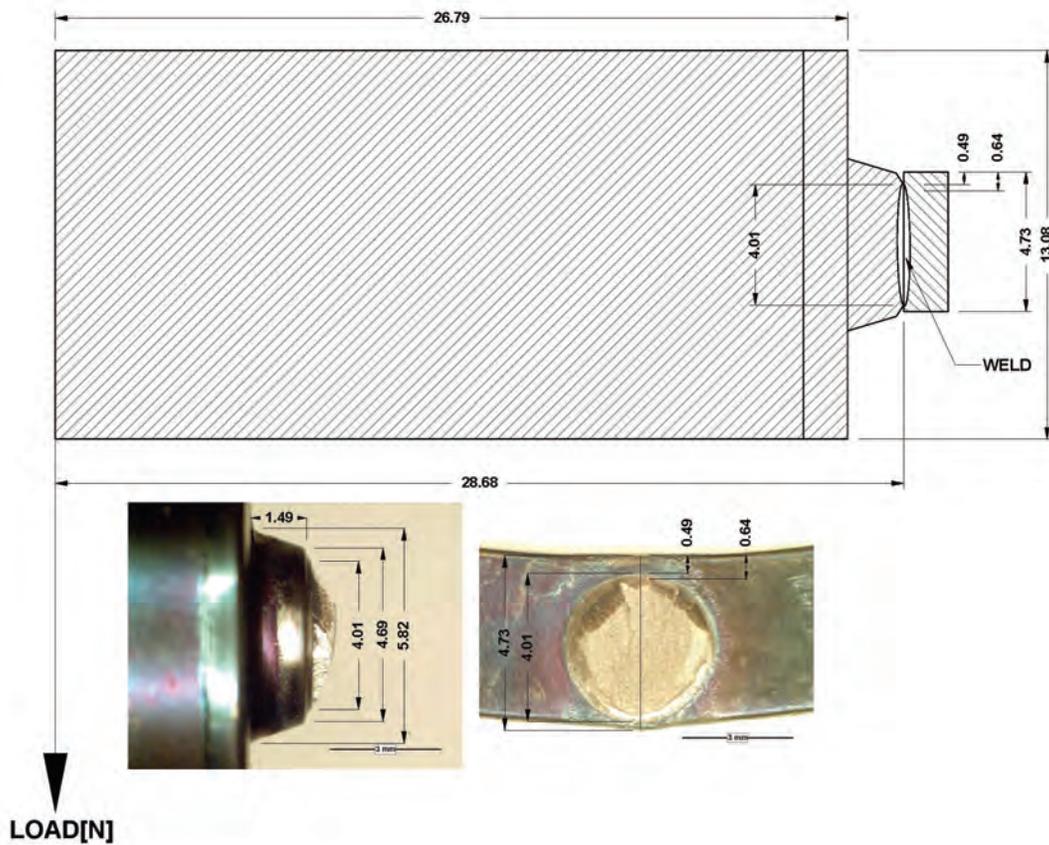
Figure 14: Dimensions of welds measured from fracture surfaces in Test 09-120

Figure 13 shows the fracture surfaces of the DHC cracks on the endcap and endplate side. The two crack segments corresponding to the K_{IH} and DHCV are similar in appearance as that of Test 09-106. Cracking appeared to be initiated at the two locations about 45° from the top of the weld. Figure 14 shows the dimensions of the weld measured from the fracture surfaces and a schematic diagram of the endplate and endcap notch constructed from the measured dimensions.

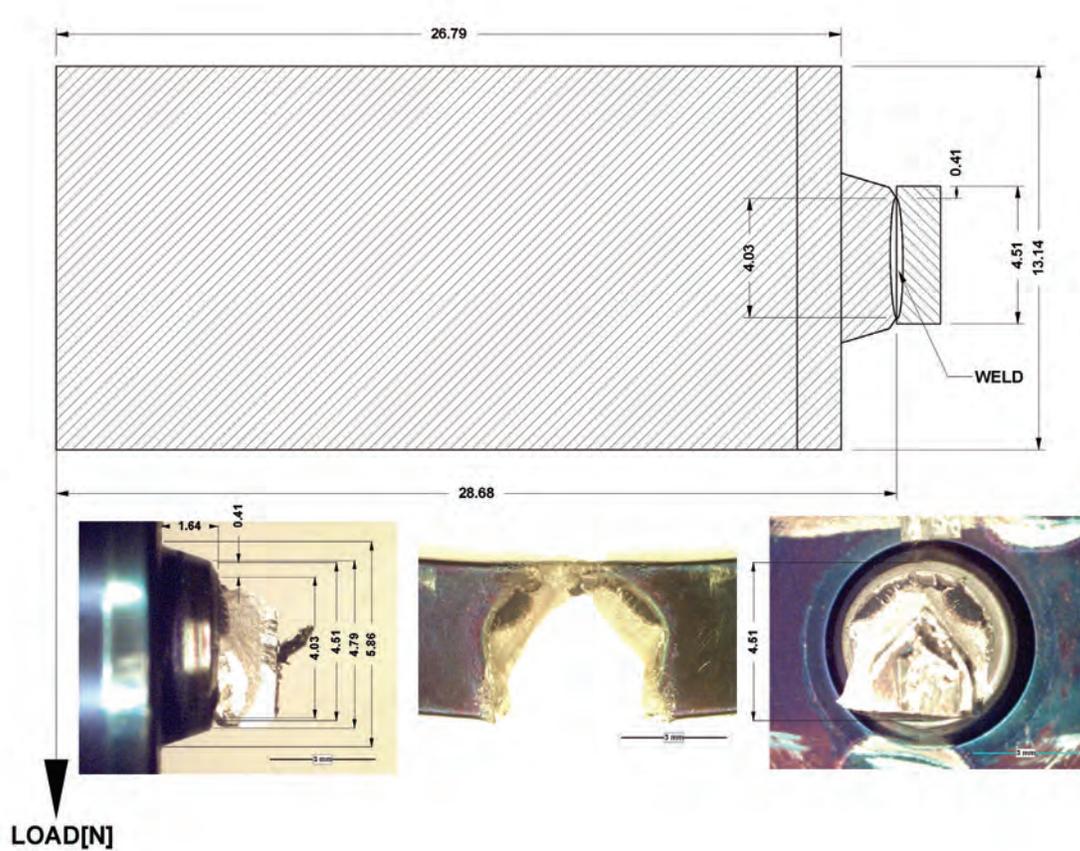
Figure 16: Dimensions of welds measured from fracture surfaces in Test 09-136

Figure 15 shows the fracture surfaces of the DHC cracks on the endcap and endplate side. The endplate strip was torn off in the attempt to break open the cracked sample. The two crack segments corresponding to the K_{IH} and DHCV are clearly visible and cracking appeared to be initiated at the two locations about 45° from the top of the weld. Figure 16 shows the dimensions of the weld measured from the fracture surfaces and a schematic diagram of the endplate and endcap notch constructed from the measured dimensions.

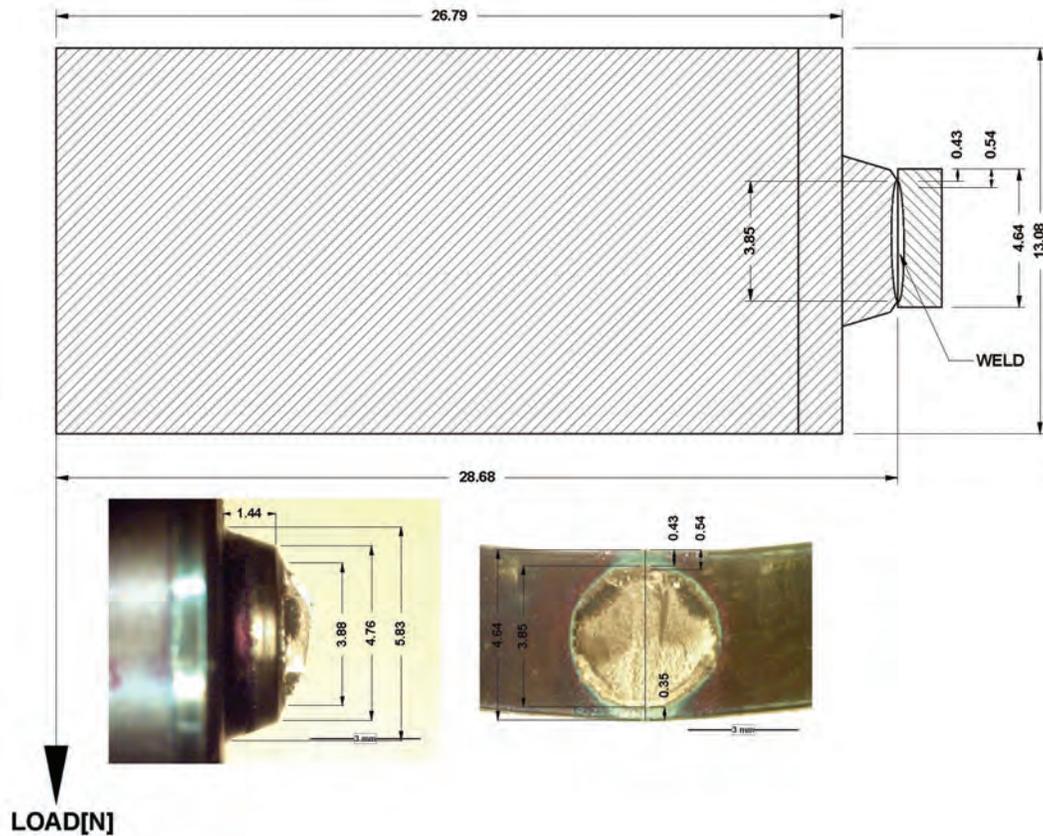
Figure 18: Dimensions of welds measured from fracture surfaces in Test 09-148

Figure 17 shows the fracture surfaces of the DHC cracks on the endcap and endplate side. The two crack segments corresponding to the K_{IH} and DHCV are clearly visible in which cracking appeared to be initiated at the two locations about 45° from the top of the weld. Figure 18

shows the dimensions of the weld measured from the fracture surfaces and a schematic diagram of the endplate and endcap notch constructed from the measured dimensions.

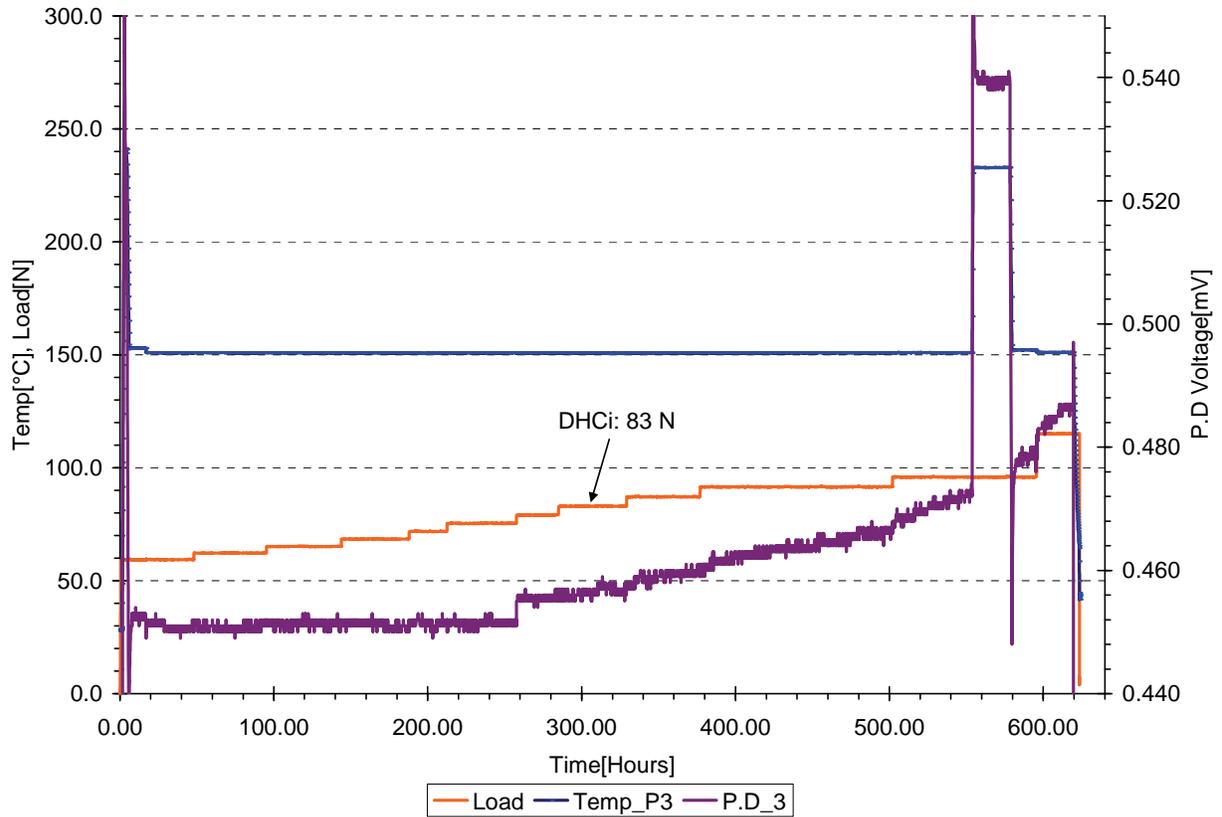
Figure 19: Record of K_{IH} and DHCV tests in Test 09-124 of the GE 37-element bundle; sample was loaded on the OD side of the endplate

Test 09-124: : This test was performed on the endplate weld of Element # 17 in DHC rig # 4 with the OD side of the endplate loaded under tension. The sample was subjected to both the K_{IH} and DHCV test procedures. Figure 19 shows the test record which indicated that cracking initiated at an applied load of 83 N.

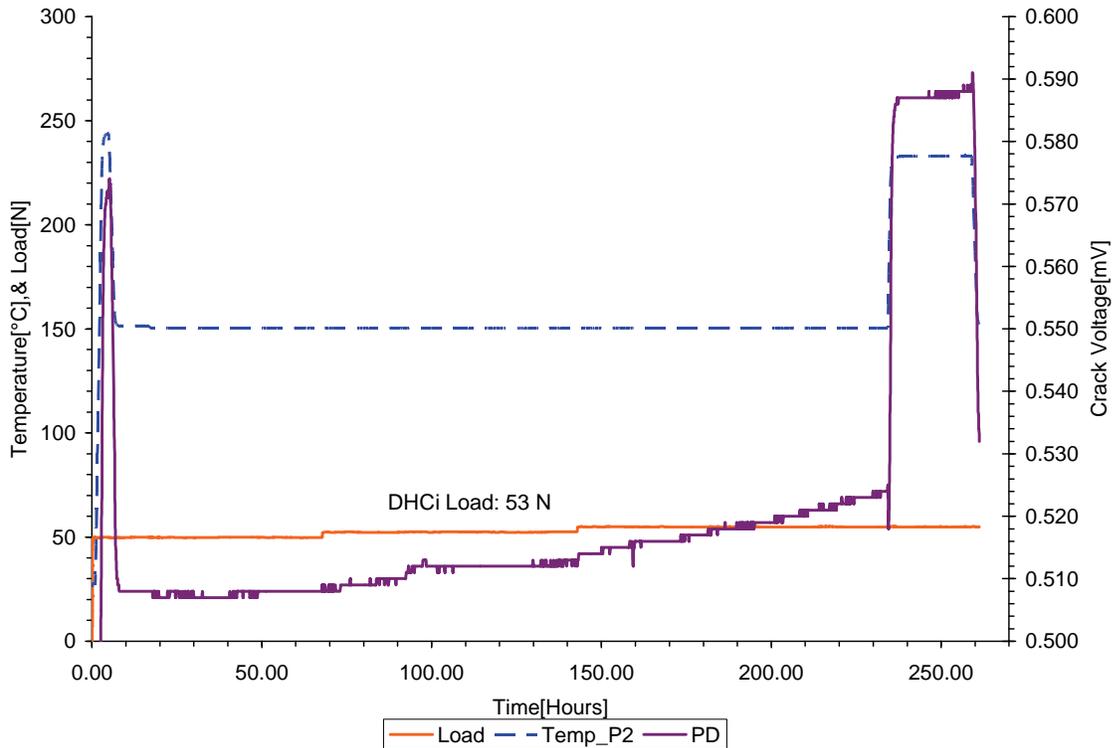
Figure 23: Record of K_{IH} test in Test 09-125 on element # 2 of the GE 28-element bundle; sample loaded on the ID side of the endplate

subjected to the K_{IH} test only. Figure 23 shows the test record which indicated that cracking initiated at an applied load of 53 N and steady crack growth was obtained with further increase in load. The crack initiation load of 53 N is lower than that of the welds from the GE 37-element bundle.

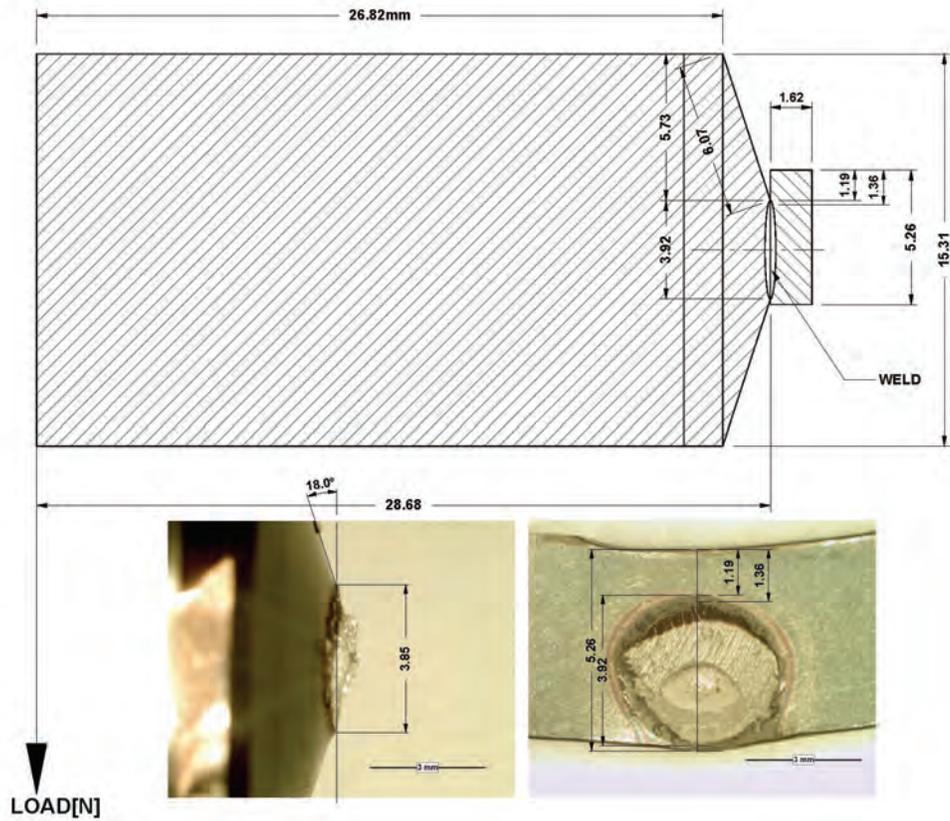
Figure 25: Dimensions of welds measured from fracture surfaces in Test 09-125 on GE 28-element bundle

Figure 24 shows the fracture surface of the DHC crack after heat-tinting. The location of crack initiation appeared to be at the top of the weld, as the crack was longest at that location. The weld was skewed towards the OD side of the endplate. This is consistent with the result of metallographic examination shown in Figure 4. In addition, the weld area appeared to be closer to an elliptical shape instead of the “circular” shape observed in the welds of the GE 37-element bundle. Figure 25 shows the dimensions of the weld measured from the fracture surfaces and a schematic diagram of the endplate and endcap notch constructed from the measured dimensions. The notch depth on the ID side was deeper than that of the welds from the GE 37-element bundle, as a result of the weld skewing towards the OD side of the endplate. Therefore, it is expected that higher load will be required to initiate DHC from the OD side of the endplate.

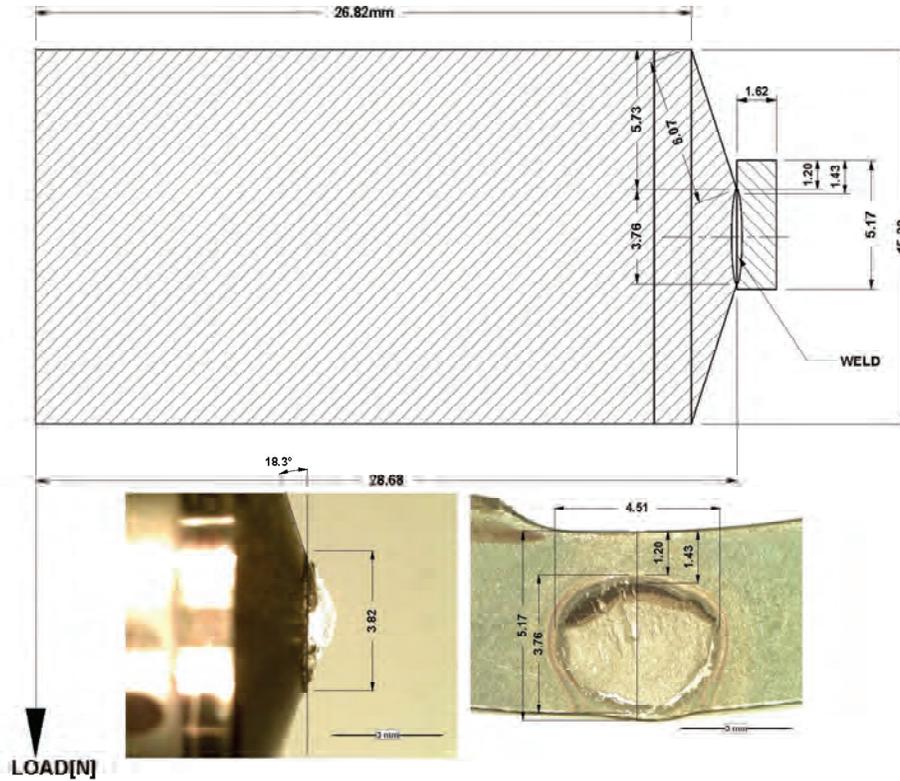
Figure 27: Dimensions of welds measured from fracture surfaces in Test 09-130 on GE 28 element bundle

Figure 26 shows the fracture surfaces on the endcap and endplate side. The two crack segments corresponding to the K_{IH} and DHCV test are clearly visible. The fracture surface is similar to that of Test 09-125 in which cracking appeared to have initiated near the top of weld. The weld had an elliptical shape and was skewed towards the OD side of the endplate. Figure 27 shows the dimensions of the weld measured from the fracture surfaces and a schematic diagram of the endplate and endcap notch constructed from the measured dimensions. The

profile and location of the weld with respect to the endplate are similar to that of the sample in Test 09-125.

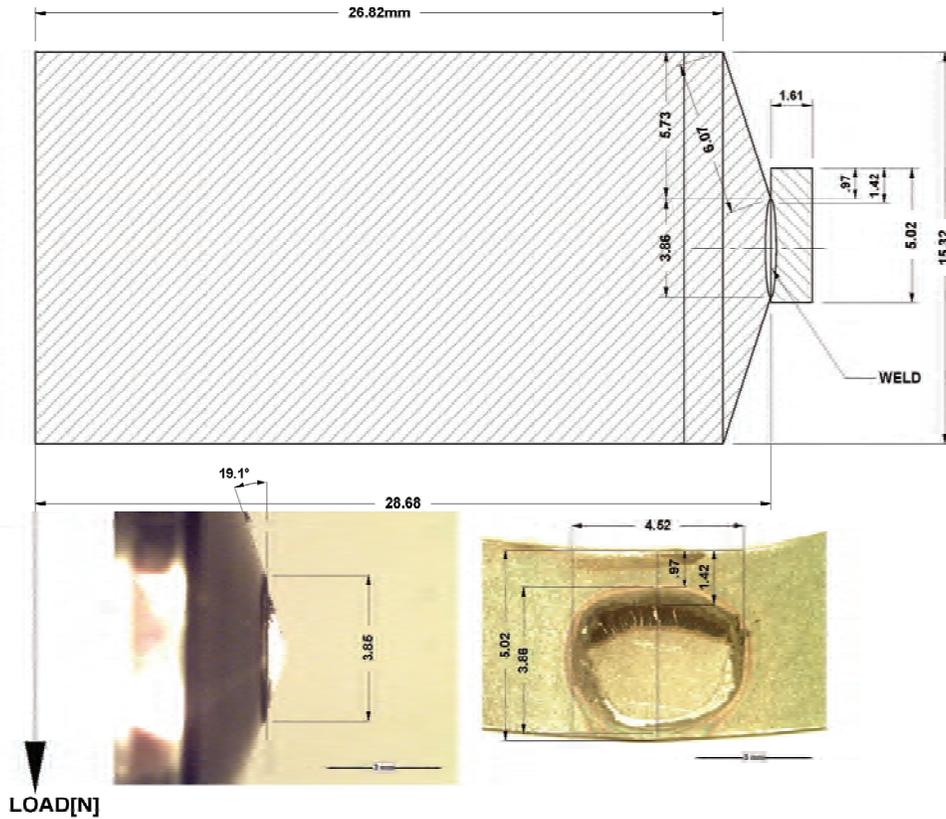
Figure 29: Dimensions of welds measured from fracture surfaces in Test 09-144 on GE 28-element bundle

Figure 28 shows the fracture surface on the endcap and endplate side which are similar to that of Tests 09-125 and 09-130. Cracking appeared to have initiated from the top of the weld. The

weld had an elliptical shape and skewed towards the OD side of the endplate. Figure 29 shows the dimensions of the weld measured from the fracture surfaces and a schematic diagram of the endplate and endcap notch constructed from the measured dimensions.

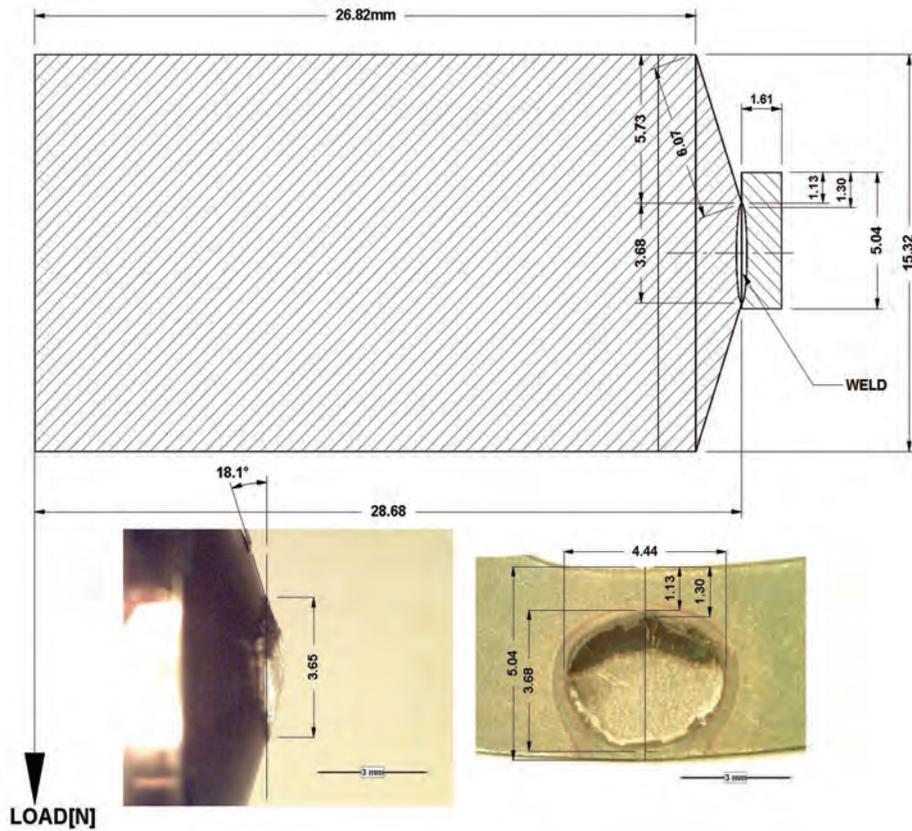
Figure 31: Dimensions of welds measured from fracture surfaces in Test 09-172 on GE 28 element bundle

Figure 30 shows the fracture surfaces on the endcap and endplate side. The two crack segments corresponding to the K_{IH} and DHCV test are visible. Cracking was initiated at the top of weld. The weld had an elliptical shape and was skewed towards the OD side of the endplate. Figure 31 shows the dimensions of the weld measured from the fracture surfaces and a schematic diagram of the endplate and endcap notch constructed from the measured dimensions.

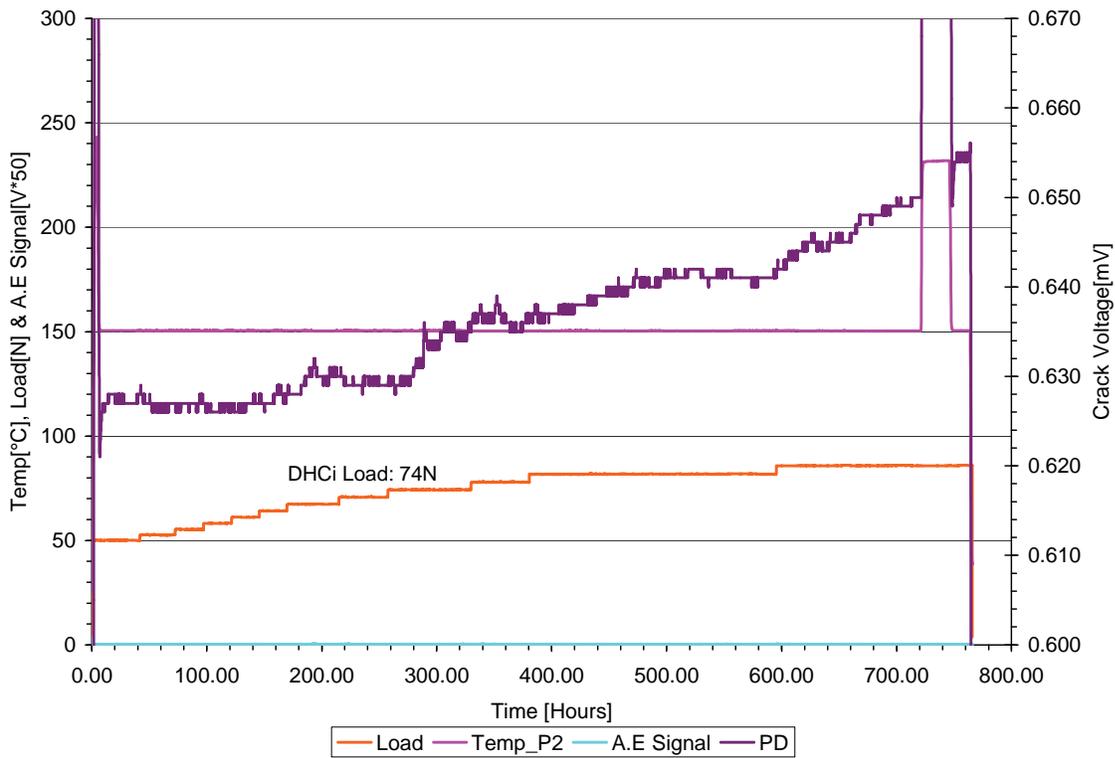
Figure 32: Record of K_{IH} and DHCV tests in Test 09-182 on element # 8 of the GE 28-element bundle; sample loaded on the OD side of the endplate

Test 09-182: This test was performed on the endplate weld of element # 8 in DHC rig # 6 with the OD side of the endplate loaded under tension. The sample was subjected to both the K_{IH} and DHCV test procedures. Figure 32 shows the test record which indicates that cracking initiated at an applied load of 74 N, which is significantly higher than the tests with the sample loaded on the ID side.

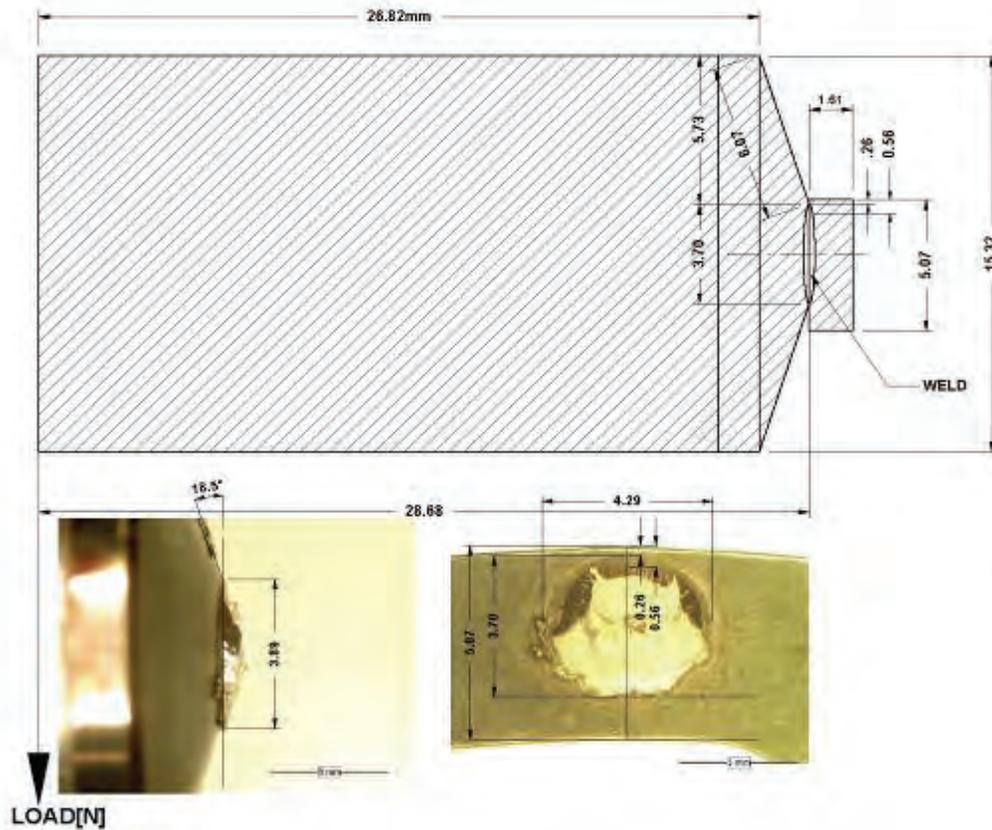
Figure 34: Dimensions of welds measured from fracture surfaces in Test 09-182 on GE 28 element bundle

Figure 33 shows the fracture surfaces on the endcap and endplate side. Unlike the tests with the samples loaded on the ID side, cracking appeared to have initiated near the 45° away from the top of the weld. The weld was skewed towards the OD side of the endplate. Figure 34 shows the dimensions of the weld measured from the fracture surfaces and a schematic diagram of the endplate and endcap notch constructed from the measured dimensions.

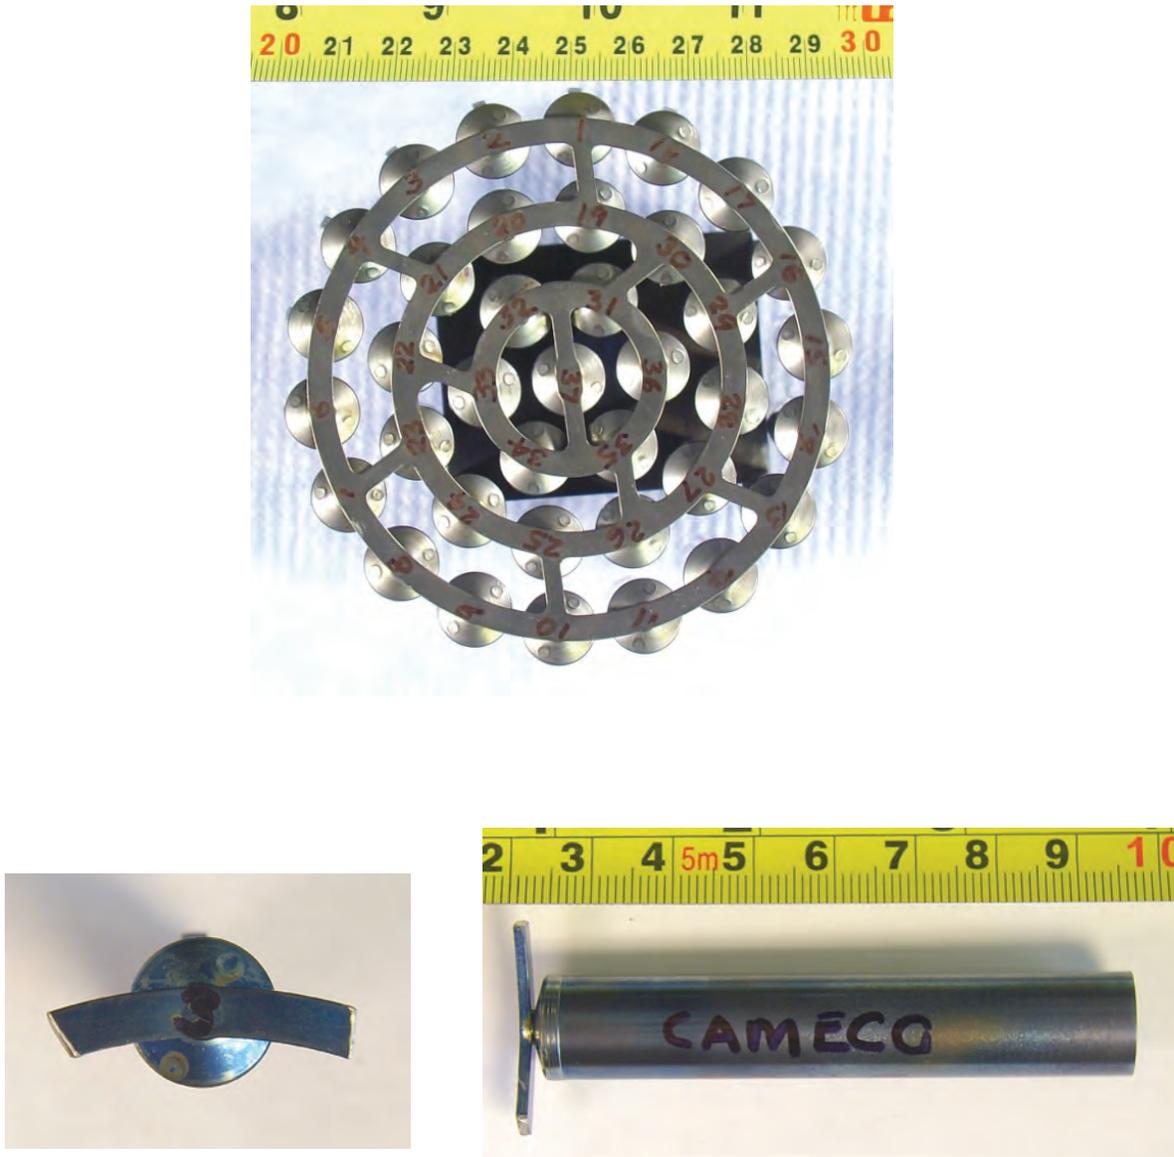
Figure 35: Sample for Test 09-135 from the CAMECO 37-element bundle

Test 09-135: This test was performed on the endplate weld of element # 6 in DHC rig # 6 in with the ID side of the endplate loaded under tension. Figure 35 shows the sample which was subjected to the K_{IH} test procedure only. Figure 36 shows the test record. No increase in potential drop was observed after the load was incrementally increased to 80 N. At this load level, significant vertical deflection of the sample was observed through the furnace window. Testing was terminated at this stage without the heat-tinting cycle.

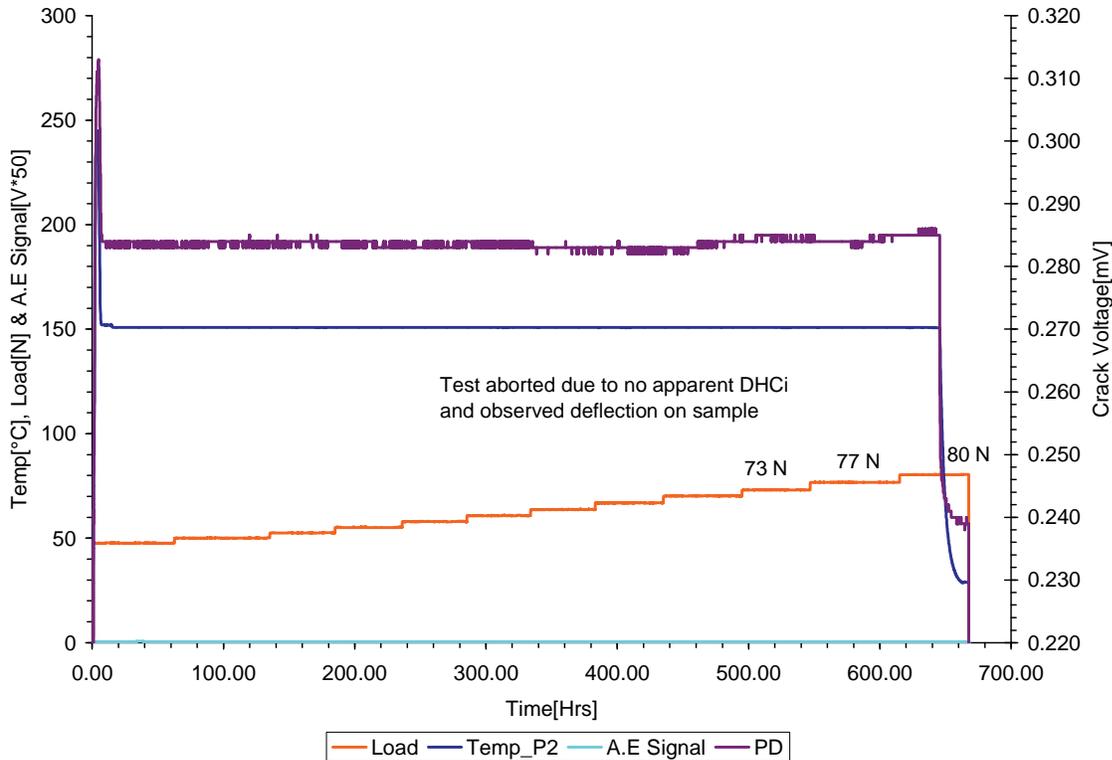
Figure 36: Records of Test 09-135 on element #3 of the CAMECO 37-element bundle

Assuming a maximum crack length of 424 μm and a DHCV of 8×10^{-10} m/sec (see other CAMECO test summarized in Table 5), it is estimated that the cracking time was about 147 hours. This suggests that cracking was initiated at 73 N according to the record shown in Figure 36. As fractographic examination was not performed to characterize the dimensions of the weld geometry and depth of weld discontinuity, it was not feasible to calculate the K_{IH} value of this endplate weld.

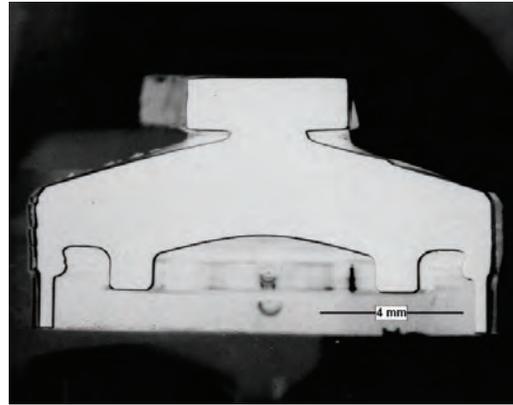
After the DHC test, the sample was examined metallographically to determine the notch profile and weld continuity. The sample was sectioned near the edge the weld (Figure 37a), mounted and then ground towards the weld. Figure 37b shows the section in the as-polished condition at about 1.7 mm from the mid-section of the weld. It should be noted that the notch at this plane

(b) As-polished; 1.7 mm from centre of weld

Figure 37: DHC crack shown in metallographic section about 1.7 mm from mid-section of weld of sample from Test 09-135

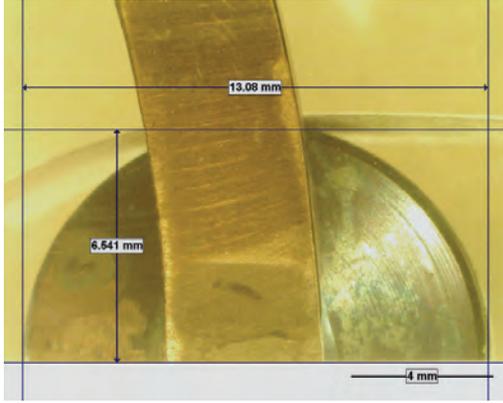
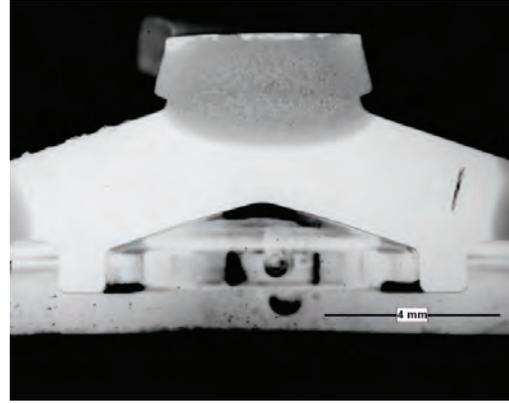
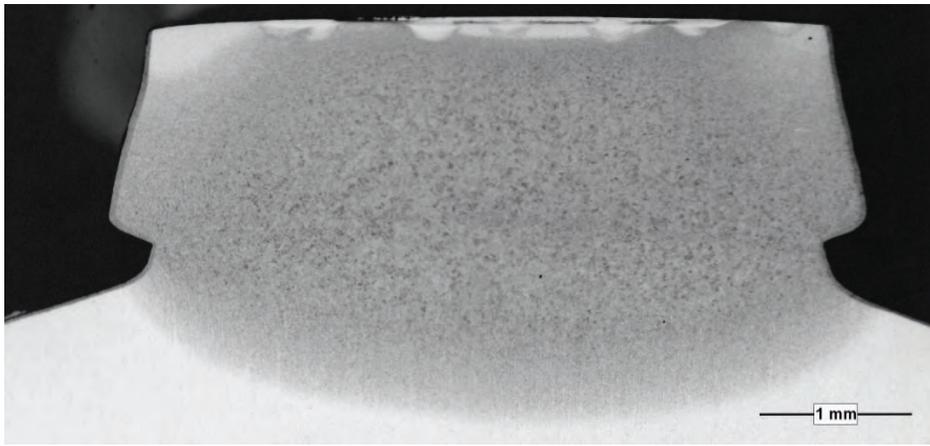
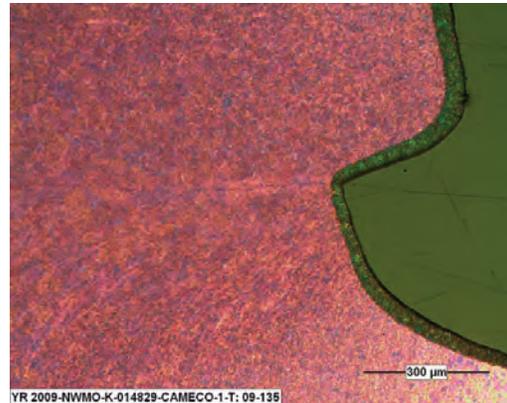
Figure 38: Metallographic section near centre of weld of sample from Test 09-135

will appear deeper, as it is not at the mid-section of the weld. At higher magnification, a crack was observed at the ID side of the weld which grew at about 30° into the endplate side of the weld (Figure 37c). The sample was anodized which revealed the hydride layer on the sample surface (Figure 37d). At the higher magnification, the crack path appeared to be decorated with hydride particles. At this plane, the DHC crack was about 424 μm long. Upon further grinding to the mid-section of the weld, the crack disappeared as shown in Figure 38. The notch at the mid-section of the weld was relatively blunt and no weld discontinuity was observed.

(c) Anodized showing the weld and heat-affected-zone

(e) Anodized, OD side
