Determination of the Threshold Stress Intensity Factor and Velocity of Delayed Hydride Cracking of Endplate Welds in CANDU Fuel Bundles with Different Design and Manufacturers

NWMO TR-2010-25

G. K. Shek

Kinectrics Inc.

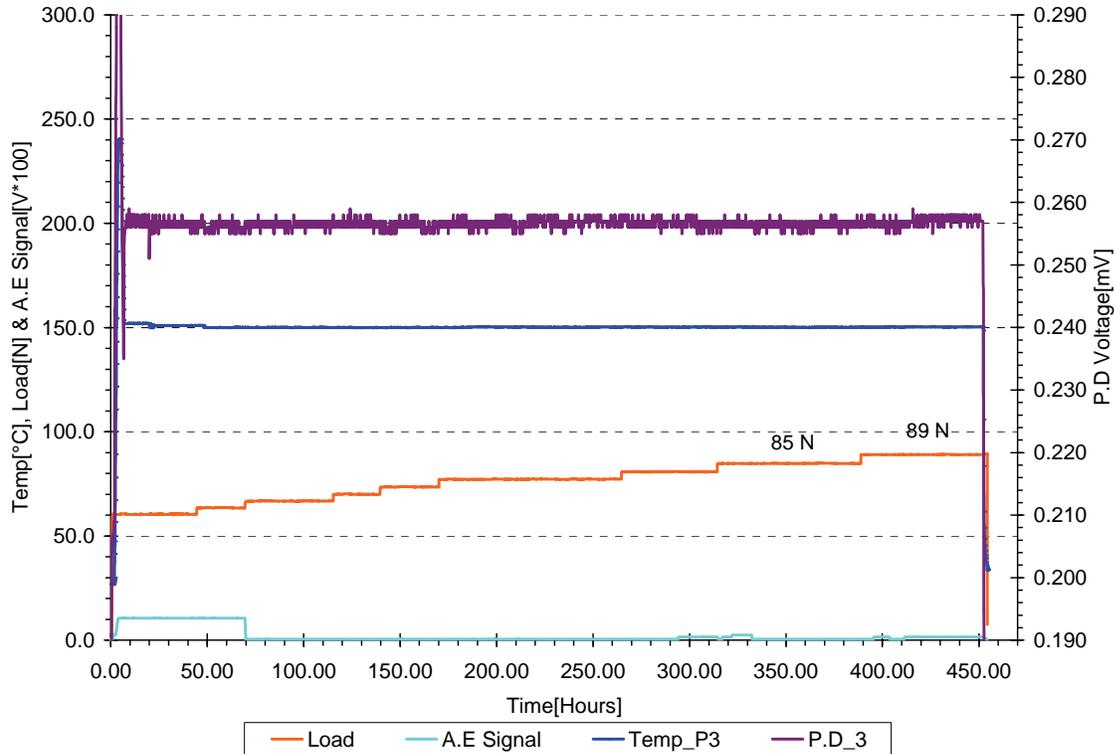
Figure 39: Record of K_{IH} test in Test 09-186 on element #18 of the CAMECO 37-element bundle; sample loaded on ID side of endplate

Test 09-186: The test was performed on the endplate weld of element # 18 in DHC rig # 4 with the ID side of the endplate loaded under tension. The sample was subjected to the K_{IH} test procedure only. This test was performed at the same time as 09-135 in a separate loading rig. Figure 39 shows the test record in which no cracking was detected at a final load of 89 N. At this load, there was a large deflection of the sample and testing was terminated without the heat-tinting thermal cycle

After the DHC test, the sample was peeled open and a small crack with a thin surface oxide was observed at a location about 45° from the top (Figure 40). The crack length was estimated to be about 0.25 mm. Using an estimated DHCV of 8×10^{-10} m/sec, the estimated cracking time was about 88 hours which suggested that cracking was initiated at a load of 85 N, according to test record shown in Figure 39.

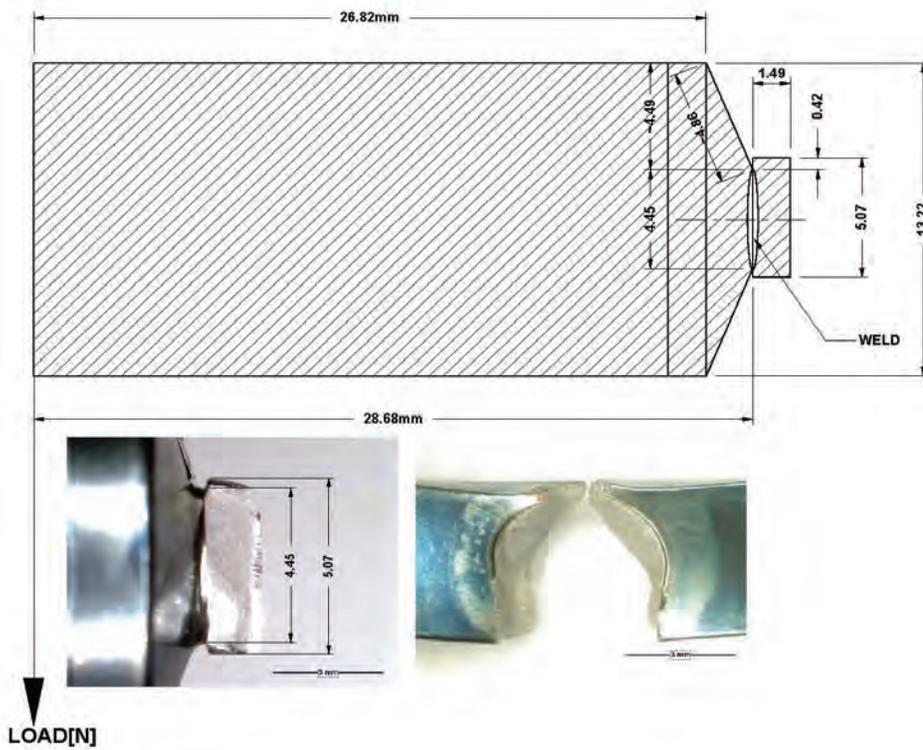
Figure 41: Dimensions of welds measured from fracture surfaces in Test 09-186 on CAMECO 37-element bundle

Figure 41 shows the dimensions of the weld measured from the fracture surfaces and a schematic diagram of the endplate and endcap notch constructed from the measured dimensions. The K_{IH} value for this weld was calculated in Wasiluk (2011) and the result is shown in Table 5.

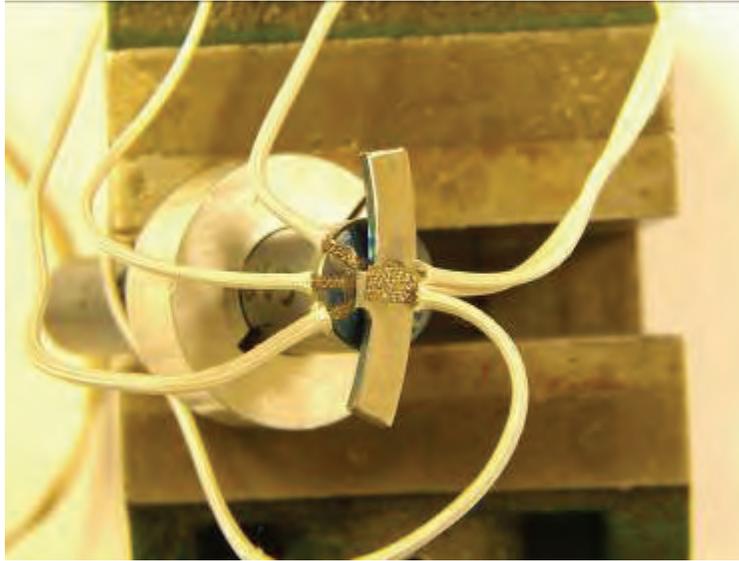
Figure 42: Three sets of potential drop leads were placed on the sample of some of the tests performed on CAMECO 37-element fuel bundle

Test 09-204: The test was performed on the endplate weld of element # 5 in DHC rig # 4 with the ID side of the endplate loaded under tension. The sample was subjected to both K_{IH} and DHCV test procedures. In this test, three sets of potential drop probes were used for crack detection: at the top of the weld and at the two locations about 45° away from the top of the weld (Figure 42). Figure 43 shows the test record of Test 09-204 which indicates that cracking appears to initiate at both 45° locations at an applied load of 80 N.

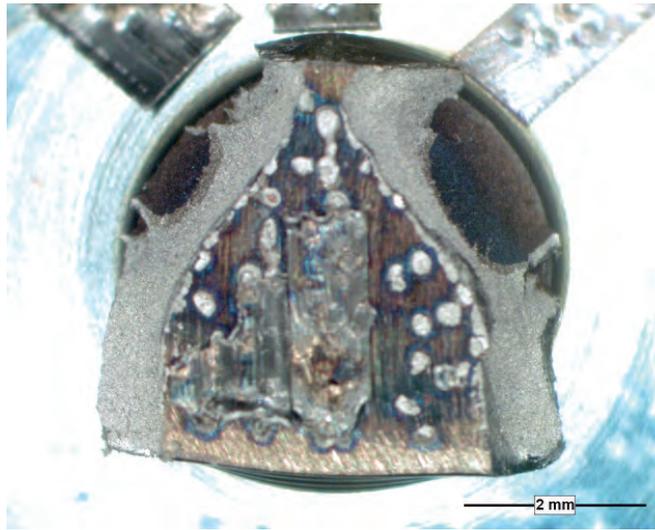
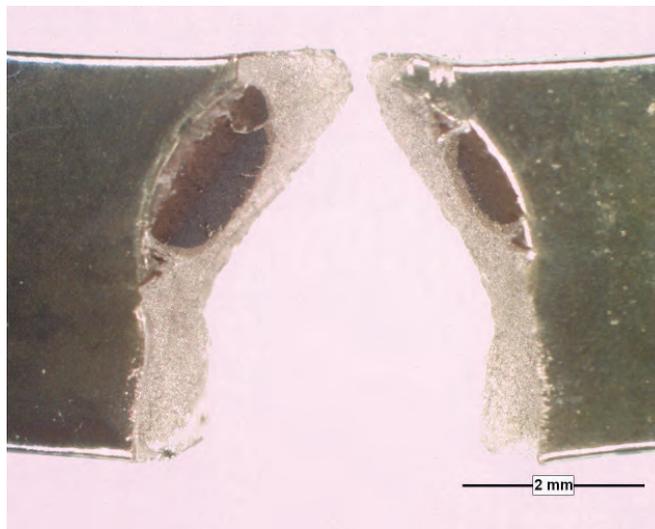
Figure 44: Fracture surfaces of sample in Test 09-204 of CAMECO 37-element bundle

Figure 44 shows the fracture surfaces of the DHC cracks on the endcap and endplate side. The two crack segments corresponding to the K_{IH} and DHCV are visible in which cracking appeared to be initiated at the two locations about 45° from the top of the weld. Figure 45 shows the dimensions of the weld measured from the fracture surfaces and a schematic diagram of the endplate and endcap notch constructed from the measured dimensions. The K_{IH} value for this weld was calculated in Wasiluk (2011) and the result is shown in Table 5.

(a) Fracture surface on endcap side

(b) Fracture surface on endplate side

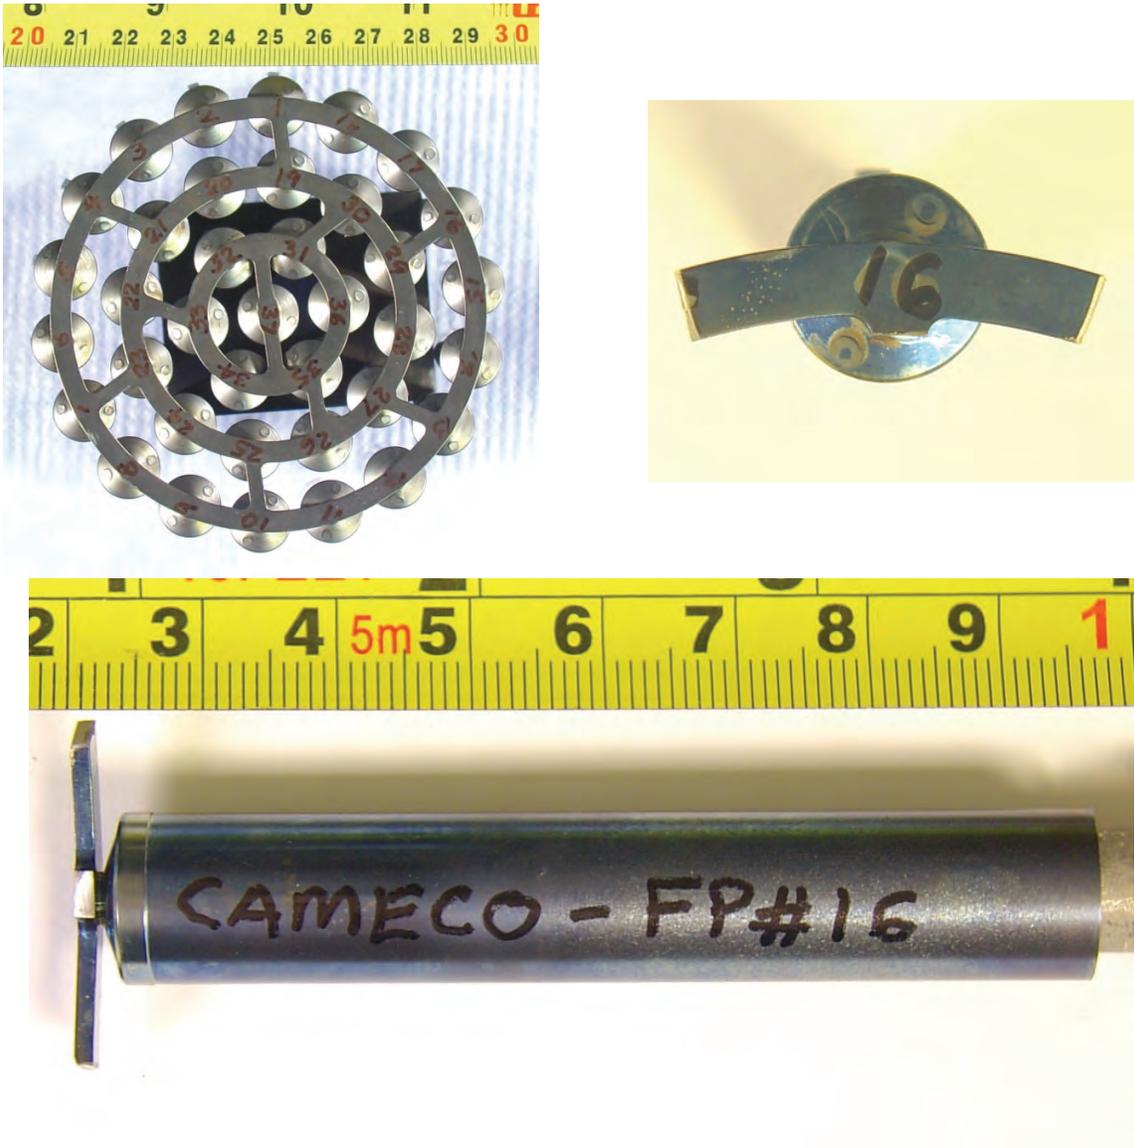
Figure 46: Sample for Test 09_208 from the CAMECO 37-element bundle; Element 16 is at one of locations with the radial brace between the outer and intermediate rings

Test 09-208: The test was performed on the endplate weld of element # 16 in DHC rig # 6 with the ID side of the endplate loaded under tension. As shown in Figure 46, the endplate of this sample contained a portion of the radial brace material. The sample was subjected to the K_{IH} test procedure only. Similar to the set-up in Test 09-204, three sets of potential drop probes were used for crack detection. However, the potential drop probe at the top of the weld was detached during testing and no data was obtained from that probe. Figure 47 shows the test record of Test 09-208 which indicates that cracking appears to initiate at both 45° locations at an applied load of 80 N.

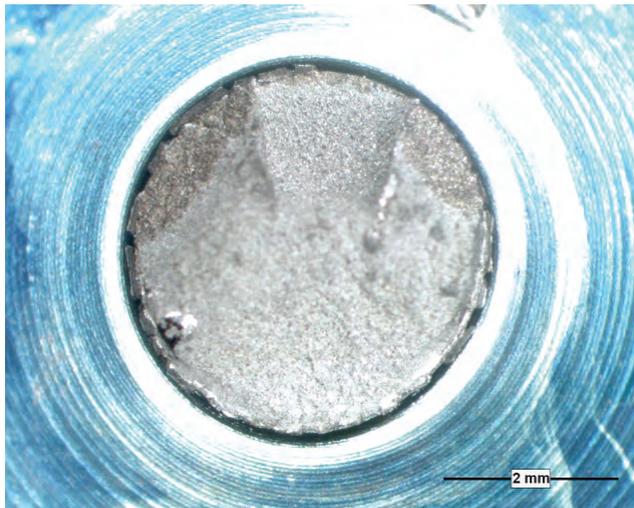
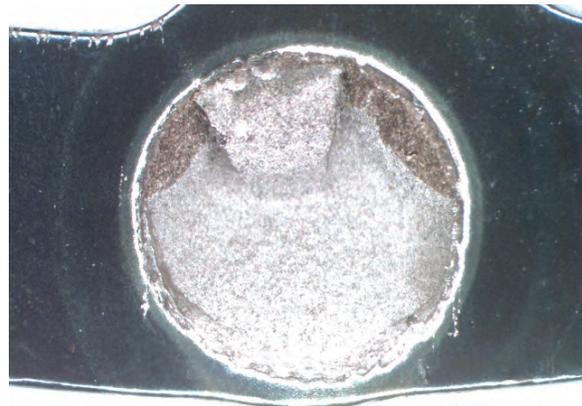
Figure 48: Fracture surfaces of sample in Test 09_208 on CAMECO 37-element bundle

Figure 48 shows the fracture surfaces of the DHC cracks on the endcap and endplate side. Cracking appears to be initiated at the two locations about 45° from the top of the weld. Figure 49 shows the dimensions of the weld measured from the fracture surfaces and a schematic diagram of the endplate and endcap notch constructed from the measured dimensions. As discussed in Wasiluk (2011), the K_{IH} value of this endplate could not be determined using the current finite-element model as a result of the presence of the brace material in the endplate.

(a) Fracture surface on endcap side

(b) Fracture surface on endplate side

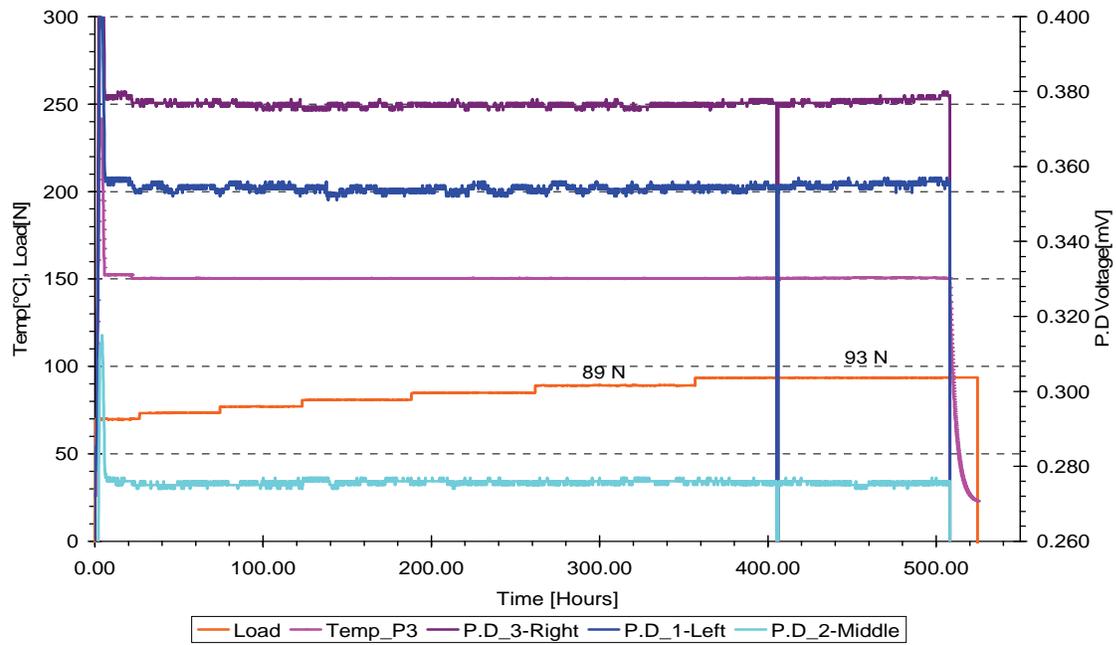
Figure 50: Record of K_{IH} test in Test 10-16 of the CAMECO 37-element bundle

Test 10-16: The test was performed on the endplate weld of element # 9 in DHC rig # 4 with the ID side of the endplate loaded under tension. The sample was subjected to the K_{IH} test procedure only. Three sets of potential drop probes were used for crack detection. Figure 50 shows the test record of Test 10-16 in which no clear indication of cracking was detected by the potential drop technique when the test was terminated at an applied load 93 N.

After the DHC test, the sample was peeled open and a small crack with a thin surface oxide was observed at a location about 45° from the top (Figure 51). The maximum crack length was measured to be about 0.31 mm. Using an estimated DHCV of 8×10^{-10} m/sec, the estimated cracking time was about 108 hours which suggested that cracking was initiated at the final load of 93 N according to the test record shown in Figure 50.

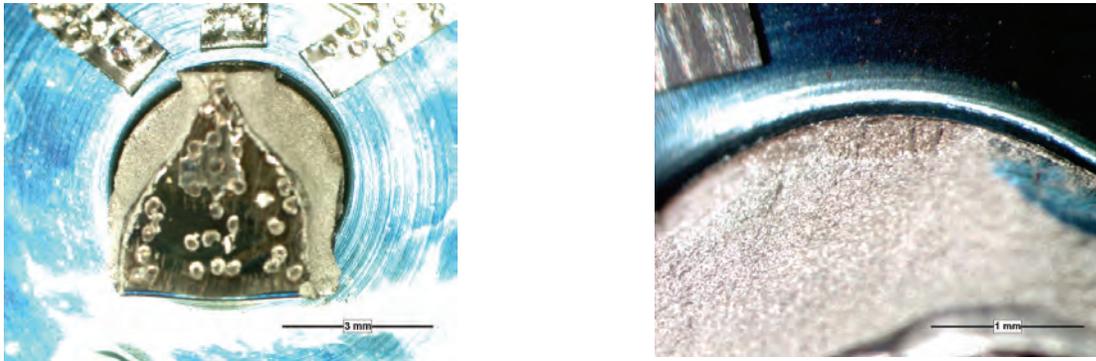
Figure 51: Fracture surfaces of sample in Test 10-16 on CAMECO 37-element bundle

(a) Fracture surface on endcap side at two magnifications

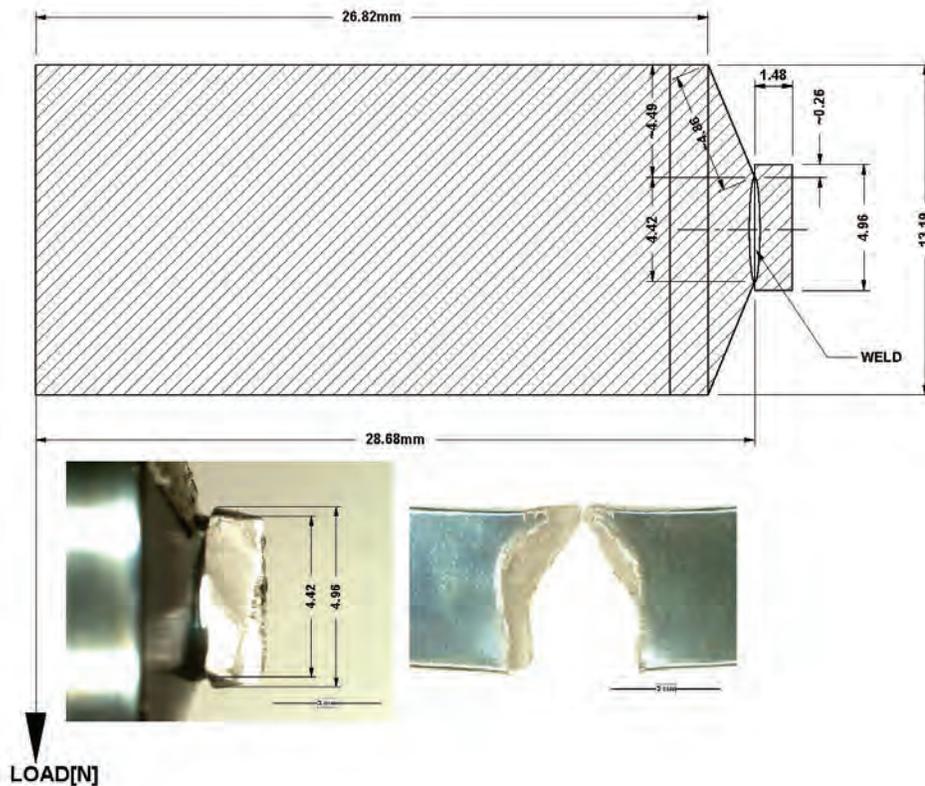
Figure 52: Dimensions of welds measured from fracture surfaces in Test 10-16

Figure 52 shows the dimensions of the weld measured from the fracture surfaces and a schematic diagram of the endplate and endcap notch constructed from the measured dimensions. The K_{IH} value for this weld was calculated in Wasiluk (2011) reference [4] and the result is shown in Table 5.

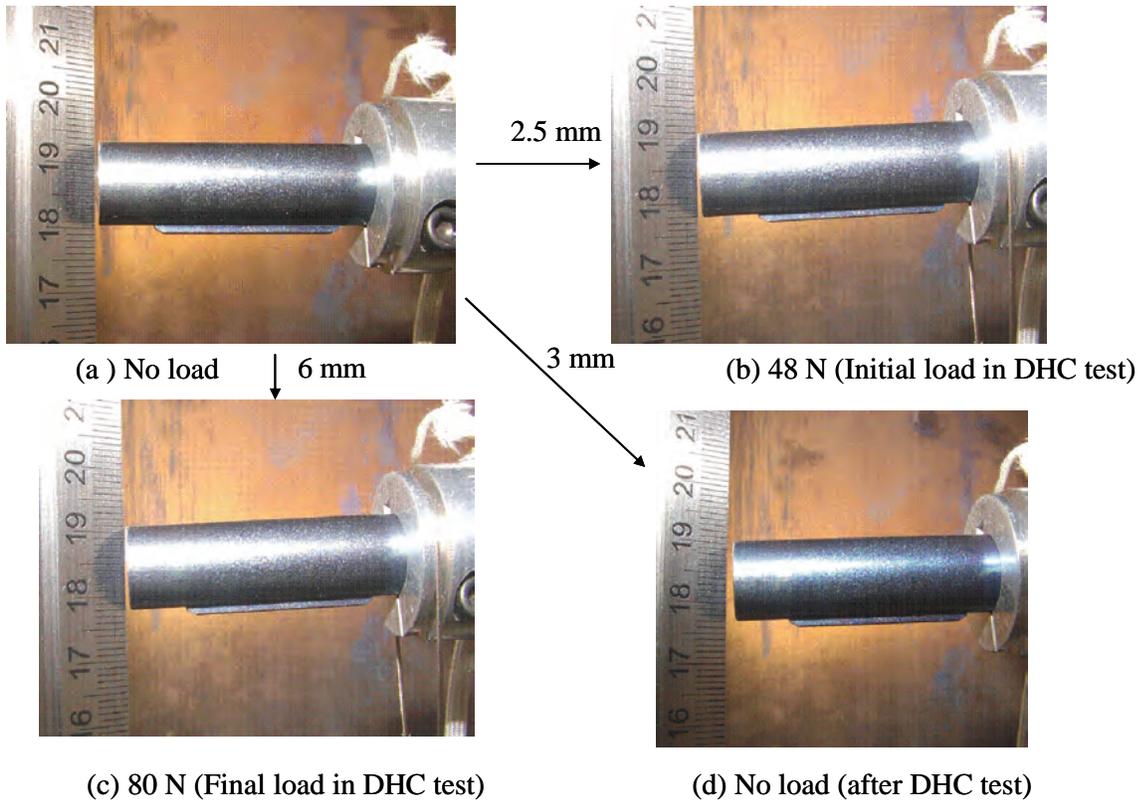
Figure 53: Deflection of sample in Test 09-135 (CAMECO bundle, DHC ring #6) at different loading stages

In Section 3.3, it was mentioned that significant sample deflection was observed towards the end of the K_{IH} tests when the samples were loaded to a relatively high load. This is illustrated in Figure 53 showing the sample deflection at various stages in Test 09-135 (CAMECO sample loaded from the ID side in Test Rig # 6). Figure 53a is the reference position when the sample was installed in the loading rig without applied load. The end of the sample was deflected for about 2.5 mm when a load of 48 N was applied at room temperature before enclosing the loading assembly in the furnace (Figure 53b). If the load was removed at this stage, the sample would spring back to the reference position. The deflection increased to about 6 mm when the applied load was raised to 80 N at the end of the K_{IH} test (Figure 53c). The 6 mm deflection was measured at room temperature after the furnace was removed from the loading assembly. When the load was removed at this stage, there was a permanent deflection of about 3 mm from the reference position (Figure 53d).

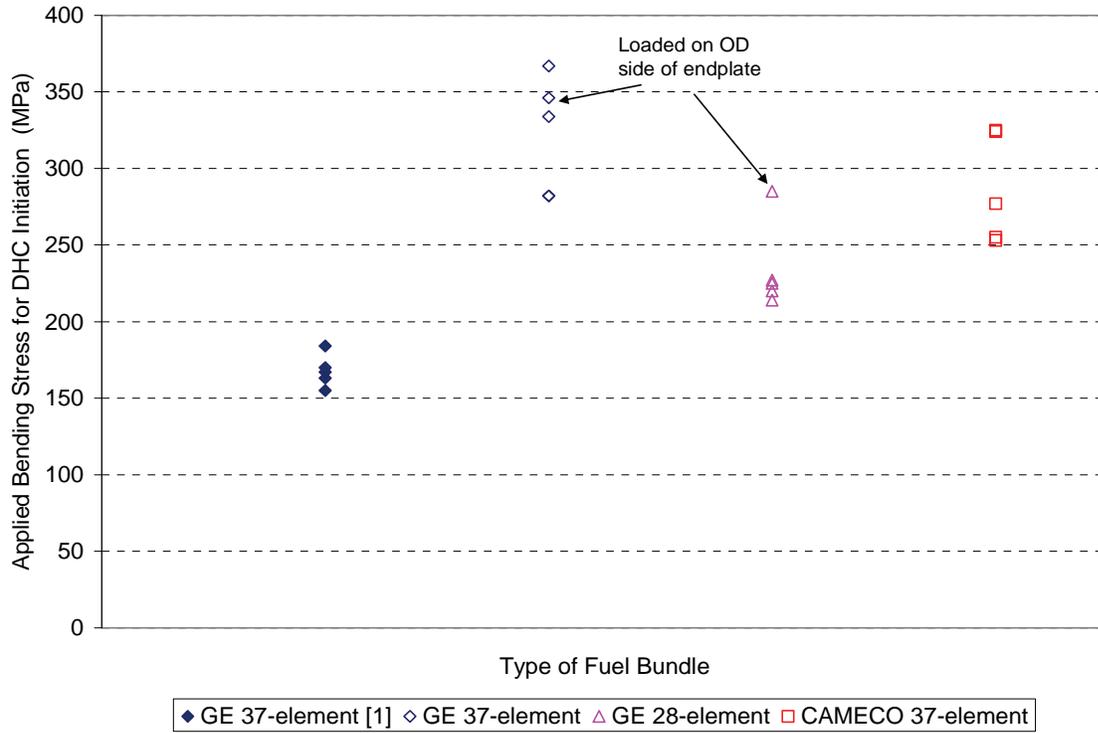
Figure 54: Comparison of applied bending stress for DHC initiation of endplate welds from different fuel bundles

Figure 54 compares the applied bending stresses for DHC initiation from the endplate welds of the three fuel bundles tested in the current program and the GE 37-element bundle tested in Shek and Wasiluk (2009). The applied bending stresses to initiate DHC cracking were lower for the GE 37-element bundle tested in Shek and Wasiluk (2009). For the three bundles tested in the current program, it appears that the GE 37-element bundle welds had the highest bending stresses for DHC initiation, followed by the CAMECO 37-element bundle. The GE 28-element bundle welds had the lowest bending stresses for DHC initiation. For the GE 28-element bundle, the bending stress required for DHC initiation was higher when the weld was loaded on the OD side of the endplate than when it was loaded from the ID side, due to the difference in notch depth as a result of the weld skewed towards the OD side. The variability in applied bending stress for DHC initiation from the endplate welds of the different fuel bundles is likely due to both differences in weld geometry and material properties.

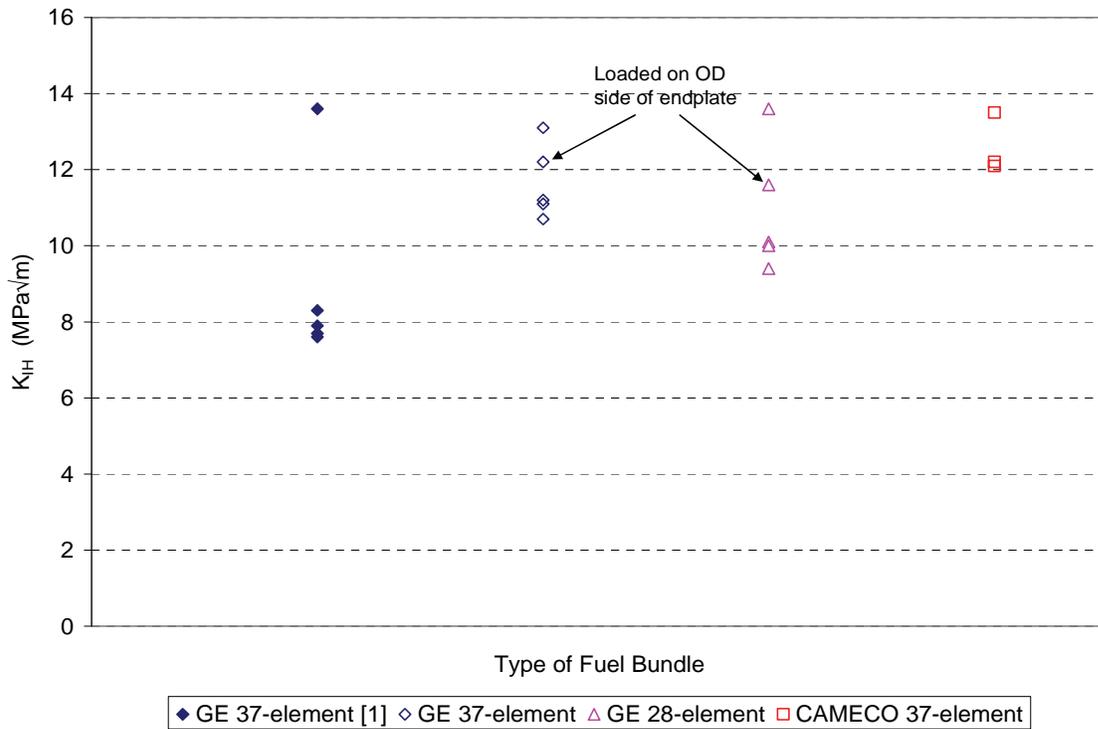
Figure 55: Comparison of KI_H values of endplate welds from different fuel bundles

Figure 55 compares the K_{IH} values for DHC initiation from the endplate welds of the three fuel bundles tested in the current program and the GE 37-element bundle tested in Shek and Wasiluk (2009). It appears that there were no large differences in K_{IH} values among the endplate welds of the three bundles tested in the current program. Furthermore, there was no large difference in K_{IH} values between the welds loaded on the ID and OD side of the endplate, within the scatter of the data. For the endplate welds of the GE 37-element bundle tested in Shek and Wasiluk (2009), four out of the five data appear to have lower K_{IH} values than that of the three bundles tested in the current program.

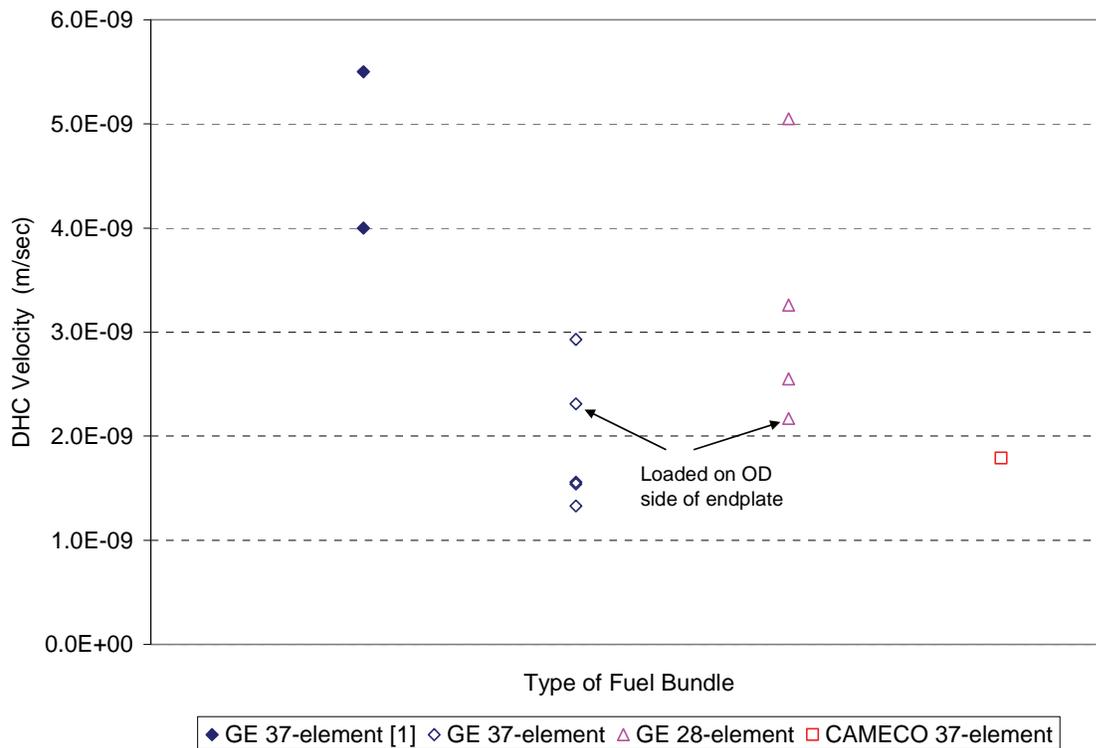
Figure 56: Comparison of DHCV at 150°C of endplate welds from different fuel bundles

Figure 56 compares the DHCV at 150°C from the endplate welds of the GE 37-element bundle tested in reference [1] and the endplate welds of the three bundles tested in the current program. Only the two DHCV data from the outer element welds from Shek and Wasiluk (2009) are used for comparison. Within the scatter of the limited data, it appears that there are no large differences in DHCV of the endplate welds among the three bundles tested in the current year. The DHCV data from the GE 37-element bundle in Shek and Wasiluk (2009) are higher than those from the current test program.
