PHASE 2 INITIAL BOREHOLE DRILLING AND TESTING AT IG_BH04/05/06 - IGNACE AREA

*WP01 Site Demobilization Report – Site
Infrastructure for IG_BH06*

APM-REP-01332-0353

Golder Associates Ltd.

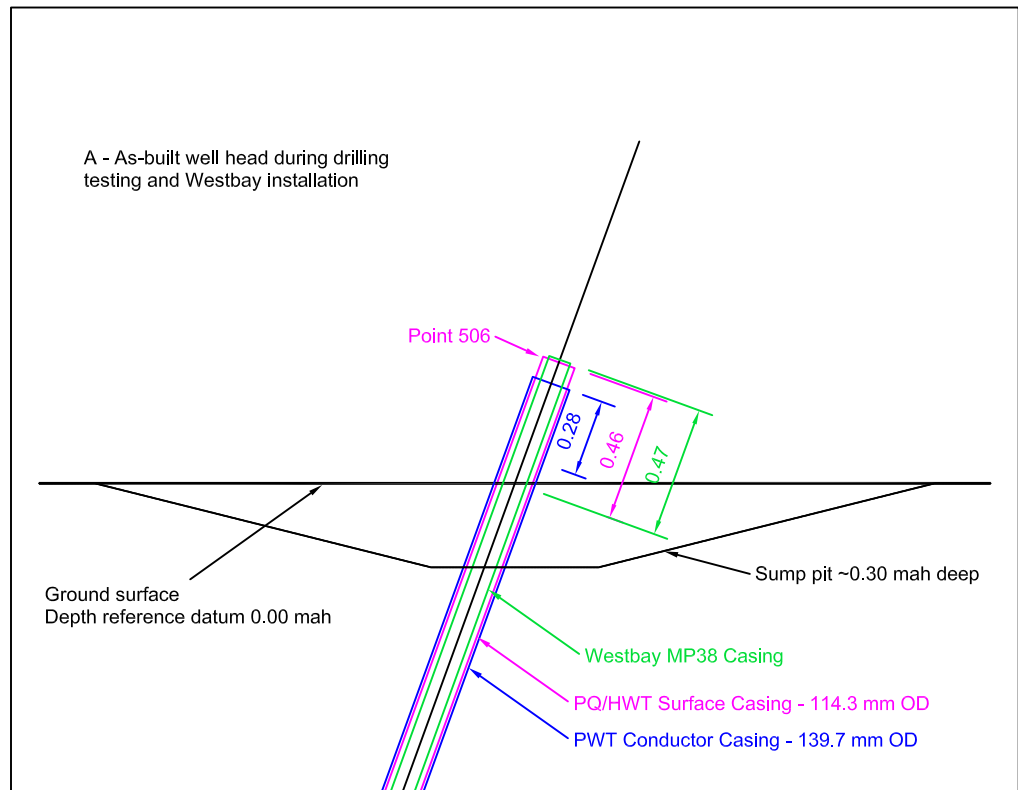
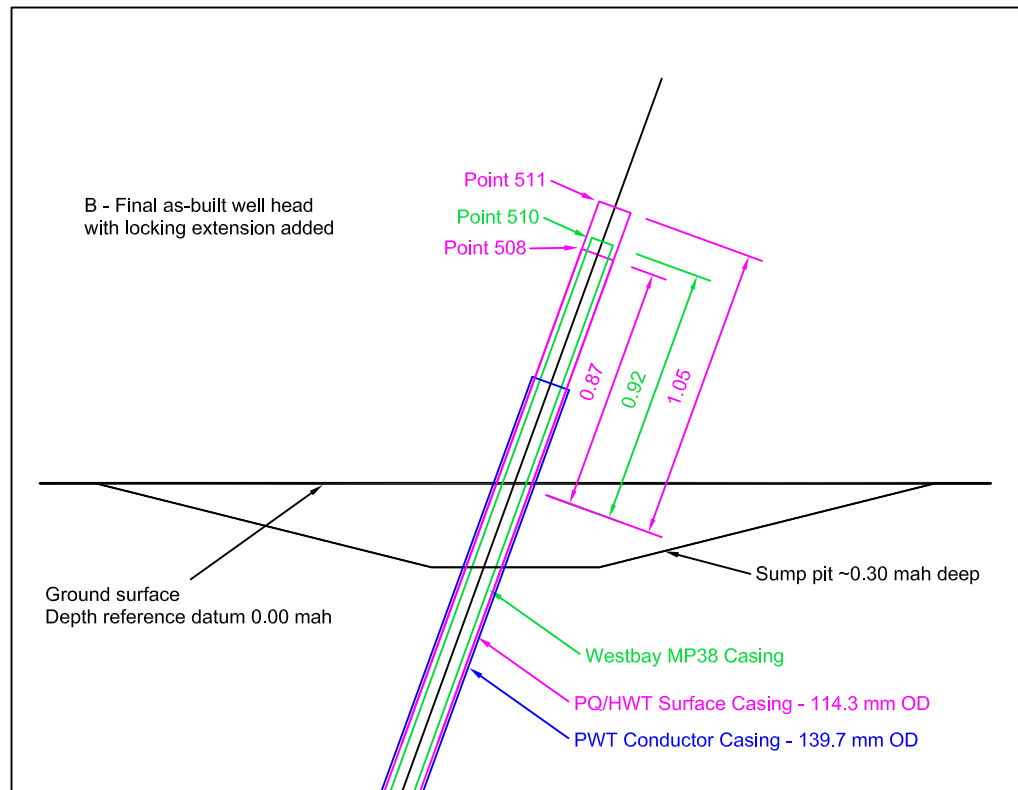
Attachment 3 - Schematic Showing IG_BH06 Well Head

A - Initial Well Head during Drilling / Testing and B - Final Well Head with Locking Extension Added
