Preliminary Hazard Identification for the Mark II Conceptual Design

NWMO-TR-2016-02

January 2016

Saario & Riekkola Oy

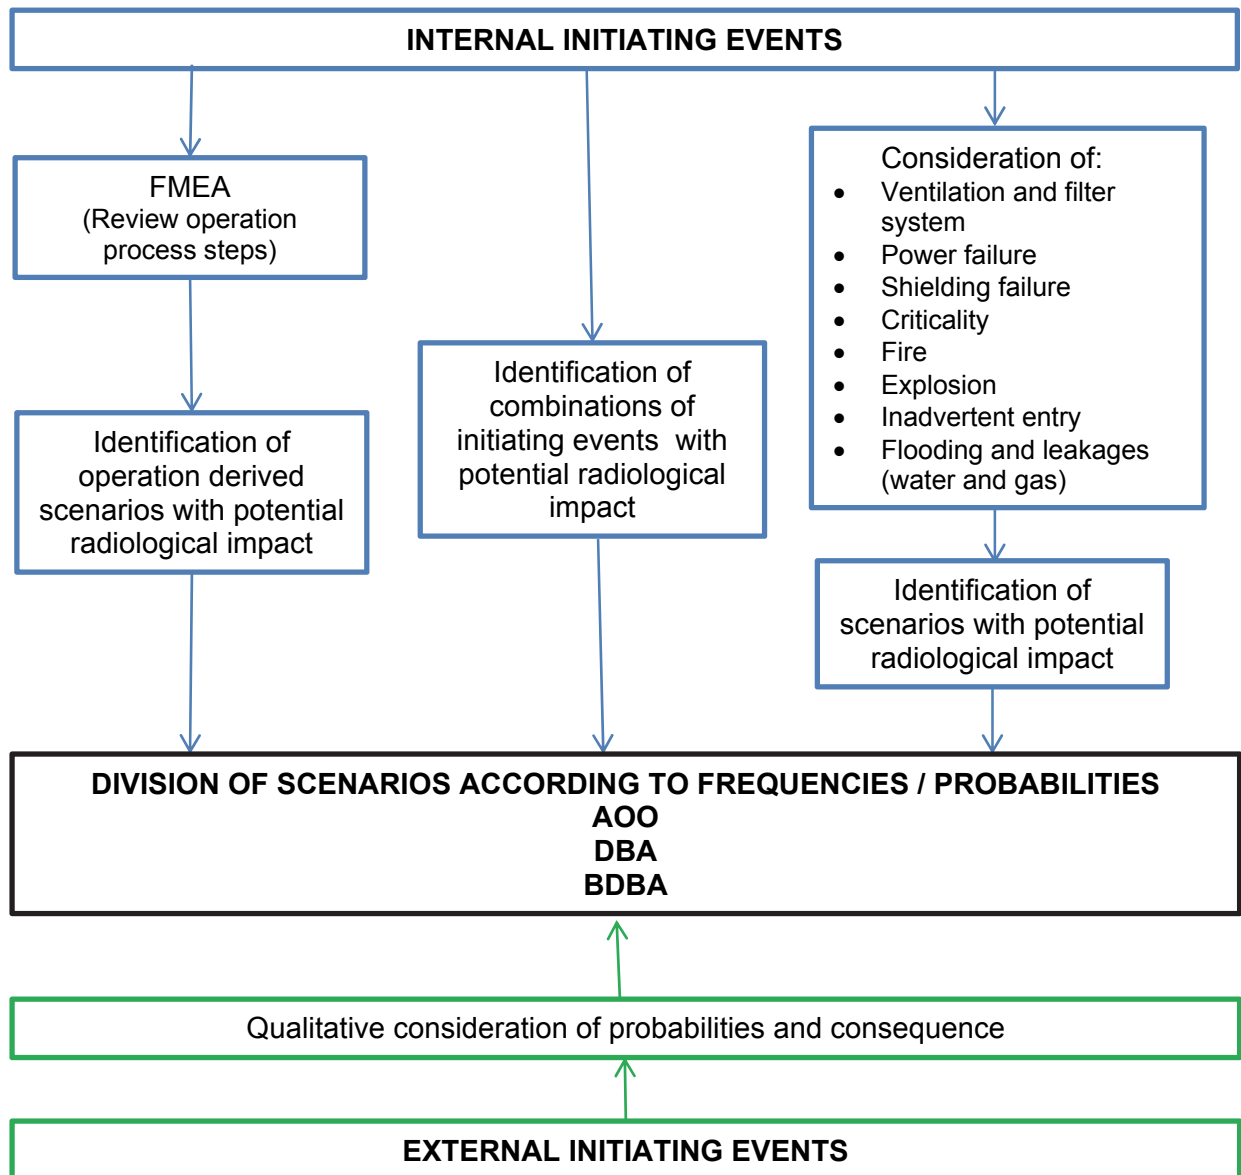
Figure 1: Methodology and Work Flow for Preliminary Hazard Identification

Hazard assessment methodology (Figure 1) is identified based on literature review and considering the need for NWMO's preliminary hazard identification for the Mark II conceptual design. The proposed methodology includes compilation of the disposal process steps and their logical screening to identify relevant accident scenarios that could lead to radiological consequences. The process steps for the conceptual design are based on the preliminary ALARA (as low as reasonably achievable) dose assessment of the Mark II concept (Reijonen et al. 2014). In this report, the process steps are modified slightly for the recent development in the UFPP design, and are included in Appendix B. The identified process step list, together with the conceptual design, is the starting point in the hazard/scenario identification.

The first step of the hazard identification is the identification of initiating events. The process steps are reviewed and screened for potential hazards or accidents, leading to a list of internal initiating events. (Internal initiating events are those internal to the process or operations and are generally associated with equipment failure and human actions). The methodology selected for the screening process should be comprehensive to allow for future iterations, as there are no specific Canadian regulations that identify the accident scenarios. Methodology employed should also be transparent and traceable, to allow systematic documentation that can be updated based on the future iterations in design and hazard assessments during the design development stage.

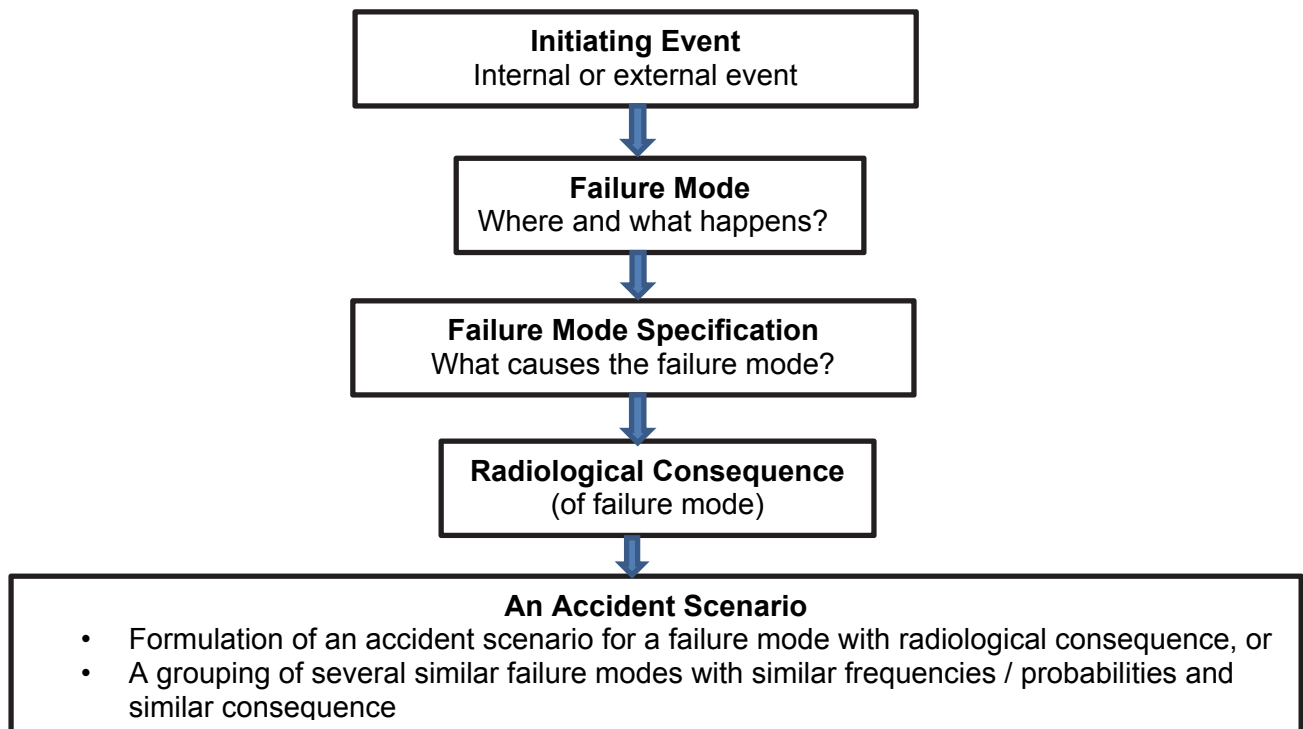
Figure 2: Schematic of Scenario Identification Process

Figure 2 shows the schematic on how the accident scenarios are identified. In general, the process begins with identification of initiating events, followed by determination of failure mode (i.e., where and how the failure mode could occur?). Failure mode may be detailed and a cause of the failure is postulated (i.e., what causes the failure?). From these, an accident scenario with a radiological consequence is formulated. If failure modes have similar frequency and consequence, they can be binned as only one accident scenario. At the end of this report identified accident scenarios are divided according to frequencies as AOOs, DBAs or BDBAs.

As there is a significant number of failure modes identified in the FMEA process that could lead to longer or additional worker exposure, these failure modes are grouped according to their similarity (Figure 2). For example, the FMEA failure modes identified under “Perform smear test” II-4.1 and II-4.2 are grouped together under “Smear test failure”. See Appendix C. Another example is the failure modes identified under “Detach tie-downs of loaded UFTP” II-6.1 and II-6.2, which are grouped under “Tie down detachment problem”. This grouping is presented in Appendix C last column. Appendix C also identifies potential accident scenarios

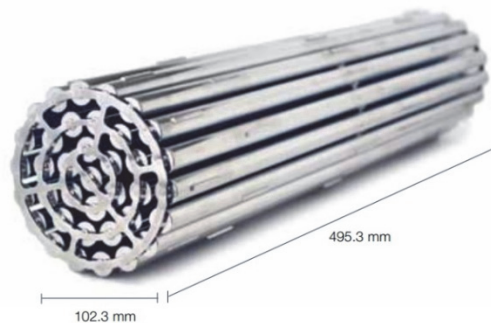
Figure 4: A CANDU Fuel Bundle

Used fuel to be disposed in the planned DGR is CANada Deuterium Uranium- **CANDU fuel** (Figure 4) that uses natural uranium. Canadian used fuel consists primarily of used CANDU fuel, which is generated at commercial nuclear power reactors in Ontario, Québec and New Brunswick. In addition, there are very small quantities of used fuel from research and isotope-producing reactors in Canada.

A CANDU **fuel bundle** consists of 28 to 37 elements containing uranium pellets. The fuel sheath is manufactured from Zircaloy 4, a zirconium metal alloy. Once filled with uranium pellets, the sheathing material is sealed at both ends with zircaloy plugs and welded together into a cylindrical matrix with plates at each end. A typical CANDU fuel bundle is shown in Figure 4. Each fuel bundle is approximately 500 mm long, 102 mm in diameter and weighs about 24 kg.
