PHASE 2 INITIAL BOREHOLE DRILLING AND TESTING AT IG_BH04/05/06 -IGNACE AREA

WP01 Commissioning Report - Site Infrastructure Setup for IG_BH06

APM-REP-01332-0302

Golder Associates Ltd.

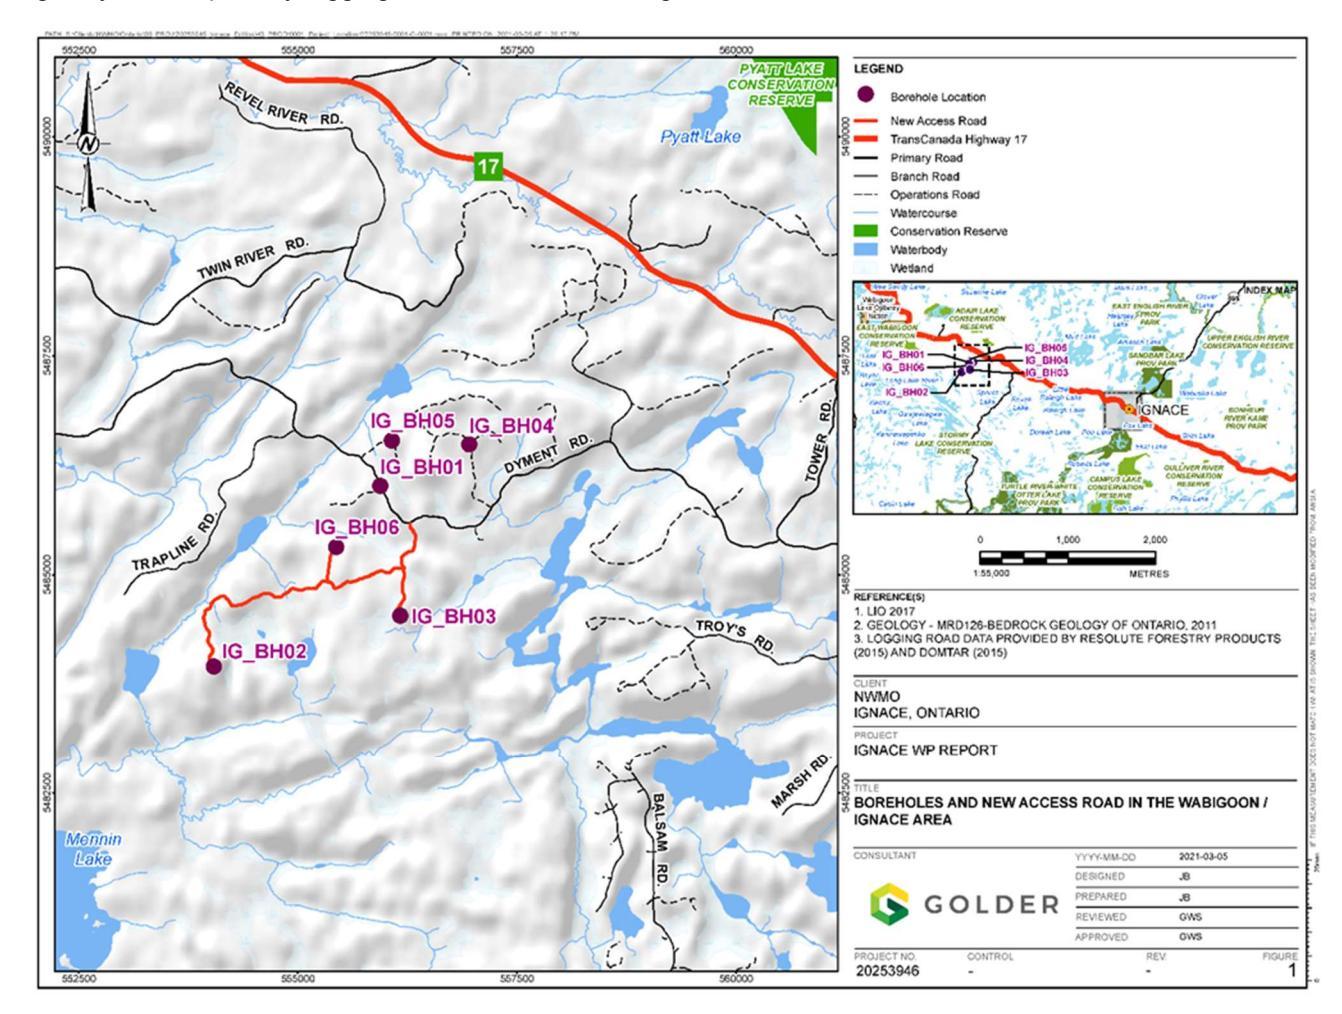
Figure 1: The Ignace area – access roads and drill sites for IG_BH04, IG_BH05 and IG_BH06.

This project involves testing of deep borehole IG_BH04 and the drilling and testing of deep boreholes IG_BH05 and IG_BH06 in the Ignace area within the identified Revell Potential Repository Area. The work comprises a total of eleven work packages and is being carried out by a team led by Golder Associates Ltd. (Golder) on behalf of the NWMO. The overall program at IG_BH06 is described in the Borehole Characterization Plan for IG_BH06 (Golder 2021a). The Ignace area is located a direct distance of approximately 21 km southeast of the Wabigoon Lake Ojibway Nation and a direct distance of 43 km northwest of the Town of Ignace. Access to the area is via Highway 17 and primary logging roads, as shown on Figure 1.

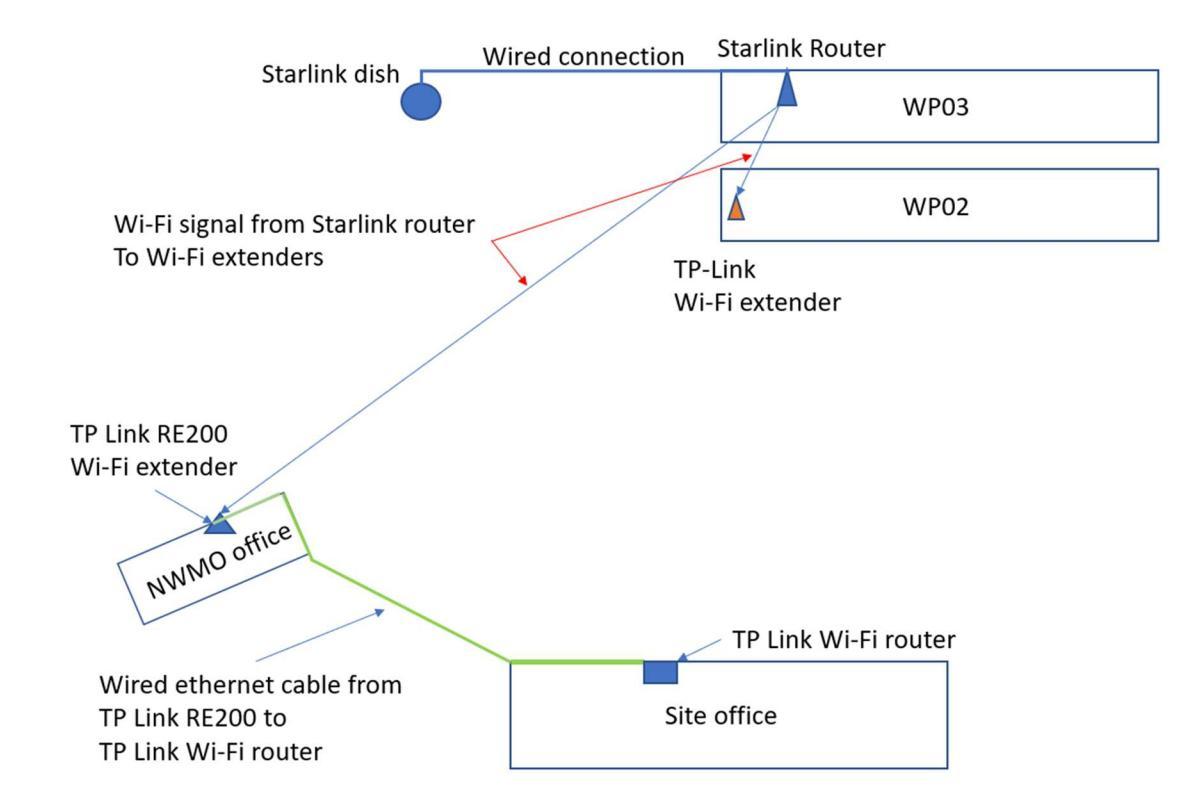
Figure 2: Configuration of devices used to broadcast internet signal at IG BH06

The main satellite signal receiver was installed on the southwest corner of the site and was wired to the Starlink internet router located in the Core Logging Seacan. The internet signal was then transmitted wirelessly by a TP-Link RE200 Wi-Fi extender (Wi-Fi extender) in the Core Storage Seacan and received and rebroadcasted by another Wi-Fi extender in the NWMO/WLON office trailer. The signal from the Wi-Fi extender in the NWMO/WLON office trailer was received and rebroadcasted by another Wi-Fi extender in the Golder office trailer.

Figure 2 below shows the configuration used to broadcast the internet signal across the IG BH06 site.

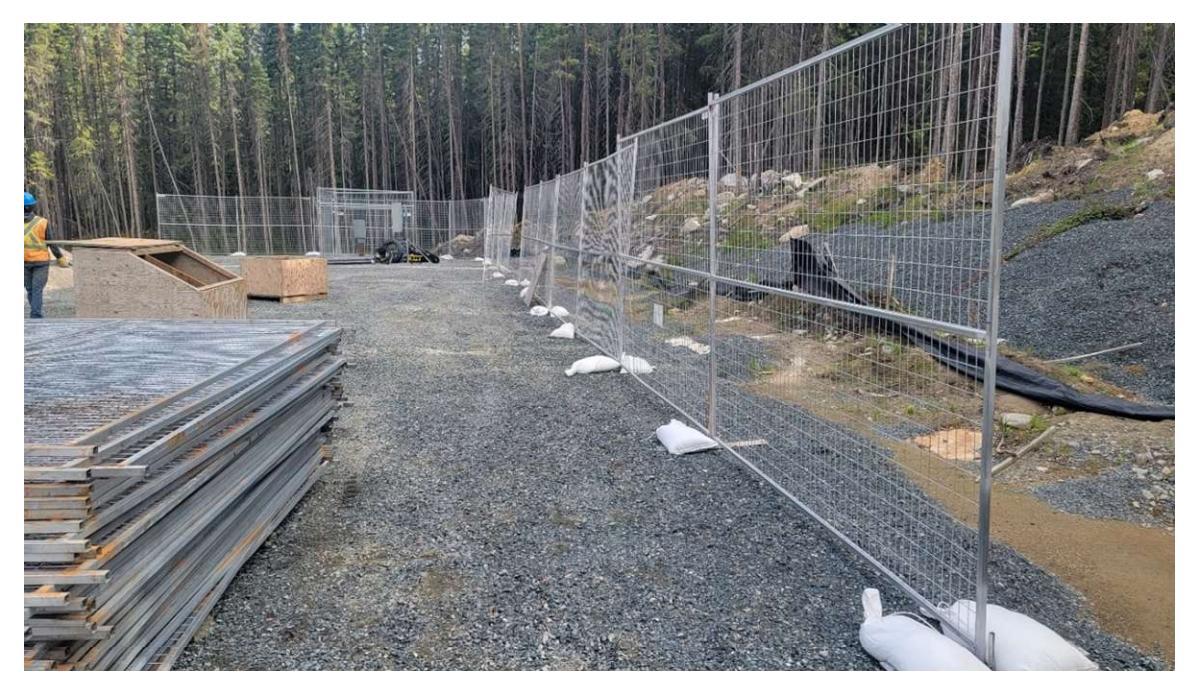
Approximately 190 m (620 ft) of 2.5 m (8 ft) tall fencing was transferred from the IG_BH04 site to IG_BH06 for use as perimeter fencing around the site to define the work area in addition to 30 m (98 ft) of 3.0 m (10 ft), provide security and to discourage wildlife from entering the site. Installation of the perimeter fencing at IG_BH06 is shown in Appendix B, Photo 1.

An additional 43.9 m (144 ft) of 2.9 m (9.5 ft) tall fencing was required to be mobilized to site to complete the perimeter fencing as the site layout of IG_BH06 has a larger footprint than IG_BH04.

Photo 1 - Installation of the perimeter fencing around IG_BH06.

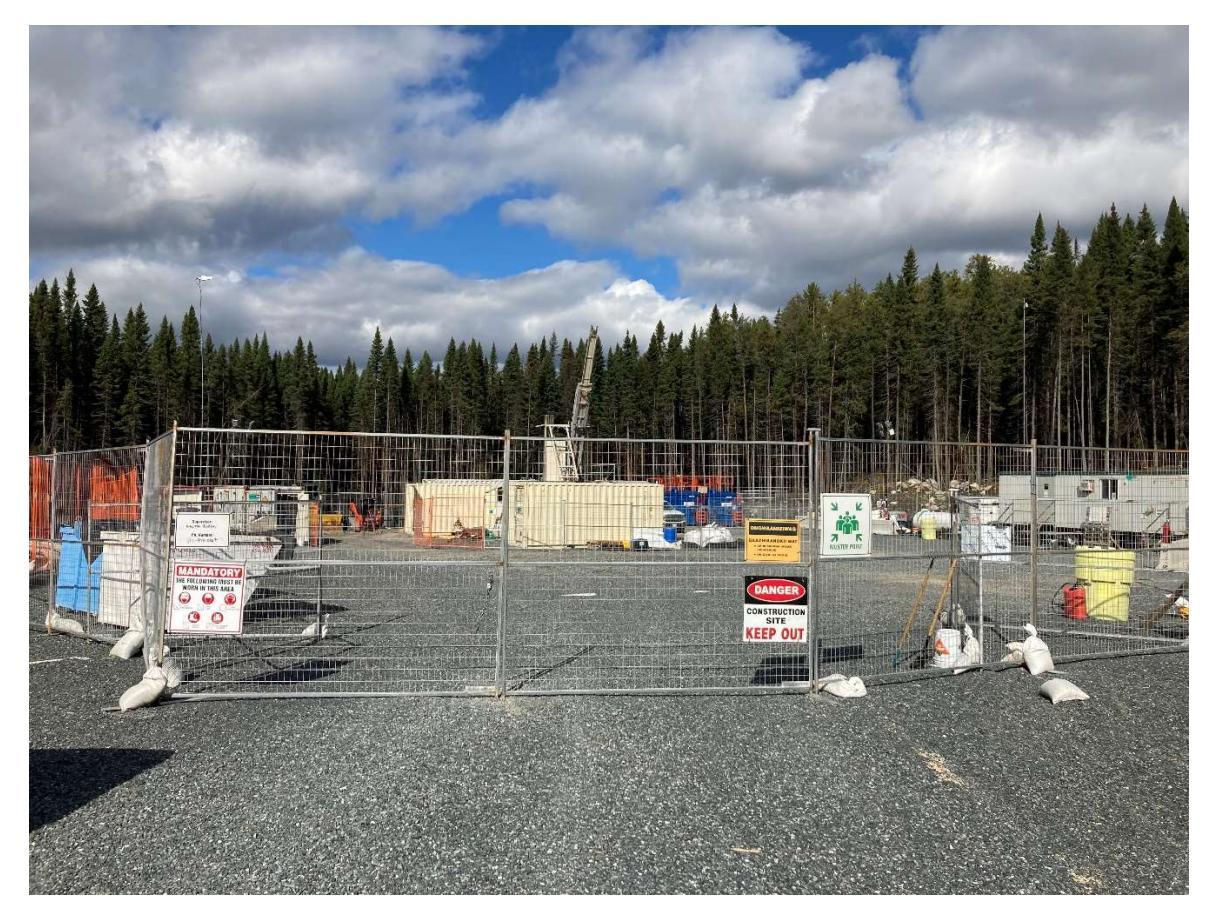
A lockable gate was installed on the south side of the site, to allow worker access to the site from the parking lot (Appendix B, Photo 2).

Safety signage was installed at the entrance to site, and at defined areas such as the muster station, no-smoking areas, and designated smoking areas. The safety signage mounted at the entrance gate is shown in Appendix B, Photo 2.

Photo 2 - Lockable site gate at IG_BH06 and safety signs.

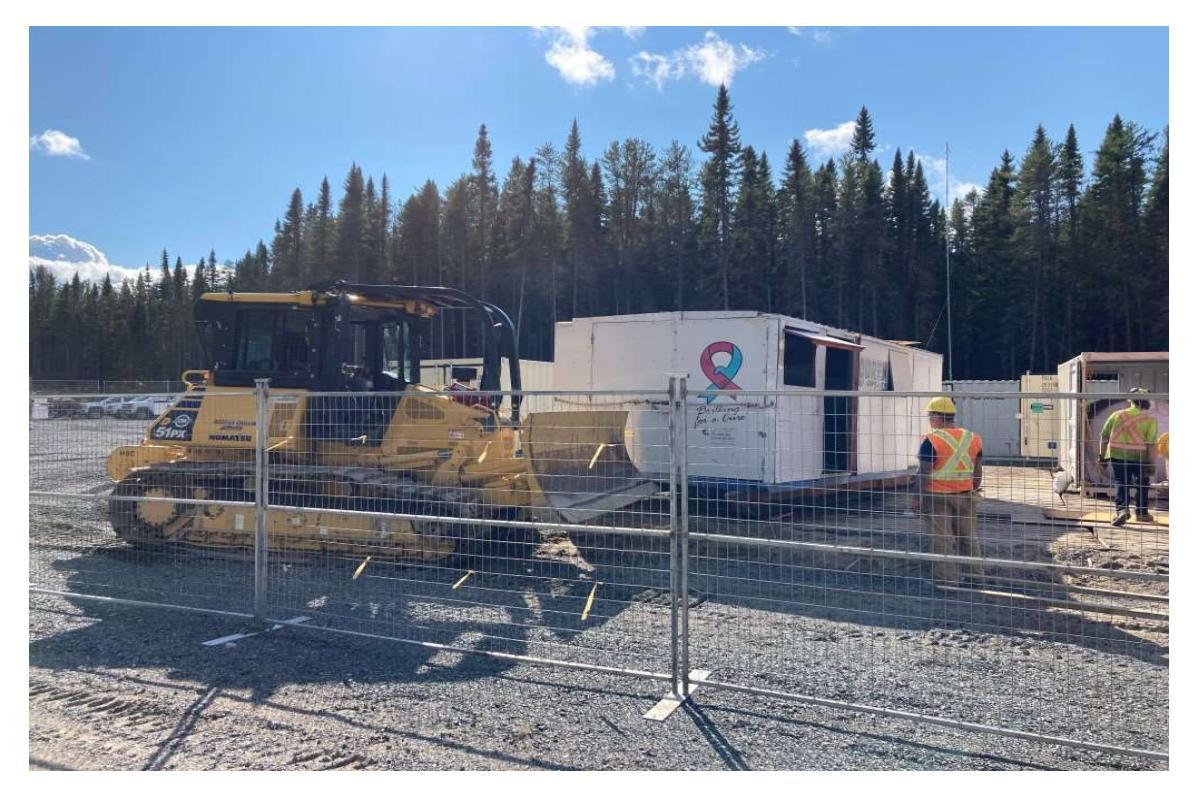
In addition to the perimeter fencing, approximately 70 m (230 ft) of 1.8 m (6 ft) tall fencing was transferred from IG BH04 and installed at IG BH06 around the drill rig area to define an exclusion zone (Appendix B, Photo 3).

Photo 3 - Installation of drilling area fencing.

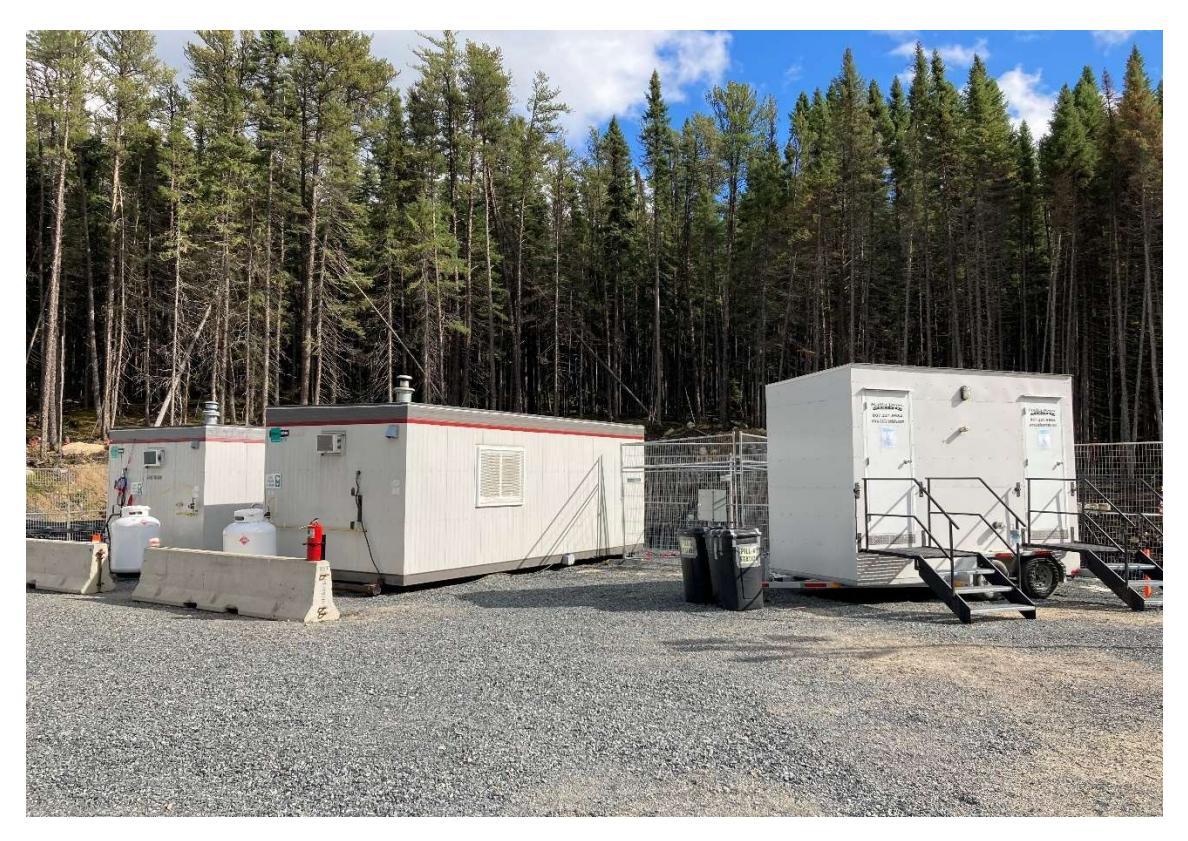
A 12 x 3 m (40 x 10 ft) mobile office trailer was set up on the east side of the site and two 7.3 x 3m (24 x 10 ft) mobile office trailers were set up on the southeast corner of the site. The office trailers functioned as field offices for Golder, NWMO/WLON, and Rodren, respectively. The office trailers were heated and air conditioned, had electrical power, and internet service via Starlink satellite internet service. Cellular service directly outside the trailers is available at a signal strength of 2 bars, however service inside the trailers is limited.

Photo 4 - NWMO/WLON site and site washroom trailers.

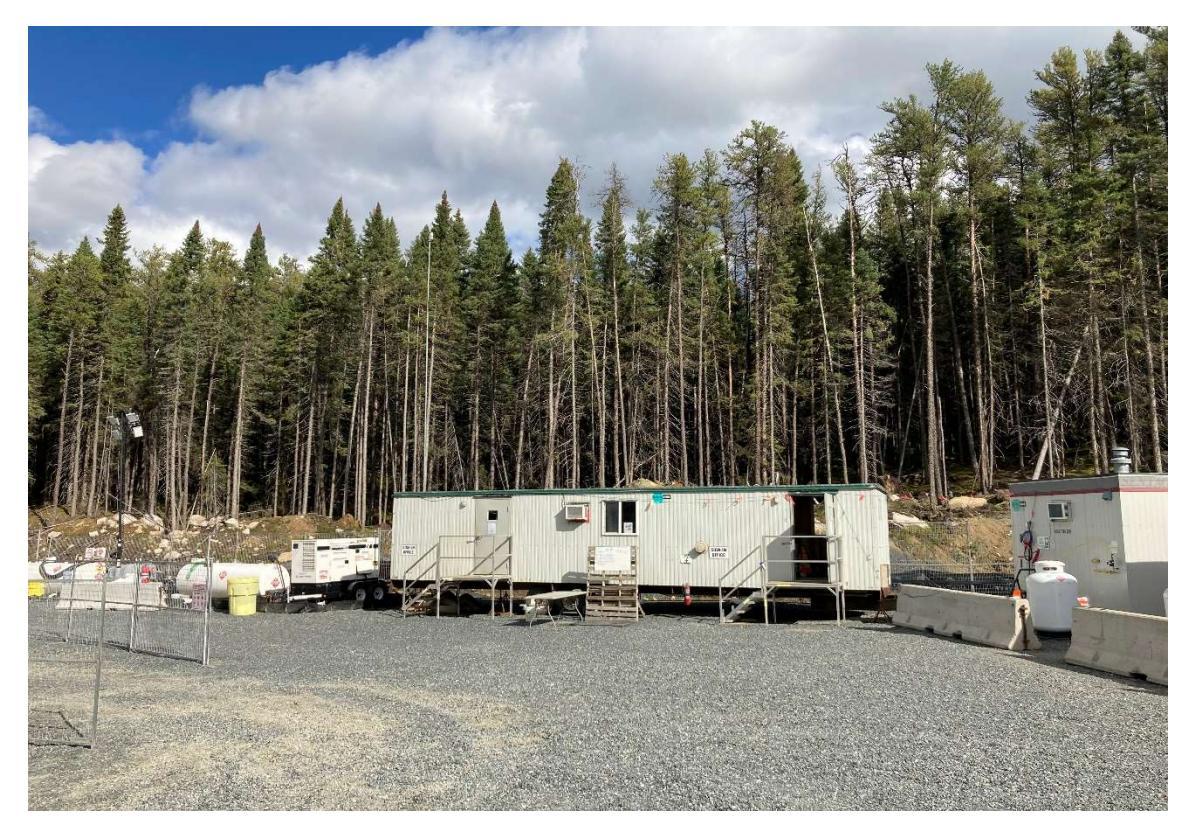
Photo 5 - Golder office trailer.

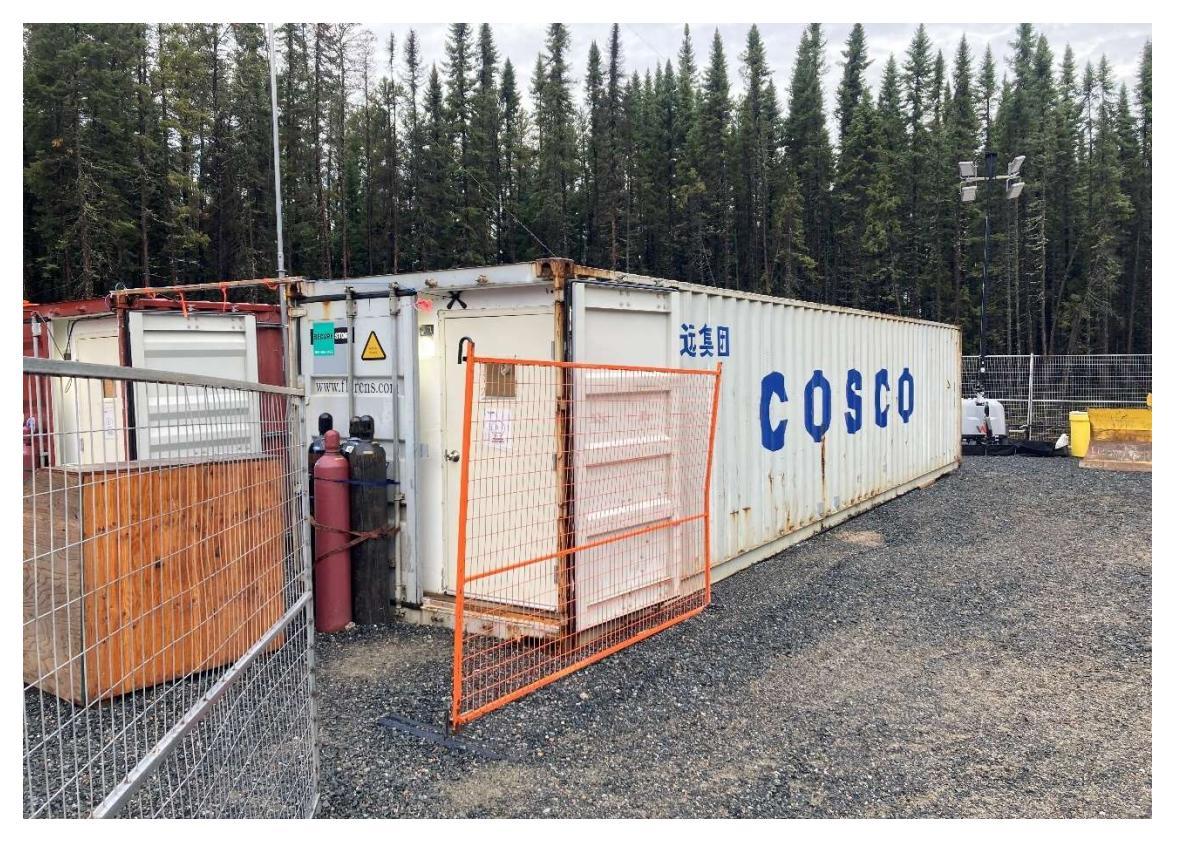
The seacans were used as working, office, and laboratory space, and for the storage of equipment and samples. One seacan was designated as the WP02 Core Storage Seacan (Core Storage Seacan) (Appendix B, Photo 6) and the other was designated as the WP03 Core Logging Seacan (Core Logging Seacan) (Appendix B, Photo 7).

Photo 6 - WP02 core storage seacan – exterior.

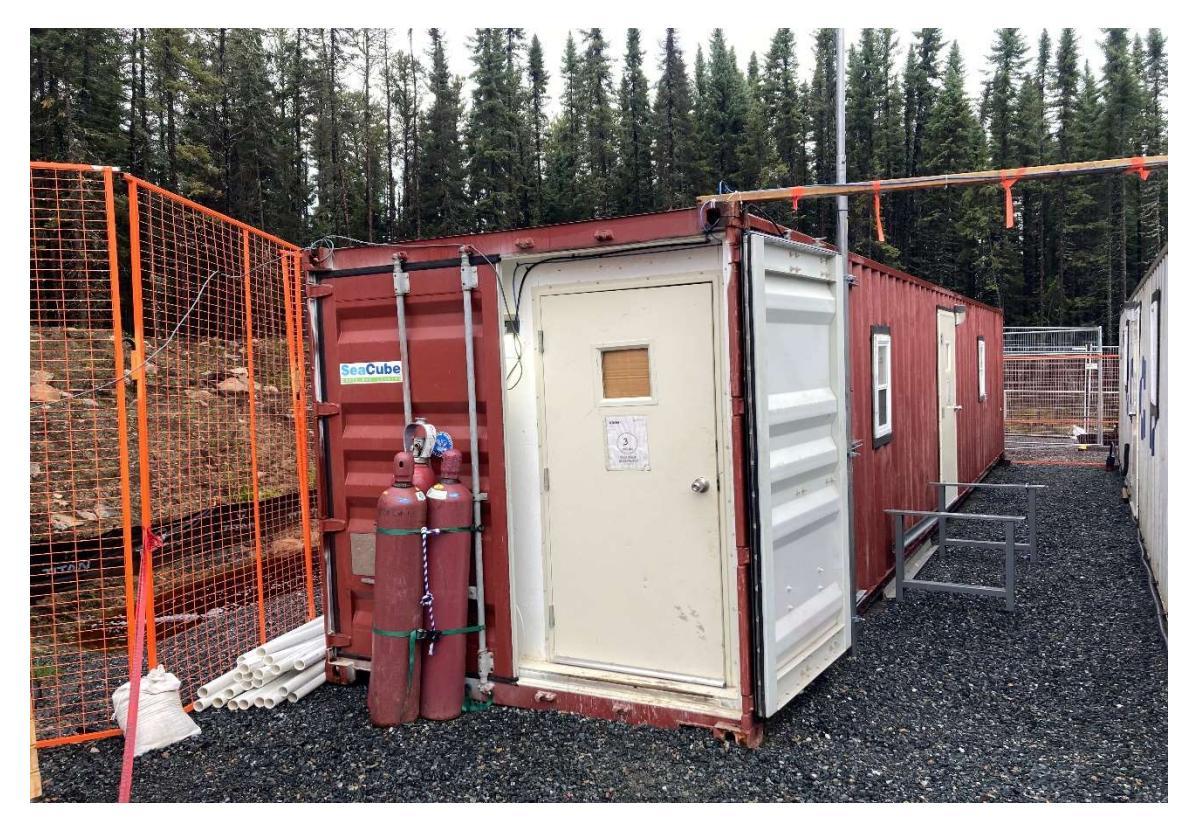
Photo 7 - WP03 core logging seacan – exterior.

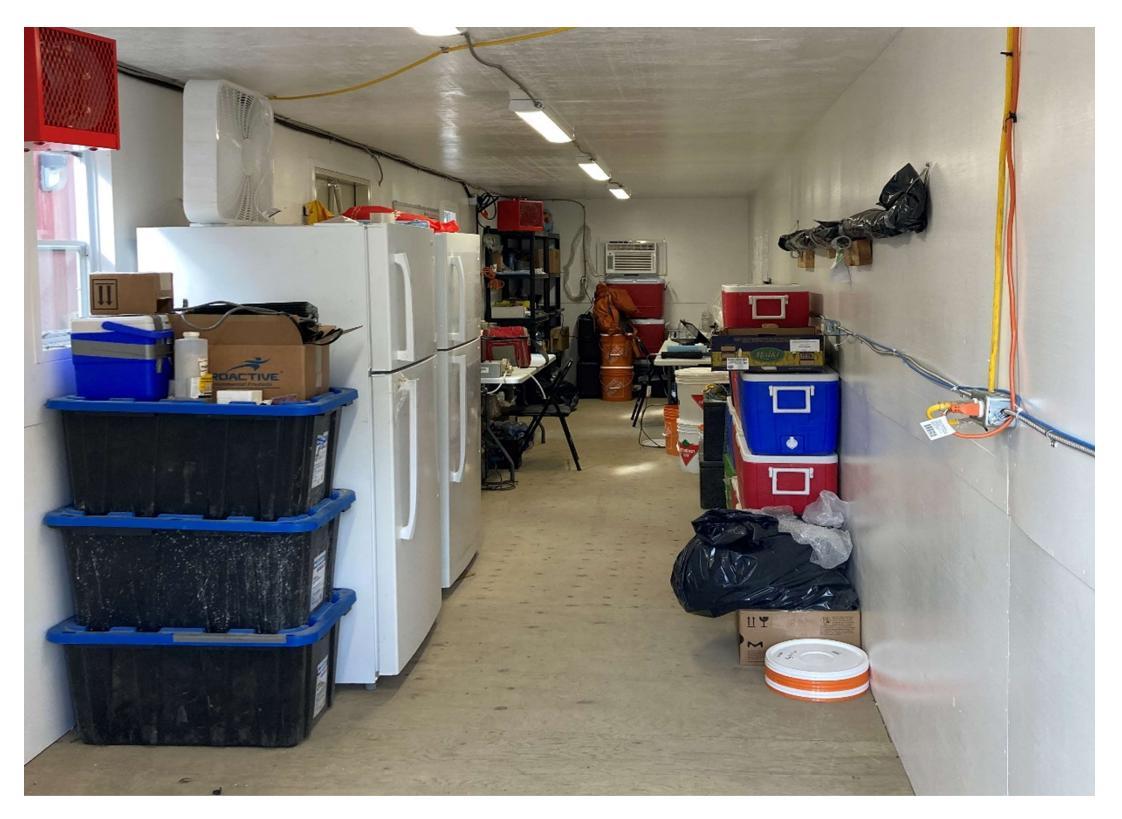
Two custom built core photography systems were set up in the Core Logging Seacan and consist of aluminum frames with suspended cameras for taking core and core boxes photos (Appendix B, Photo 9). Refrigeration for water samples and select drill core samples was provided by two refrigerators located in the Core Storage Seacan. The refrigeration system was used for temporary sample storage until the samples could be shipped off site to the appropriate laboratories or archives (Appendix B, Photo 8).

Photo 8 - WP02 core storage seacan - interior.

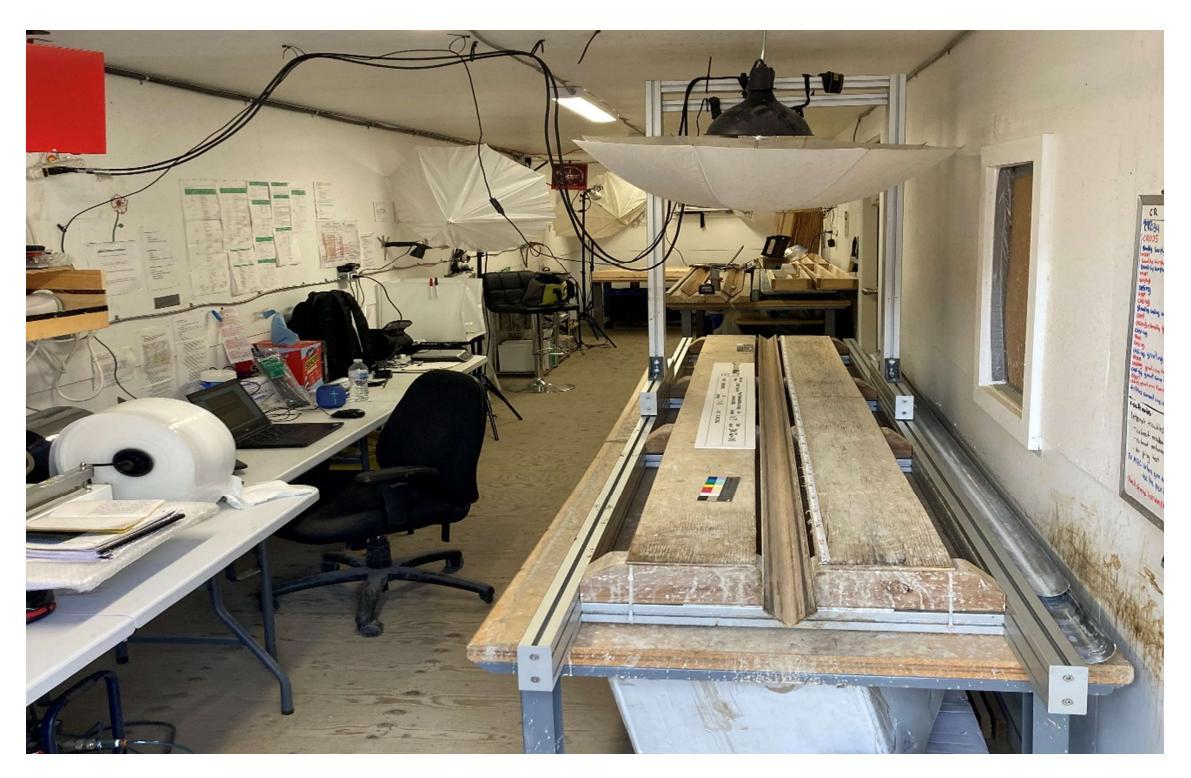
Photo 9 - WP03 core logging seacan - interior.

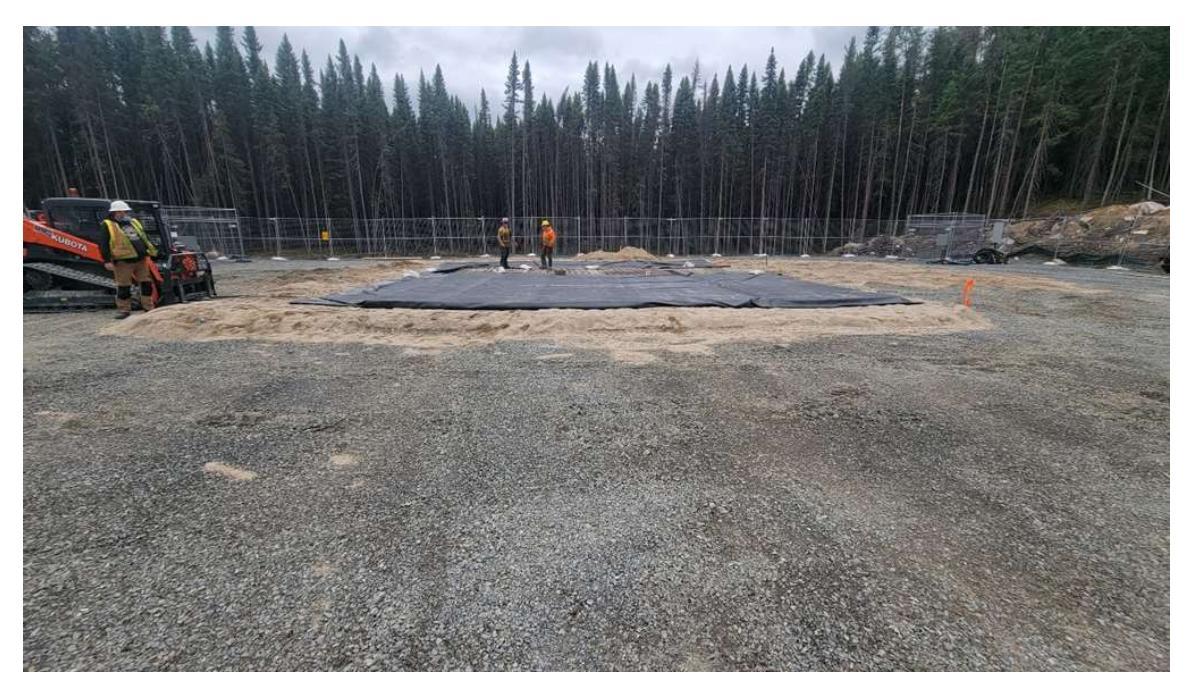
Prior to arrival of the drill rig on site, the drill pad was set up with a secondary containment system which was constructed on site to capture any drill fluid spills that could potentially occur at the drill or drill fluid circulation system. The system was designed with a central sump and the drill pad was graded to slope into the central sump. The containment liner consisted of one rubber layer sealed to the outer casing of the borehole to prevent leaks through the liner (Appendix B, Photo 10).

Photo 10 - Drill pad secondary containment system installation.

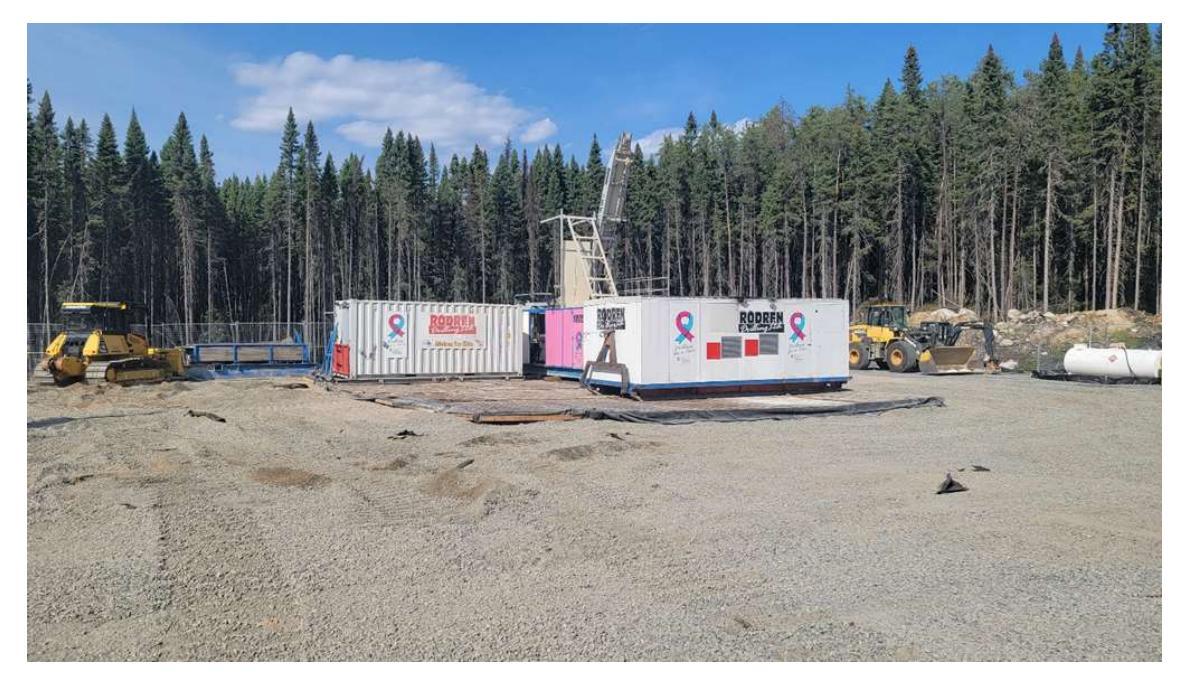
The drill pad was designed so that any drill fluid spills that occurred would drain to the central sump, where it could be pumped into a wastewater storage tank, as required. The secondary containment system provided approximately 195 m² (~2,100 ft²) of lateral coverage, large enough to encompass the footprints of the drill rig, Australian Mud Company (AMC) Solids Removal Unit (SRU) centrifuge, wastewater tank, and fluorescein tank. The wastewater and fluorescein tanks were stored in a 6 x 2.5 m (20 x 8 ft) seacan located on the drilling rig secondary containment (Appendix B, Photo 11).

Photo 11 - Setting up the drilling rig, AMC SRU, and wastewater and fluorescein tanks seacan.

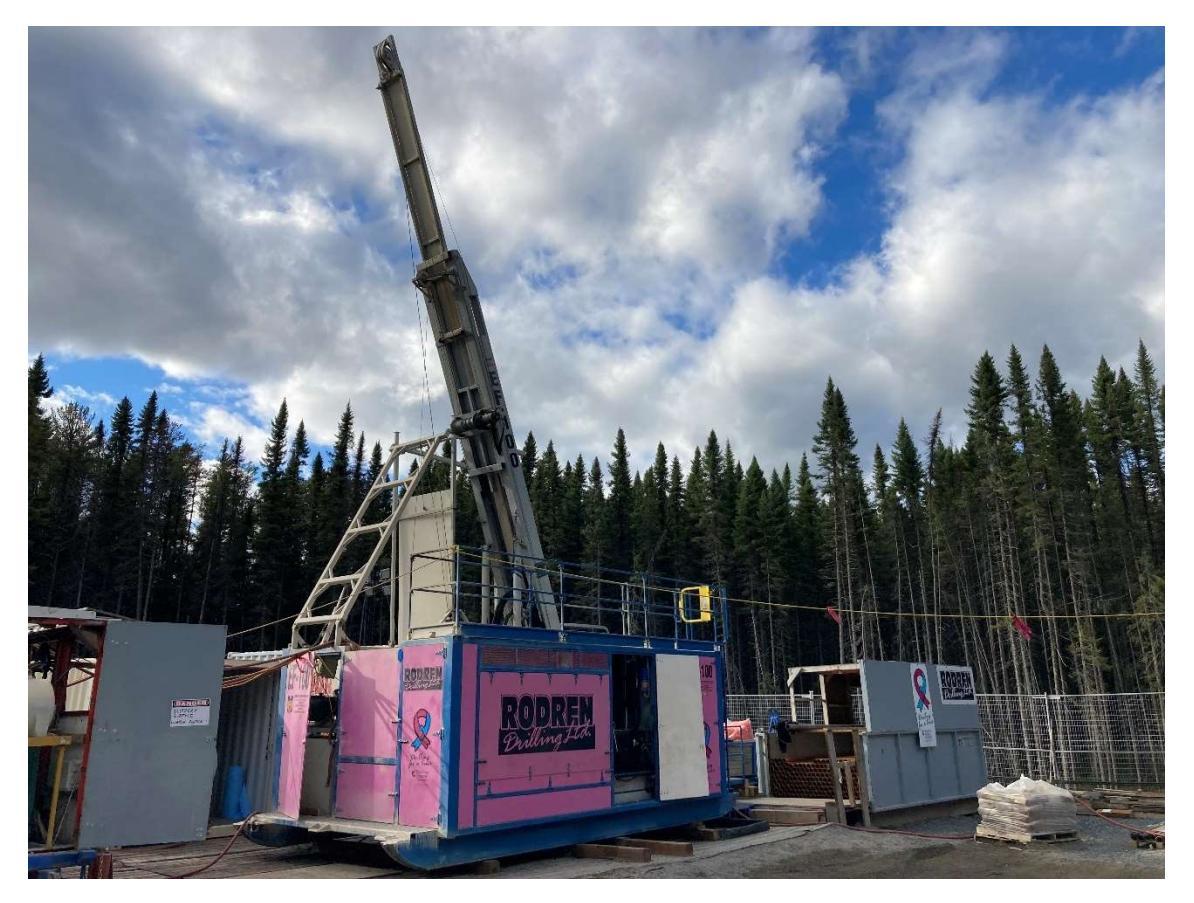
The drill rig was a rotary EF-100 manufactured by Discovery Drill Manufacturer (DDM) Ltd. (Appendix B, Photo 12). The drill was oriented over the planned borehole location, at a dip of 70° from horizontal and azimuth of 360° degrees

Photo 12 - Drilling rig by Discovery Drill Manufacturer - EF-100.

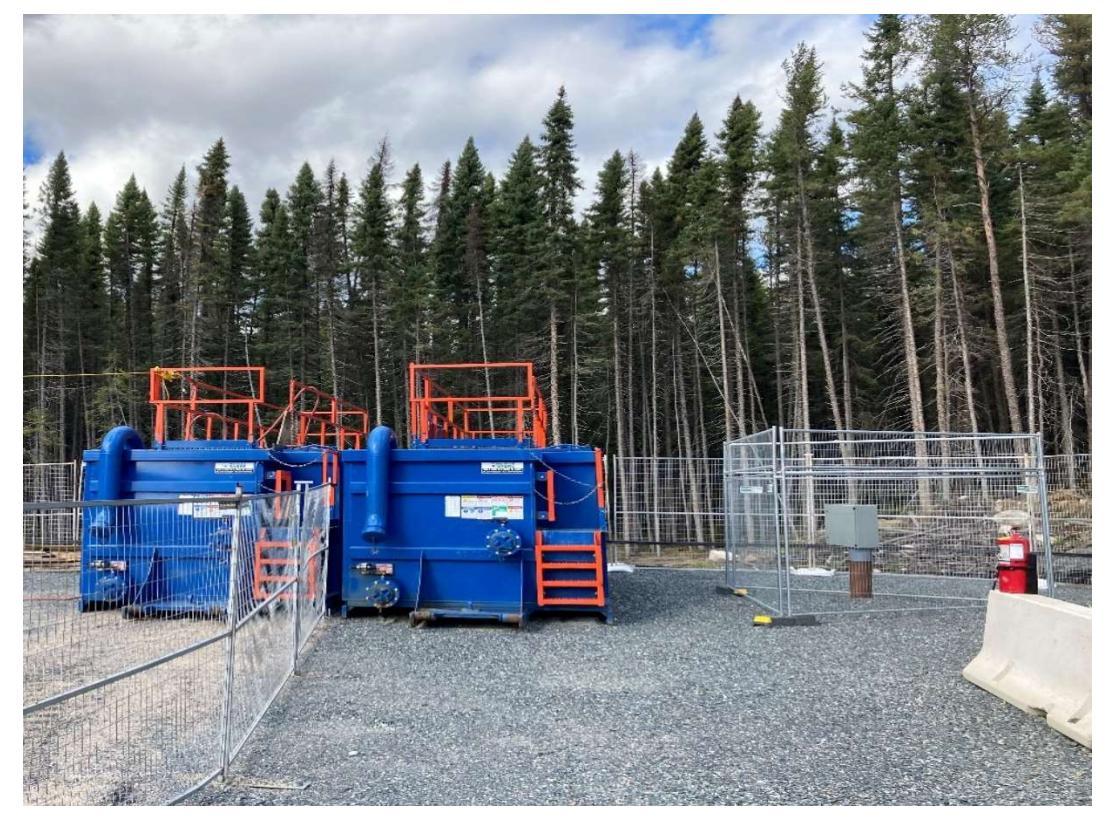
Photo 13 - Two 28,350 litre baker tanks.

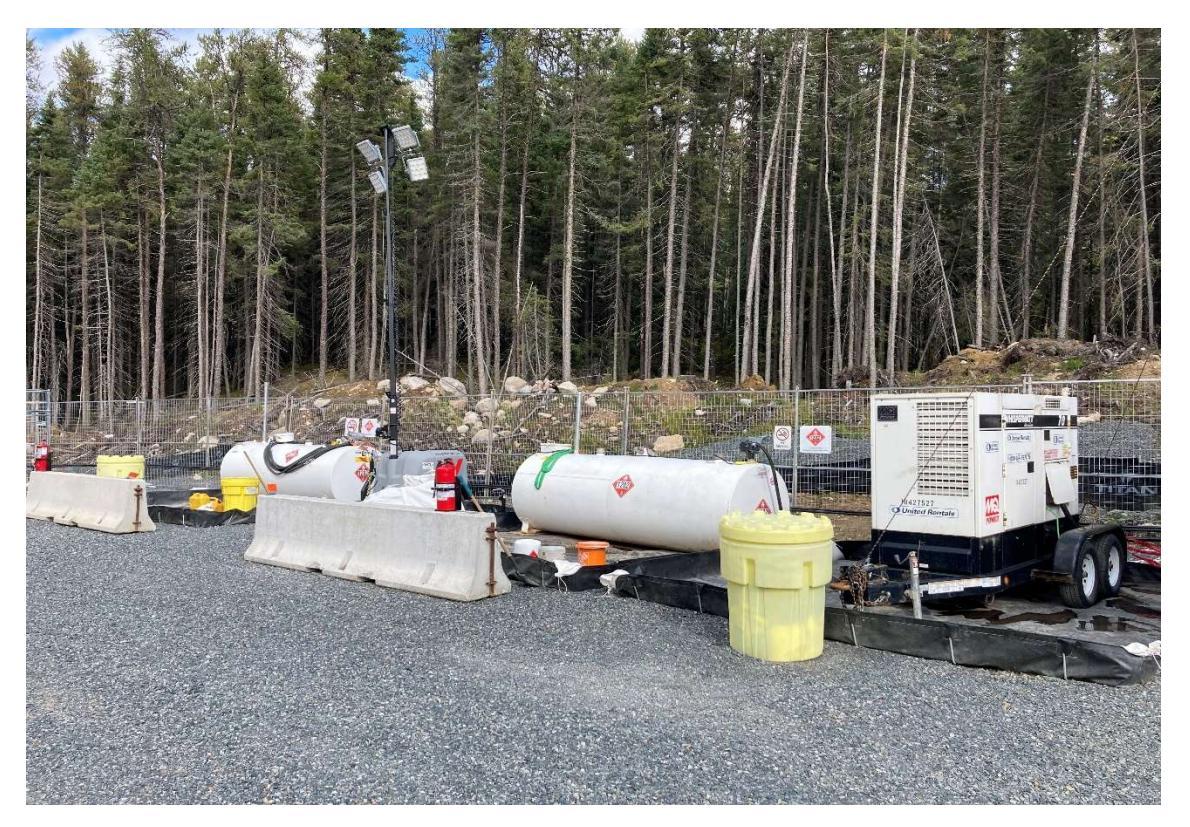
From site set-up in August 2021, the site was powered by MQ WhisperWatt 70 diesel-electric generator, which supplied 56 kW (70 kVA) of 120 V single-phase output. It was used to power the site office trailers, core logging and storage seacans, washroom trailer, and a portable power system on the drill pad. The location of the generator was chosen to minimize the length of electrical distribution cables, to protect the generator from vehicular traffic, and to allow for access by truck if the generator required repairs or replacement. The generator was placed inside a secondary containment berm with a containment capacity of 4,800 L (1,265 US gallons), sufficient to contain approximately six times the amount of fuel and oil in the system.

Photo 14 - Power generator, 2 fuel tanks in secondary containment and spill kits.

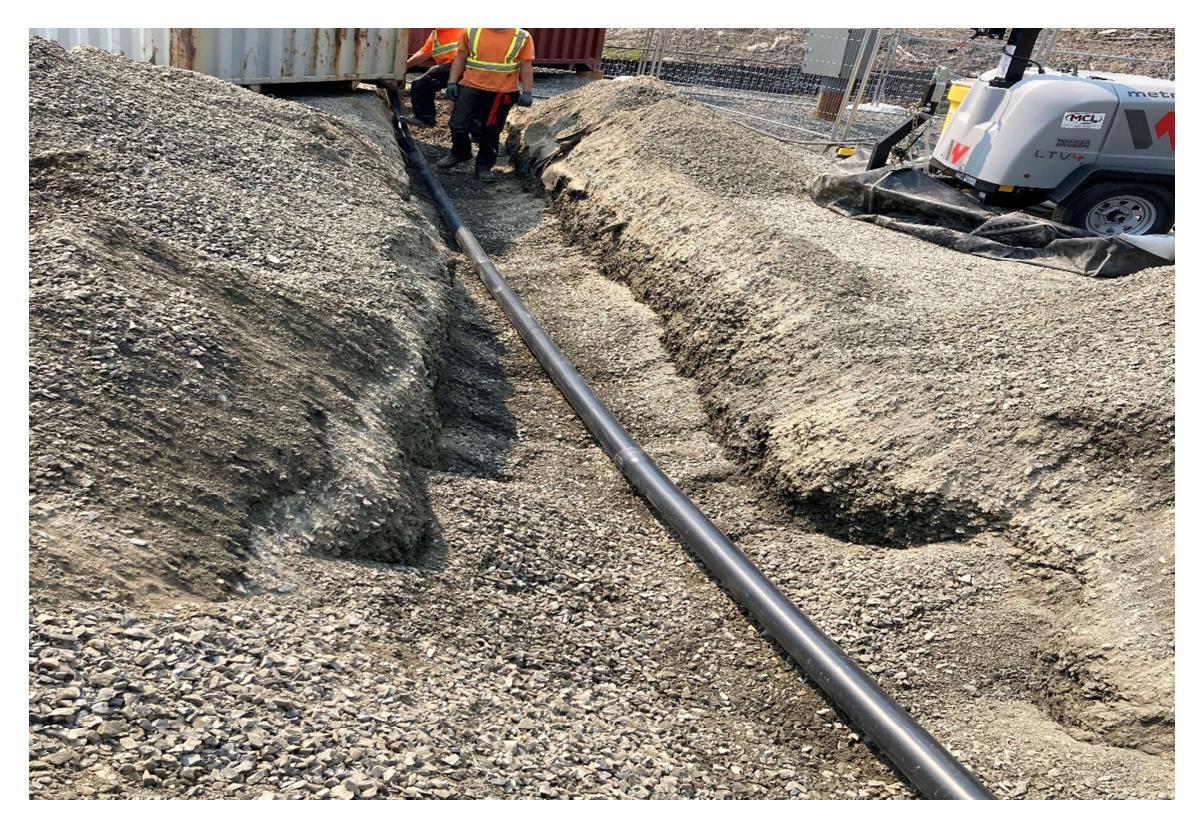
Photo 15 - Trenching and ABS conduit installation.

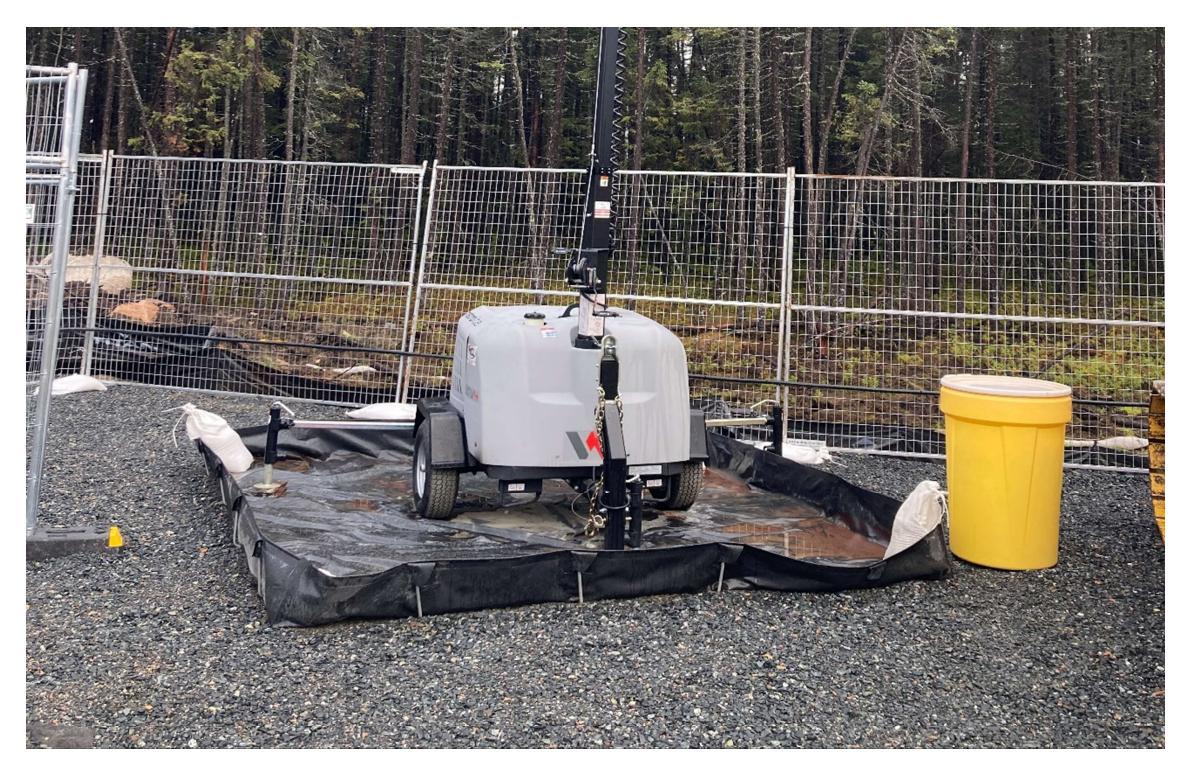
Three 4-kW - Wacker Neuson Metrolite LTV4 diesel powered light towers with LED lights were installed at the site to provide outside illumination during work at night. The light towers were positioned to allow for an even distribution of light. The light tower placement also considered: ground stability, level of activity in the area, and the ability to access the light towers by truck for refueling or repairs. The light towers were all placed within their own secondary spill containment. The containments were sized so that the entire light tower footprint would be within containment. The containment capacities of 2,800 L (740 US Gallons) and 1,150 L (304 US Gallons) exceeded the maximum volume of fuel and oil within the light towers of 180 L (47.5 US Gallons).

Photo 16 - Light tower in a secondary containment and spill kit.

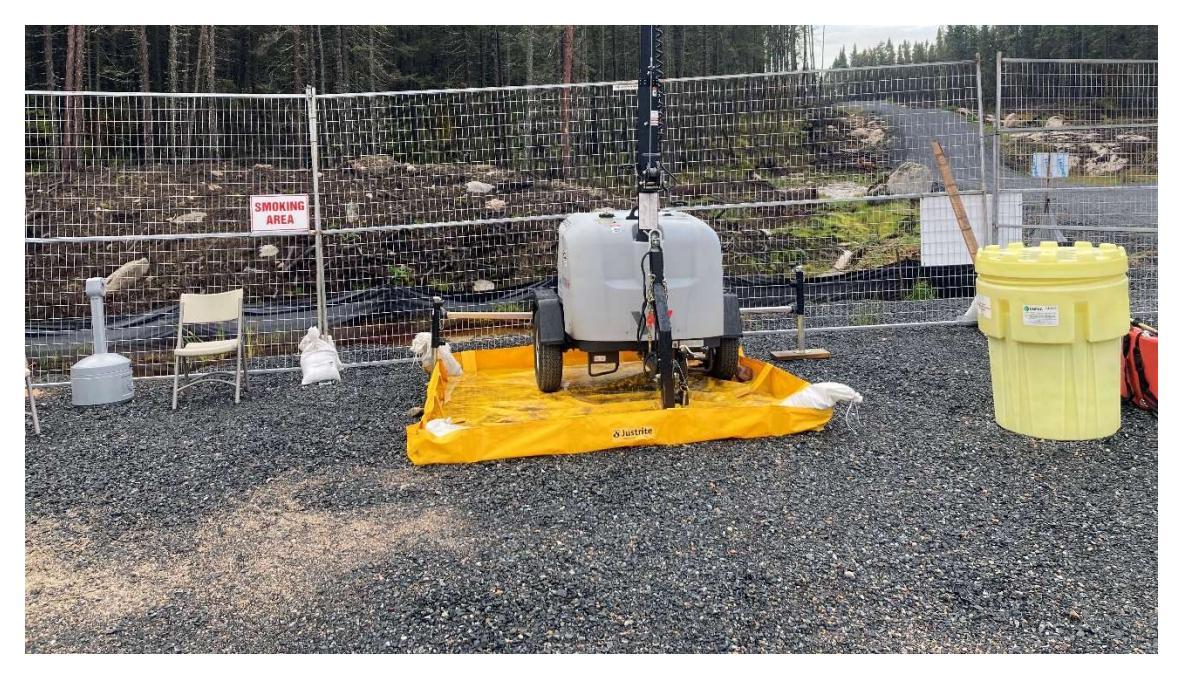
Photo 17 - Light tower in secondary containment and spill kit.

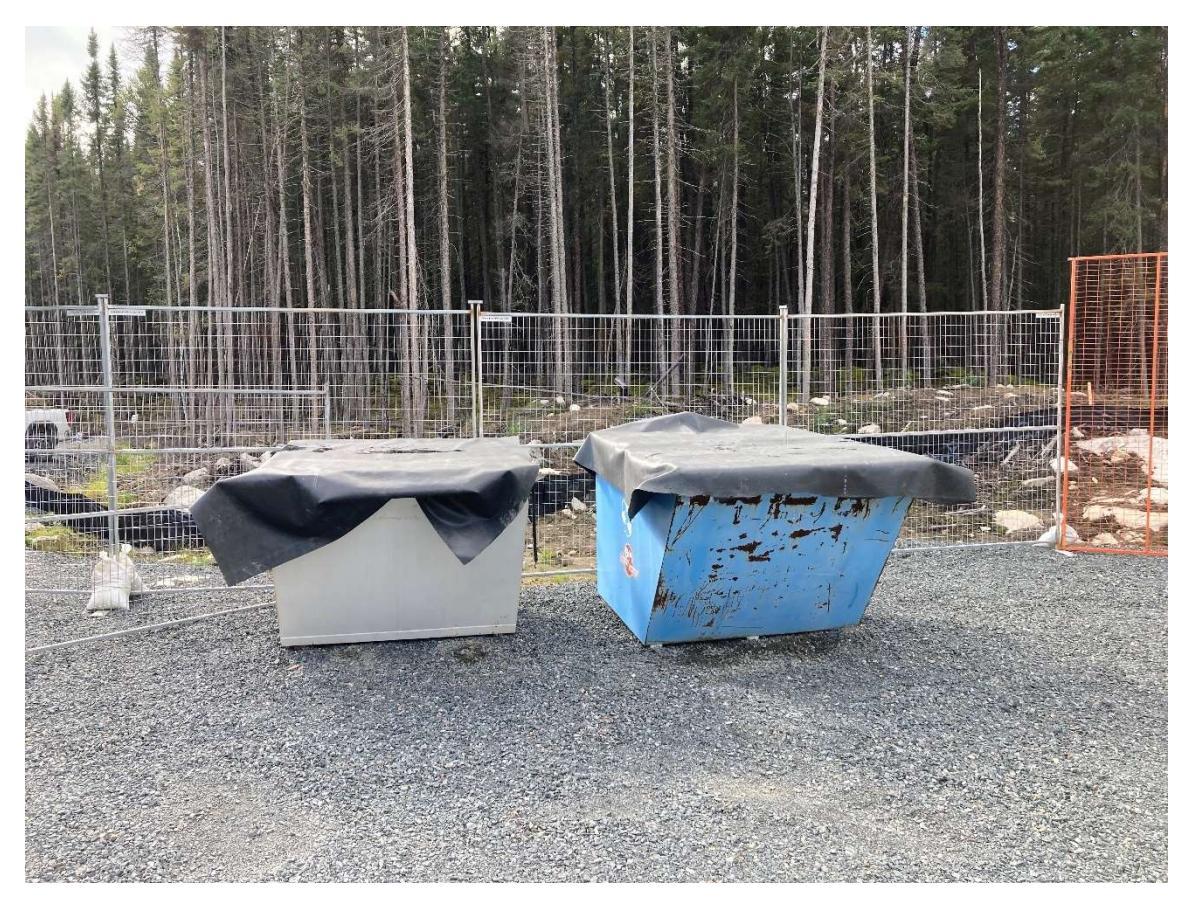
Non-hazardous solid waste was managed using one garbage bin and one recycling bin located near the front entrance to the site, for ease of access by the garbage and recycling truck. The bins were both located inside the fenced area and had lids which could be secured to prevent access by animals and covered with impermeable liner to prevent rainwater accumulation in them. The bins were sourced by B&M Deliveries of Dryden, Ontario, and waste material was transported by B&M Deliveries to the Dryden Landfill Site, located southwest of Dryden, Ontario (Appendix B, Photo 18).

Photo 18 - Garbage and recycling bins covered with impermeable liner.
