PHASE 2 INITIAL BOREHOLE DRILLING AND TESTING AT IG_BH04/05/06 -IGNACE AREA

WP01 Commissioning Report - Site Infrastructure Setup for IG_BH06

APM-REP-01332-0302

Golder Associates Ltd.

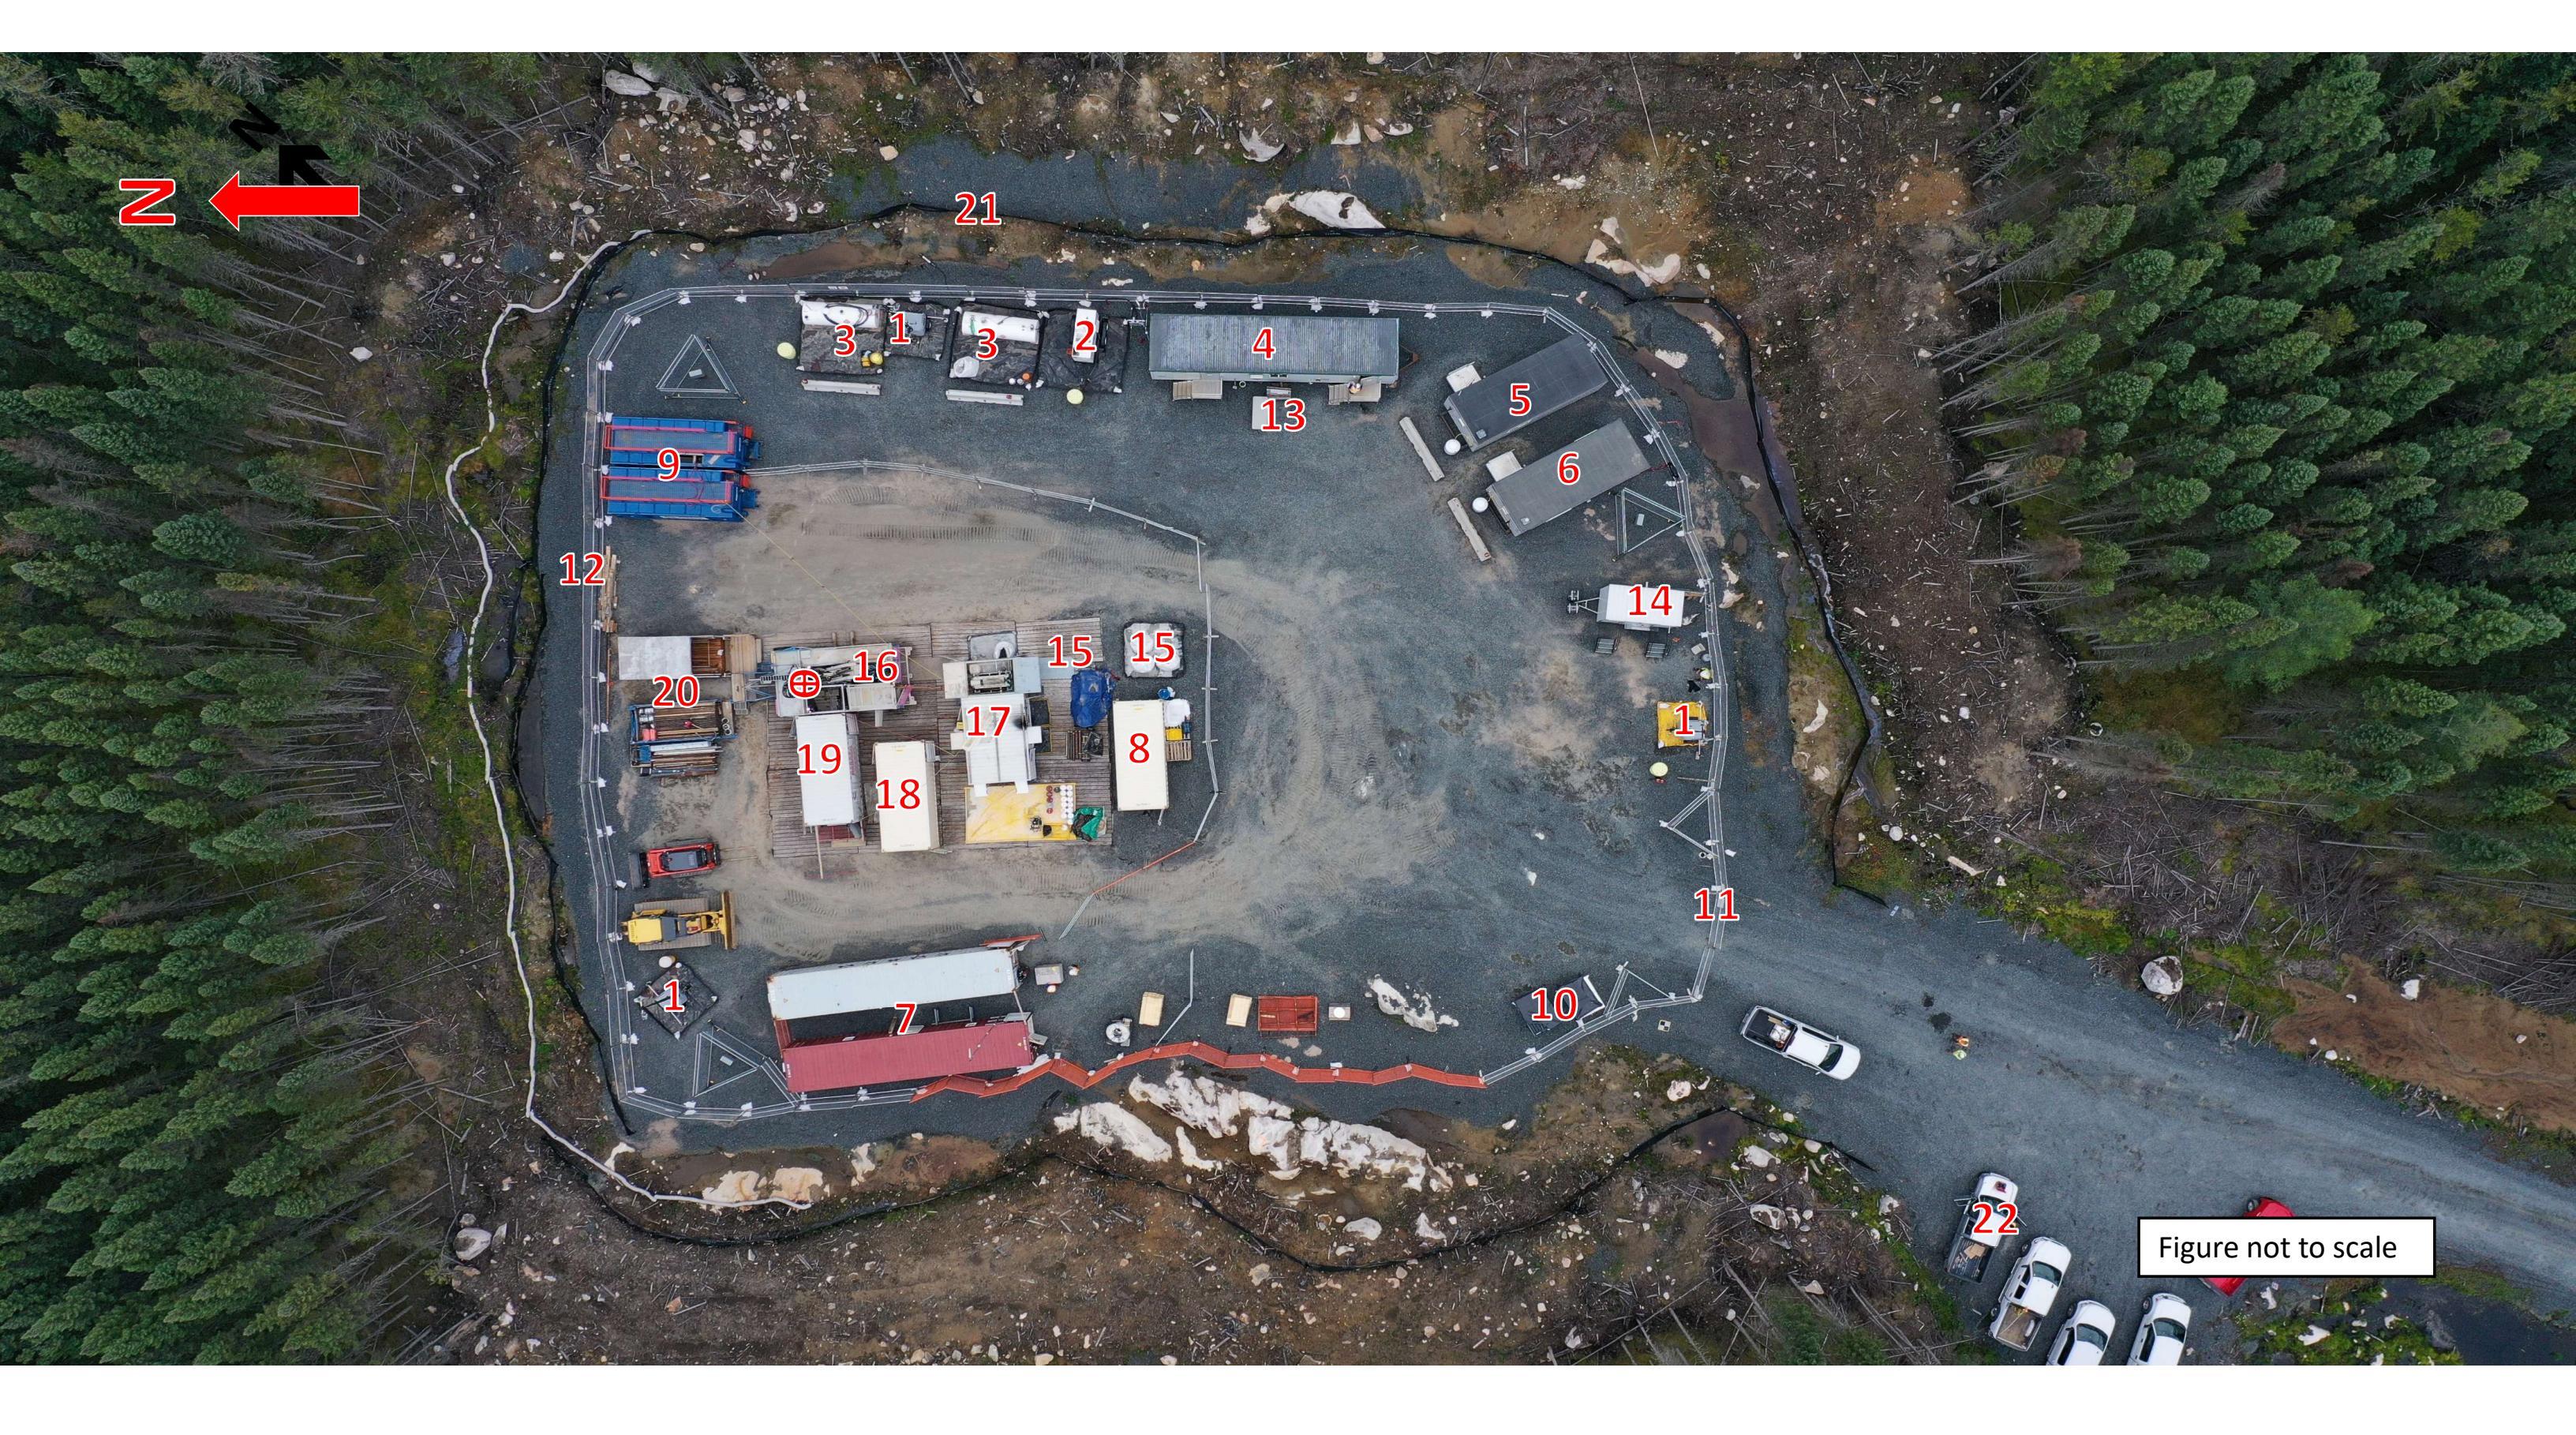
As-Built Site Facilities Layout - IG_BH06

1	Light Towers- 4-kW - Wacker Neuson Metrolite LTV4	13	Tailgate Meeting Area
2	Power Generator – 56 kW - MQ WhisperWatt 70	14	Site Washroom Trailer
3	Fuel Tank - 4,500 L double-walled fuel storage tank	15	Drill Cuttings Storage - drilli bags that are stored in seco
4	Golder's Site Trailer - 40' x 10' mobile office trailer	16	Drill Rig - Skid Mount rotary Drill Manufacturer Ltd.
5	NWMO/WLON Site Office - 24' x 10' mobile office trailer	17	Centrifuge Unit - Australian Unit
6	Rodren Drilling Site Office - 24' x 10' mobile office trailer	18	Wastewater, and Fluorescei
7	WP03 Core Logging and WP02 Core Storage Seacans – 40' x 8' modified shipping containers	19	Core Extraction Shack
8	General Storage Seacan - 20' x 8' seacan	20	Rod Sloop
9	Water Tanks - two 28,350 litre Baker tanks	21	Silt Fence
10	Solid Waste Bins - one garbage bin and one recycling bin	22	Parking Lot with room for 6
11	Site Security - One lockable gate	Ð	IG_BH06 Location

An aerial image showing the as-built site layout, along with with a legend of the main site infrastructure elements, is provided in Appendix C.
