PHASE 2 INITIAL BOREHOLE DRILLING AND TESTING, IGNACE AREA

Site Commissioning Technical Report IG_BH04

Site Commissioning Technical Report – IG_BH04

Phase 2 Initial Borehole Drilling and Testing, Ignace Area Project Number: SCB1912026 Document Number: SCB1912026-REP-006 R3

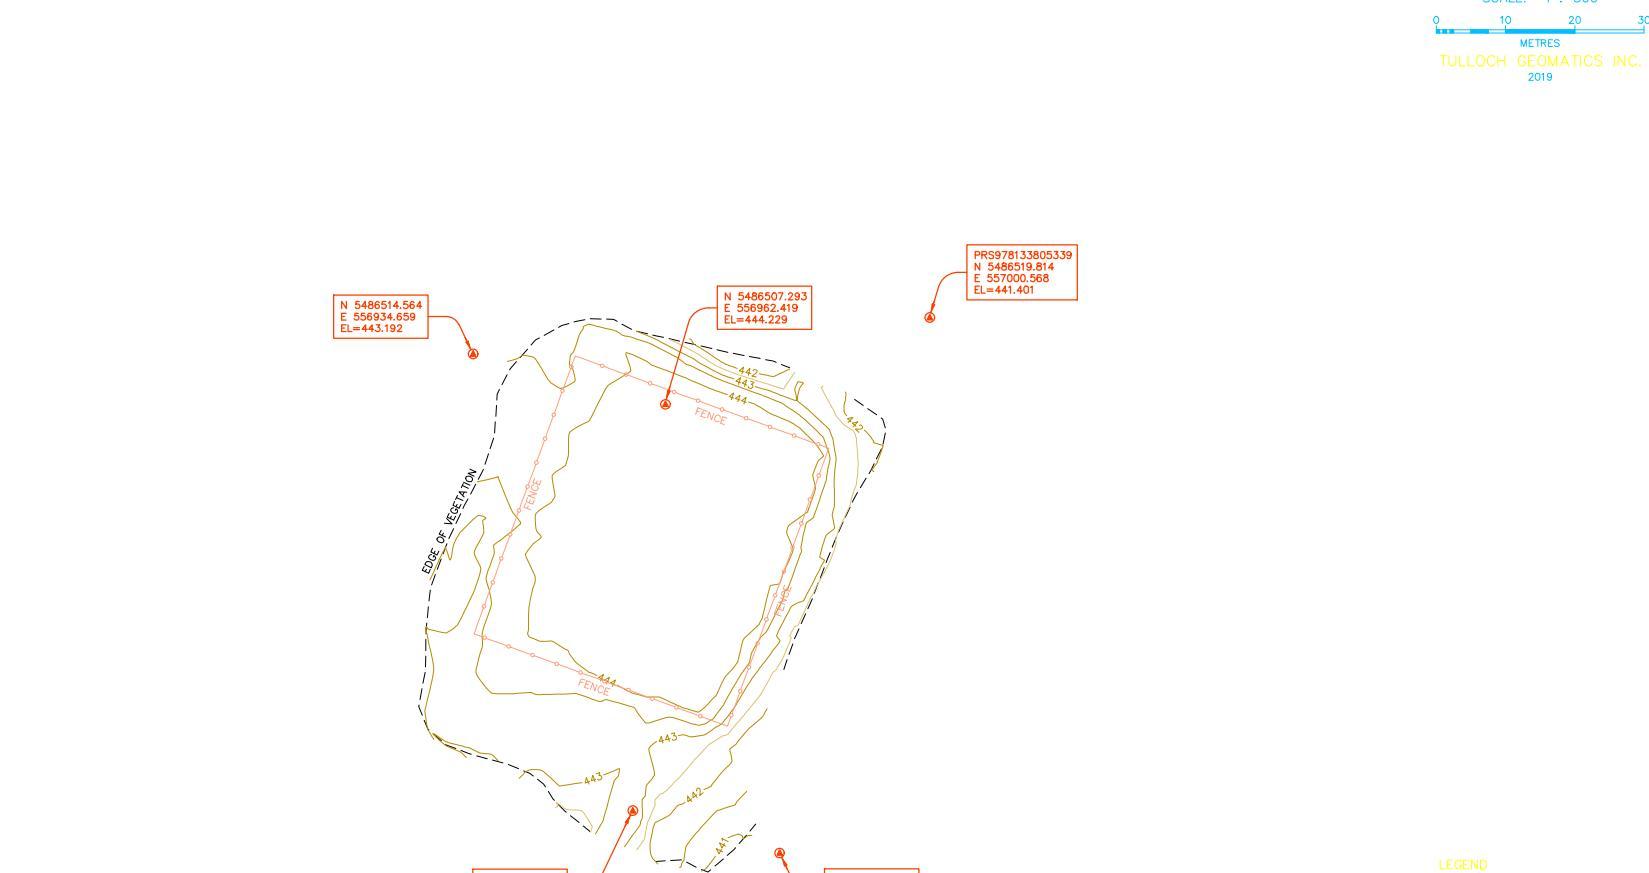
Appendix E As-Built Figure (Controlled Document No. SCB1912026- FIG -003- R02)

N 5486448.659 E 556957.703 EL=443.360

N 5486442.540 E 556978.890 EL=440.948

ELEVATIONS SHOWN HEREON ARE IN METRES AND CAN BE CONVERTED TO FEET BY DIVDING BY 0.3048. ELEVATIONS ARE REFERED TO VERTICAL CONTROL MONUMENT 0011993U067 HAVING A PUBLISHED ELEVATION OF 419.358m CGV028-78.

For the final as-built survey, please refer to Appendix E: As-Built Figure (Controlled Document No. *SCB1912026- FIG -003-* R02).
